REVISION A - GROUND INVESTIGATION REPORT

Home Farm, Bedfield, Suffolk, IP13 7EE

Chapter Build Group Ltd

Project no: 61647

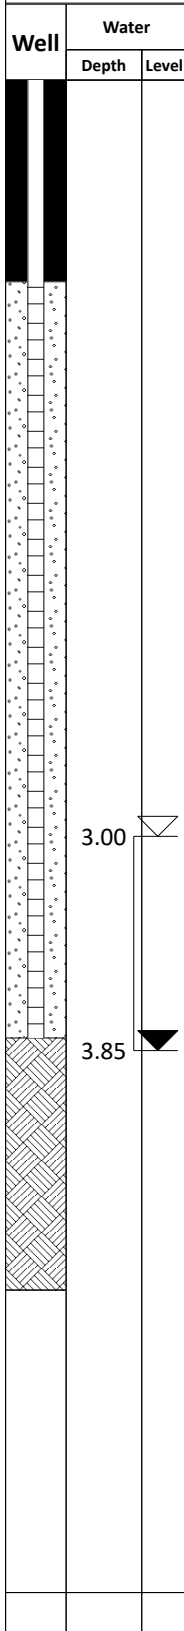
0.15					Yellow medium to coarse SAND.	
					0.30					MADE GROUND	
					0.40	ES1				Very soft to soft dark brownish greenish black slightly gravelly slightly sandy CLAY with root material. Gravel is angular to subangular fine to medium flint and occasional brick.

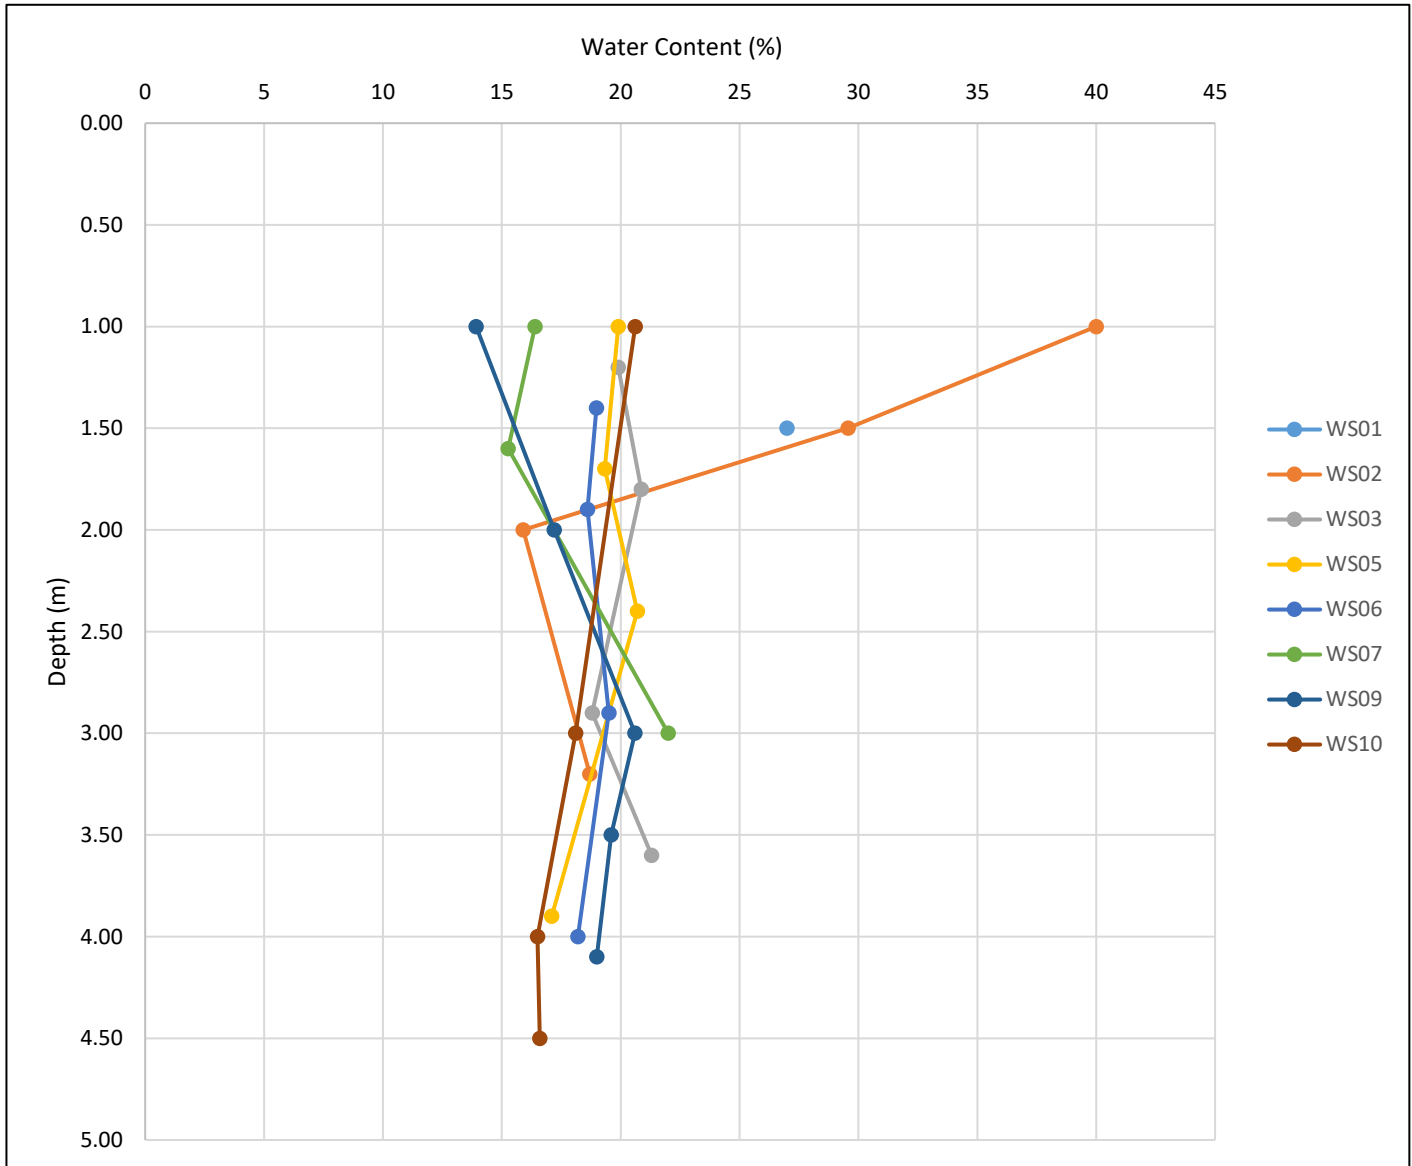
Contract	Home Farm, Bedfield
Serial No.	40963_1

WATER CONTENT VS DEPTH BELOW GROUND LEVEL
