CLEAVE COTTAGE LITTLE TORRINGTON DEVON

Ecology Survey

July 2022

PES reference: PES/1502

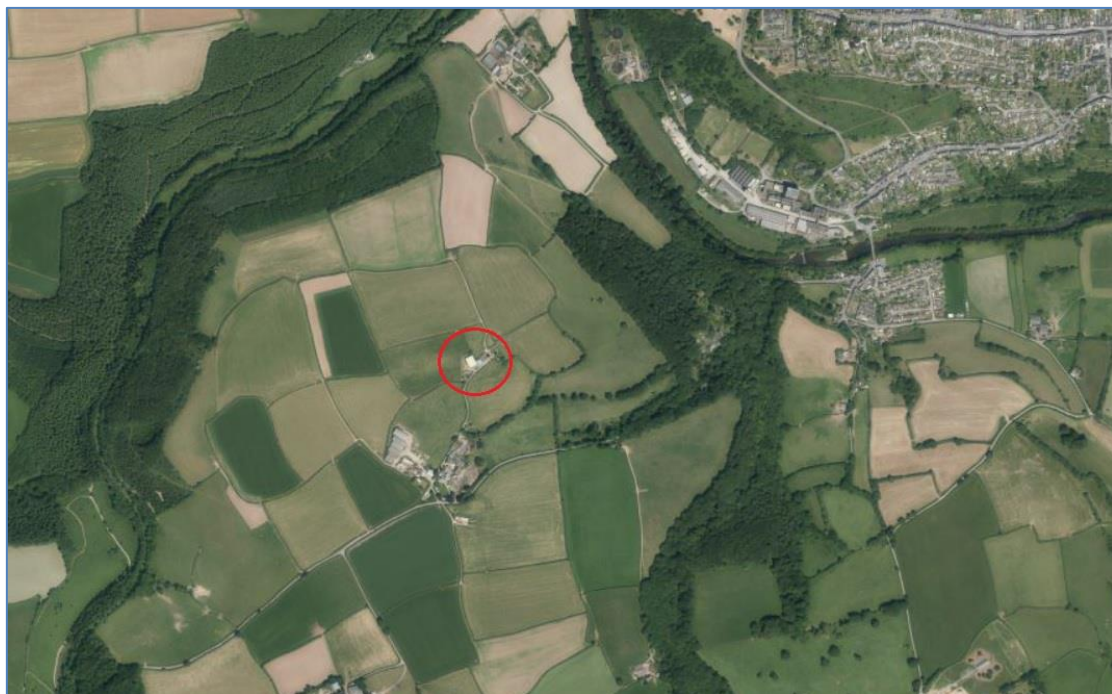
connectivity with surrounding riparian habitats associated with the River Torridge (Fig 2).

Fig 2 – Aerial photograph showing surrounding land-use.

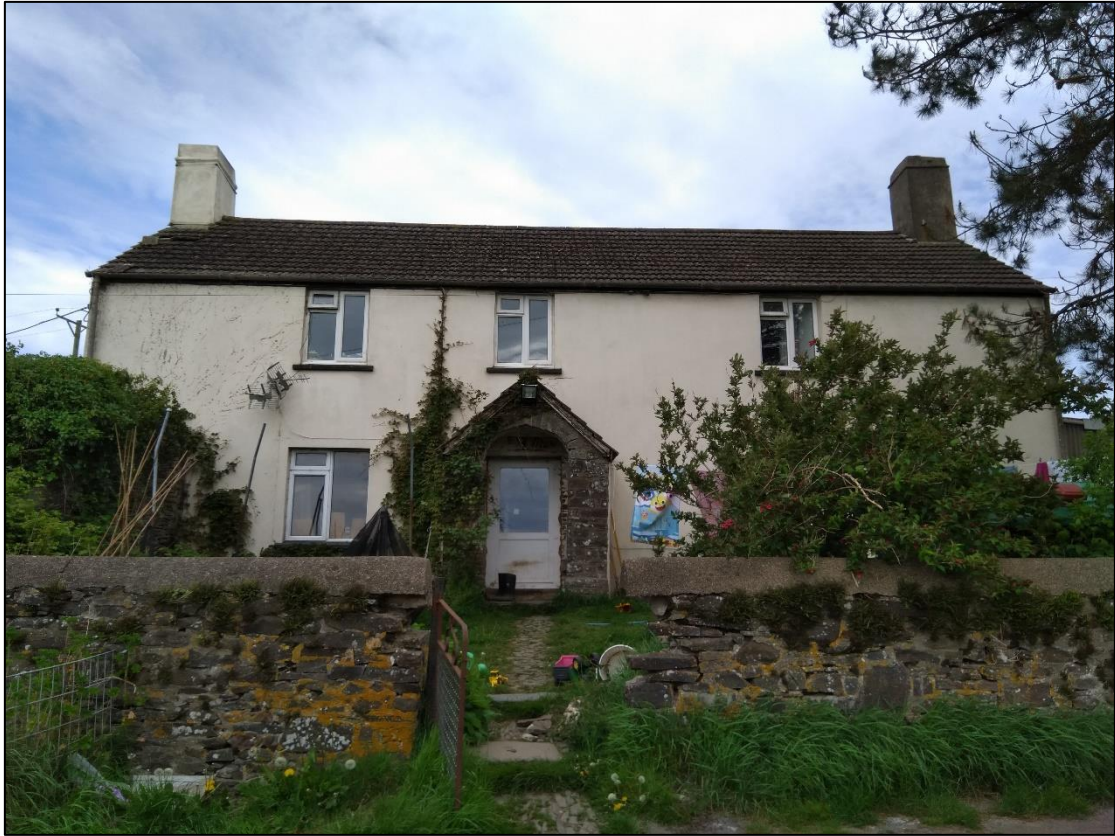
Cleave Cottage is of rendered block construction with a man-made tiled roof (Fig 3).

Fig 3 – Cleave Cottage (south elevations).

Cleave Cottage is a detached two-storey house of rendered block construction, with man-made roof tiles. The roof has two rendered chimney stacks with lead flashing at the base. There are wooden fascias, and barge boards. Modern additions to the building include a simple lean-to extension at the rear, and double-glazed uPVC doors and windows throughout (Fig 3). The building has many potential access points for bats underneath raised slates, timber fascias and ridge tiles. Sparrows are nesting in under lifted roof tiles at the eaves.

Sparrows are identified nesting in the roof eaves (also inspected by, but unobtainable to, the farm cats). The following is recommended:

- *Demolition works shall not commence during the bird nesting season which occurs between March and August.*

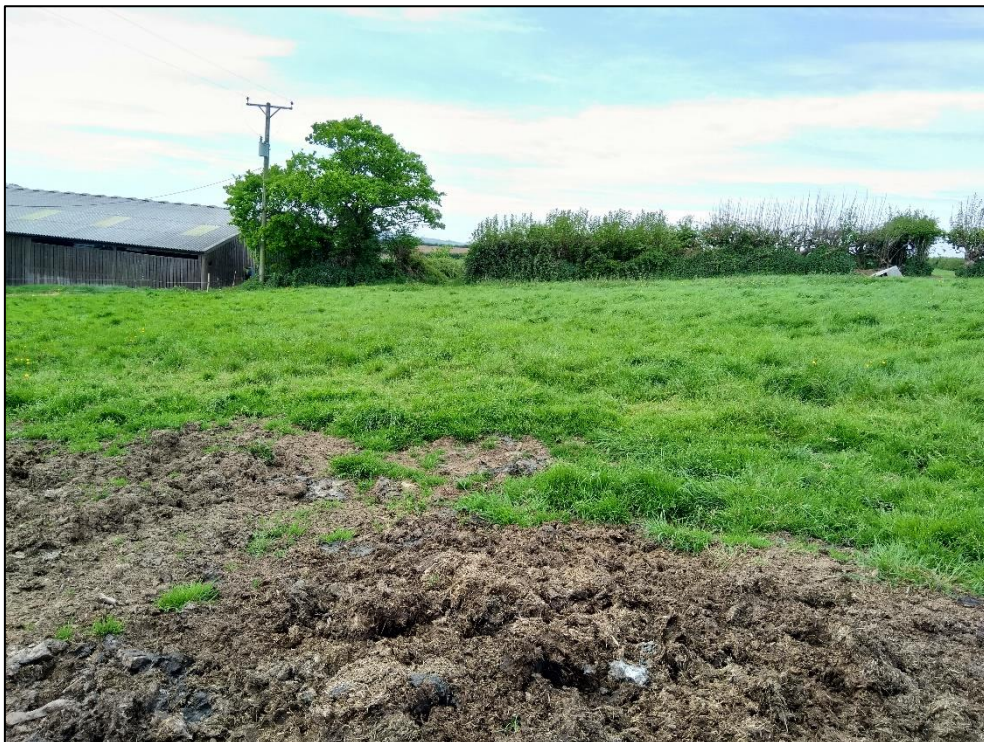
Fig 4 – Surveyed land parcel earmarked as the location of the new build.

The land to the rear of the house where the new build will be located, forms part of a larger parcel of improved grassland (Fig 4). Supplementary feeding of cattle has been made in this location and the resulting botanical species are typical of disturbed and nutrient-enriched soil, including Nettles and Docks. It is considered the land is of low ecological value.

The land is degraded and of low ecological value. The Local Planning Authority may wish to see a 10% gain in biodiversity following completion of the new build. It is considered that this gain will be achieved by the reversion of the existing house' footprint to garden or pasture.
