Heritage Statement – prepared for Town Farm, 43 High Street, Cheddington, LU7 0RG

Reason for submission: Intention to replace two entry doors

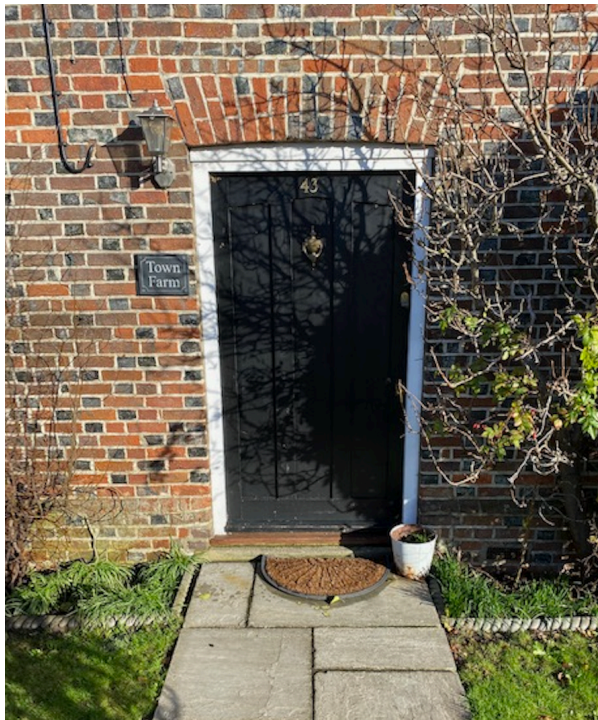
Existing front door as seen in January 2023:

It has two external-facing doors – the front door leading onto the High Street and the kitchen side door which leads into the Town Farm parking area. The front door is described as a ‘wide C20 door, also with cambered head’ by Historic England. The kitchen door is believed to have been installed in the 80s and is a wooden stable door (pictures of both existing doors have been supplied separately and are also below for reference).

Feature	Description	Significance	Proposed Works	Possible impact	Justification or Mitigation
External front door	Black wooden front door with a design featuring 3 vertical panels	Medium	Replace the door, the replacement also being black, wooden and replicating the existing design.	None	The existing door is unusable – it has not opened for a number of years due to severe warping. It also allows significant loss of heat given gaps between the door and the frame etc. The replacement door would be tailor-made to replicate the existing front door.
External kitchen	Black wooden	Low	Replace the door, the	None	The existing door allows

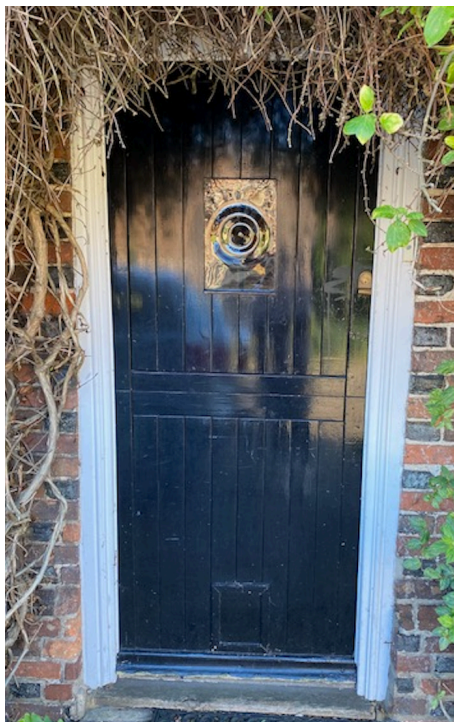
Existing kitchen side door as seen in January 2023:

side door	stable door including a rectangular pane of glass		replacement also being a black wooden stable door and including rectangular panes of glass on the upper section.	for significant heat loss as to combat warping over the years, previous owners have shaved wood off. Equally, the door is a security risk with poor locks and not closing tightly. The replacement door has been selected to be as close as possible in design/look and feel to the current one whilst solving the above issues.
-----------	---	--	--	--
