**Design and Access Statement  
LBC Application for Investigative Work at Barmoor Castle  
Barmoor Country Park, Berwick-upon-Tweed,  
Northumberland, TD15 2TR**

Submitted by Spence & Dower , Historic Building Architects  
28 November 2022

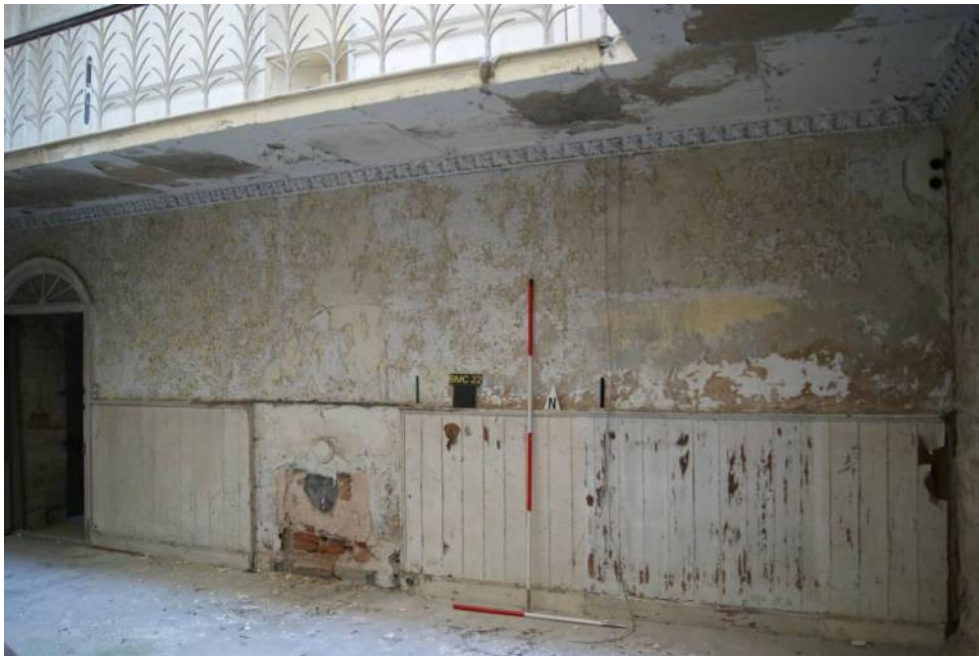
**Above: The north wall of the Great Stair**

*This appears to have been altered since first conceived, as the 'fireplace' insertion would seem to be a later installation together with the timber panelling, which most certainly does not belong with the proportions that would have been intended.*

*The location of the intended slim strip of investigation is where the staff is placed and between the short upright black markers. Might there have been a door matching the one on the left in the image at this point?*

The north wall, where it is intended there should be minimal intrusive investigation, may be thinned mediaeval masonry as on the opposite side of the wall in R19 there is brick blocking which appears to represent a doorway. This is indicated in a 1778 drawing as passing through a thick wall from the 'now' stairwell area into the old 'kitchin'. It is difficult to precisely correlate this wall with these earlier plans.

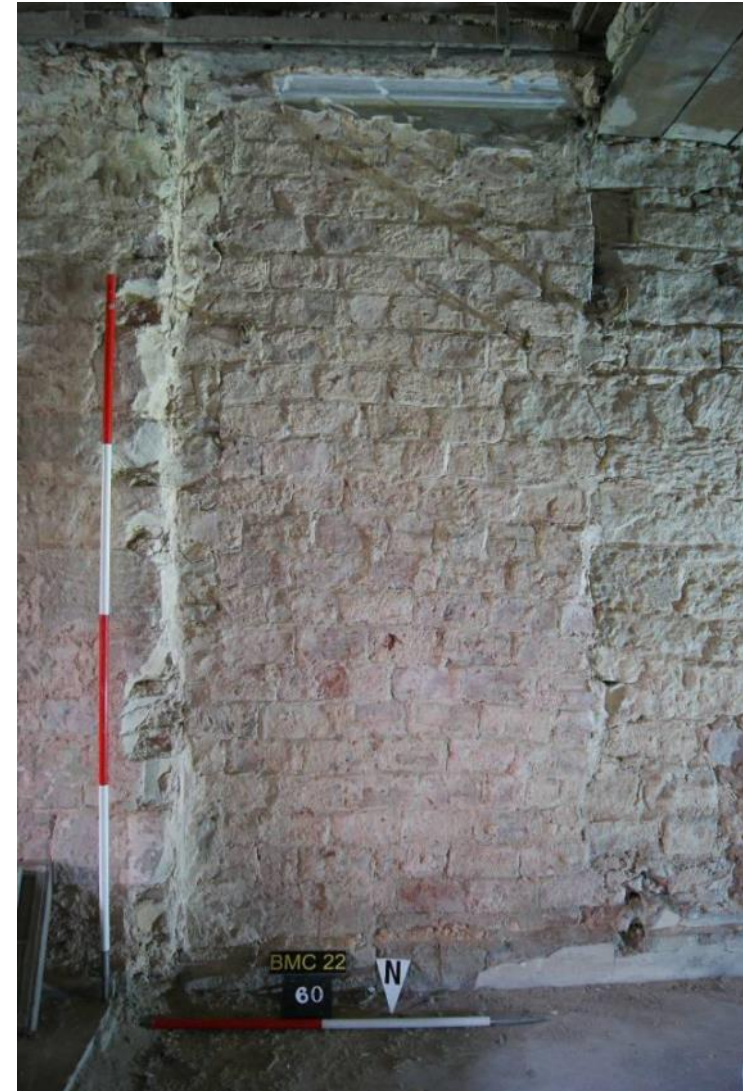
### **Below: The south wall of the 'kitchin' - behind the markers shown left.**

*Brick on end infill is clearly shown together with positive vertical junction lines, indicating a previous opening. This side of the wall will not be disturbed in the minimal opening up on the stairwell side.*

*The 'kitchin' is little changed in overall appearance since the 1778 plan. Note there is a fragment of wall plaster with narrow cornice surviving above the assumed old doorway.*

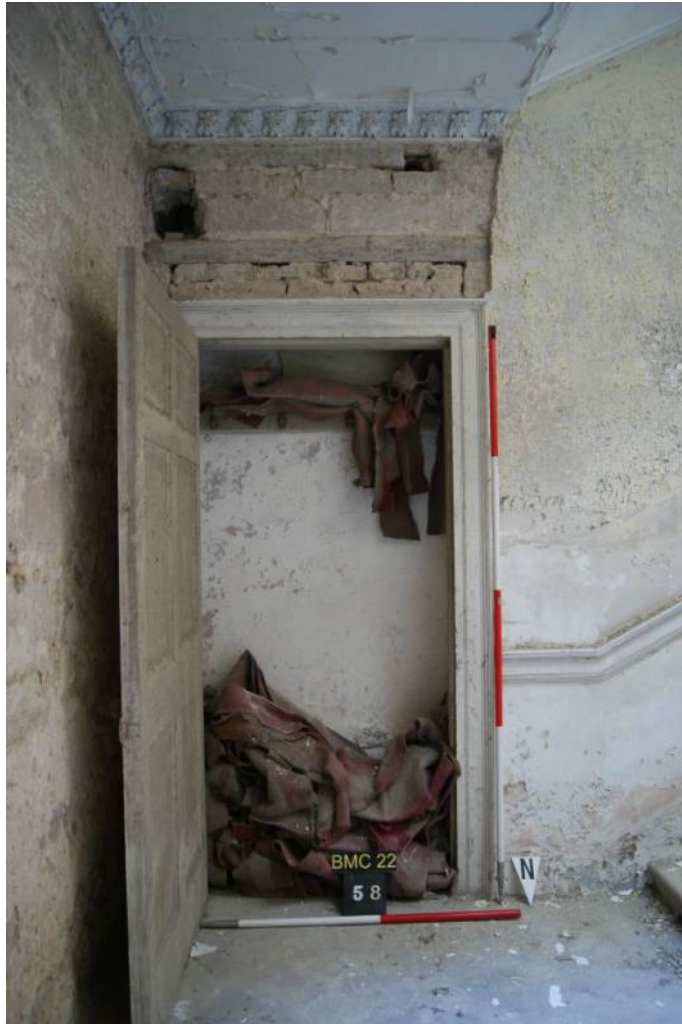
A door on the South side of the stairwell (seen in image below left) leads into a cupboard. On the 1801 floor plan this doorway is shown as linking the stairwell to a north-south passage into the servant's stair. Was this ever made?

Above the door the plaster has been removed exposing long grey-purple ashlar which might predate 1801-4. However, there is also evidence of a previous altered doorway below this ashlar.

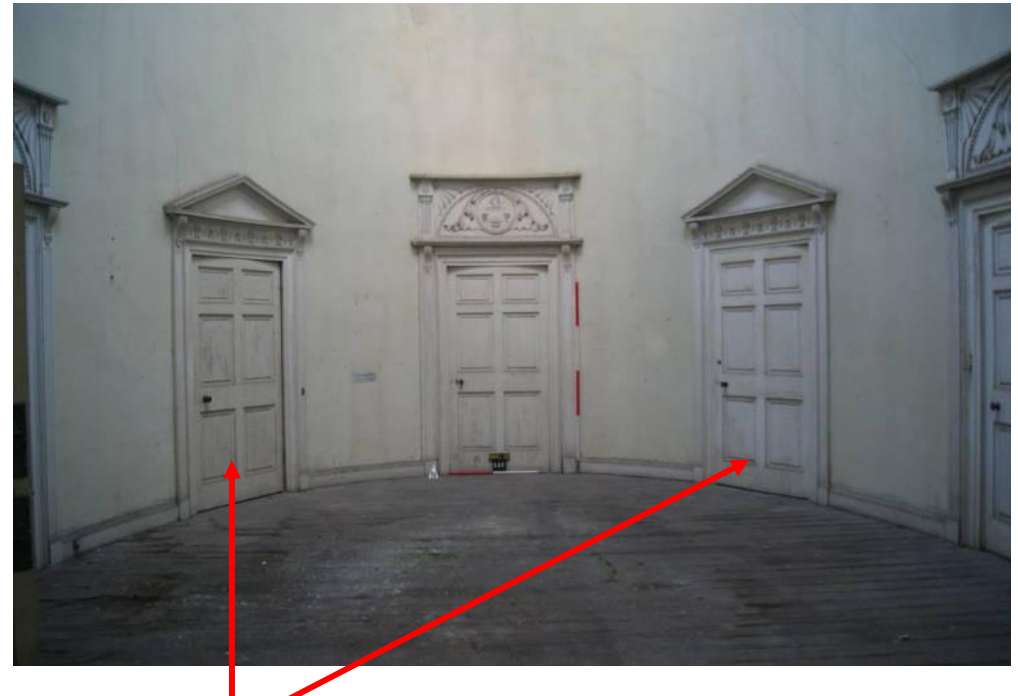
*Cupboard doors on the north wall. The central door is false.*

It has become obvious during our on-site investigations that the two existing cupboards off the central oval space (Saloon) at the north end will be invaluable without any alteration for service equipment. These cupboards are shown on the 'as existing' plan of the first floor on the next page, and also in the image below.

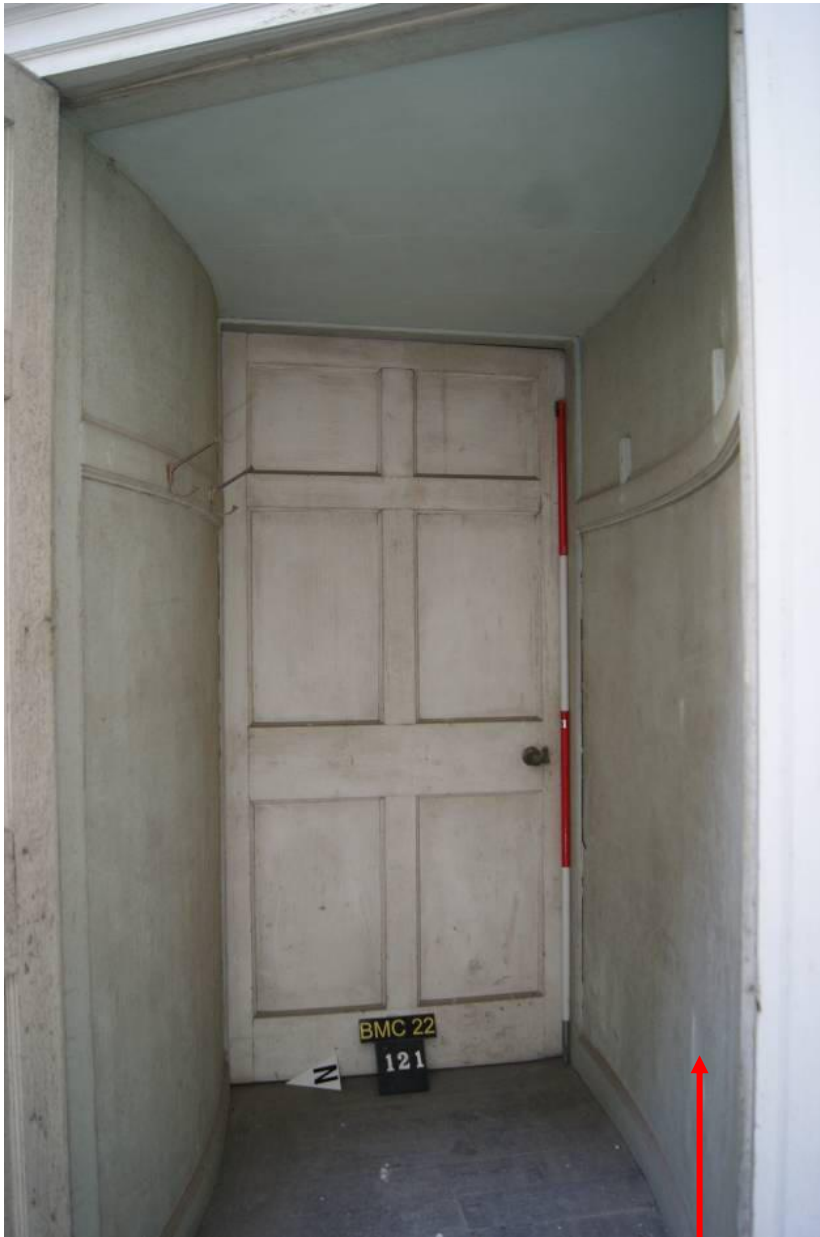
The two north cupboards in the masonry voids beyond the oval room
