**HERITAGE STATEMENT  
FOR  
BARMOOR CASTLE, LOWICK, NORTHUMBERLAND**

**Deskbased Assessment and Historic Building Assessment  
Stage 1**

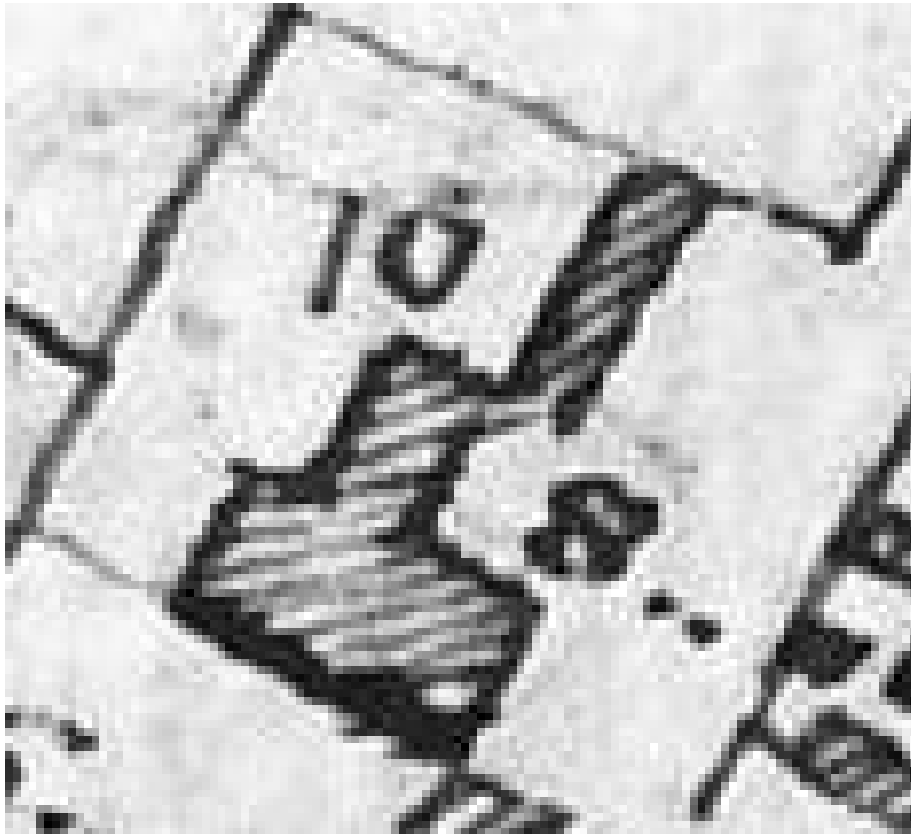
Fig. 6. 1786. From Bailey and Culley's Survey and Valuation of Barmoor Estate for Samuel Phipps.

By the agricultural improvers John Bailey and George Culley, this plan (Fig.6) again is principally concerned with the wider estate, and the appearance of the 'House' at an even smaller scale than 3 is even more difficult to interpret and the 'House' outline is unclear. A large east-west block shaded as a building may be the rectangular enclosure shown by Fryer. This may of course simply be an error. A long, thin, north-south range, not shown by Fryer, seems to abut the north-east corner of the 'House'.

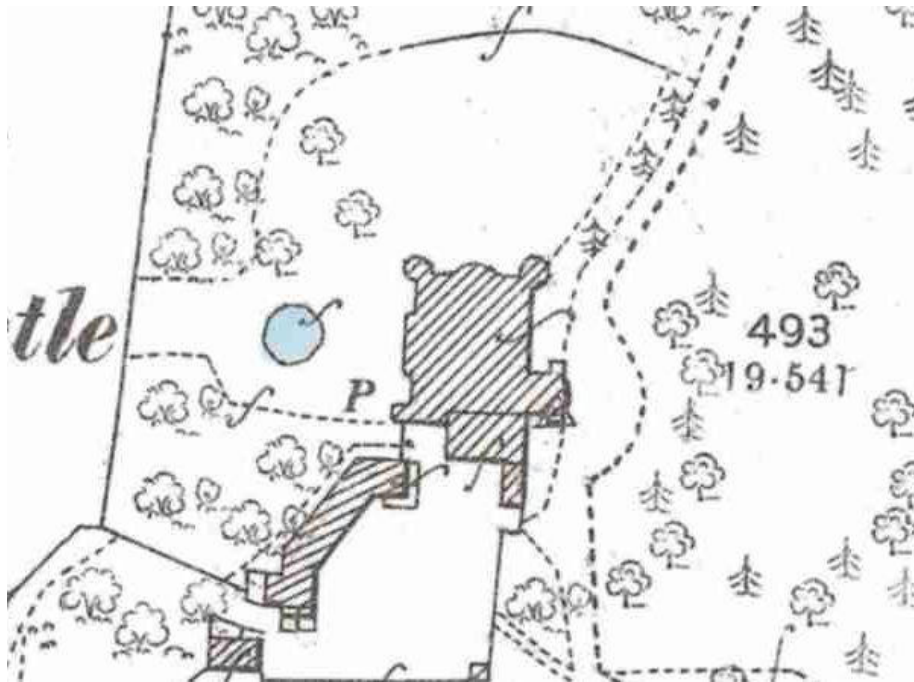
Fig. 10. 1897. From the 2<sup>nd</sup> edition Ordnance Survey 25" map, showing the South Wing 'completed' by W.H.Sitwell c.1892. A range of outbuildings has been added at the south-east corner.

This is the first known plan after the 1860 edition to show the Castle in usable detail (Fig.10). Since it post-dates Brigadier-General W H Sitwell's 'completion' of the Paterson scheme, attested by the stone plaque on the east face of the South Wing with the Sitwell crest and date 1892, the footprint of the Castle is shown here substantially as still existing.

There are however two notable differences. One is the long narrow range adjoining the south-east corner of the South Wing. The other is the pumphouse, a single-storey building abutting the south facade between the South Wing and the south-west corner turret. This raised water to a storage tank at second floor level in R74. Both these additions (which appear on Figs. 40 and 43) were demolished in the 1980s.

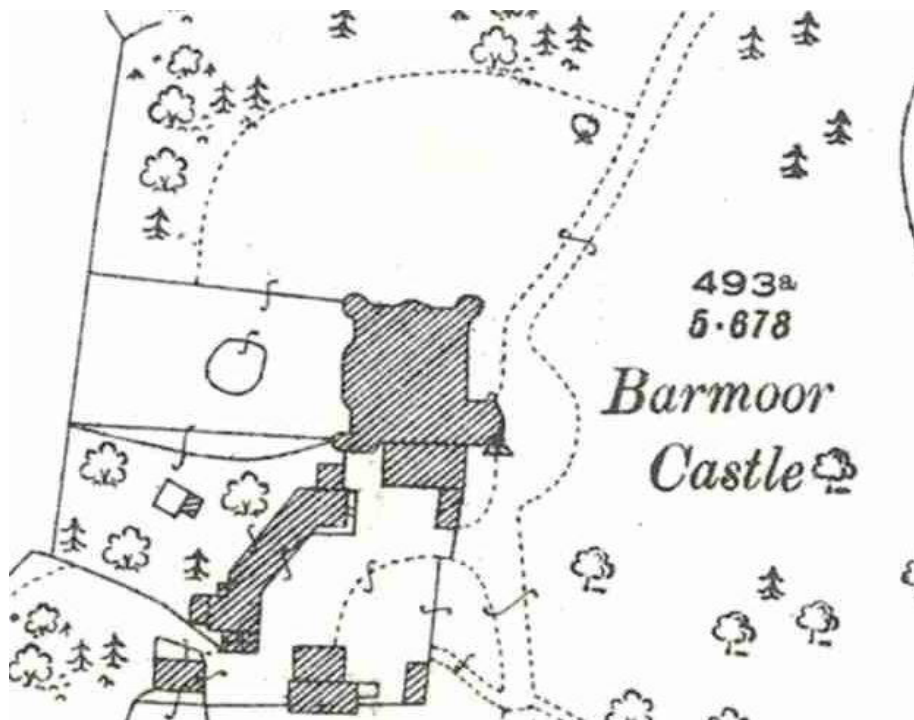
Fig. 11. 1912-22. 3<sup>rd</sup> edition Ordnance Survey 25". There have been minor alterations - an addition to the north end of the Stable Block, and outbuildings in the courtyard. There was little further change until after 1979.

The appearance of the Castle (Fig.11) is unchanged since 1897. Thereafter there was no further significant change in the castle or its environs until the early 1980s.

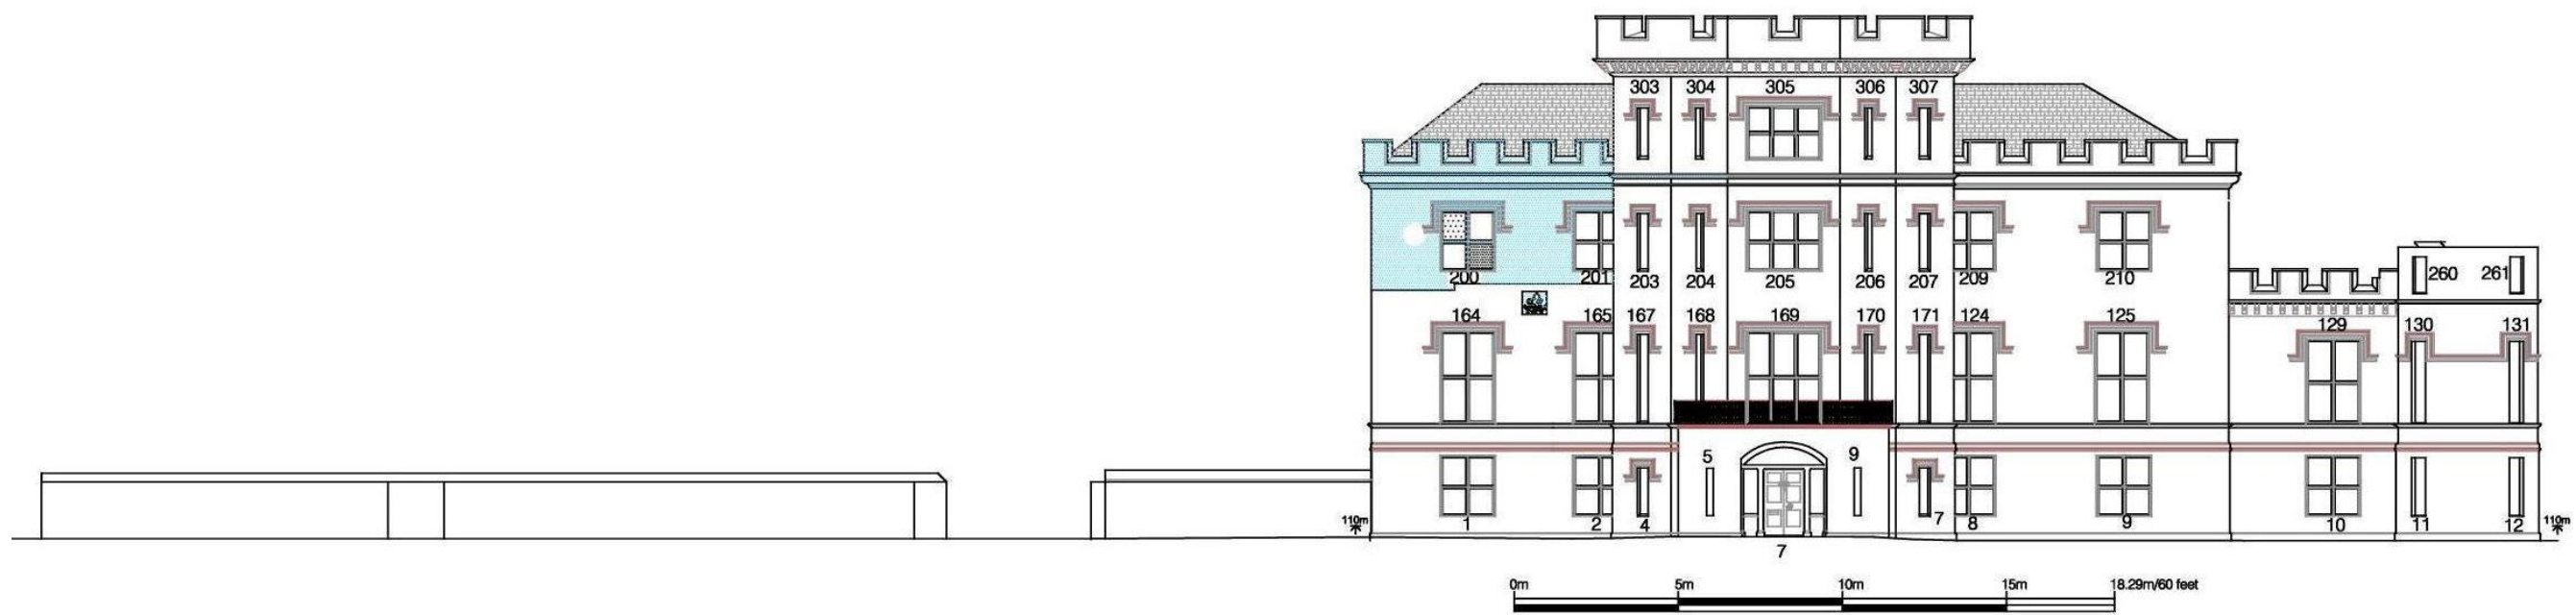
Fig. 33. Top: the East facade as built and as-existing (uncoloured), with the c.1892 raising of the South Wing shown shaded. Below: Paterson's 1801 design for the 'East or Entrance Front' showing the symmetry of the original design and the present courtyard wall on the site of Paterson's un-realised Stable Court. The scale to which Paterson's ambitious design over-reached Francis Sitwell's finances is obvious, as is the narrowness of the proposed Gatehouse compared with that as-built. There appears to have been a proposed heraldic device – a shield and swags – on the Gatehouse roof parapet.

7.2.3 Comparison of Paterson's 'proposed' drawings with the extant Castle (Fig. 33-36) shows that while much of the intended alterations to the body of the Castle were implemented, this was not without some design modifications. Financial stringency is one likely cause of such changes, but it is suggested there may also have been errors in Paterson's plans, perhaps caused by using the 1778 floor plans as a base survey. Consequently the proposed internal divisions of space could not all be fitted into the existing footprint. This is most noticeable with the Gatehouse, which the 1801 plan shows as narrower than built, and in the walls of the Central Block. This causes some problems when trying to fit digitally-transcribed overlays of the floor plans onto the modern building survey and some adjustments have had to be made to make Paterson's proposed plans 'readable' with the 'as-built' footprint. Paterson's proposed elevations, which with the exception of the southern show substantially the existing facades, are presented with existing elevations at a common scale (Fig. 33-36)..

### 10.1 East facade. (Fig.33)

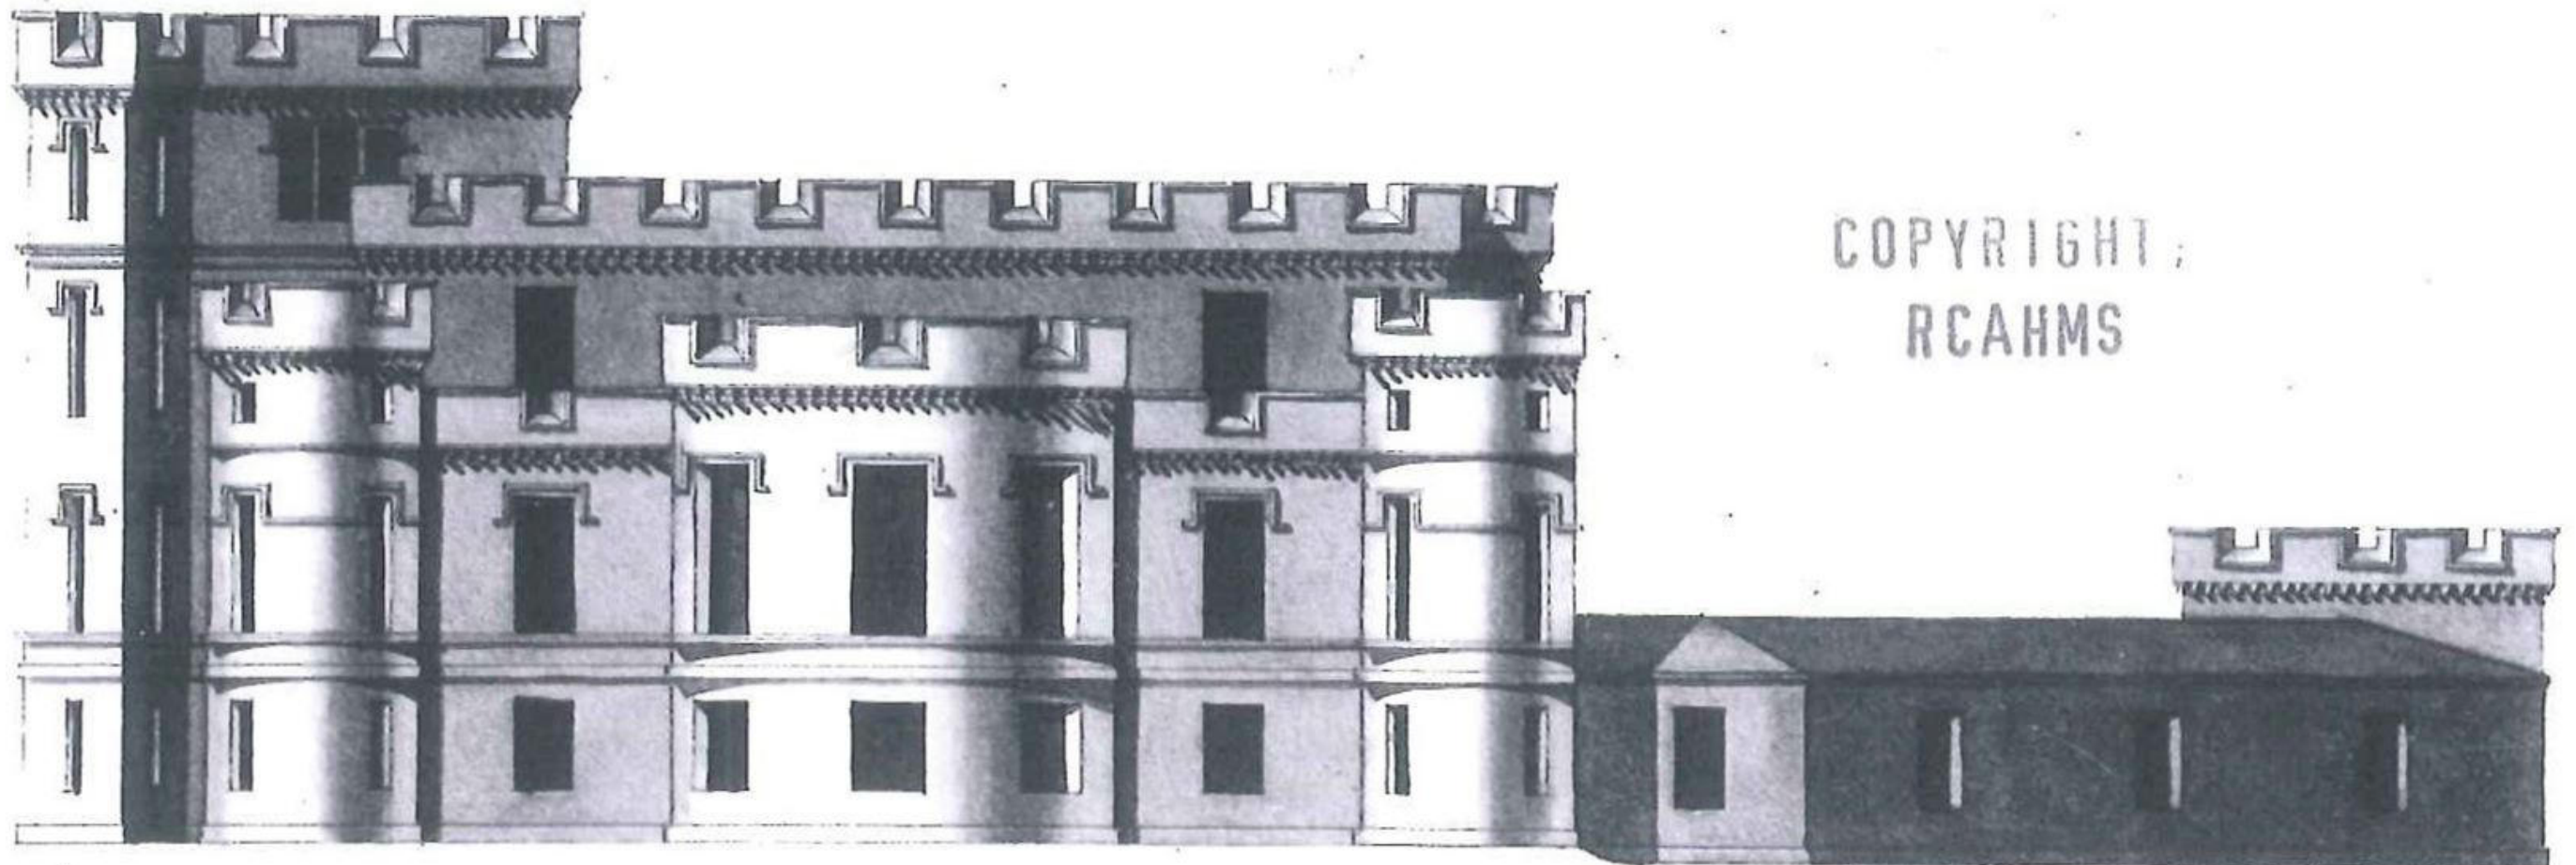
Fig. 34. Top. North facade as built and as-existing. This is entirely 1801-4 work, and is uncoloured. Below; Paterson's 1801 proposed design for the 'North Profile', showing unrealised windows to the ground floor, no upstanding roofline, and the unbuilt Stable Court to the right. In the background the two large windows in the inner north facade were omitted on Paterson's 'Bedroom Floor' plan, and would have conflicted with the roofline.

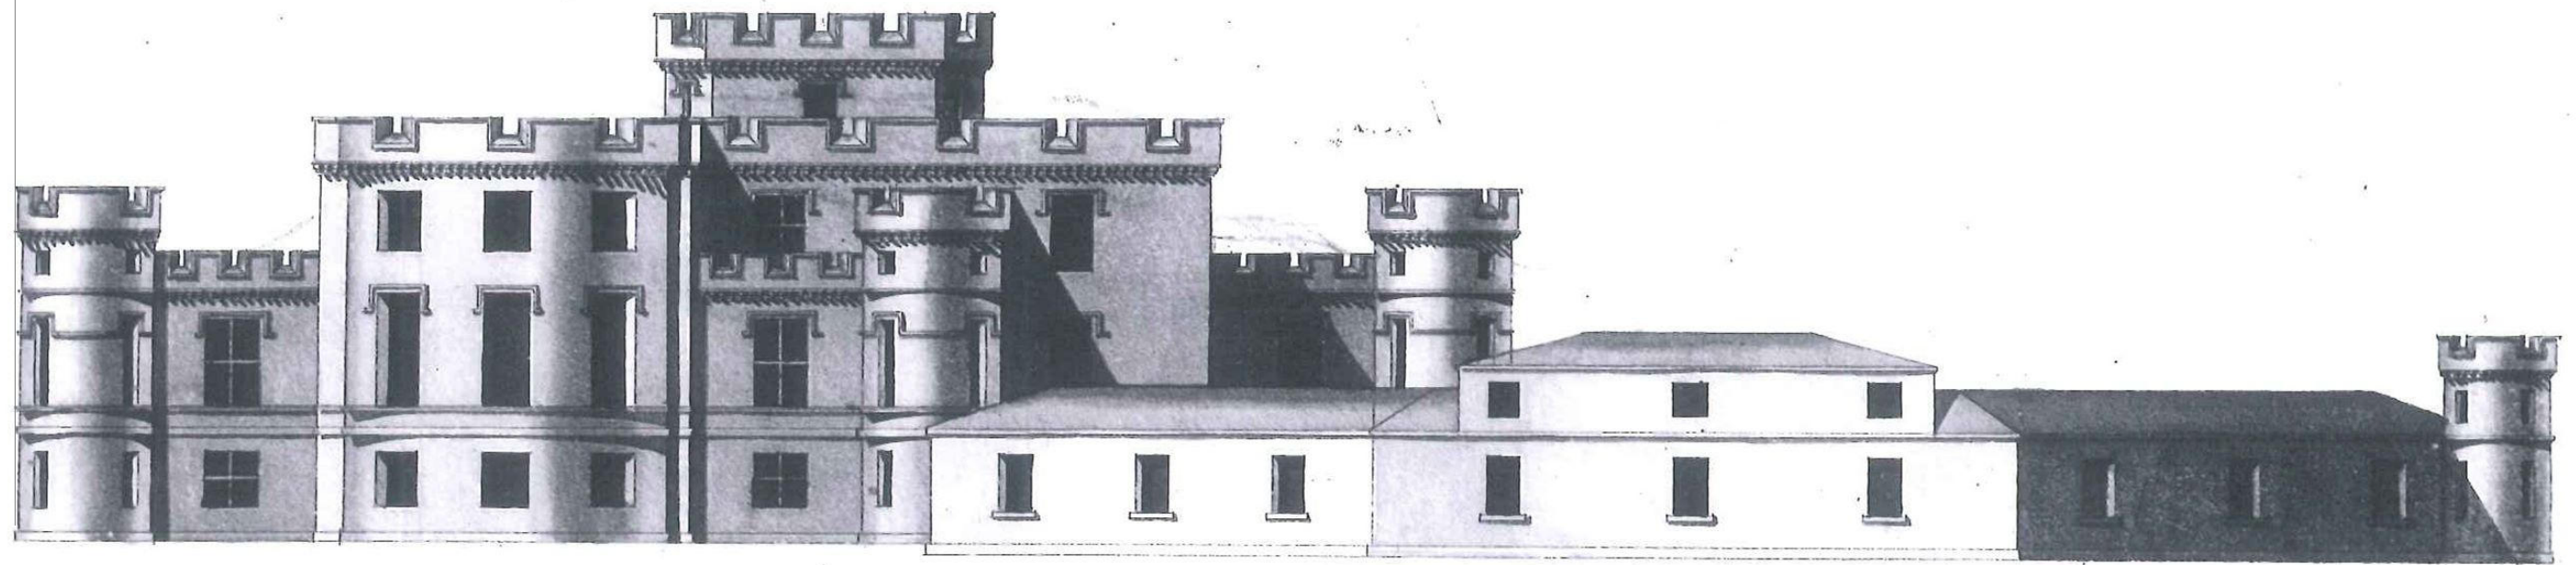
Fig. 35. Top: the west elevation as built and as-existing. This is entirely 1801-4 work and is uncoloured. Below, Paterson's 1801 proposed 'West Front' with the massive, unrealised, Stable Court to the right. Several features shown by Paterson were never constructed: the window in the west side of the Gatehouse (background) was never made, and the second floor level of the south Wing and Central Block, with large four-light windows, was not built until c.1892, and then on a more modest scale.

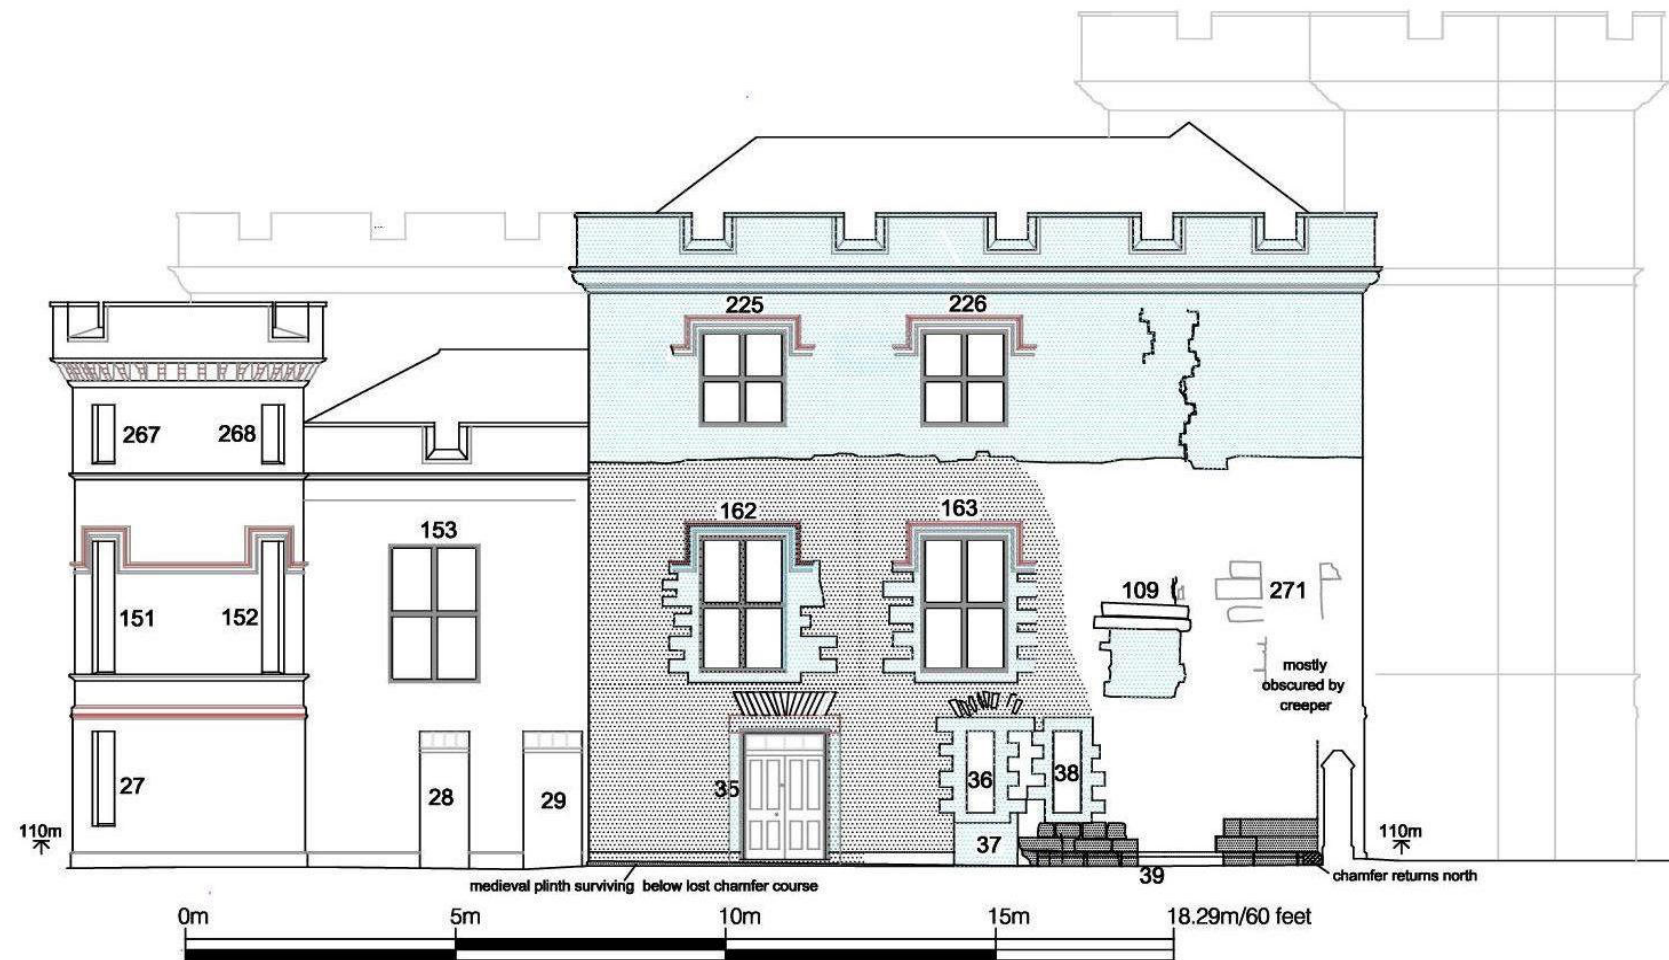
Fig. 36. Top: south elevation as built and as-existing, with the c.1892 raising of the South Wing, and associated alterations shown with blue shading. Surviving medieval fabric (where identifiable) is shaded black, and the possible late 18<sup>th</sup> century remodelling, the extent of which is not clearly definable, in grey. The 1801-4 build is uncoloured, and includes features intended to serve the unbuilt 'Study' and 'Family Bedroom'. Below: Paterson's 1801 proposed 'South Profile' with the unbuilt extension to the east facade obscuring most of the South Wing.

### **10.4 South and south-west facades (Fig. 36).**

10.4.1 The south facade comprises two separate elevations: the principal one is to the south-east and reflects the south end of the pre-1801-4 'House' and medieval tower. That on the west is offset further north, lower, and appears to be wholly of 1801-4. At ground level this was formerly butted by a pump-house, now demolished (Fig. 43-44). The south-east elevation is the more complex, rising to three storeys and built of coursed rubble (Fig.40; **P28-9**). The ground and first floor levels are partly pre-Paterson, and include the remains of the chamfered plinth [39] of the 14<sup>th</sup> century tower with some face-stones surviving above, particularly at the south-east corner and below window [38] (**P31-4**). The chamfer returns northward close to the south east angle of the present facade (**P34**). The second floor belongs wholly to the c.1892 work, done conservatively and probably cheaply rubble masonry compatible with the earlier build.

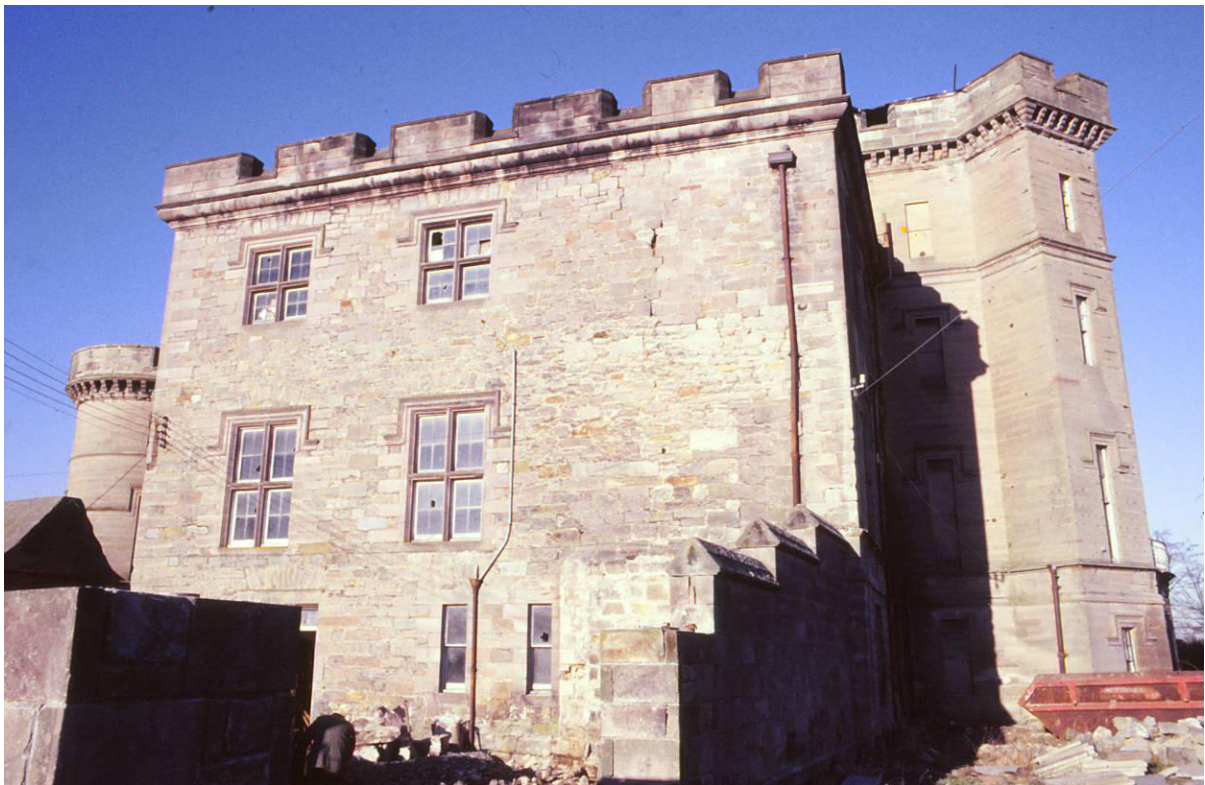
Fig. 38. The south-east angle of the Castle c.1986 with work underway, showing the stepped coped wall, part of the courtyard wall, and windows [37-8] (ground), [162-3] (first) and [225-6] (second). (J.Penn).

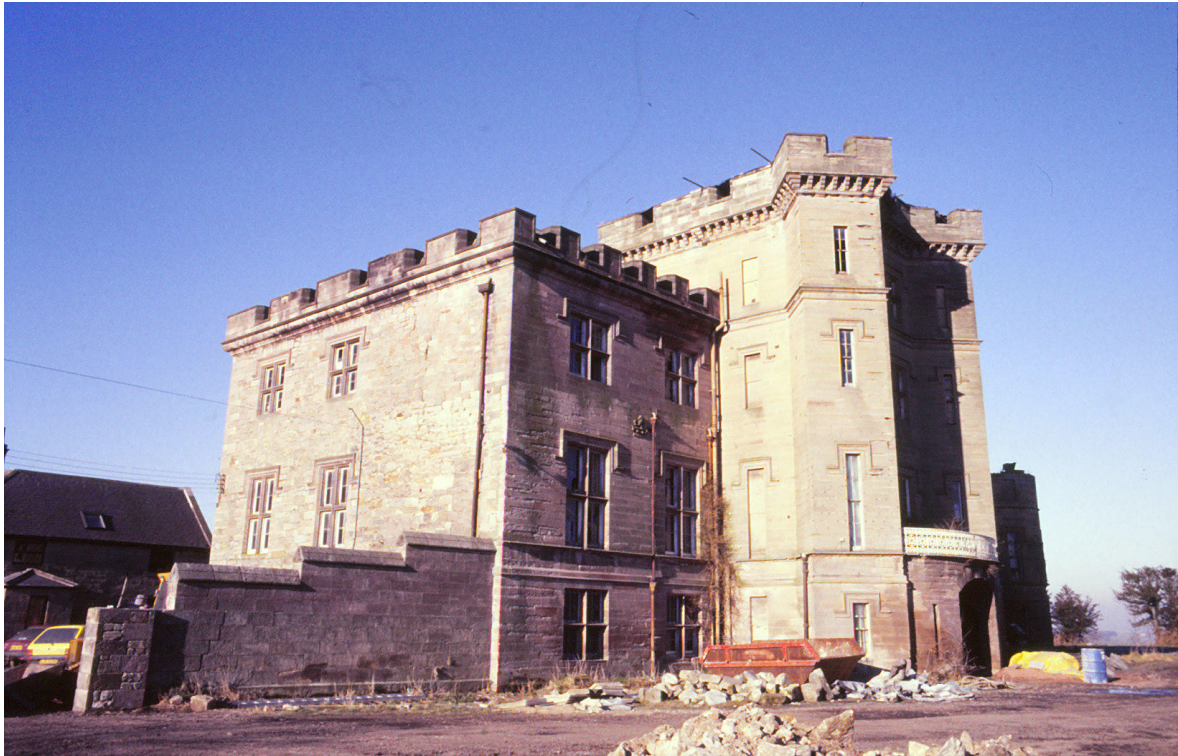
Fig. 39. The south-east angle of the South Wing with the Gatehouse, c.1986 with work on the roof underway. (J.Penn)

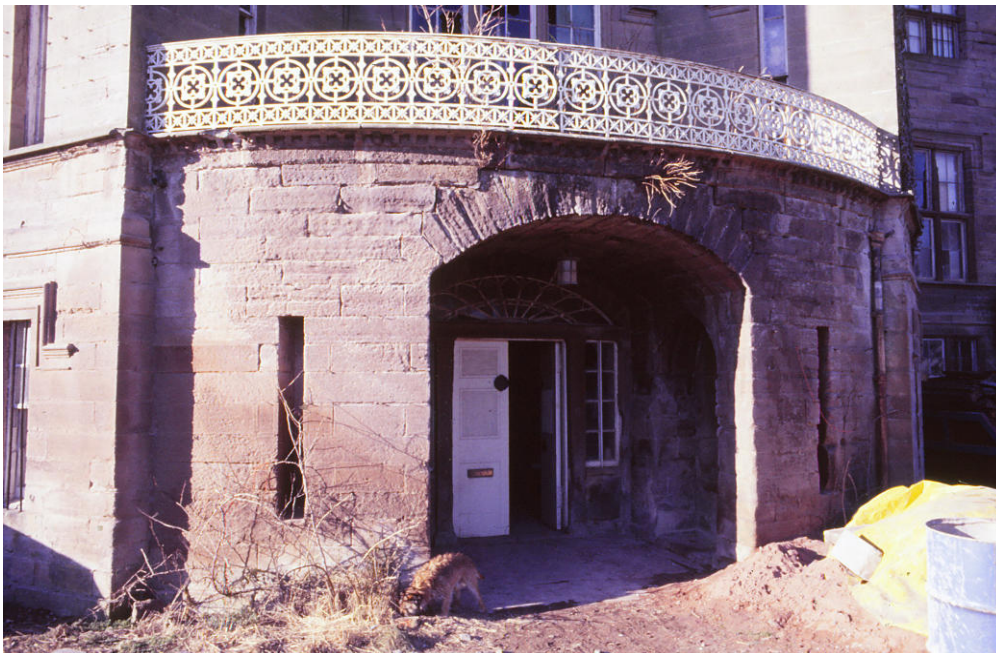
Fig. 43. The south-west facade c.1986 during roof works, showing the pump house between the South Wing and the south-west turret. (J. Penn)

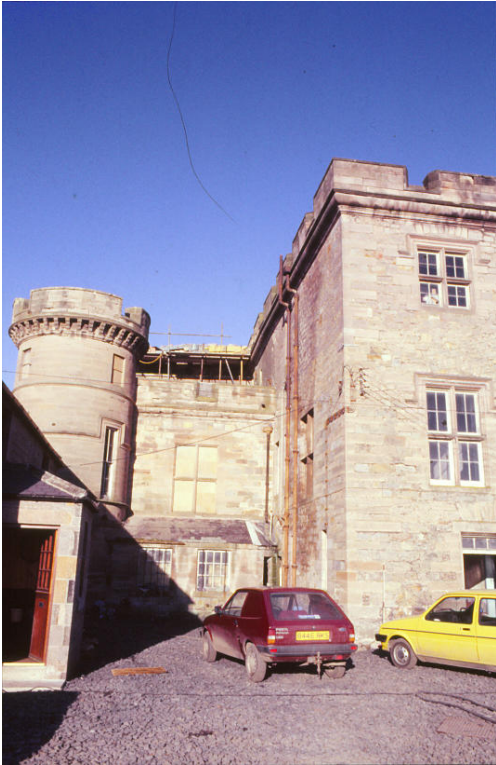
Fig. 44 . Looking down from the South Wing parapet c.1986 with the roof of the pump house abutting the south-west turret.(J. Penn)

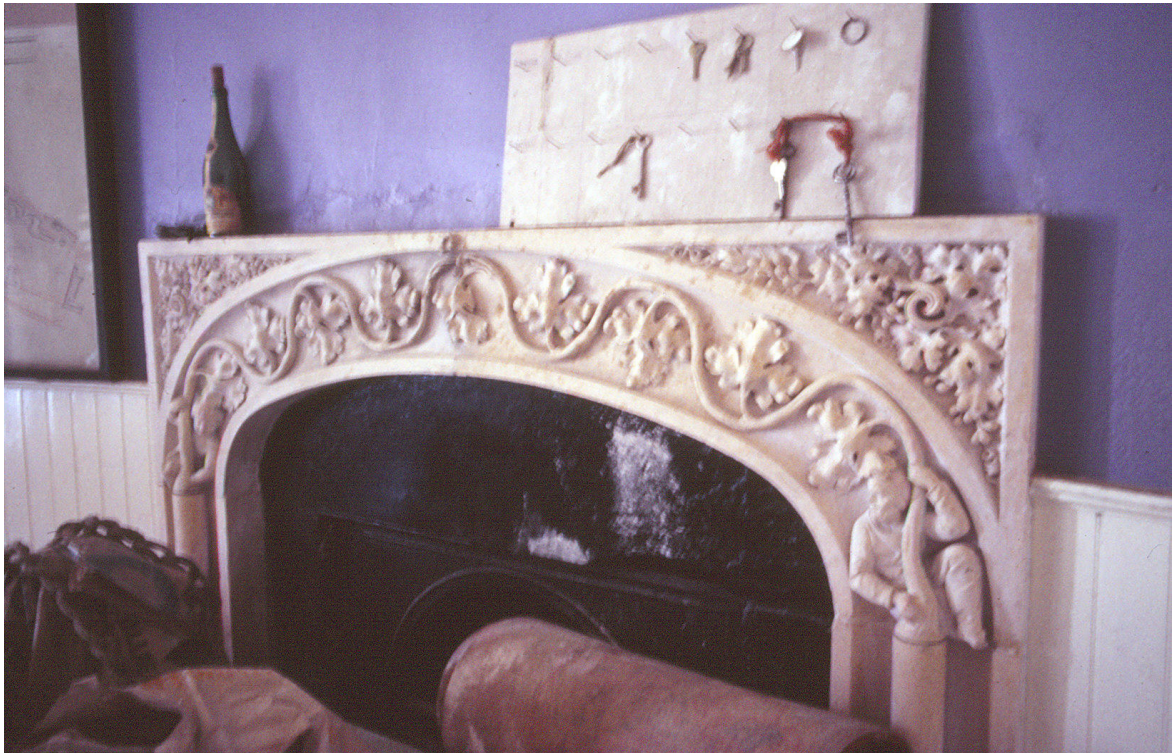
Fig. 45. Gatehouse, R10, c.1986, showing fire [197], plastered wall and matchboarding (J.Penn).

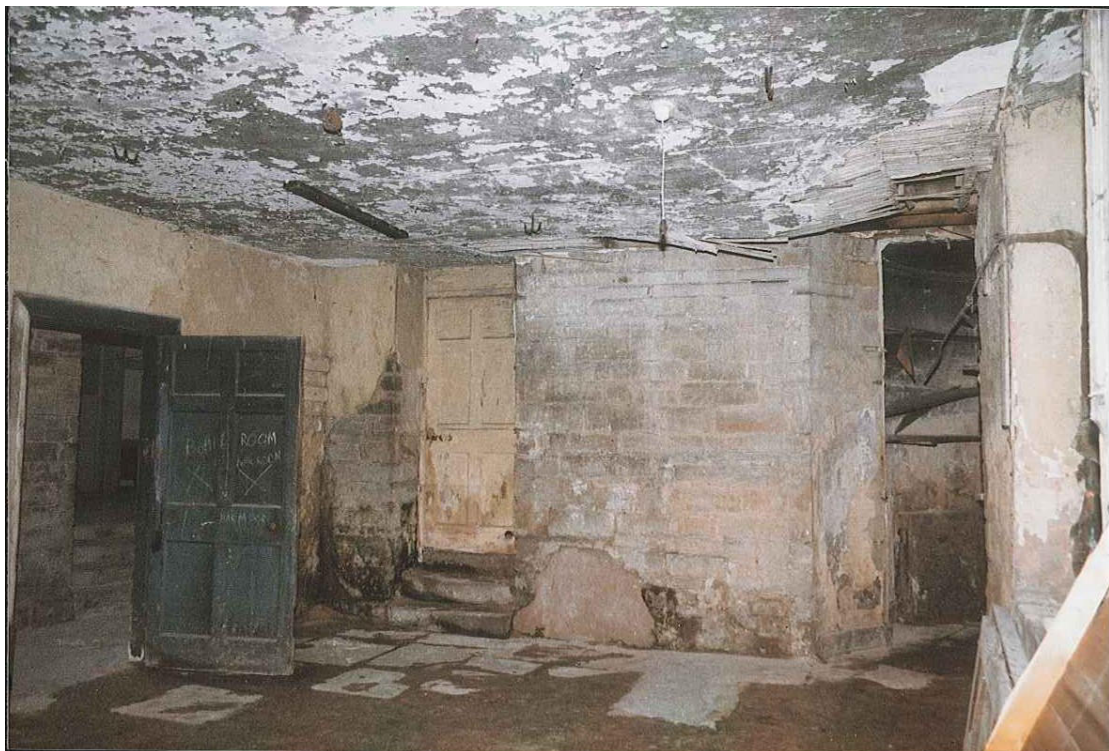
Fig. 46. R8 (Scullery) c.1984 looking south to door [31] with demolished partition to passage R8.1 on the left, and door to R13 on the right. (J.Penn).

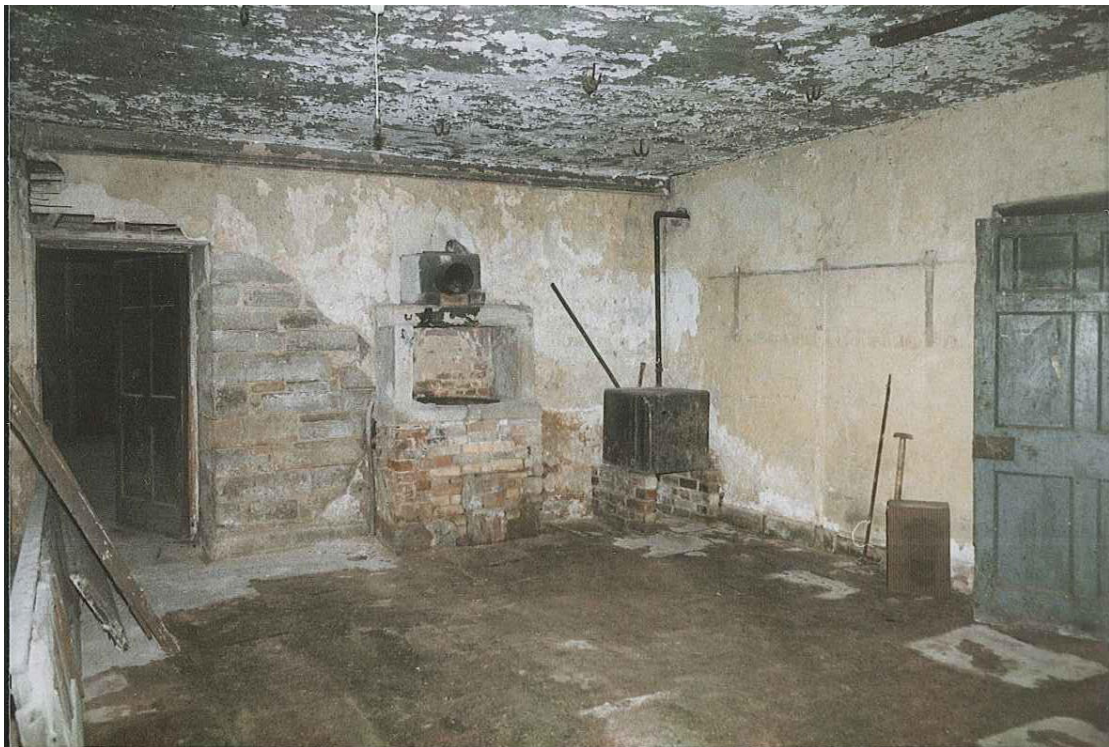
Fig. 47. R8 (scullery) c.1984 looking north-east to the copper [41] with door [43] to the kitchen on the left, and the demolished partition to passage R8.1 right. (J.Penn)

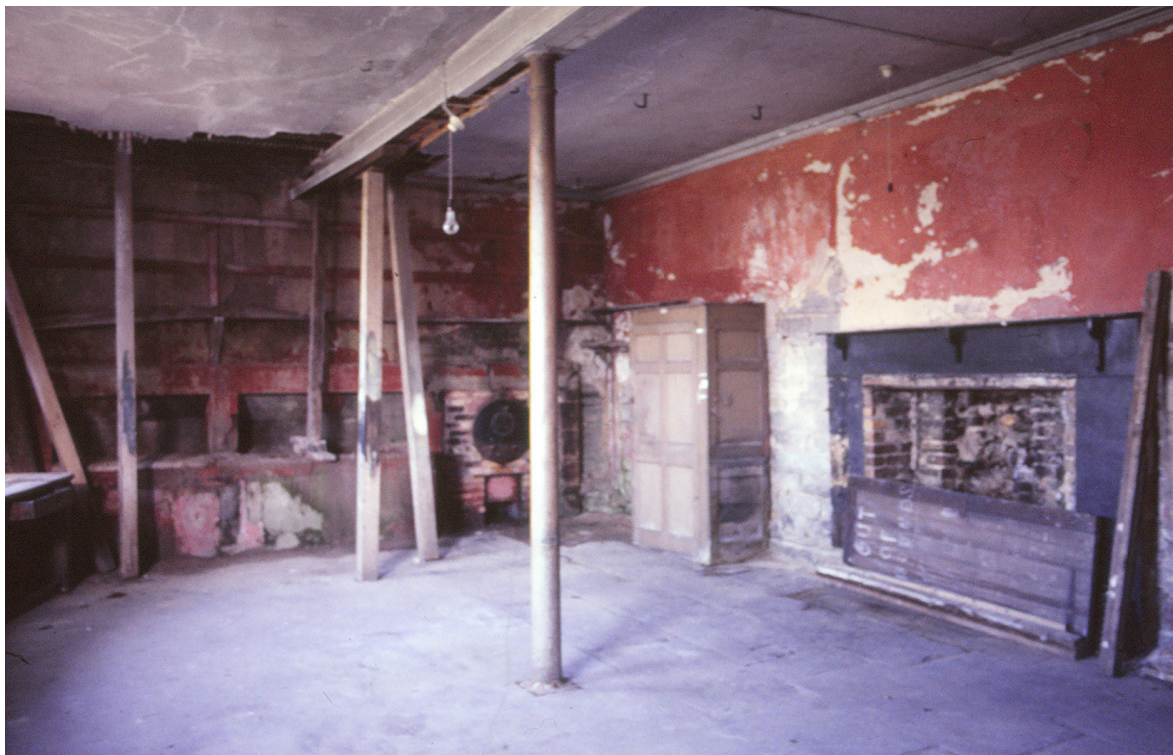
Fig. 48. R14 (kitchen) c.1984 looking north to the stewing range and oven [48-9], fire [50] right, and cast-iron column [70] centre.(J.Penn)

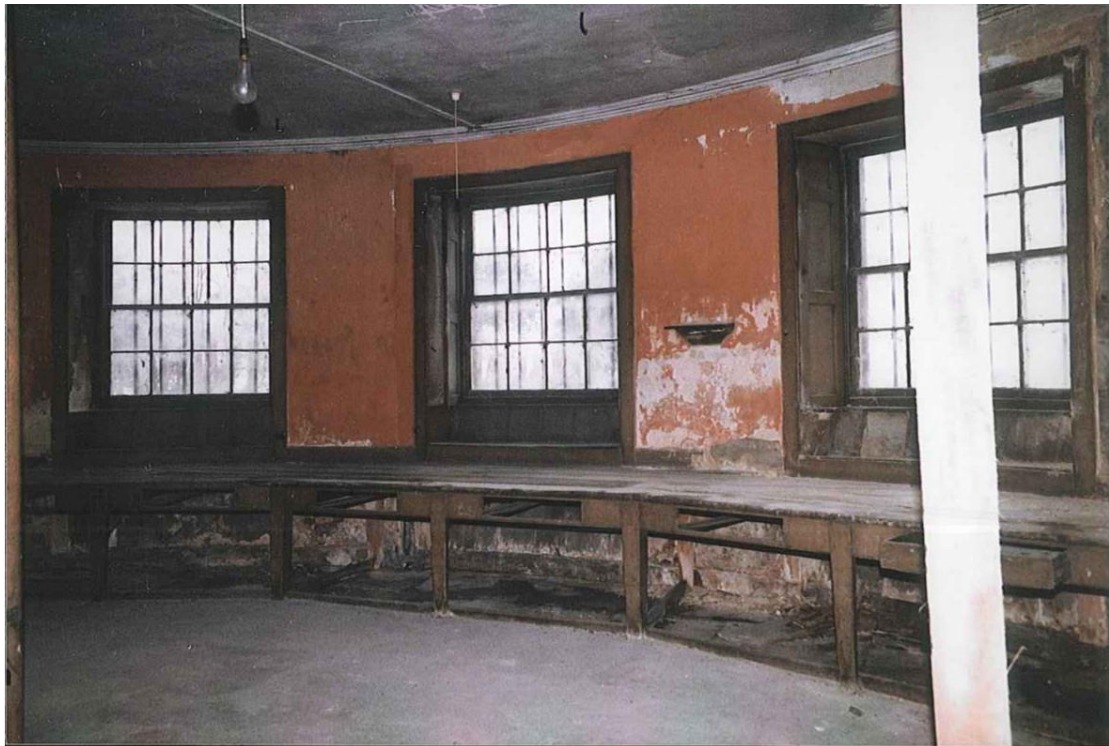
Fig. 49. R13 (kitchen) c.1984 looking south-west with windows [24-26] and workbench, now removed.(J.Penn).

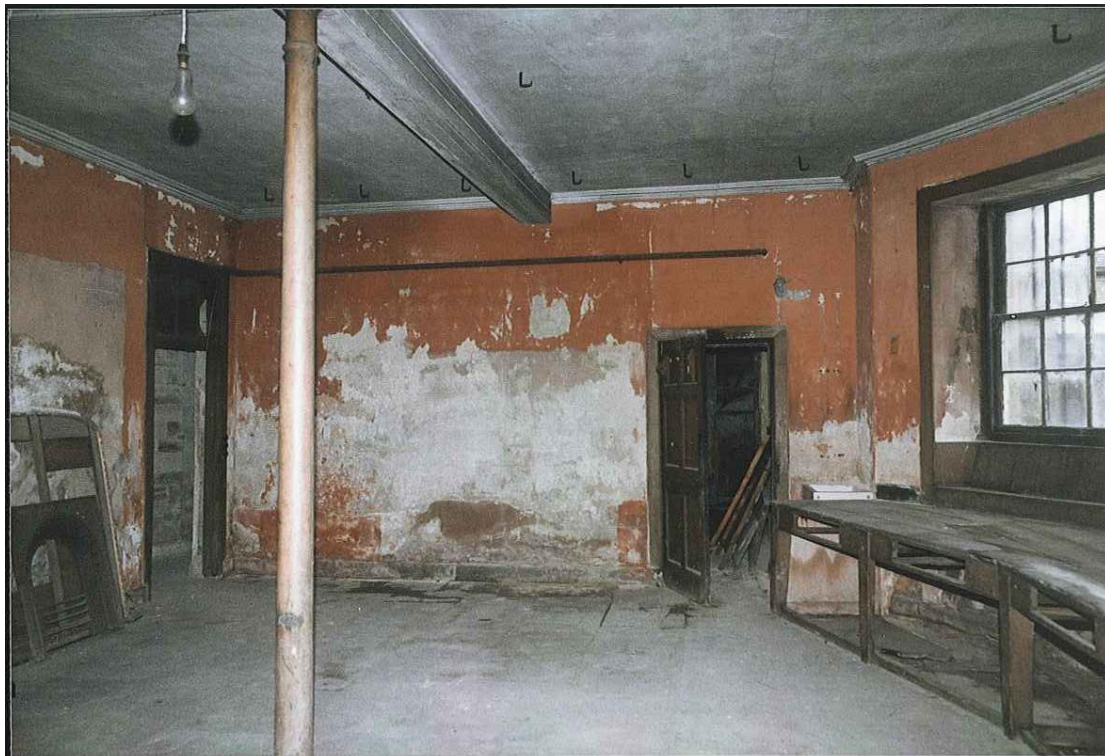
Fig. 50. R13 (kitchen) c.1984 looking south to door [43] on the right, door [52] and fire [50] left, and cast-iron column [70].(J.Penn).

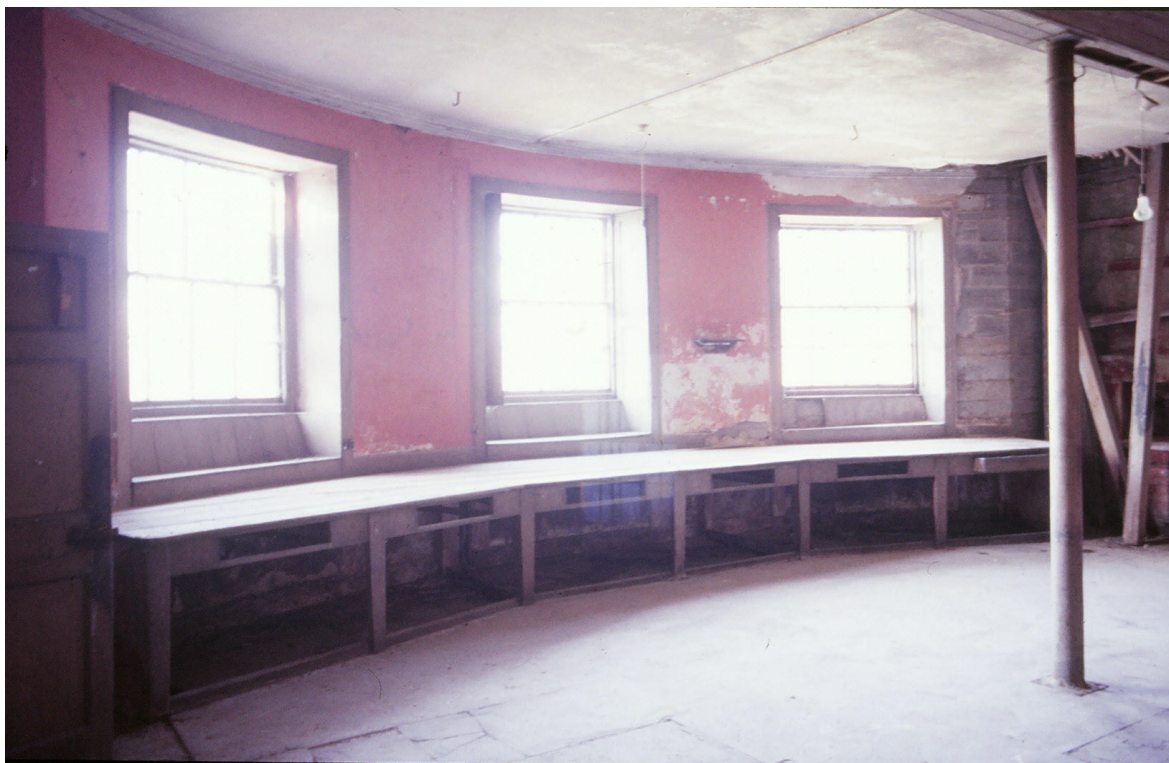
Fig. 51. R13 (kitchen) looking north-west to windows [24-26] and workbench now removed (J.Penn).

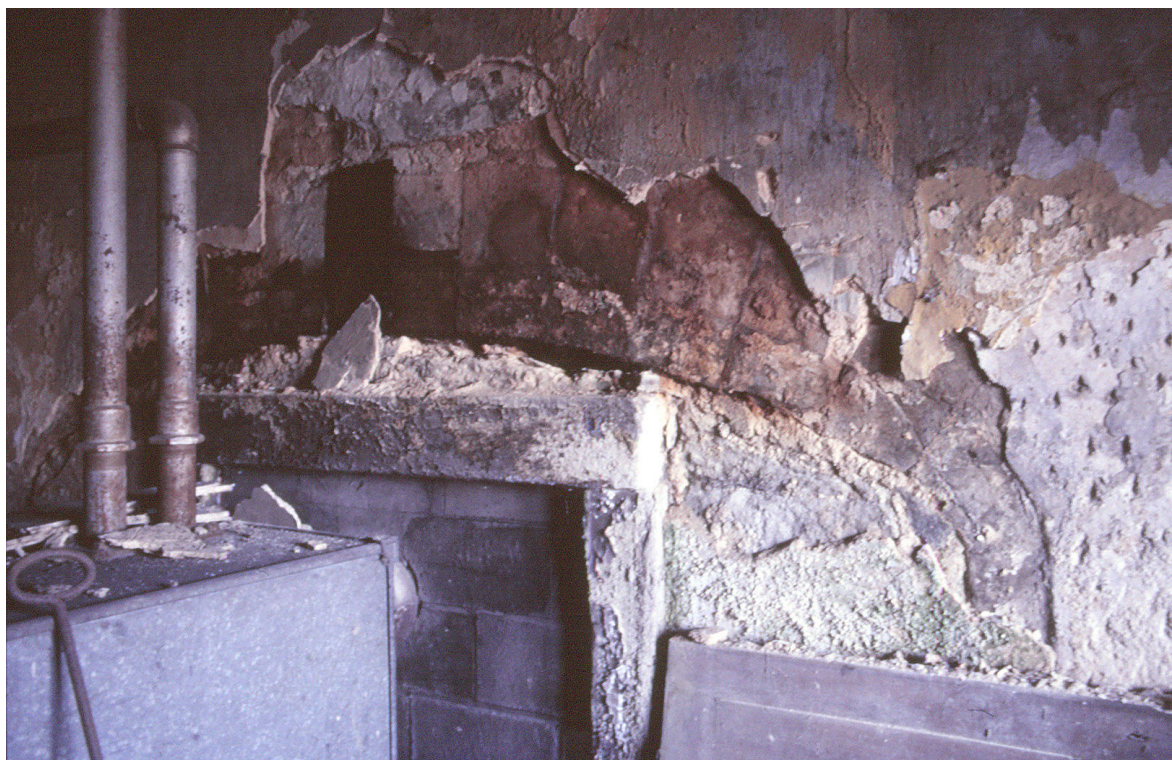
Fig. 52. R19 c.1986 with the arch of fire [63] just visible under later plaster and blocking for a solid-fuel boiler.(J.Penn).

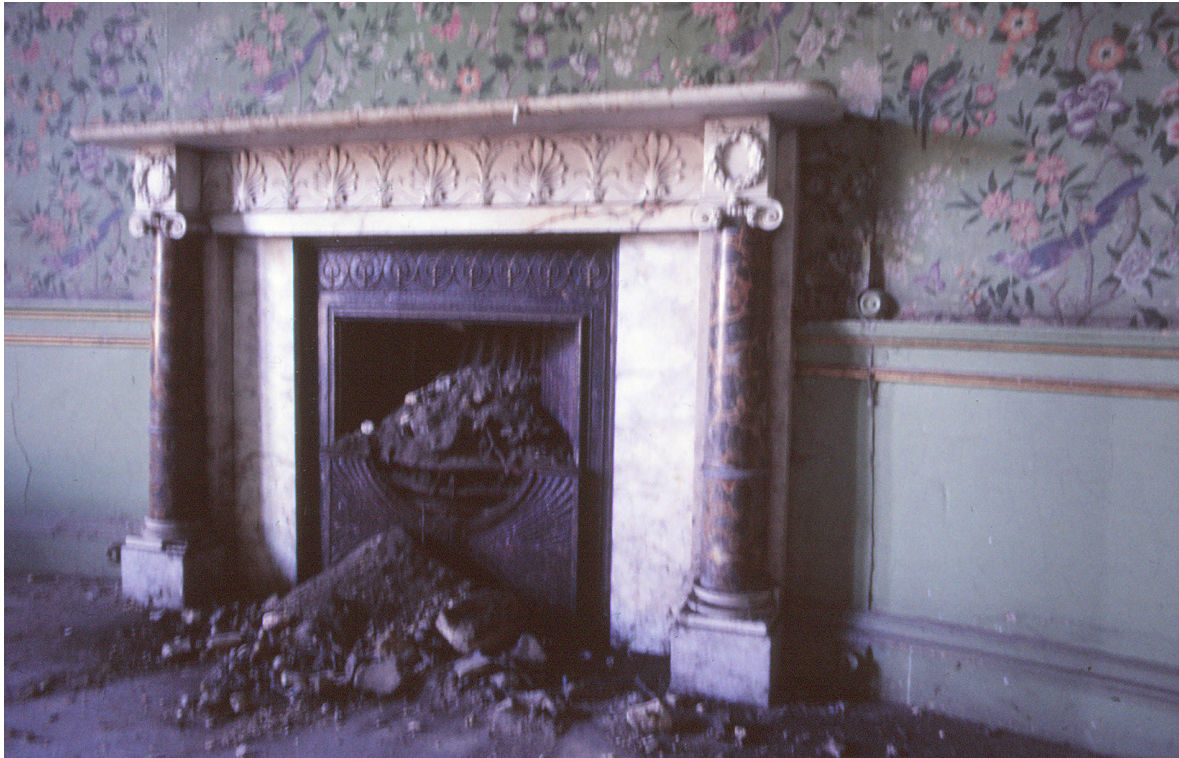
Fig. 53. R36 fire [175] c.1986 before stripping-out for dry rot remediation, showing dado rail and wallpaper. (J.Penn).

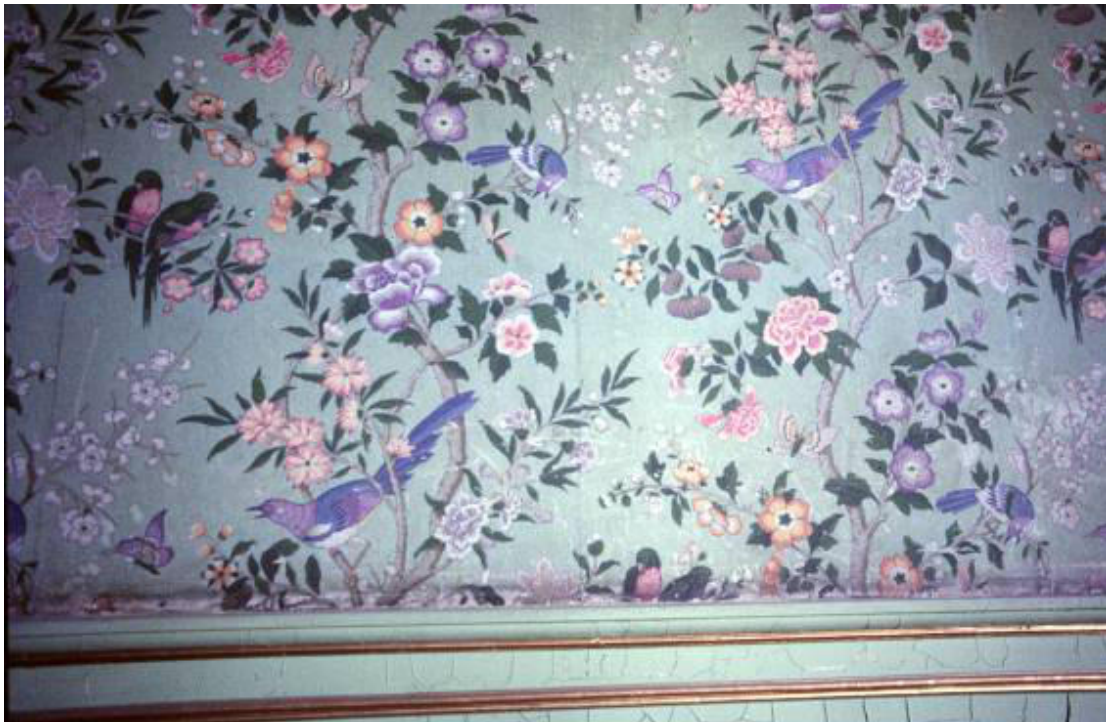
Fig. 54. R36, detail of the wallpaper and dado rail. (J.Penn).
