**HERITAGE STATEMENT  
FOR  
BARMOOR CASTLE, LOWICK, NORTHUMBERLAND**

**Deskbased Assessment and Historic Building Assessment  
Stage 1**

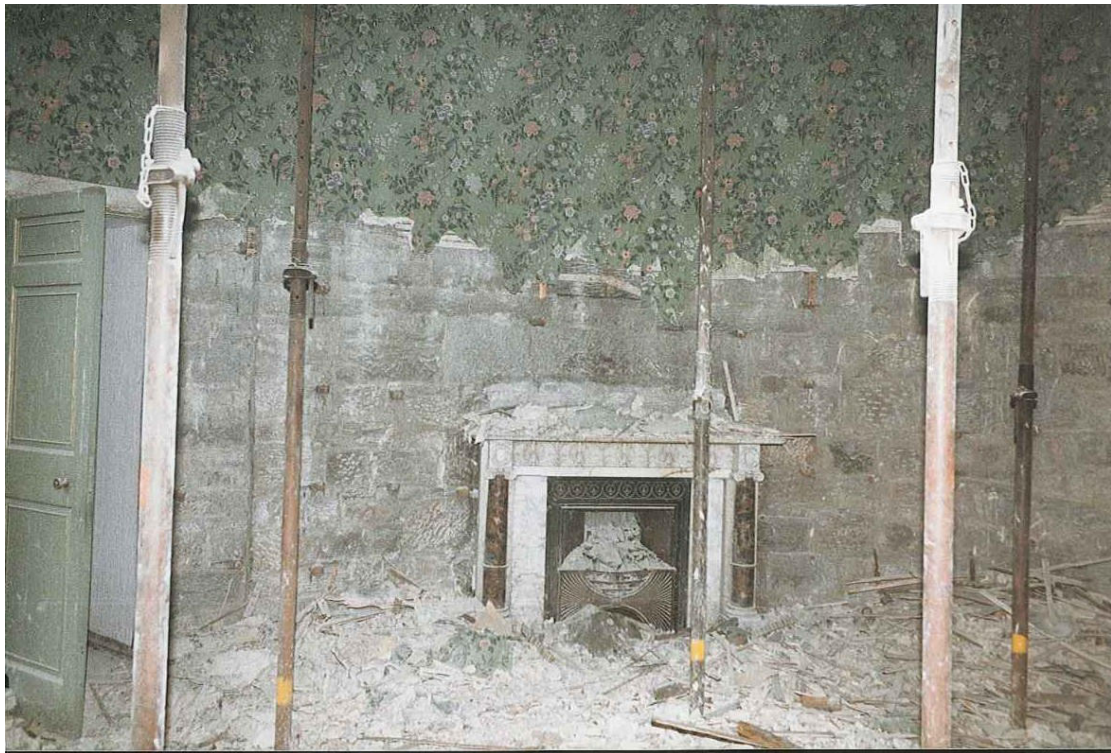
Fig. 55. R36, fire [175] c.1986 with removal of lath and plaster underway. Door [174] to R38 is on the left. Compare with P111. (J.Penn).

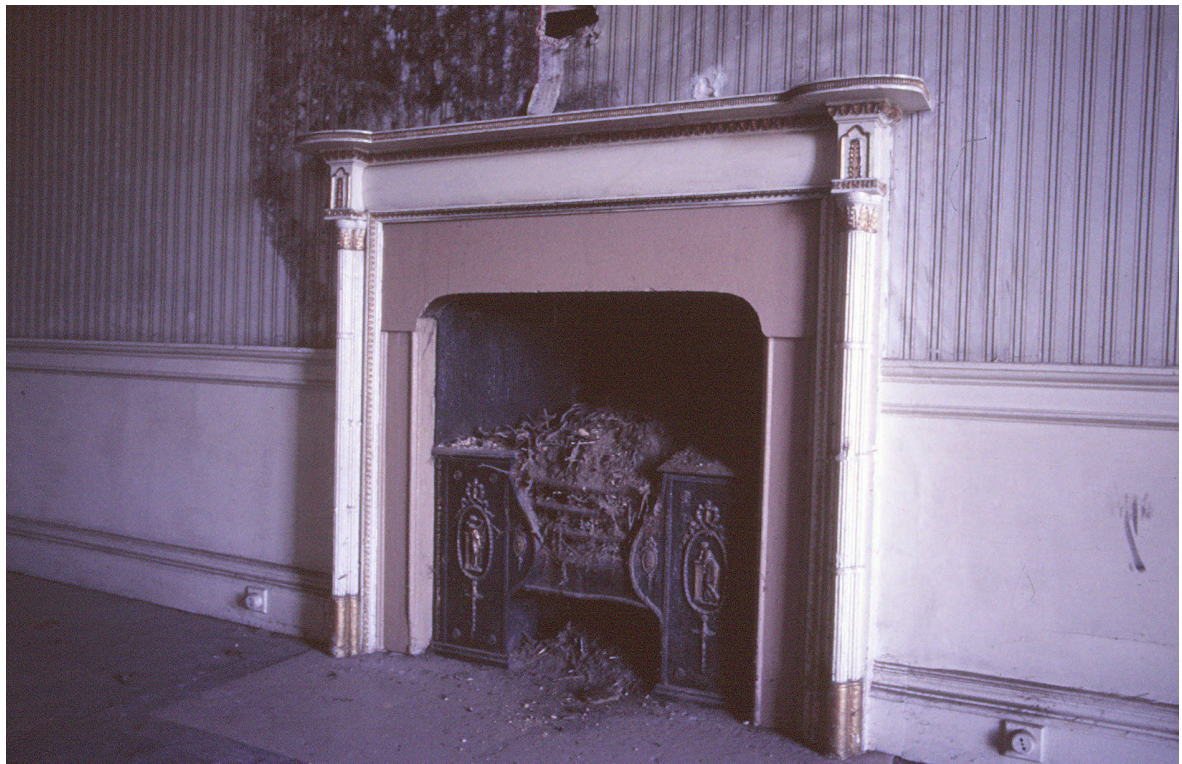
Fig. 56. R42, fire [127] c.1986. (J.Penn).

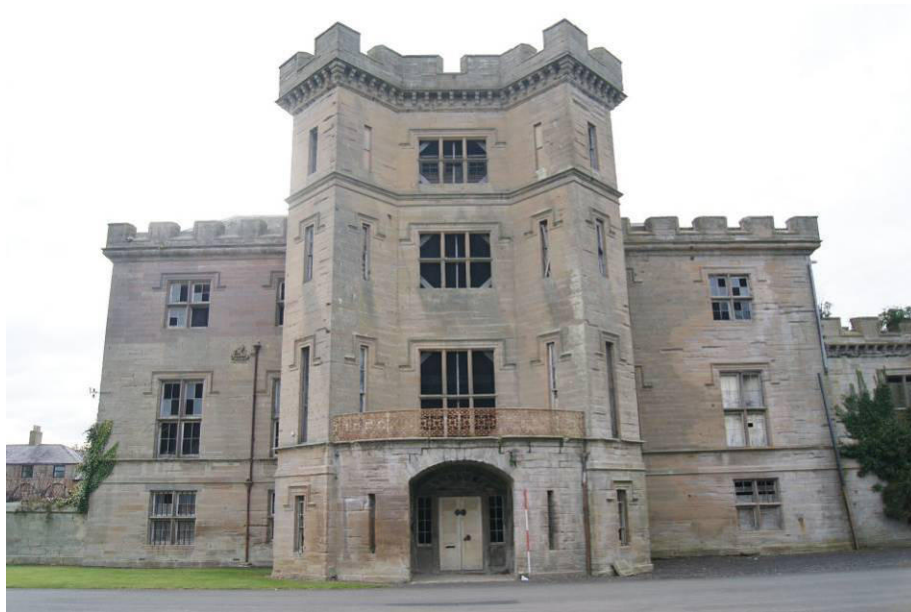
**P3.** East facade, dominated by the four-storied Gatehouse. To the south (left) the raising to second floor level of c.1892 is distinguishable by its use of red sandstone.

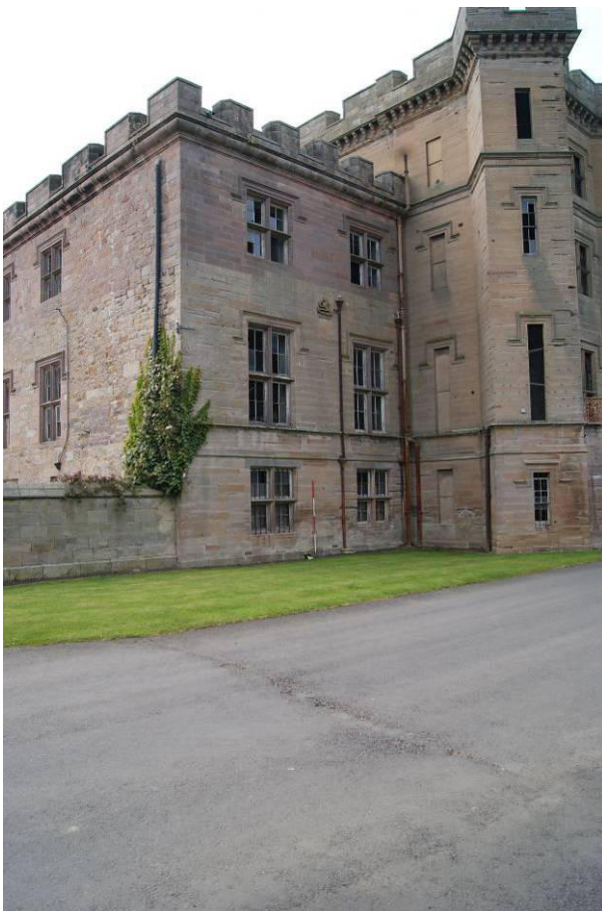
**P4.** East facade from the south showing the red sandstone masonry of the c.1892 addition, the Sitwell crest plaque below, and 'blind' windows in the Gatehouse.

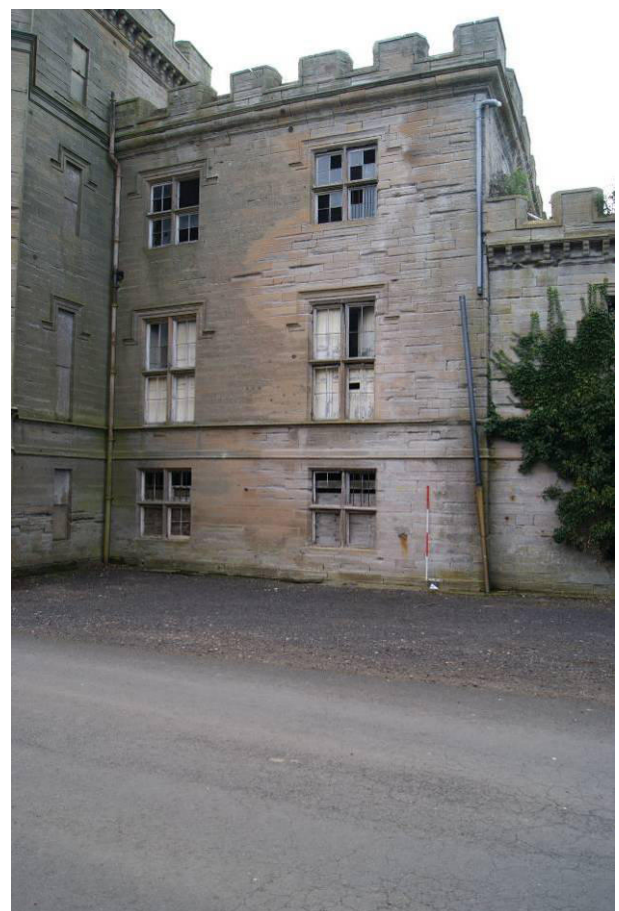
**P5.** East facade from the north, showing the late 16th-early 17<sup>th</sup> century range refaced in 1801-4 and butted by Paterson's North Range (right).

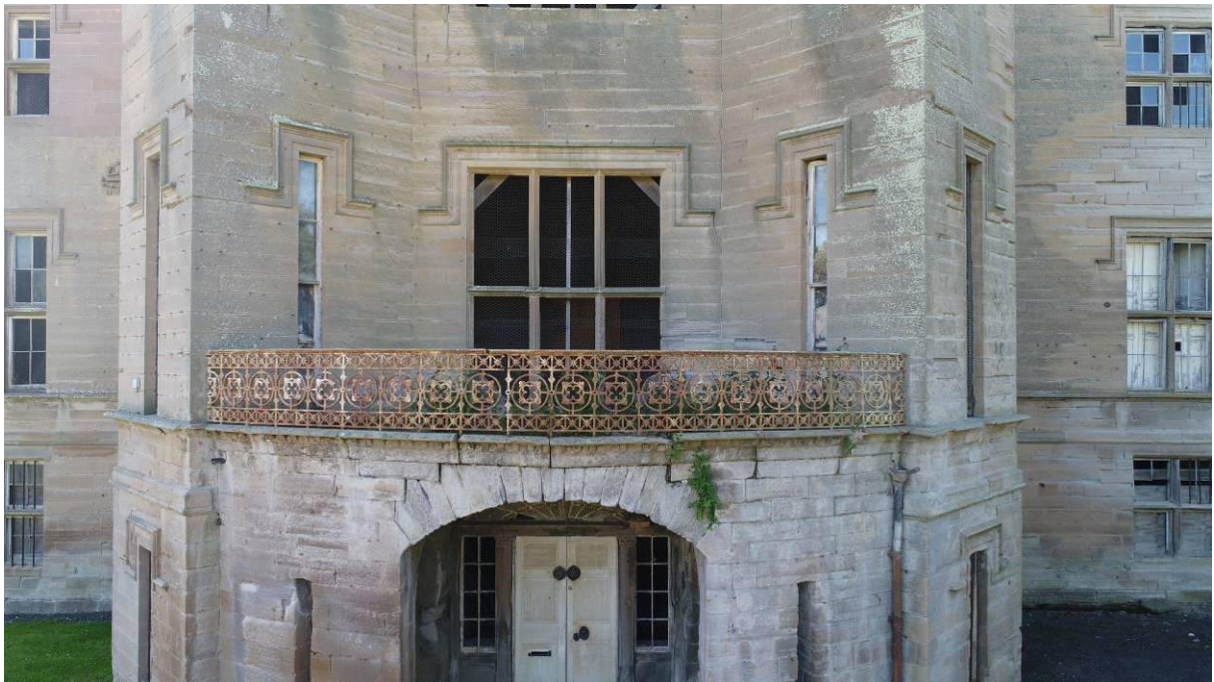
**P6.** The balcony at first floor level, with its cast-iron railing and window [169] to R36 behind. There are signs of structural movement in the arch of the porch below.

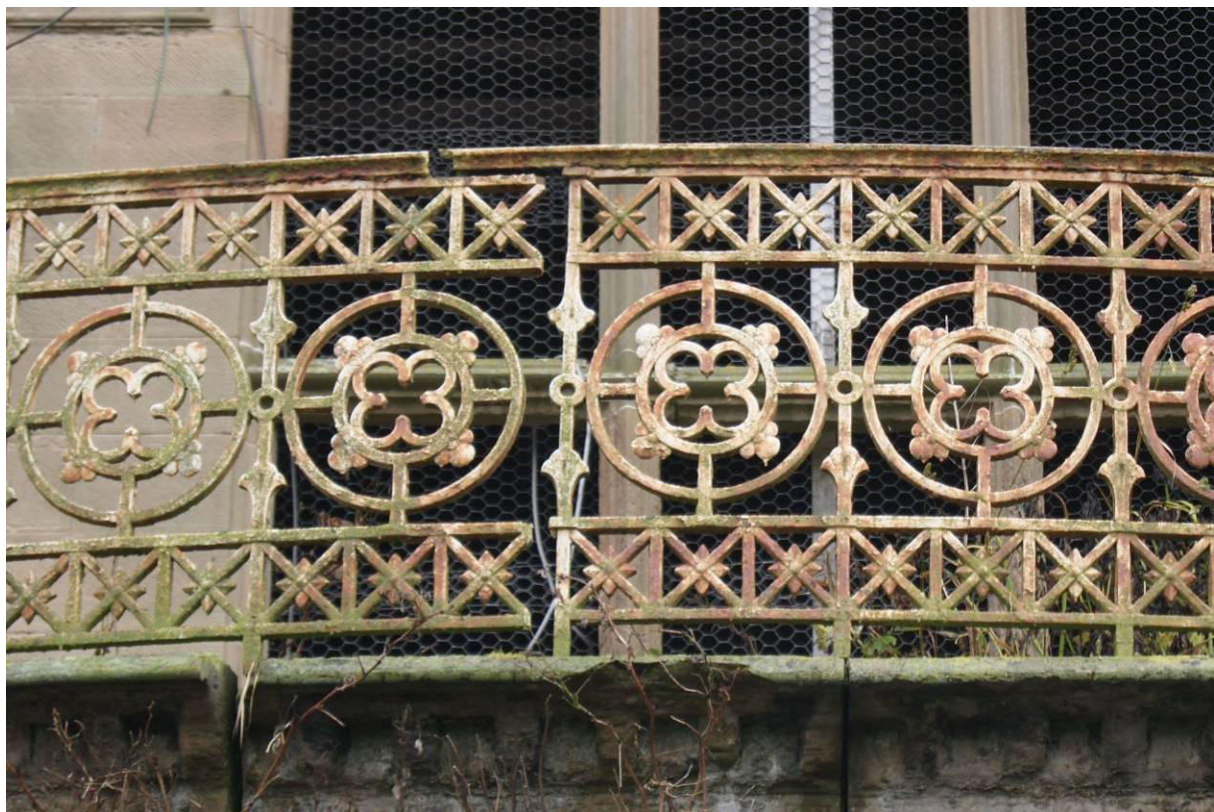
**P7.** Detail of the cast-iron balcony railing set into a moulded cornice, showing fracture due to structural movement.

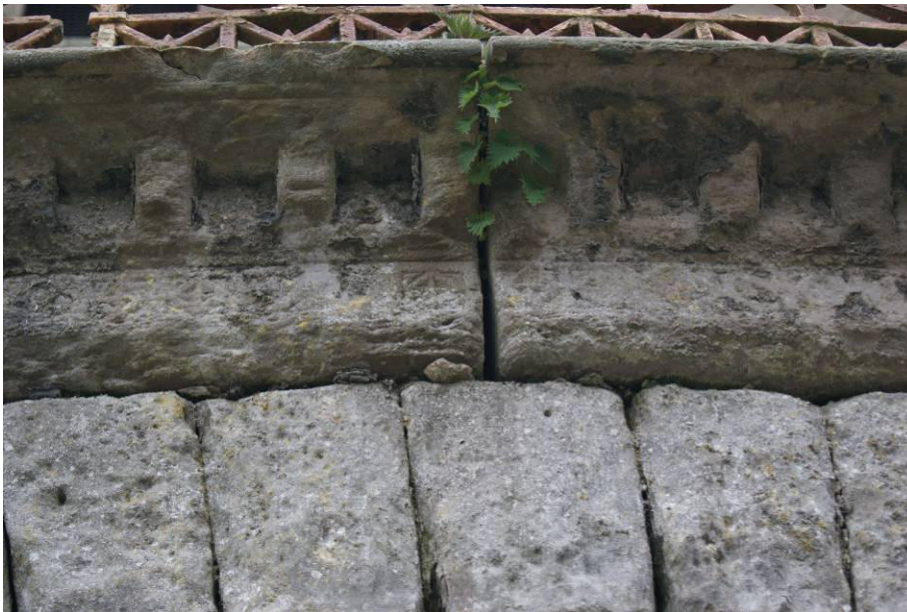
**P8.** East facade balcony. Detail of the moulded cornice to the balcony showing dentils above a badly-weathered frieze of square panels with raised lozenges and crosses – see enlargement below. Slivers of slate and stone used as levelling pieces can be seen above the arch voussoirs.

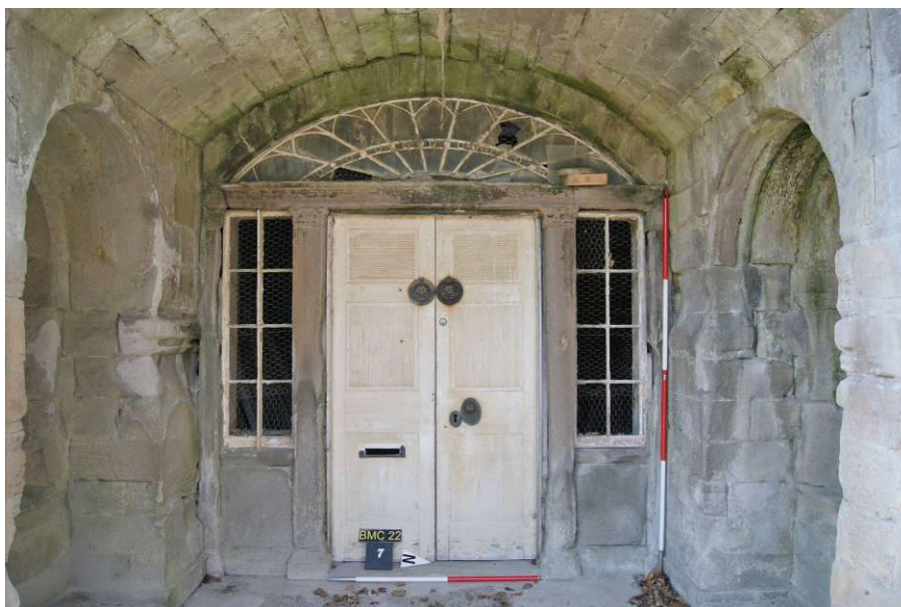
**P9.** East facade, principal entrance looking into the vaulted porch to screen wall [7] with double doors, overhead, and side lights divided by shallow pilasters possibly recycled from the pre-1801 building. Alcove niches in the north and south porch walls.

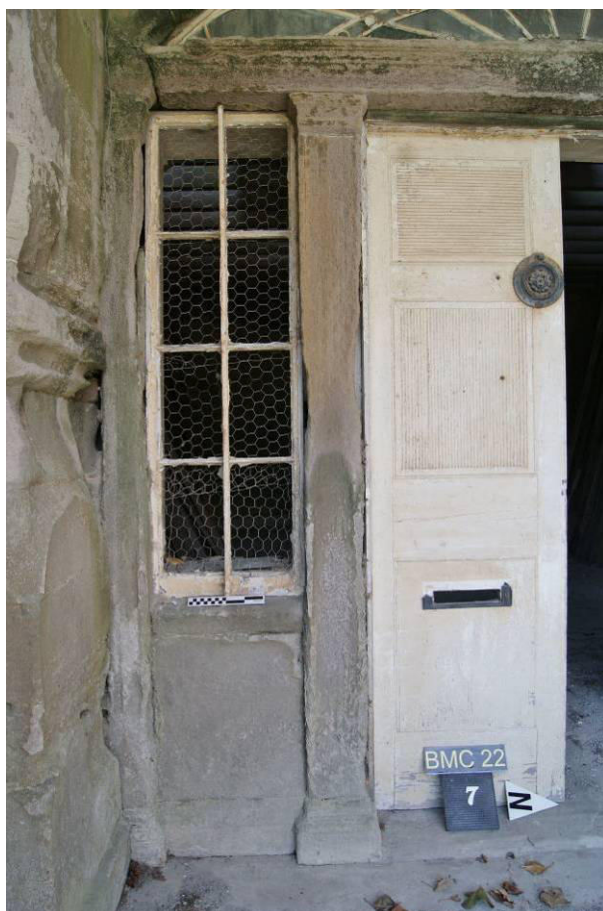
**P10.** The south side light of [7] with separate iron security bar and flanking pilasters, the left hand one is partly hidden by the butting porch masonry. The southern door leaf, three-panelled, has an inserted letterbox and probably secondary iron knocker.

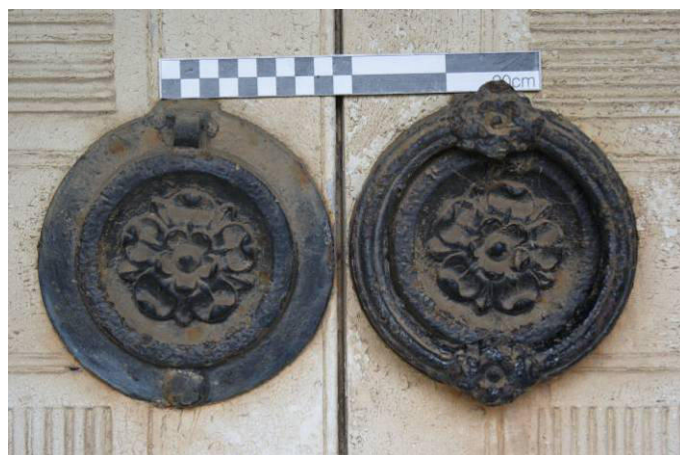
**P11.** Iron knockers, probably secondary, on the double doors to [7]. The left hand knocker has lost its ring.

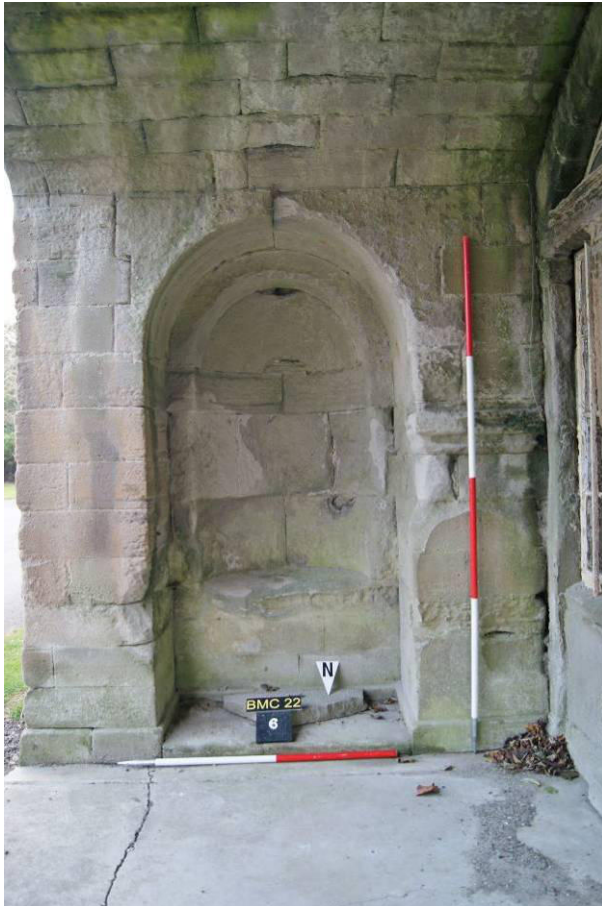
**P12.** East facade, south alcove of Gatehouse porch showing masonry, some possibly reused from the pre-Paterson 'House', butting the screen wall [7].

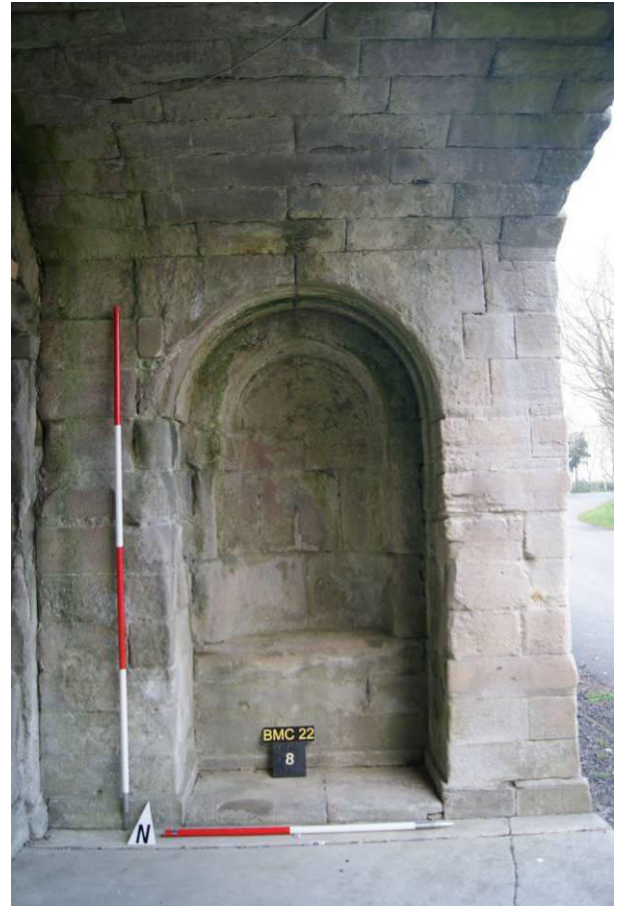
**P13.** East facade, north alcove of Gatehouse porch showing masonry again butting the screen wall [7], and also possibly containing reused masonry.

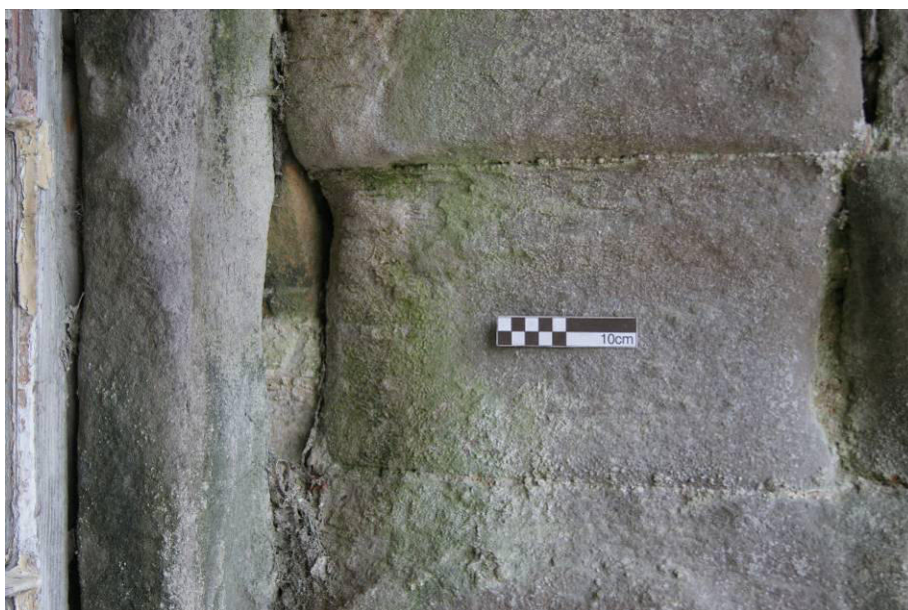
**P14.** East facade, north side of the porch showing its junction with screen wall [7], which extends behind the porch masonry.

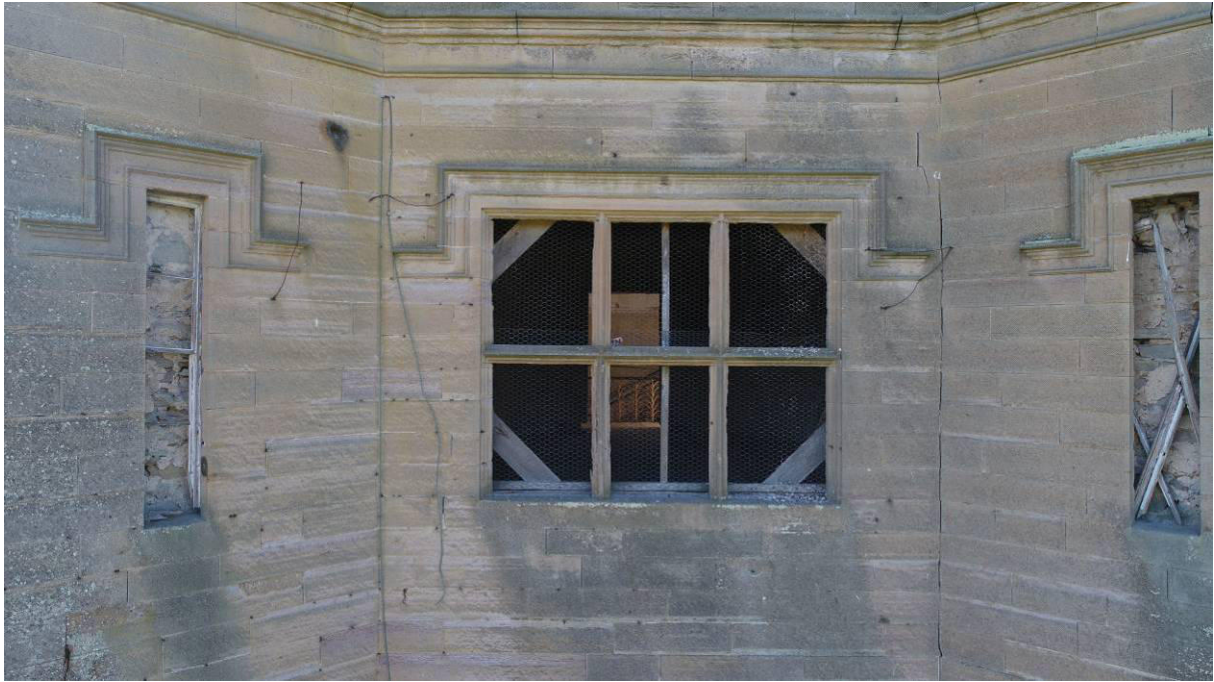
**P15.** East facade. The Gatehouse at second floor level, showing window [205] to R57, with 'blind' windows [204] and [206] to the corner turrets. Though blocked internally both of these have the remains of 'cosmetic' sashes. There is cracking in the masonry in the angle to the right of [205].

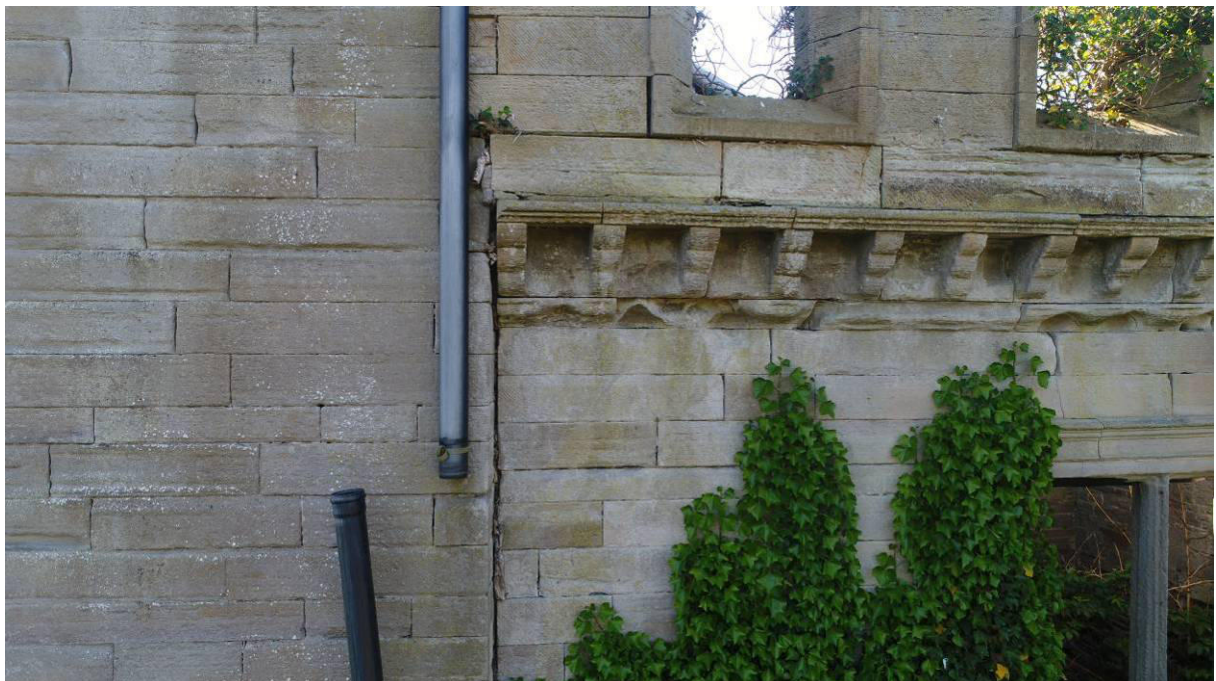
**P16.** East facade, showing the vertical butt joint at the junction of Paterson's re-faced earlier 'House' (left) with his North Range (right). The facing stones of the North Range parapet project slightly from those on the 'House', suggesting either misalignment or re-alignment during building, or displacement caused by structural movement/creeper disturbance.

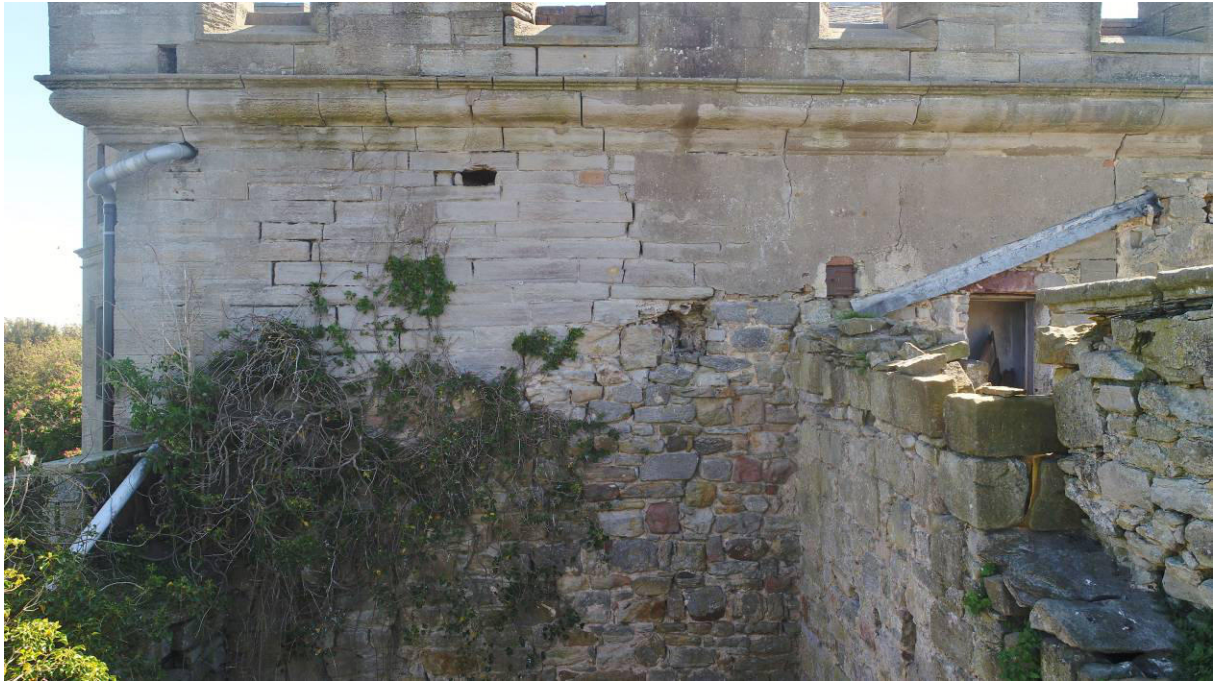
**P17.** Drone view of the north facade of the late 16<sup>th</sup>/early 17<sup>th</sup> century wing at second floor level, showing the rubble masonry of the late 16<sup>th</sup>/early 17<sup>th</sup> century range, with long purple-grey ashlars above and the north-east corner of the 1801-4 re-clad east facade (left) and crenellated parapet. A new door is proposed to be inserted immediately right of the UPVC downpipe, leading from R62 to a rooftop patio.

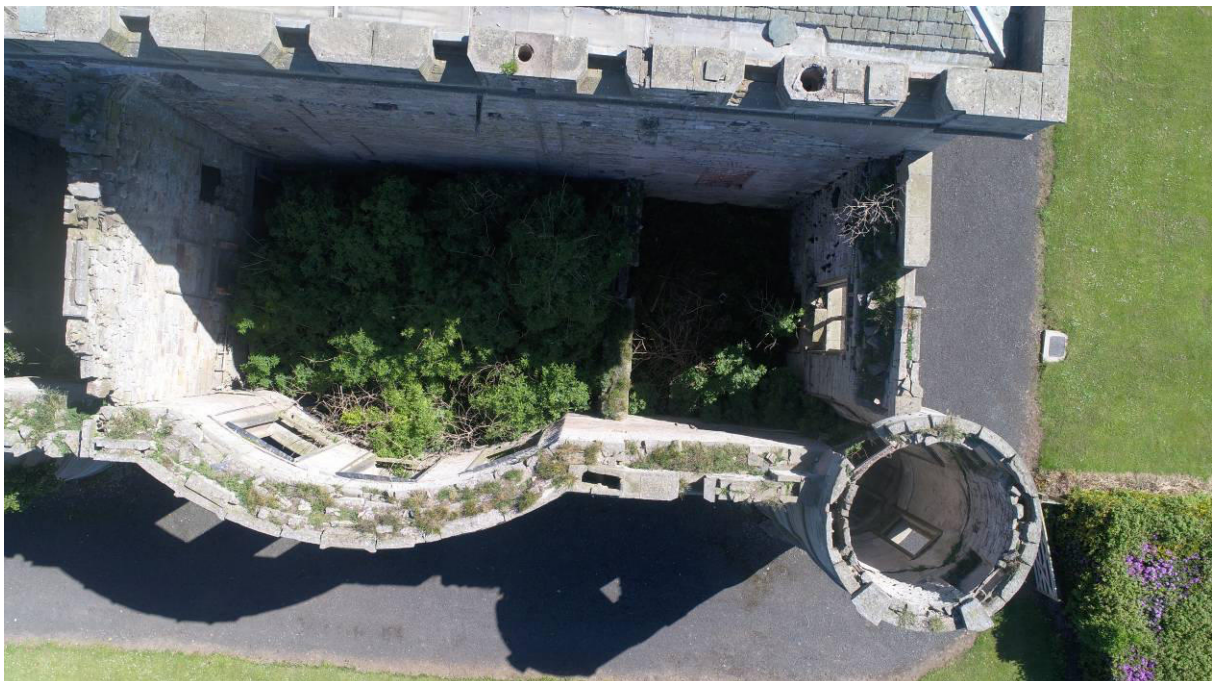
**P18.** Drone view looking down into the roofless North Range, with R21 extreme left, R22 centre, and R24 and turret R25/48 on the right. This shows the dense vegetation which has grown since 2012 and the unstable nature of the wall-heads. Between R22 and R23 is the the remains of the partition wall demolished in 2013.

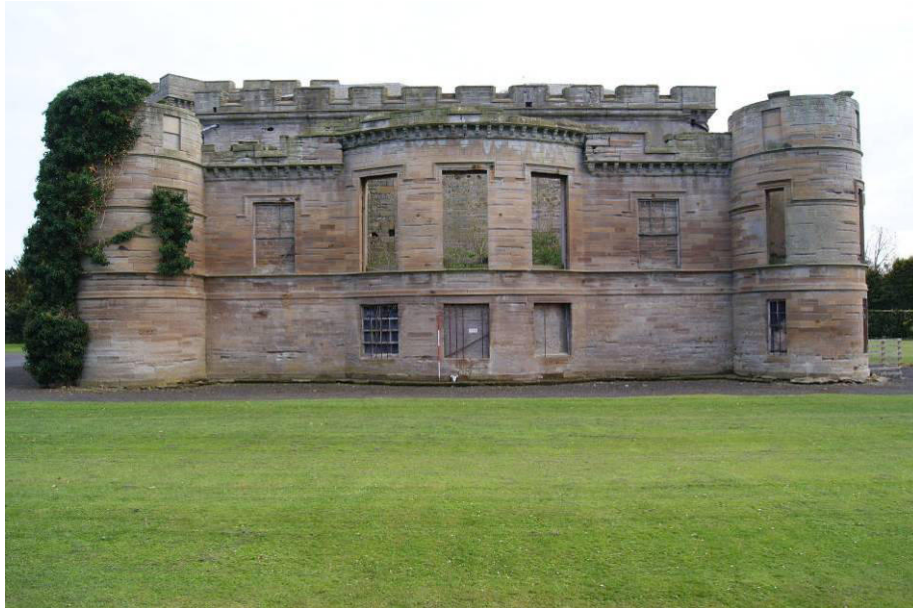
**P19.** North Range, north facade, showing barred ground floor windows [18-20] large former sashes at first floor level in the bay front [136-140], with 'blind' windows [133] and [141] either side. It is proposed to form a new 'house' within the North Range, and to convert central ground floor window [19] into a doorway.

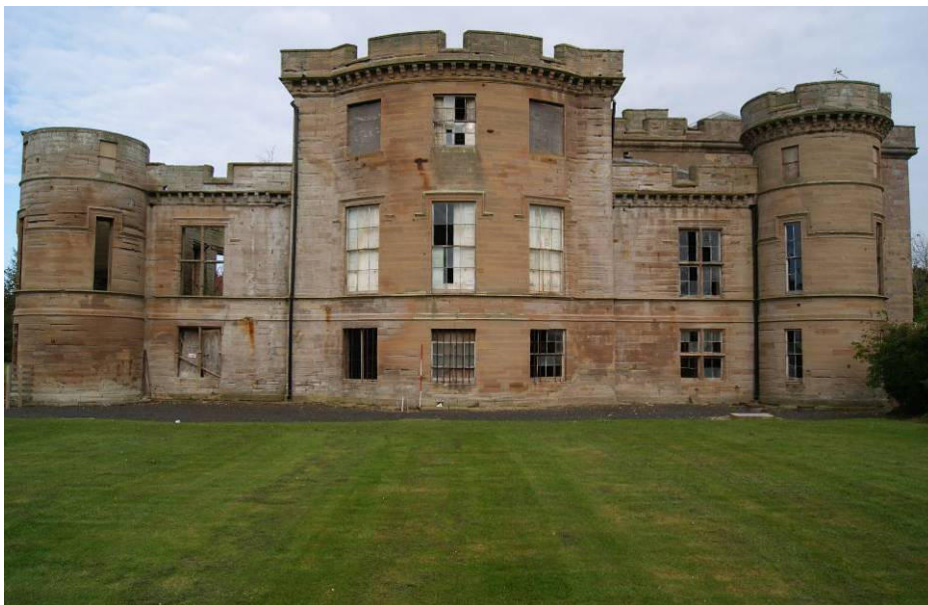
**P20.** West facade of the West Range of 1810-4, general view looking across the site of the infilled ornamental pond (which is proposed to be reinstated), showing barred ground floor kitchen windows [24-25], and tall sashes to the 'Eating Room' above [101-103].

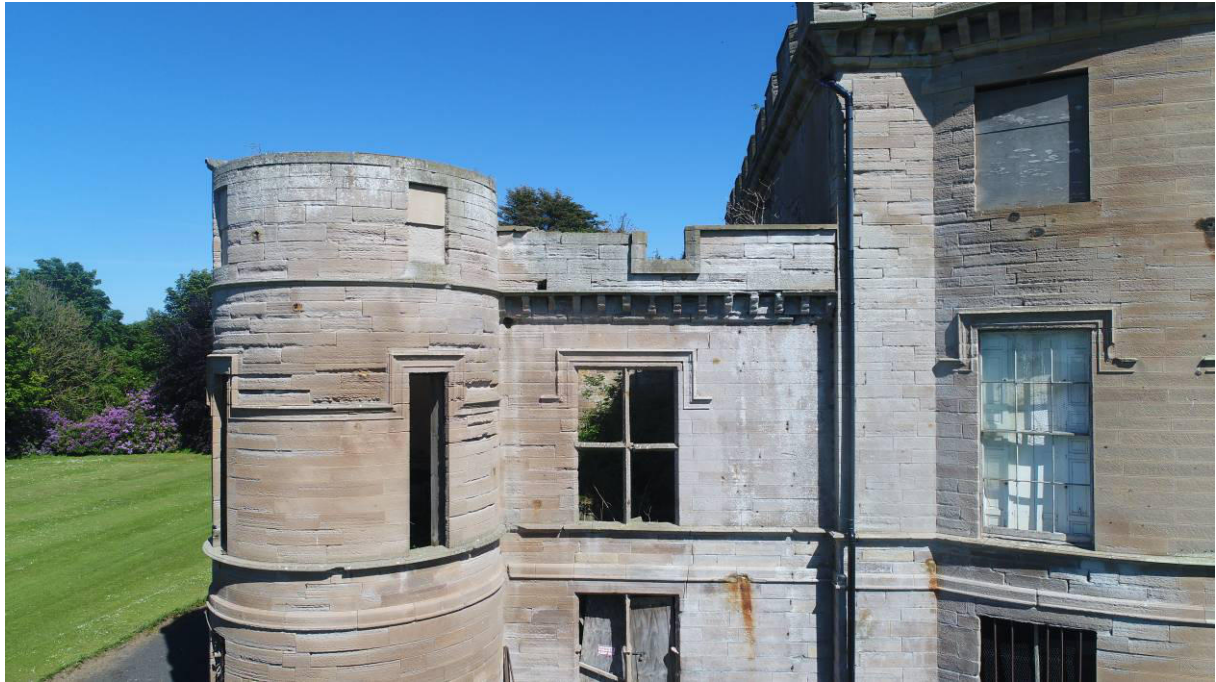
**P21.** Drone photograph of the west wall of the North Range at first floor level showing mullion and transom window [145], turret window [144] (left) and 'Eating Room' window [101] with 1801-4 curved sashes (right).

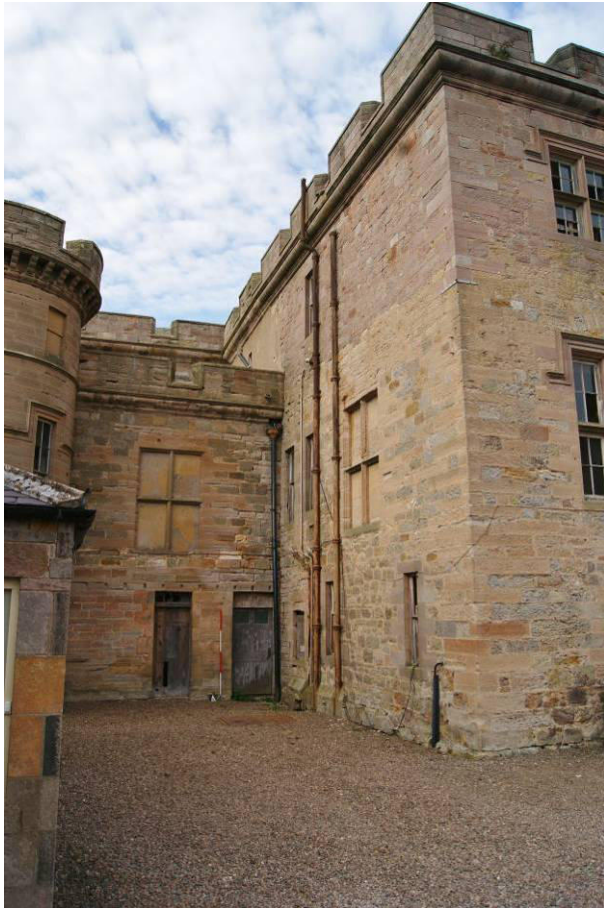
**P23.** South-west facade of the South Wing (left) and 1801-4 south facade showing doors [31] (originally a window) and [32], also 'blind' windows [153] and [161],

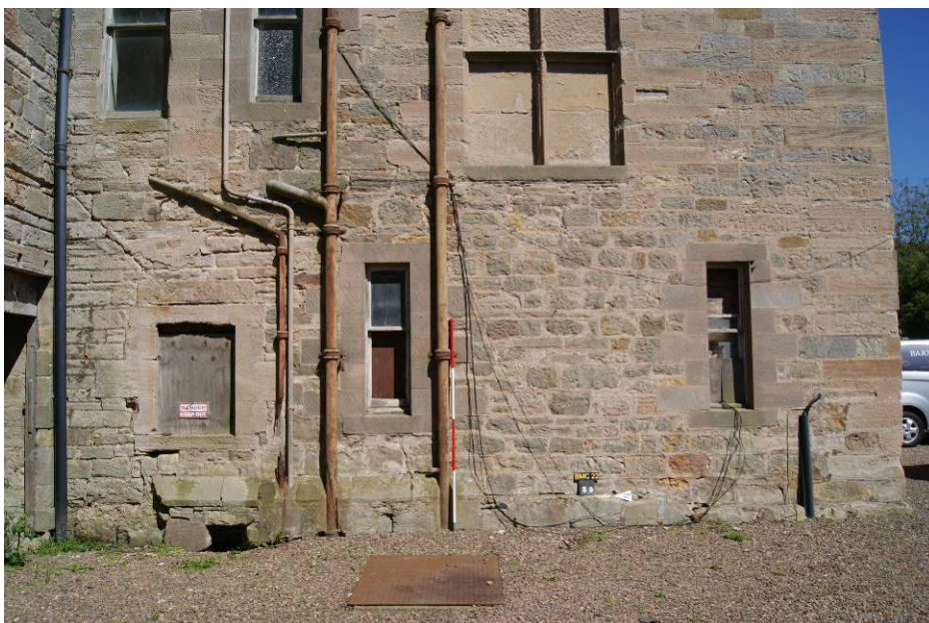
**P25.** South Wing, south-west facade, showing the remains of the medieval tower's chamfered plinth [39], c.1892 ground floor windows [33] – [35] and first floor windows [159], [160], and 1801-4 'blind' window [161].

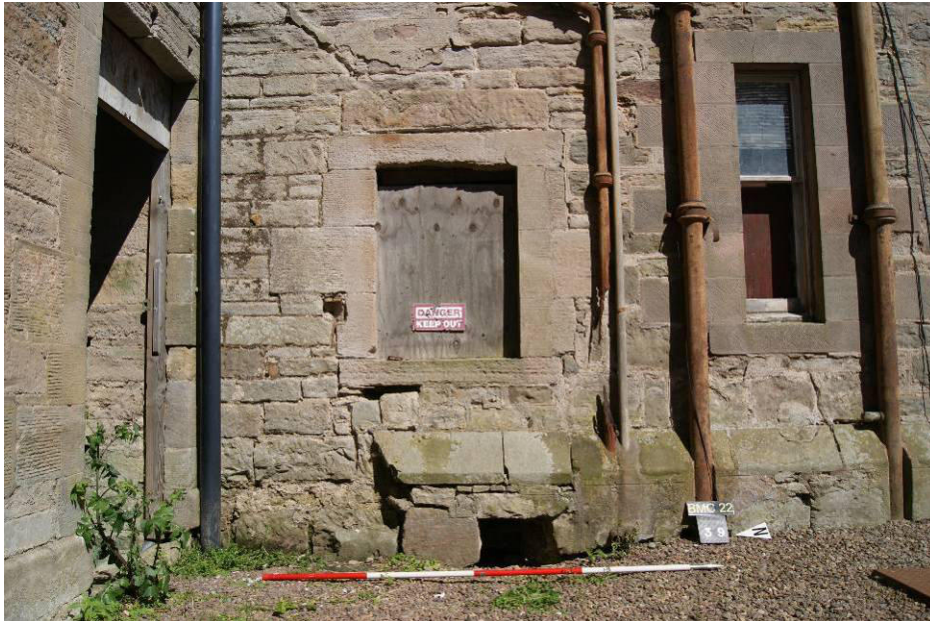
**P26.** South Wing, detail of the south-west facade showing window [33], originating in a pre-1801-4 feature, proposed to be opened into an 'secondary entrance', with the surviving medieval chamfered plinth directly below. The breach in the plinth was made to introduce services (see PX). To the left the chamfer has been cut back flush with the wall-face to accommodate the Pump House demolished in the 1980s. To the right is window [34], inserted c.1892.

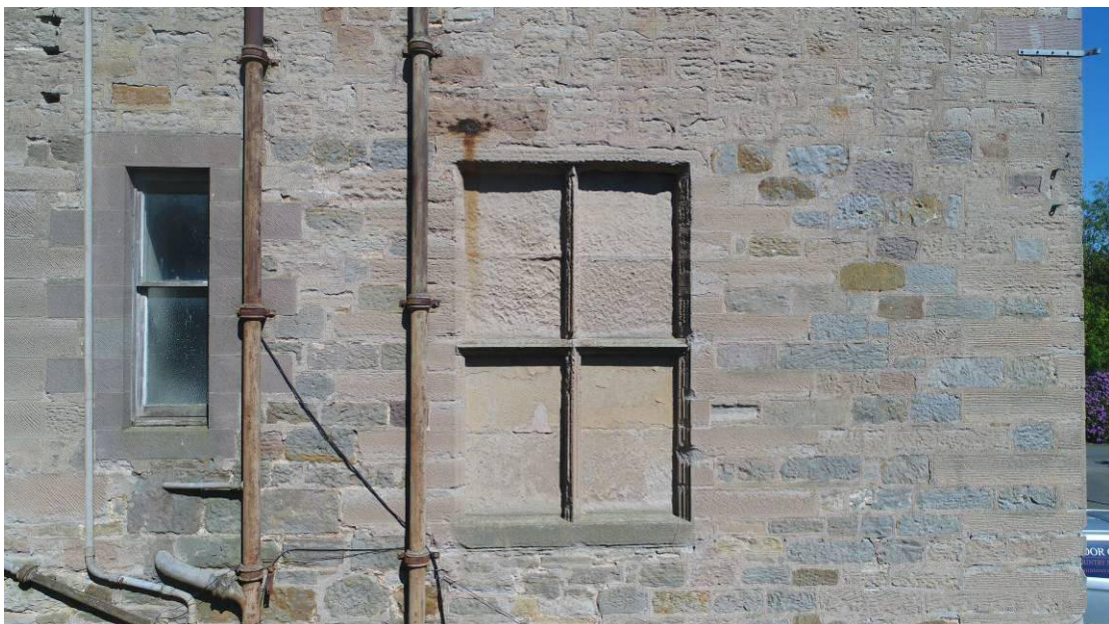
**P27.** South Wing, south-west facade drone view at first floor level showing the junction of the c.1892 second storey with the earlier, predominantly grey, masonry. Window [160] to the left was inserted c.1892, the 'blind' window [161] is part of the 1801-4 work. The multiplicity of drainpipes are late 19th-20<sup>th</sup> century. No change is proposed to the facade at this level..

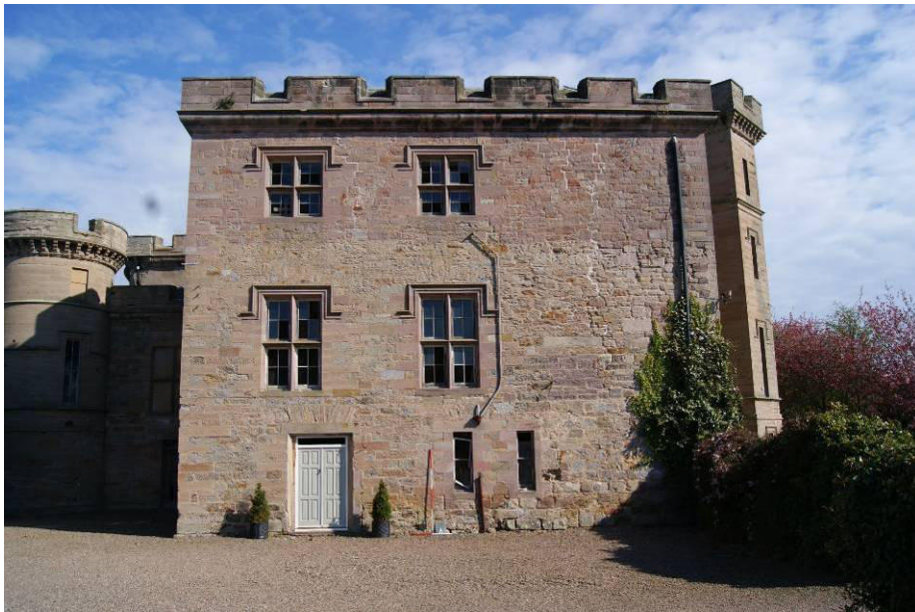
**P28.** South Wing south facade, showing the colour change in fabric from yellow-grey - which appears to be 1801-4 (right) but with some earlier (?late 18<sup>th</sup> century) masonry,(left) - to the purple-red of the c.1892 raising to second floor level.

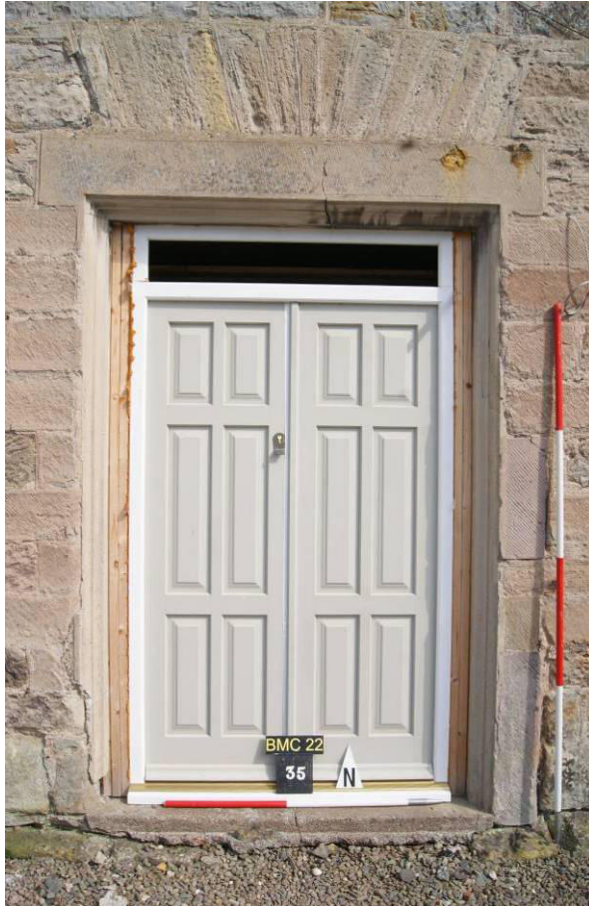
**P30.** South Wing south facade showing door [35], opened-out probably c.1892 from a window shown as existing in 1801 - the relieving arch survives. The frame is actually moulded in cement, and the cement sill cuts the medieval tower's chamfer course. The doors are recent replacements. A patio is proposed to be formed in front of this door.

10.4.2 At ground level there are three openings of c.1892. A double-leaf door [38] at the west end (**P30**) has a relieving arch above a flat stone lintel and mouldings on the jambs and lintel which appear to be cement. This has been converted from a mullioned window shown on the 1801 floor plan and is probably part of the c.1892 remodelling. To the east are two narrow sash windows [37] and [38], the former remodelled from an 1801-4 doorway:frame broken and glazing gone (**P31**). A gap in the medieval chamfer course [272] seems to represent the site of a fireplace shown as *existing* on Paterson's floor plan and thus possibly belonging to the suggested but unrecorded late 18<sup>th</sup> century remodelling. At first and second floor levels are pairs of four-light windows. Those to the first floor are probably part of the c.1892 work, but may replace earlier ones. It is noticeable that these are toward the west side of the facade, perhaps as the eastern side was intended to link to Paterson's unbuilt courtyard range. Two blocked features, fire [109] and ?doorway [271] (Fig. 40; **P29**) again seem to match as existing features on Paterson's proposed floor plans, and could belong to the suggested late 18<sup>th</sup> century remodelling.

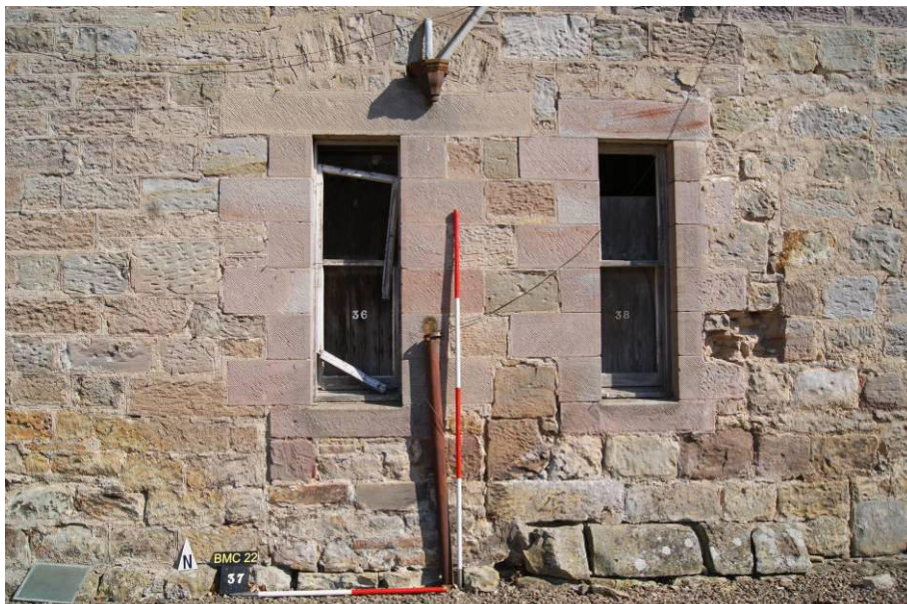
**P31.** South facade of the old 'House' with windows [37] and [38]. Window [37] has been formed, possibly c.1892, by blocking a doorway of 1801-4 which had truncated the medieval chamfered plinth [39]. A section of chamfer survives to the right with some medieval face stones apparently in situ, above.

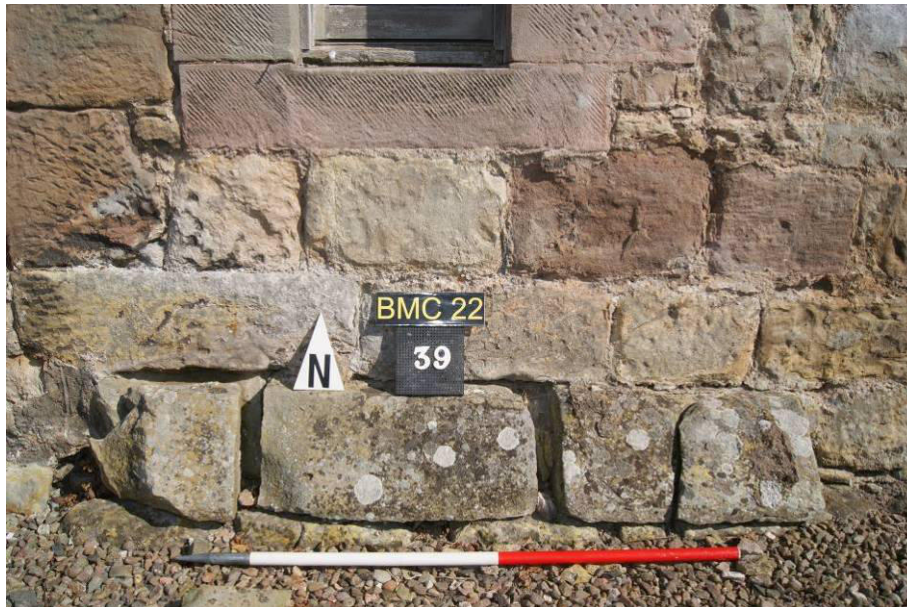
**P32.** South Wing south facade. Detail of the medieval chamfered plinth [39] and surviving facing stones below later window [38].

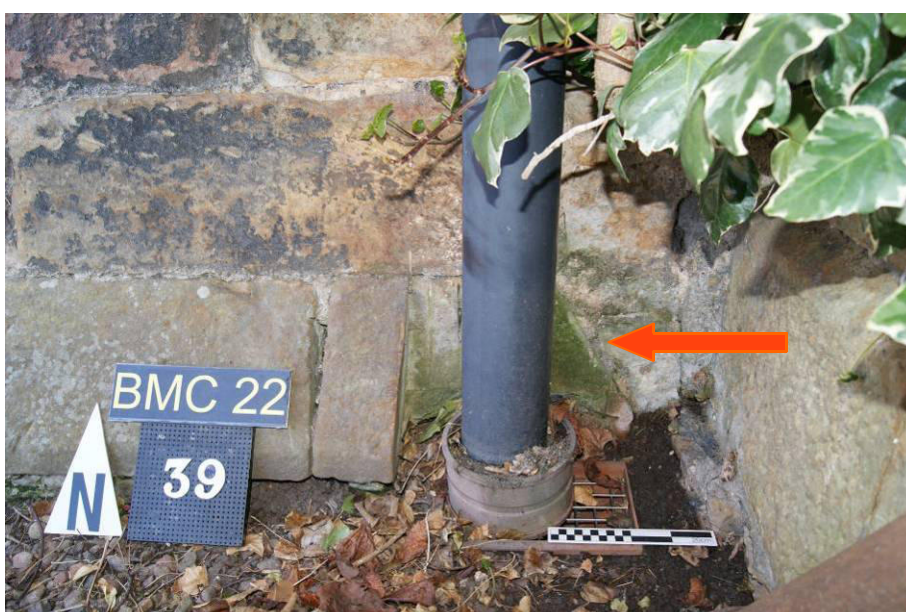
**P34.** South facade. The south-east corner of the chamfered plinth [39]. The chamfer has been cut back with a Stihl saw to insert the UPVC downpipe, but the angled face of the northward-returning chamfer can be seen behind the pipe (arrowed).

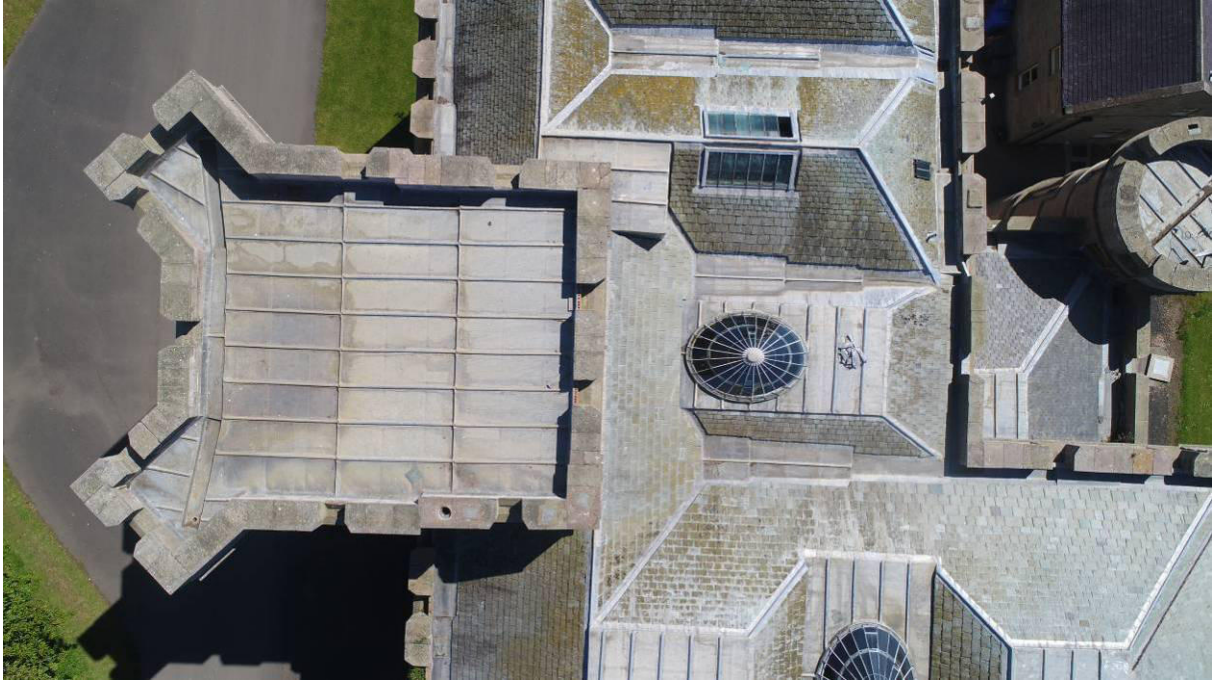
**P35.** Drone view of the Gatehouse and south wing roof showing 1980s lead and slate pitches. The cupola over the Great Stair is at the centre, and that above the Oval Saloon is just visible at the bottom of the picture.
