**HERITAGE STATEMENT  
FOR  
BARMOOR CASTLE, LOWICK, NORTHUMBERLAND**

**Deskbased Assessment and Historic Building Assessment  
Stage 1**

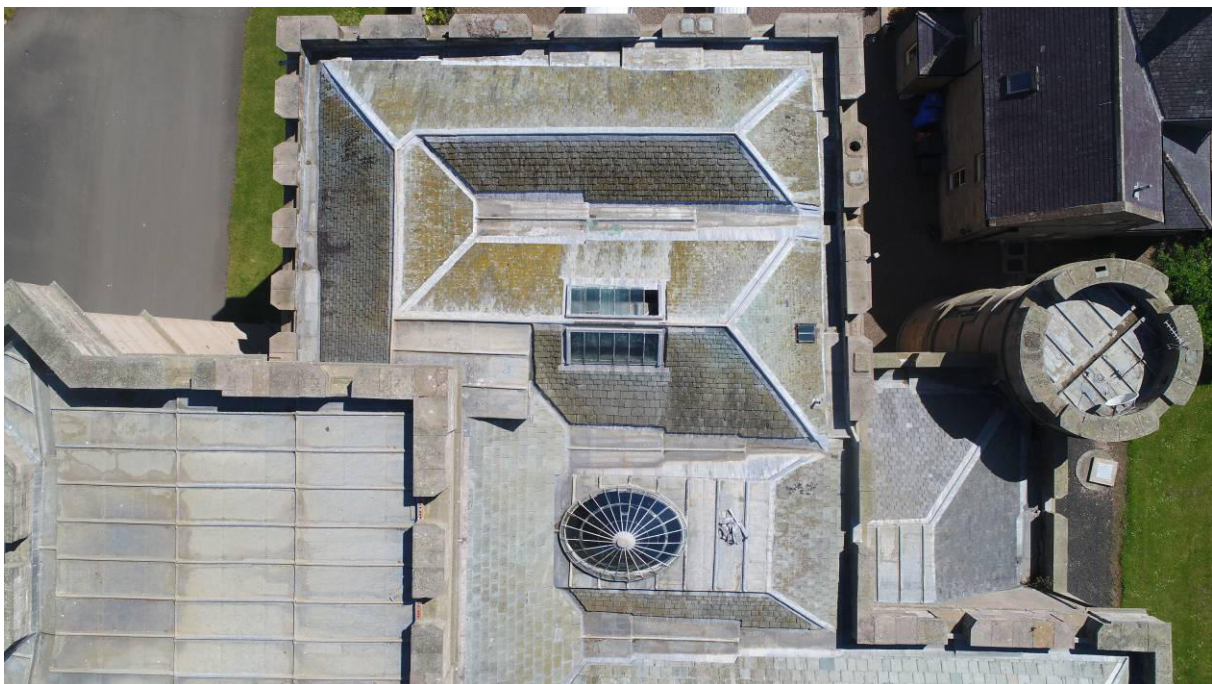
**P36.** Drone view of the South Wing roof and parapet of c.1892. The north-south slated roof is above R73. The south, The northern east-west slated roof is above R75, the southern with a rectangular skylight [315], is over the Service Stair R68, and has a hinged skylight [319] in the hip. The turret roof is above R40. The flat leaded roof at the south-west corner of the Gatehouse contains an access hatch [318]. The western parapet differs markedly in thickness from the West Range (lower right) and the c.1892 work. Capped and uncapped chimney outlets are

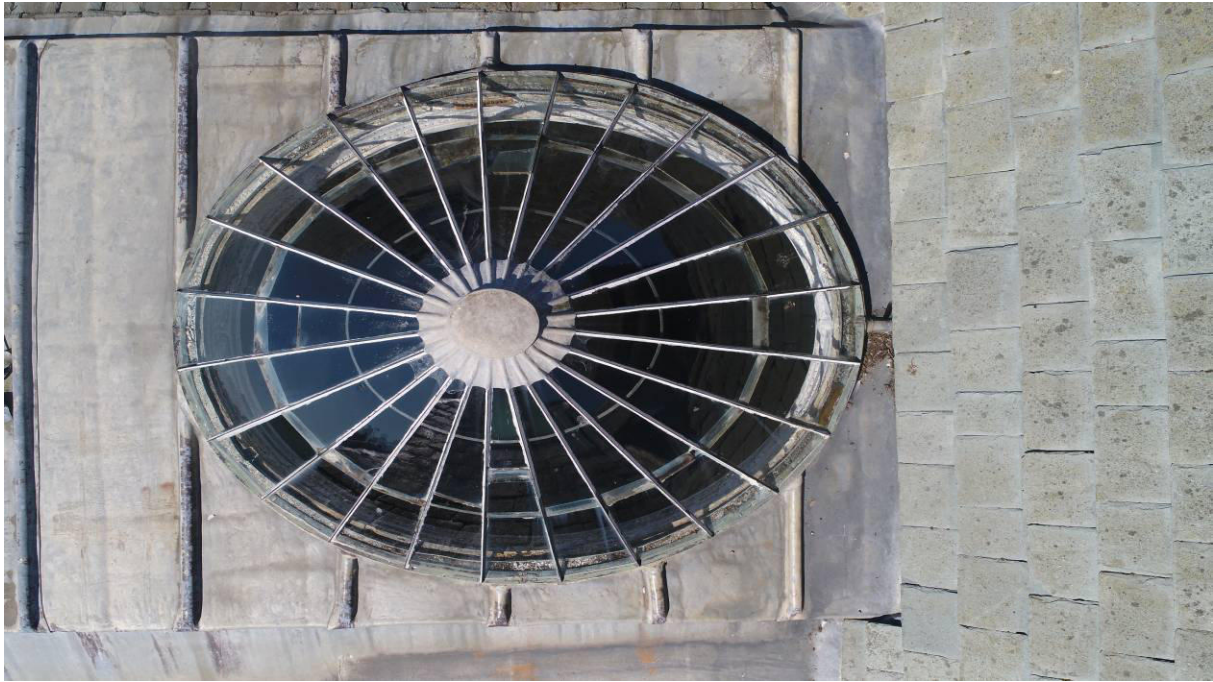
**P37.** Drone view of the Great Stair cupola [316] showing glazing ribs, glazing repairs, and decorative lead cap.

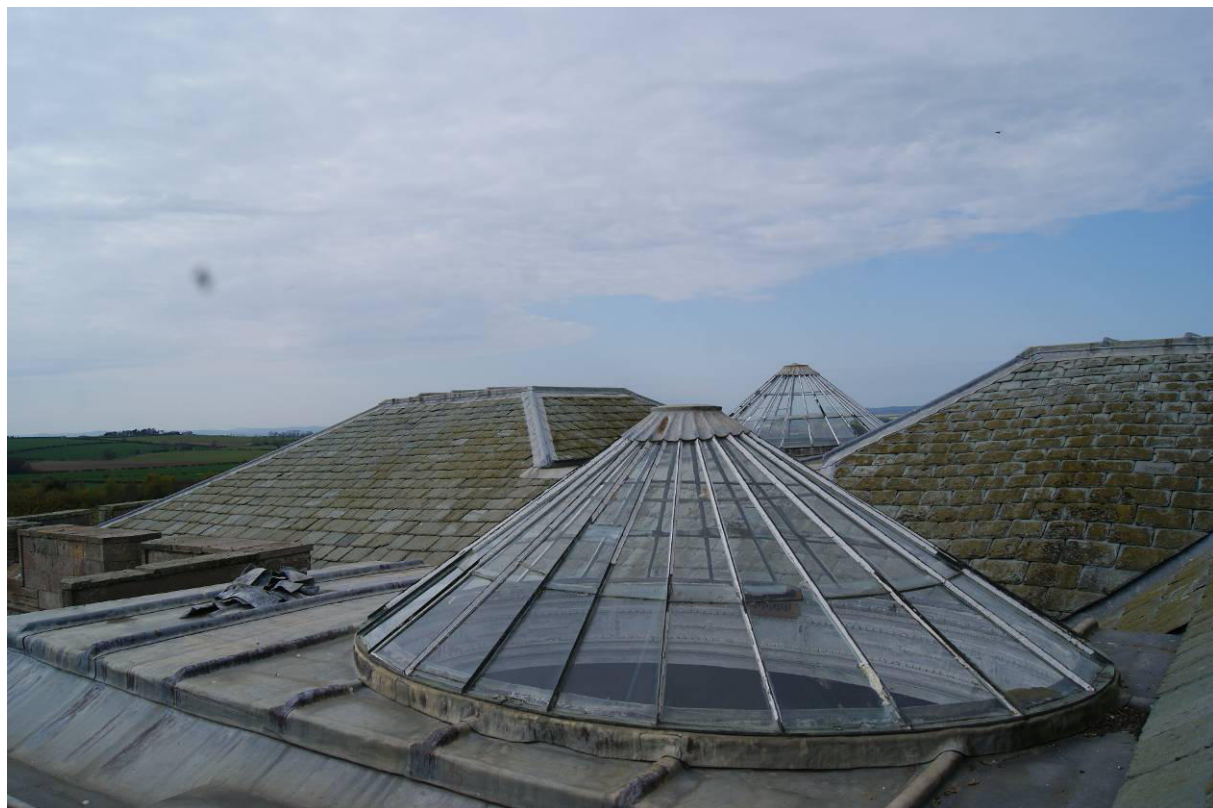
**P38.** Great Stair cupola [316] looking from the Service Stair roof-hatch [318] showing patch glazing repairs. The Oval Saloon cupola is in the background.

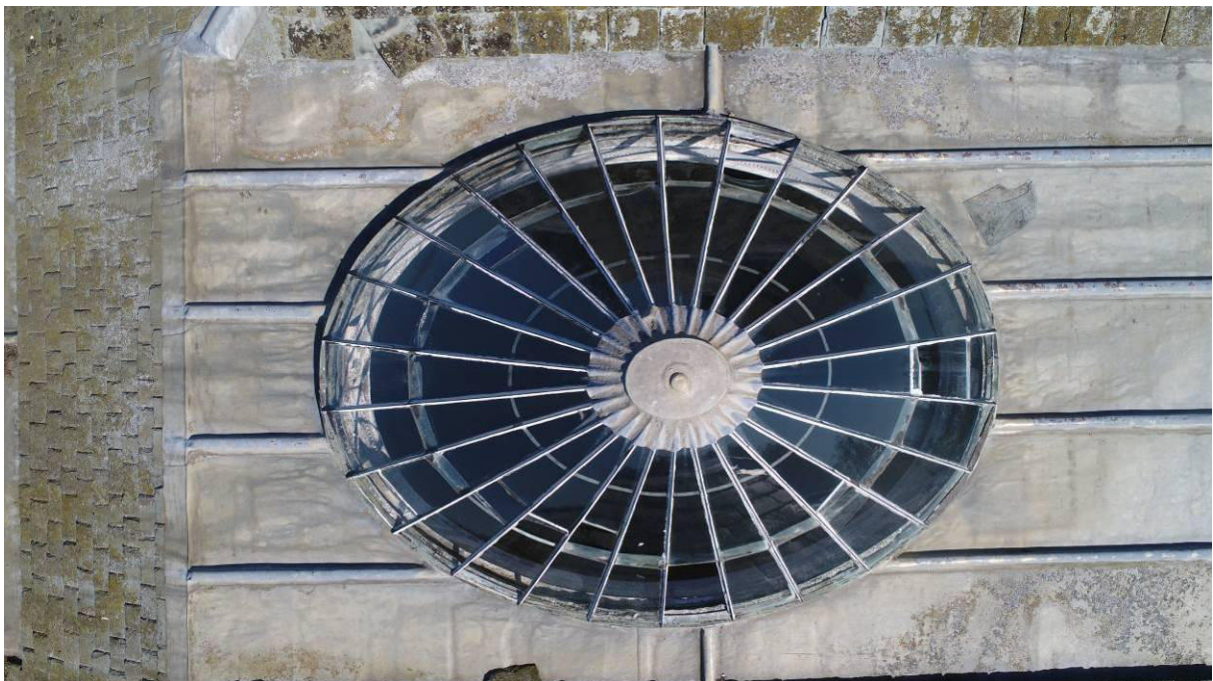
**P40.** Drone view of the Oval Saloon cupola [318] showing glazing ribs, patch glazing repairs, and decorative lead finial cap.

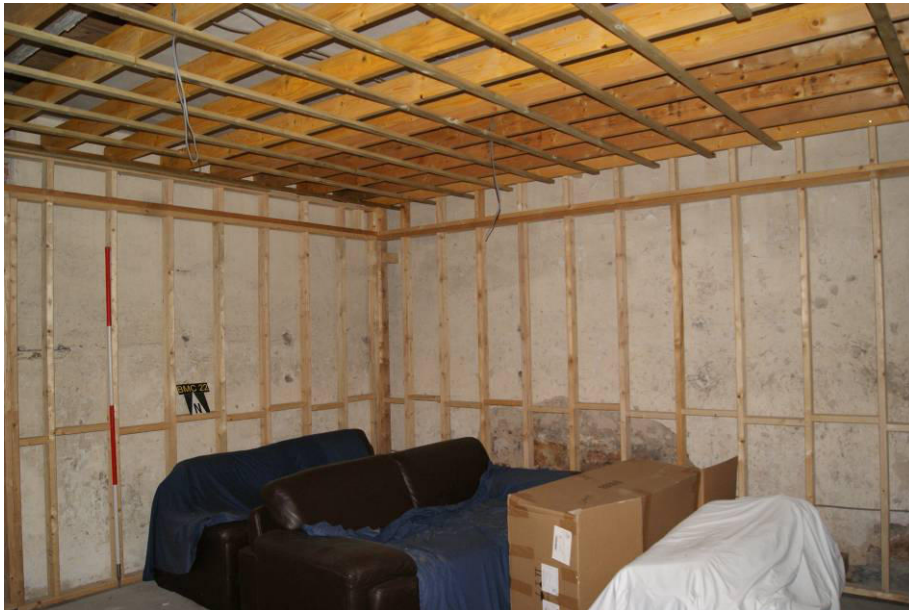
**P41.** R1 looking north-east to the site of proposed new openings in the north (left) and east (right) walls. Shows recently added timber framing for dry lining.

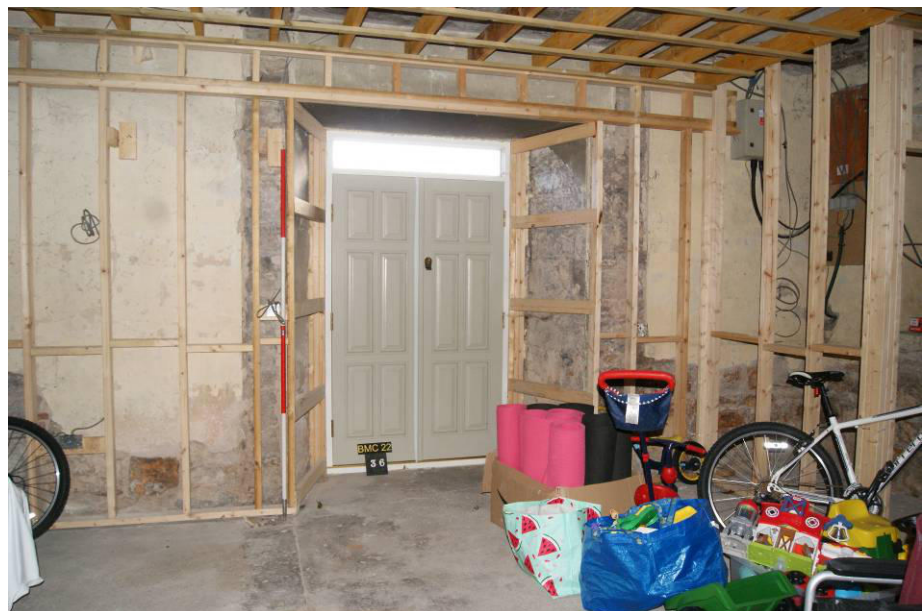
**P42.** R1 looking south-east to door [36] and window [37]. Recently replaced double doors and framing

**Doors** – External access is by the wide double-leaf doorway in south wall [36] (**P42-44**), The present frame and door leaves are recent replacements – those existing in 2012 have been retained. To the east is a blocked narrow doorway [37], shown in 1801 as leading to a passageway, converted into a window (1892?). Externally this too has a relieving arch above the lintel. In the north wall is a doorway with a late 19<sup>th</sup>/20<sup>th</sup> century six-panel leaf and modern spring-closer.

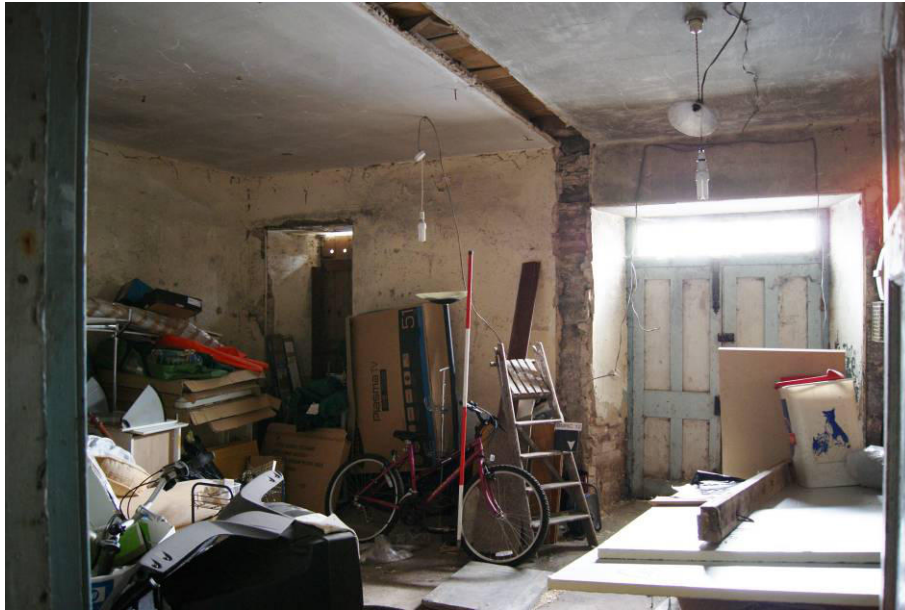
**P44.** R1 as it was in 2012, looking south-east. Showing scar of former brick partition.

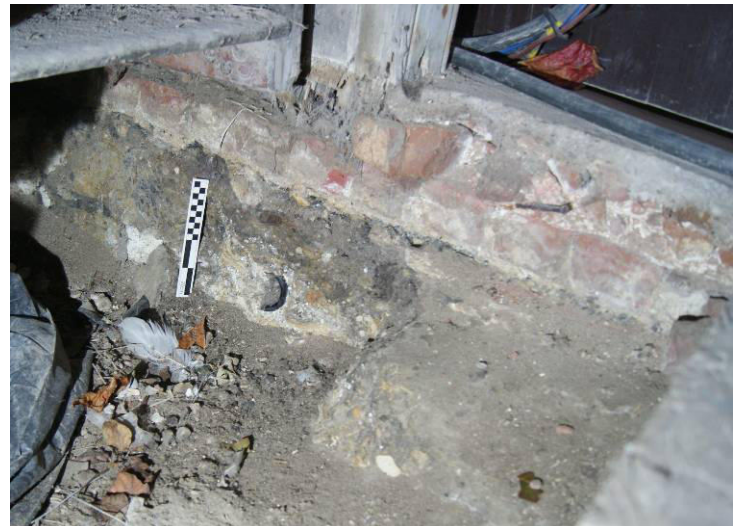
**P45.** R2 west end, showing deposits including a ?brick floor and a bottle-base, exposed in a partly backfilled 1980s service trench running from below the dumb waiter [78] to the west wall.

**Floor** – late 19<sup>th</sup>/20<sup>th</sup> century concrete screed. At the west end a large area has been broken out apparently for laying an electric supply. Traces of a possible earlier brick floor and the edge of a truncated wall are visible in the side of the cut (**P45-46**).

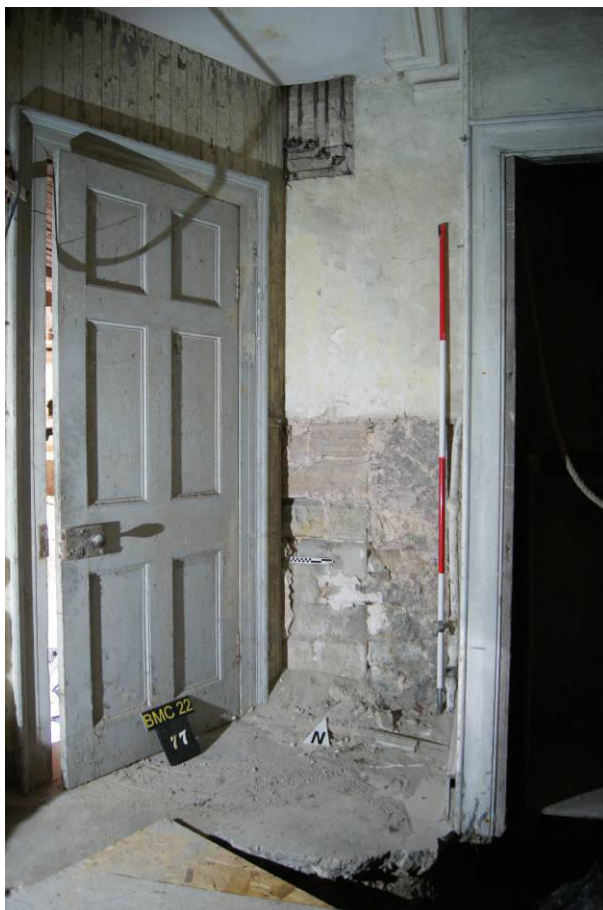
**P46.** R2, west end. Areas of the north wall stripped of plaster, showing a vertical joint between ashlar (left) and rubble masonry. A set of bell-cranks [109] is exposed above.

**Fittings** – there is a late 19<sup>th</sup> century (1892+) 'dumb waiter' service lift [78] against the north wall, at the foot of the first flight of Service Stairs [87] which rises to second floor level. A line of badly corroded servant's bells above window [33] are connected to an array of four cast-brass bell-cranks high on the wall west of the dumb waiter, from which the wires rise in tubes to another array in the roofspace above R55 (**P46,48**).

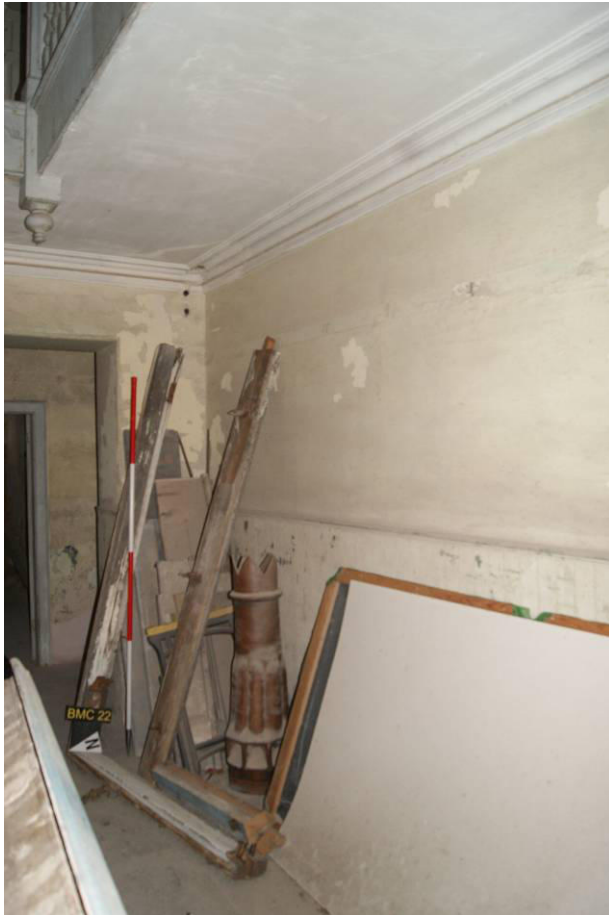
**P47.** R2. Looking east to the site of a proposed new door in the south wall, showing the matchboard lining to dado level.

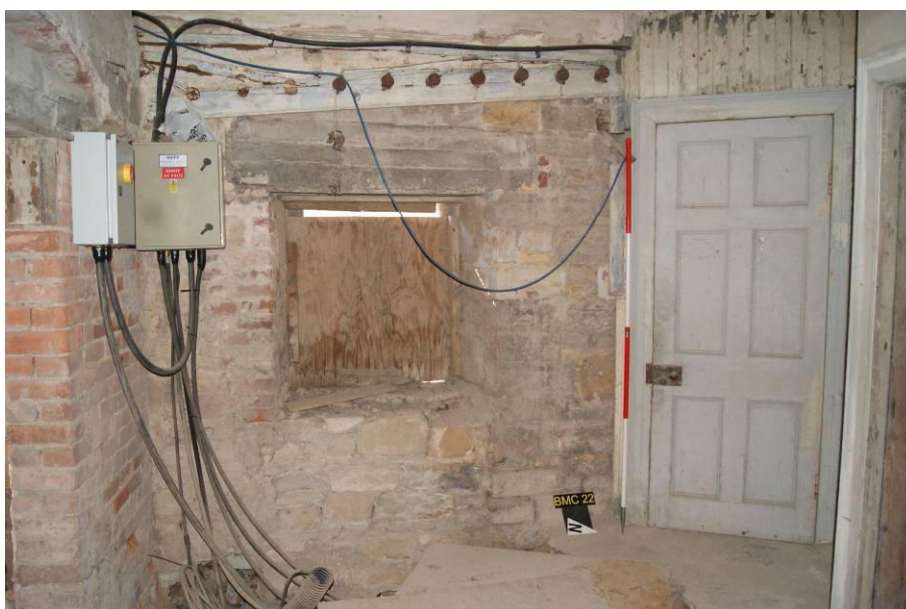
**P48.** R2. Looking west to window [33] with a line of servant's bells above and boarded-over 1980s excavation for electrical services below. Door [77] is on the right.

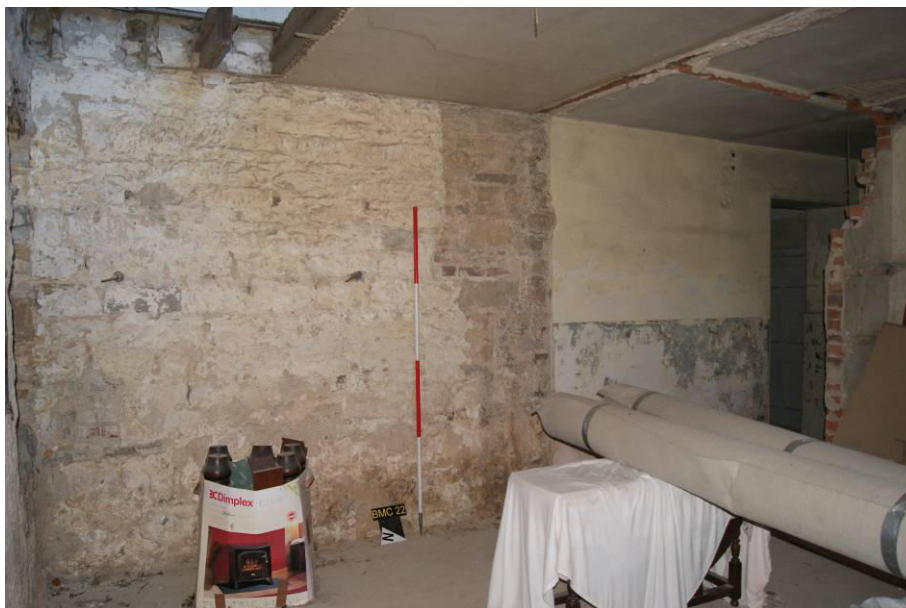
**P49.** R5. Looking north-west to the site of a proposed new doorway from R2, where render (R4) changes to exposed masonry. This wall was suggested in 2012 to be a thinned medieval feature but it now appears most likely to be 1801-4.

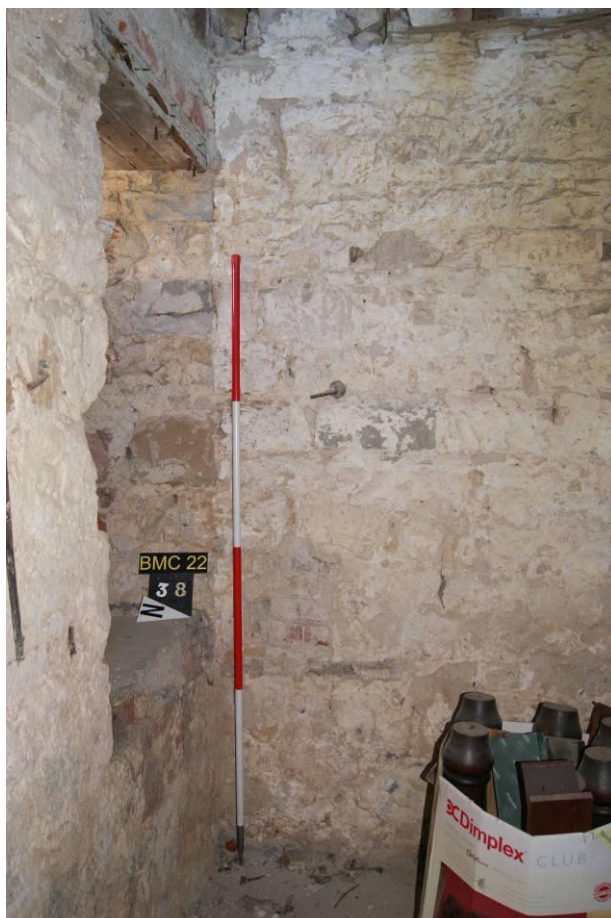
**P50.** R5. Looking west to the junction of the west and south walls at window [38]. There appears to be a butt joint between the two.

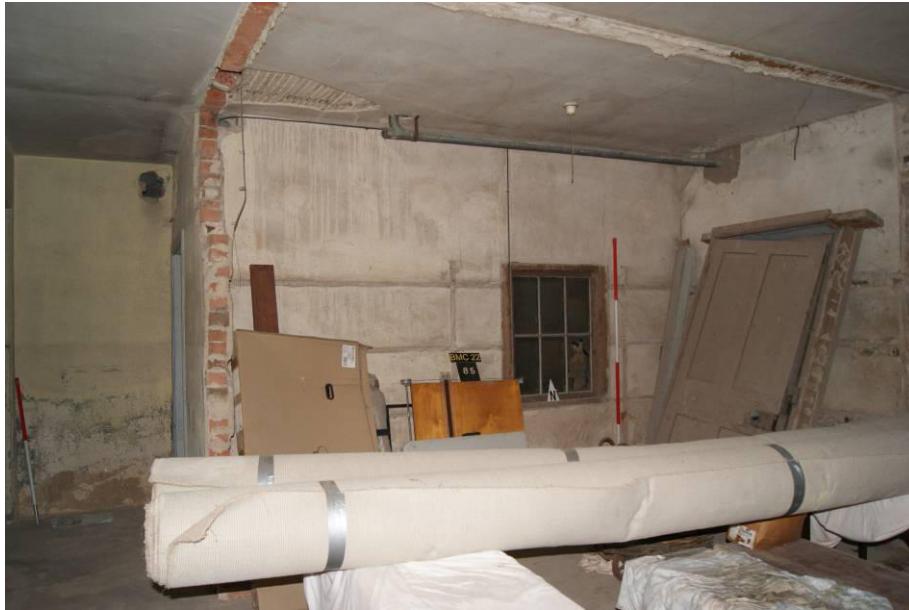
**P51.** R5 looking north to a brick partition wall with glazed panel [85] enclosing R6, this is proposed to be removed, and the space

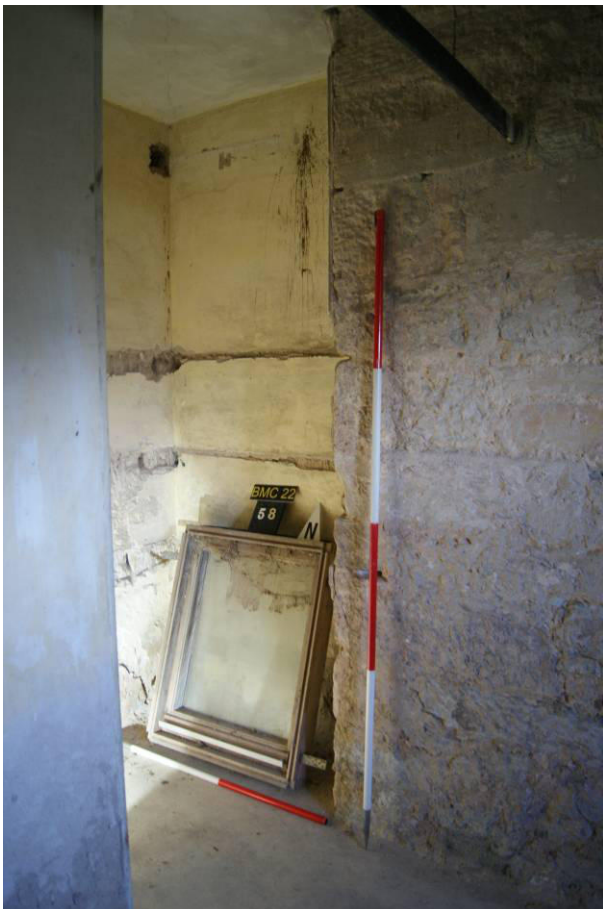
**P52.** R6 looking north-west to the site of a proposed new or re-opened doorway utilising [58] in R9.

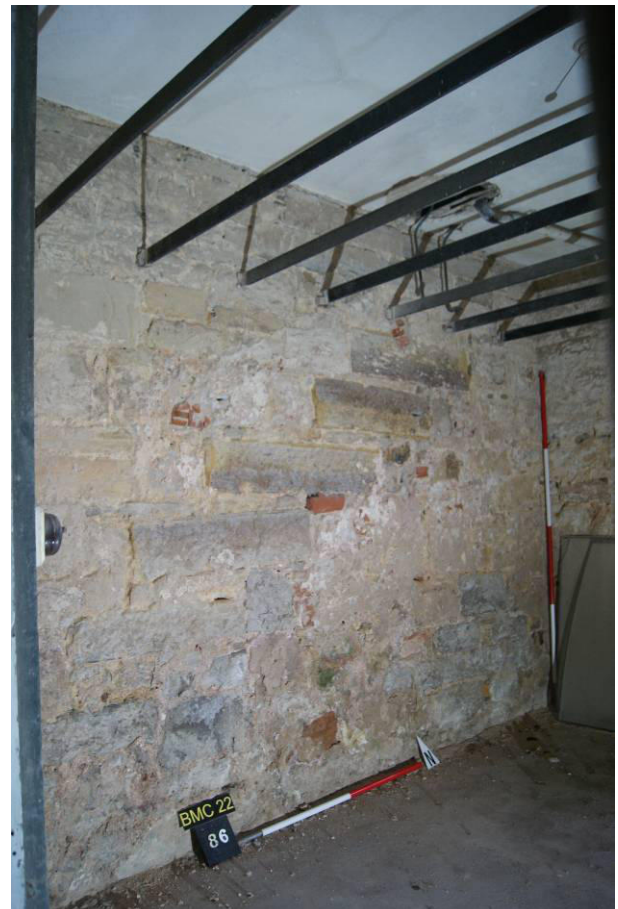
**P53.** R6 looking north-east with site of proposed lift against the north wall where truncated stone stair treads are visible. The iron game-larder racks are c.1892 or later

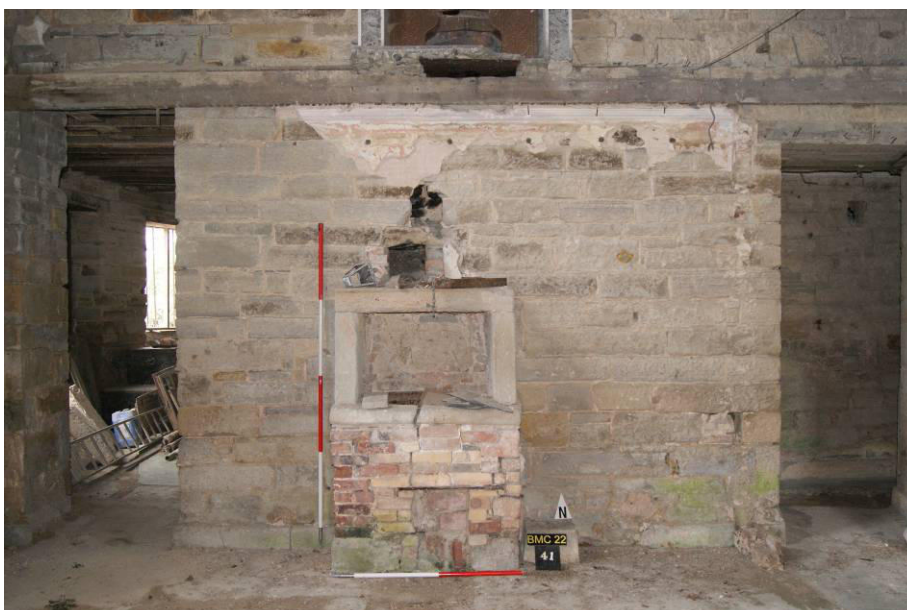
**P56.** R8 north wall of the scullery with a 'copper' [41], which is proposed to be removed, and doorways [41] and [42] either side. A new north-south partition is proposed to be inserted to the right of [41]. The stub of the 1801-4 partition wall can be seen beside [43].

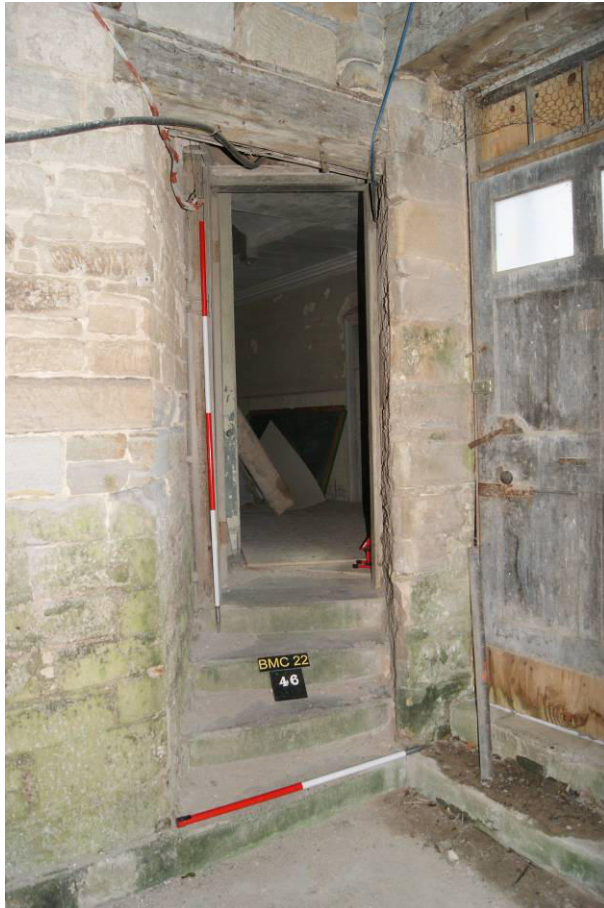
**P57.** R8 looking through [46] to the wall-passage to R2. This is proposed to be partitioned midway to form storage spaces.

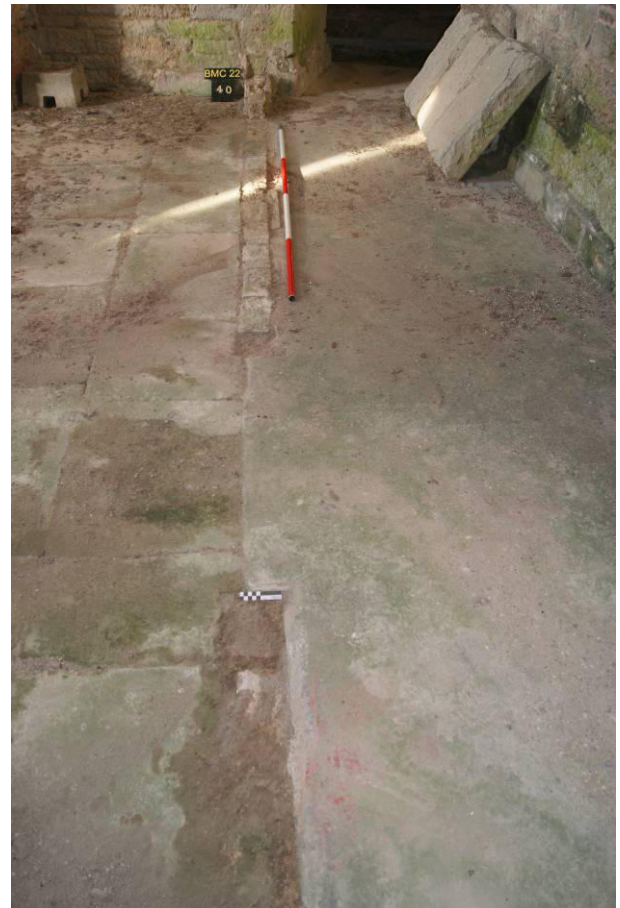
**P58.** R8 looking north. Showing the line of the lost partition wall between the scullery (left) and cement-floored

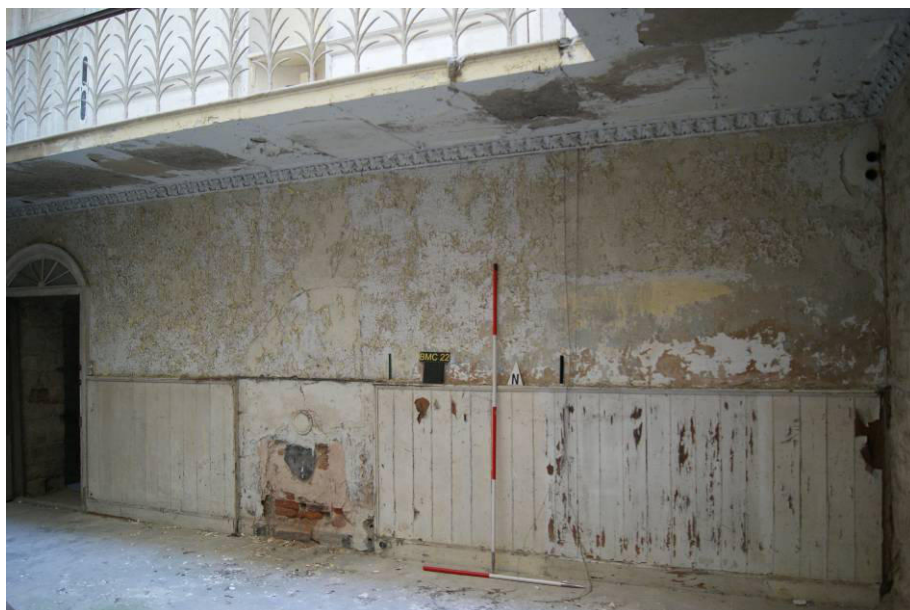
**P59.** R9 looking north-west to the site of blocked pre-1801 doorway [60], which is proposed to be re-opened. The position of the blocked doorway is marked by two black bars above the

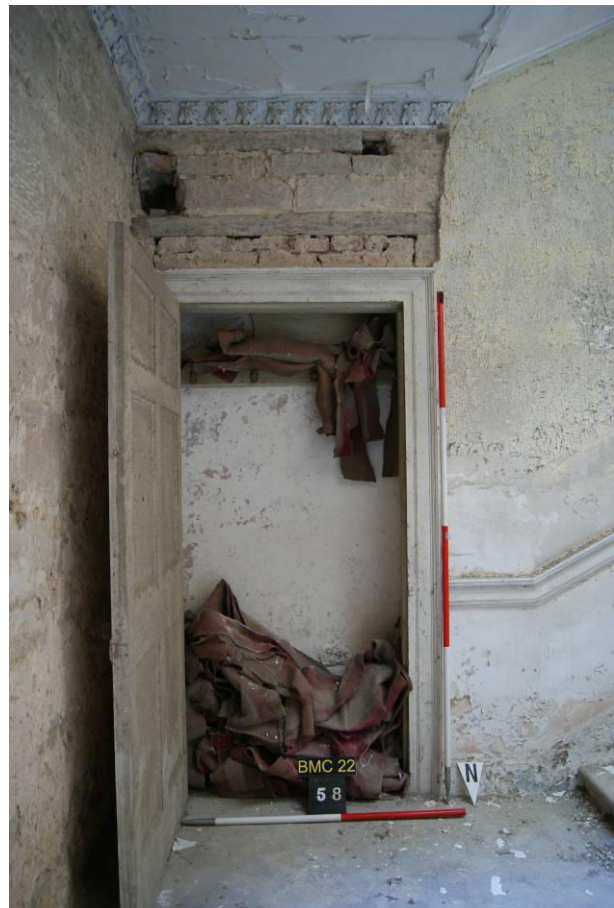
**P61.** R9, doorway to wall-closet [58] proposed to be opened as a doorway to the reconfigured areas of R5 and R6. This will involve removal of the rear of the closet.

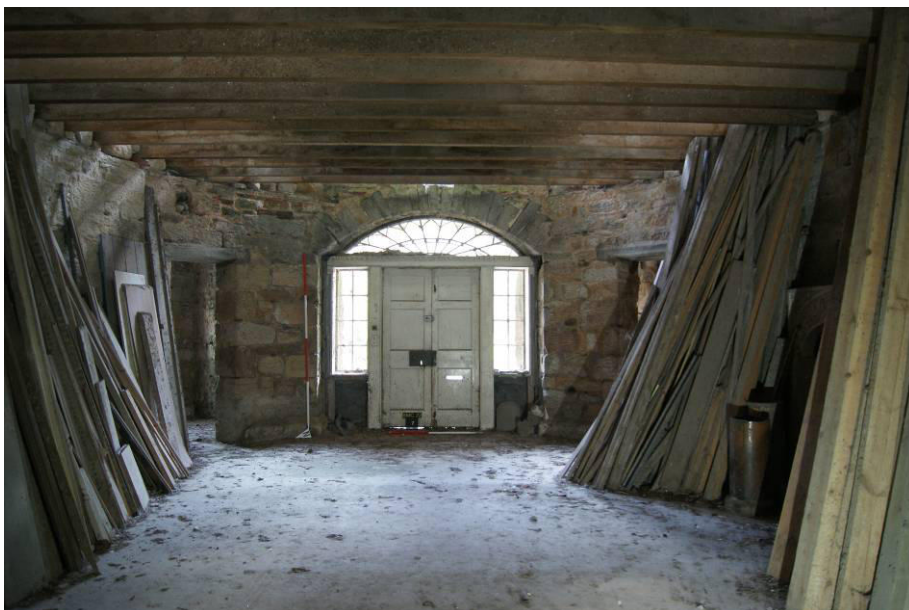
**P62.** R10 looking east to the principal entrance [7]. Building timber and detached fittings are stacked against the side walls. No significant change from 2012. Proposals would see the space

**Doors** – the principal access to the Castle is through double doors, probably 1801-4, in the east wall and set in a screen which appears to be reused from the earlier building [7]. Each of the two leafs has three panels, the upper two reeded, with decorative iron 'knockers' (that on the south missing) which sit awkwardly and are probably secondary or repositioned. The north leaf has a brass ball handle and keyhole scutcheon, with modern Yale lock above, and the south has a letterbox slot (P62-63).

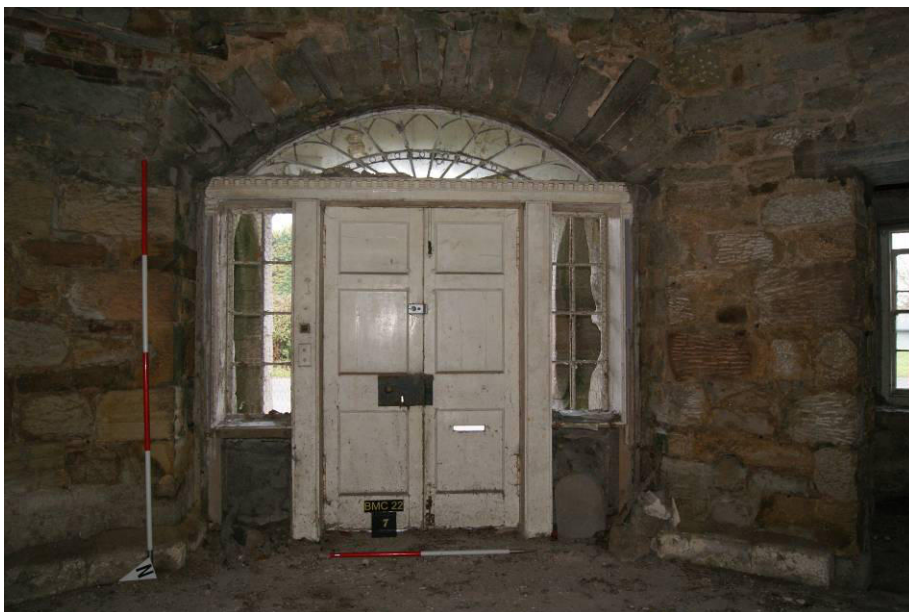
**P63.** R10 looking east to [7] showing the principal entrance doorway with flanking windows and overhead. Little changed since 2012. This feature will be restored.

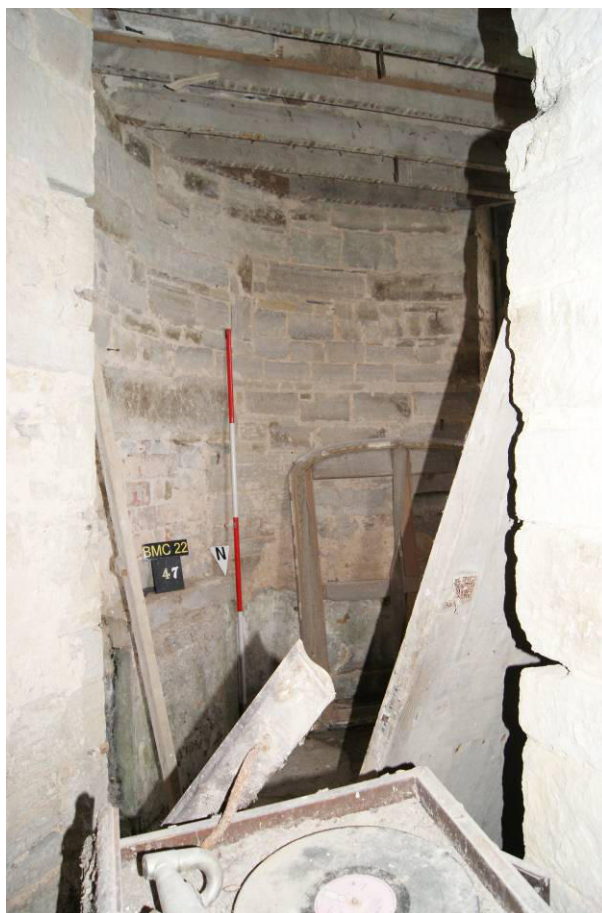
**P64.** R13, labelled the 'Pastry' on the 1801 floor plan. Looking west through [44], with detached fittings, blocked fire [47 (left)], and showing evidence for old

**R13 West range.** Circular turret room off R8 - scullery/washhouse. Labelled 'Pastry' on the 1801 floor plan. Since the best pastry required cool conditions, such rooms were usually sited away from the heat of the kitchen. R13 does have a blocked fireplace opening, though whether it was ever used is unclear. Proposed for W.C.

**Ceiling** – lath and plaster soffit removed, joists and floorboards of 1<sup>st</sup> floor turret room exposed, some showing evidence for old dry rot..

**Fire** - there is a blocked fireplace [47] on the south-east side. The surround is missing.
