SINDERHOPE SHIELD

ALLENDALE

AN HISTORIC BUILDING ASSESSMENT

JANUARY 2018

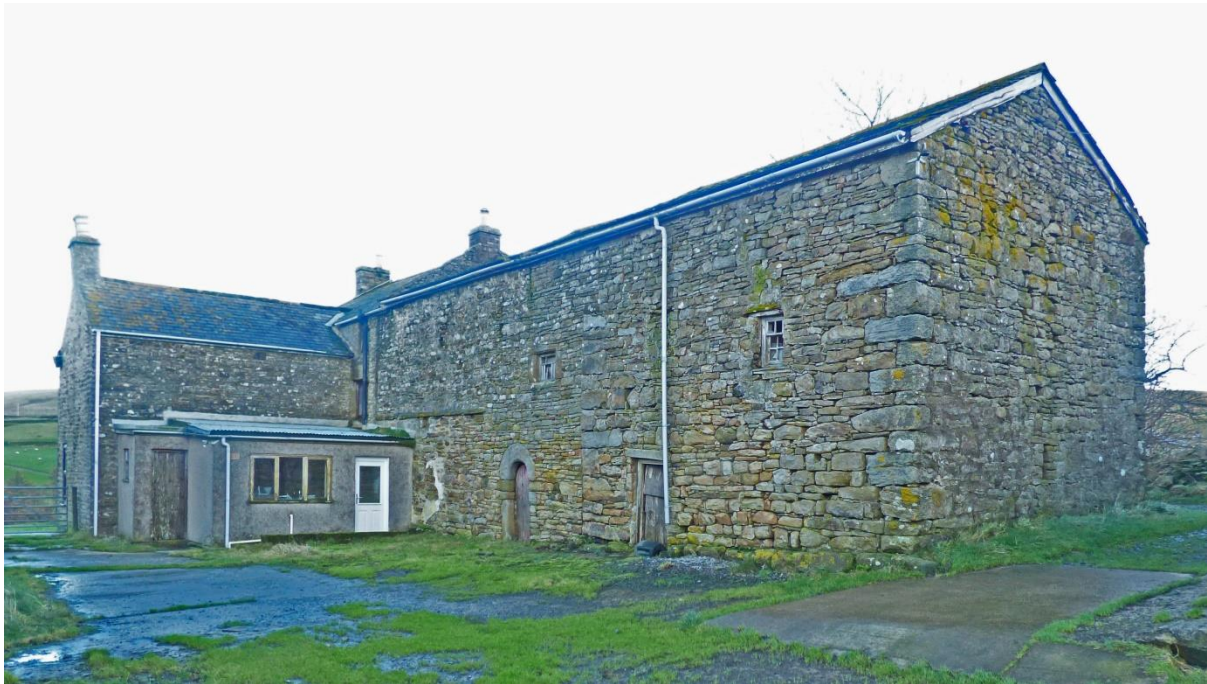
North-west view

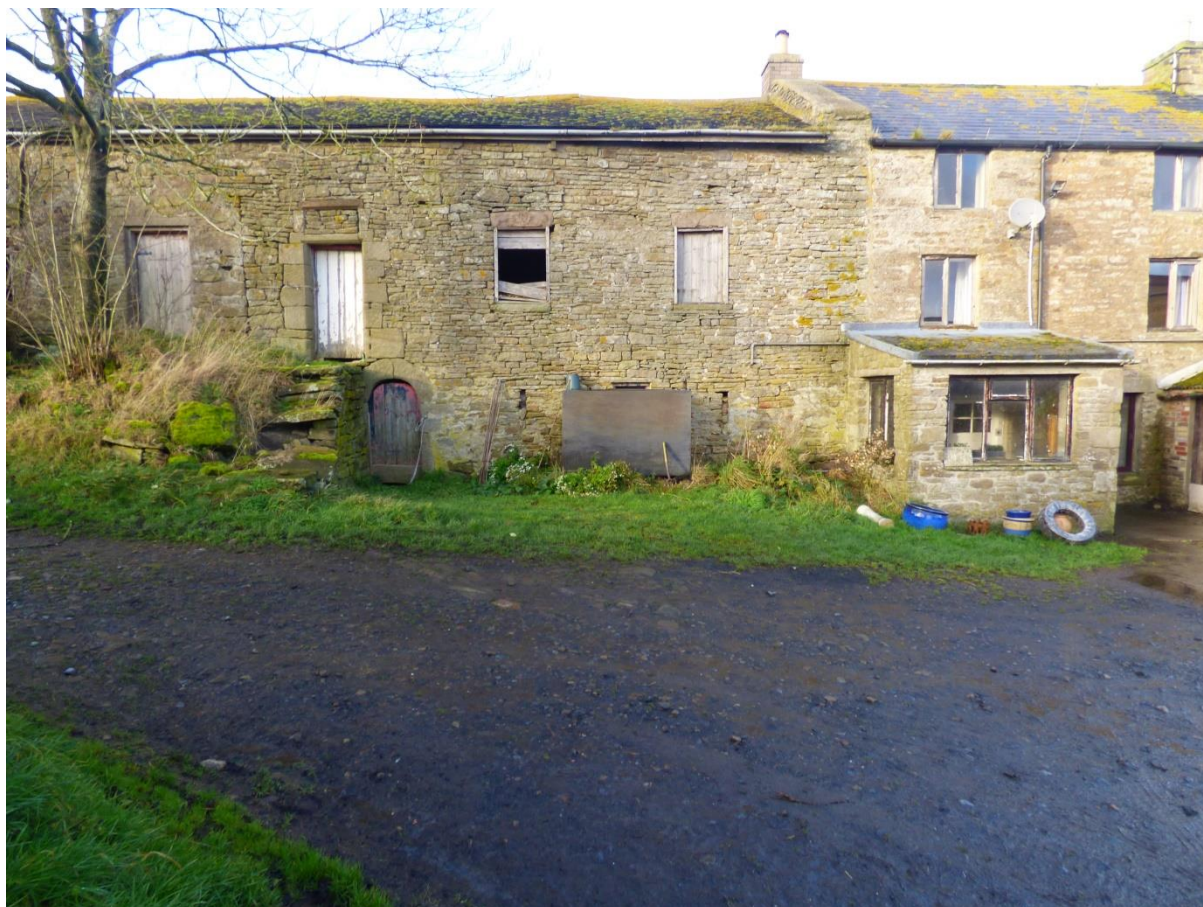
The range from the south, the Bastle on the far l., the Bastle-derivate House in the centre and the Farmhouse with its modern porch to the r,

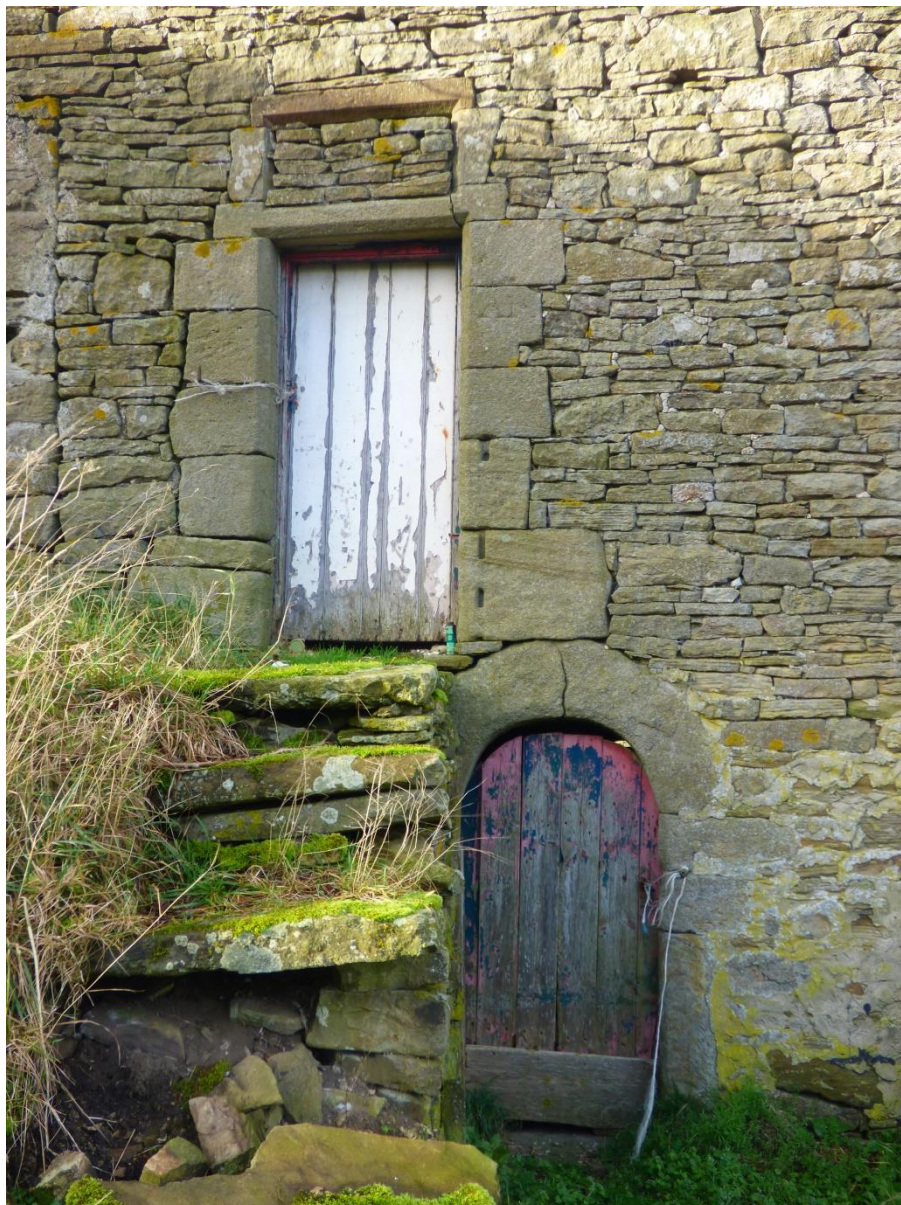
The upper and lower doorways of the Bastle-derivative House; notice slots of railings in the east jamb of the upper doorway, with remains of external platform and stair in the foreground.

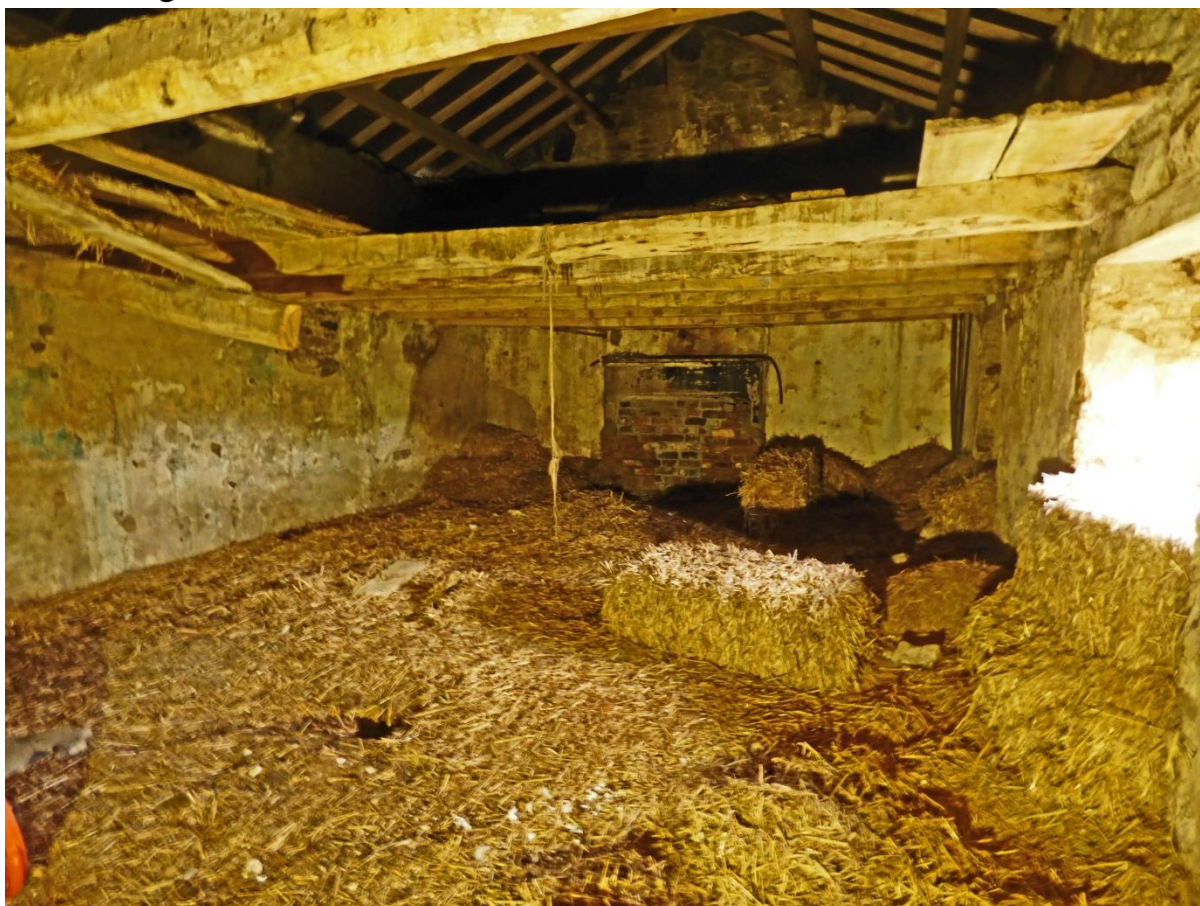
The Bastle-derivative House, first floor looking east

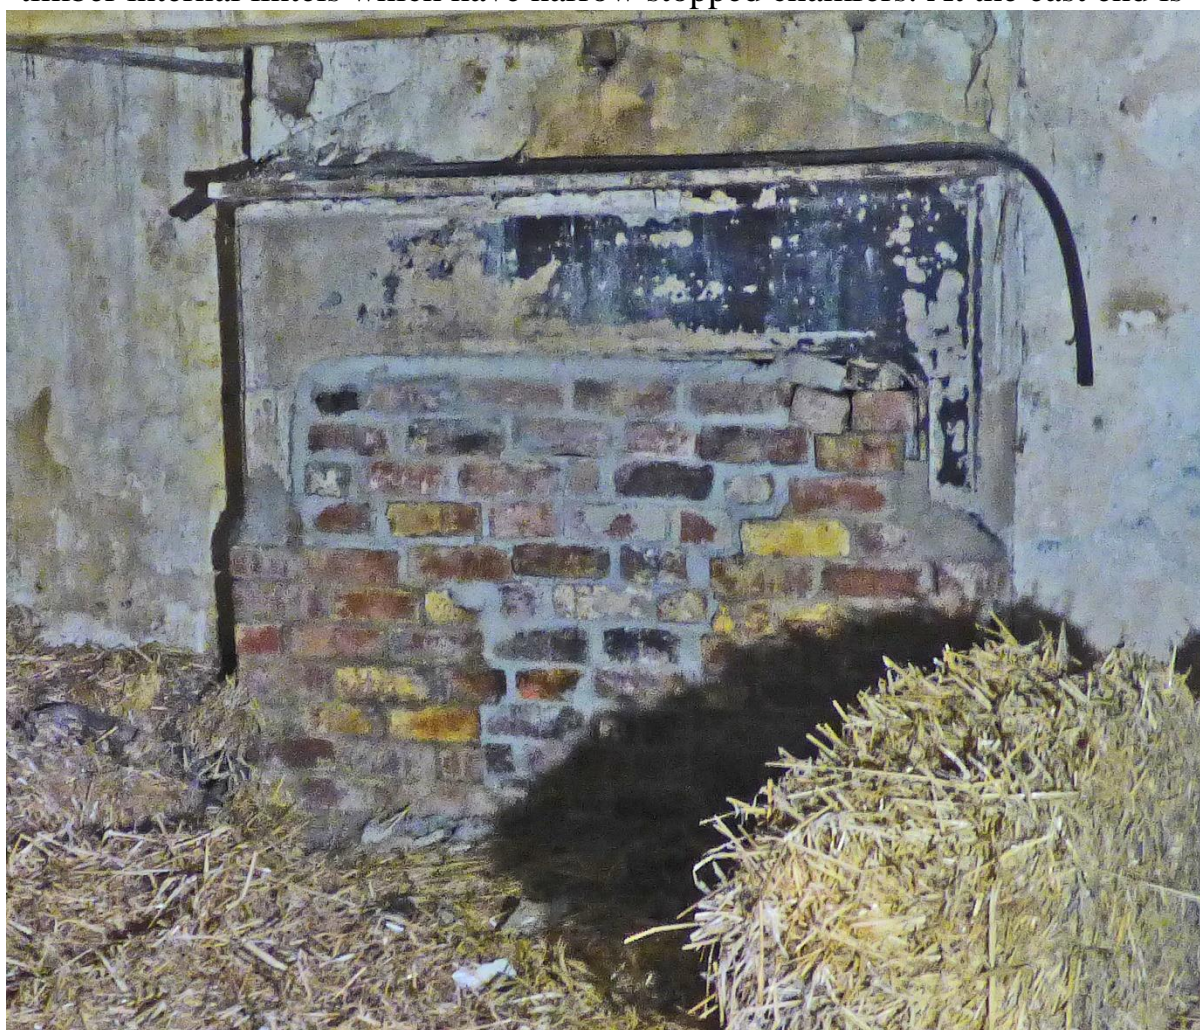
an interesting original fireplace (above) with its lintel set forward on corbels, its surround moulded on both extrados and intrados, and its recess now infilled with brick. The ceiling has been carried on transverse beams, chamfered on their lower angles; some of the very broad old floor boards they carried survive

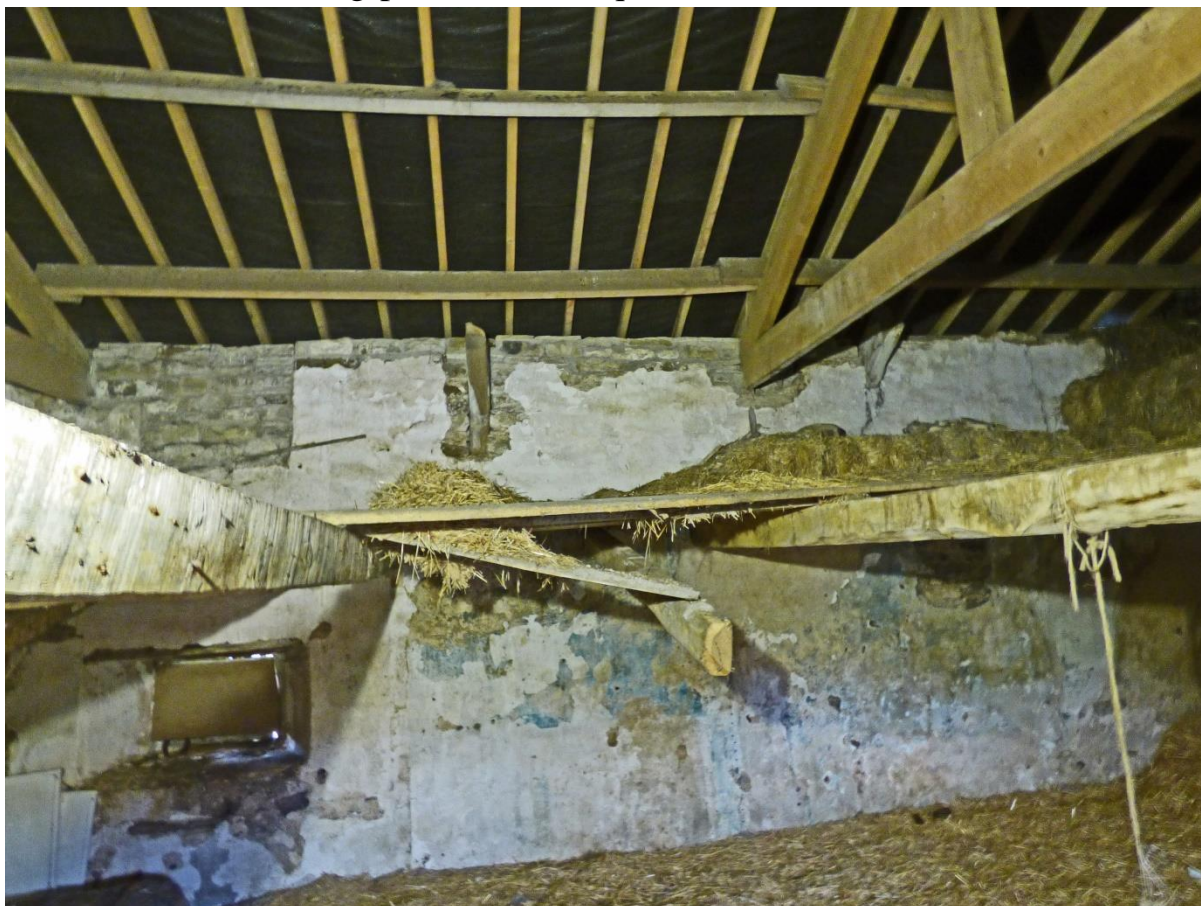
The Bastle-Derivative House; interior of north wall with collapsing second-floor beams, stubs of two upper cruck trusses and recent roof

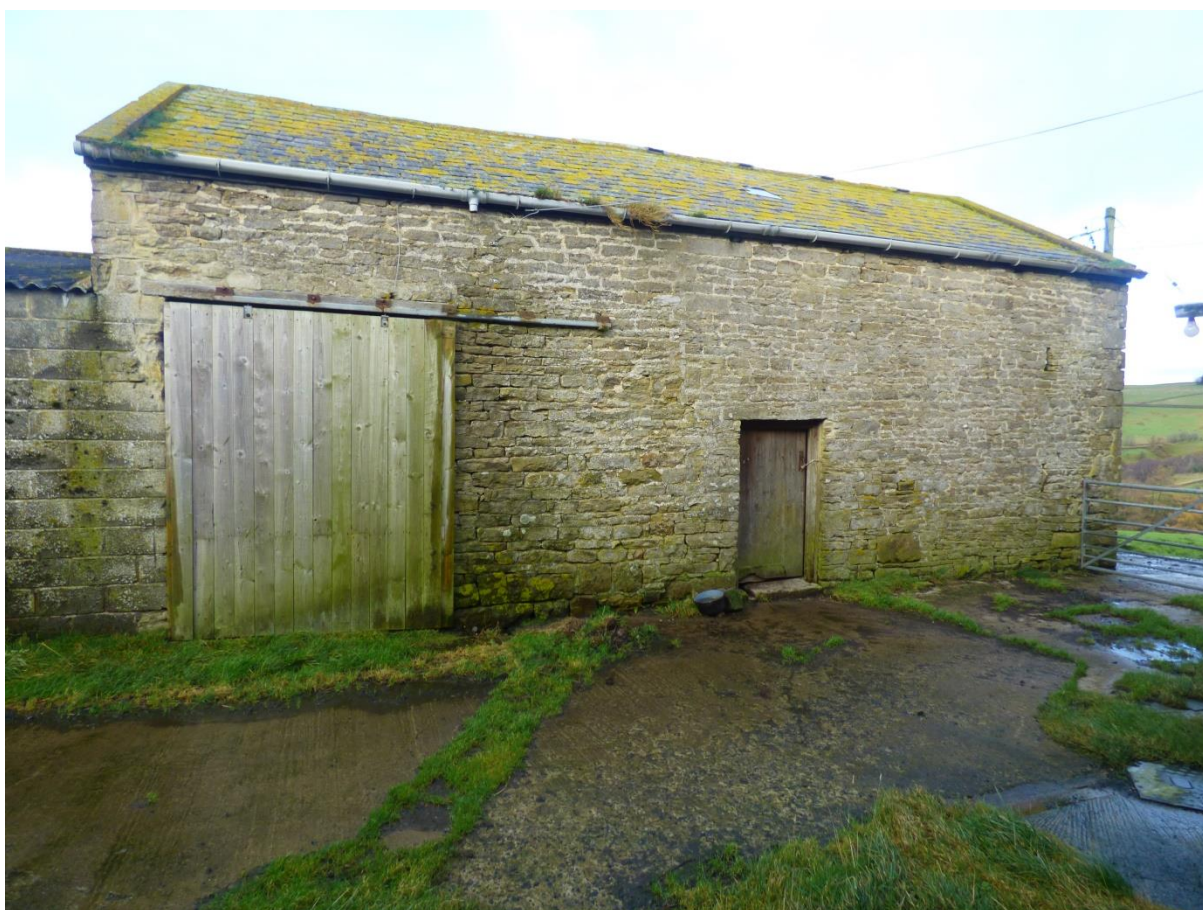
The Northern Barn from the south
