COYNE ENVIRONMENTAL

**The Vinery
Yeomans Drive
Aston
SG2 7EJ**

PRELIMINARY ECOLOGICAL APPRAISAL

January 2022

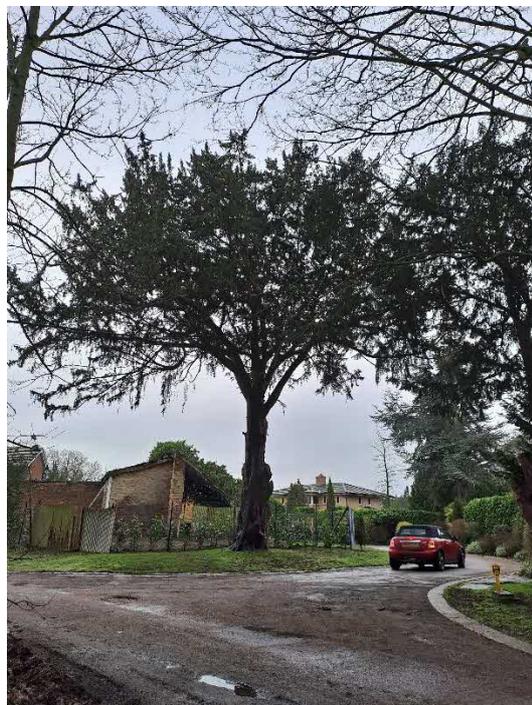
It is Area 38 of the HCC Landscape Character Area map. An area of uniform fields, primarily pasture, well managed hedges and woodlands (oak/hornbeam), with parklands and golf course, lying between Stevenage Brook and the River Beane valley. Soils are mainly calcareous clay over chalky till. The nearest HMWT Nature Reserve is Ridlins Mere

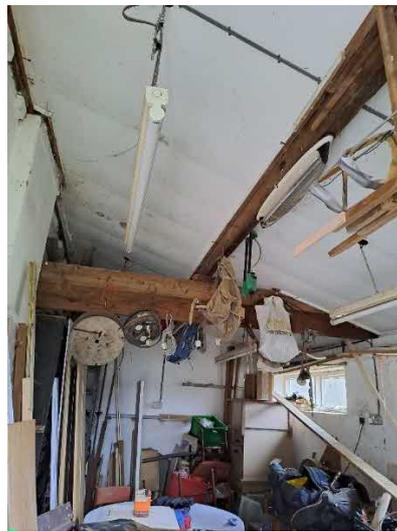
The application site is a historic remnant of Aston House former kitchen garden and part of the remaining enclosing brick wall. It is a good example of a Victorian glasshouse for growing vines, of metal glazing bars on a brick-built plinth base, constructed on the outside of the garden wall, with an adjacent original wooden door giving access to the potting shed. This is on a raised base, with brick steps leading to the brick building and slate roof. The potting sheds main side wall is covered in decorative clay hanging tiles.

The whole structure is in poor condition. Dense ivy covers the former glazing but vines (assumed dormant) are still trained along the back wall. This is in reasonable condition for its age. The potting shed is a single room with sloping ceiling and rafters and tiles above and no void between. The whole room is in poor condition but the external walls and the hanging cladding appear sound with no signs of cracks or broken tiles.

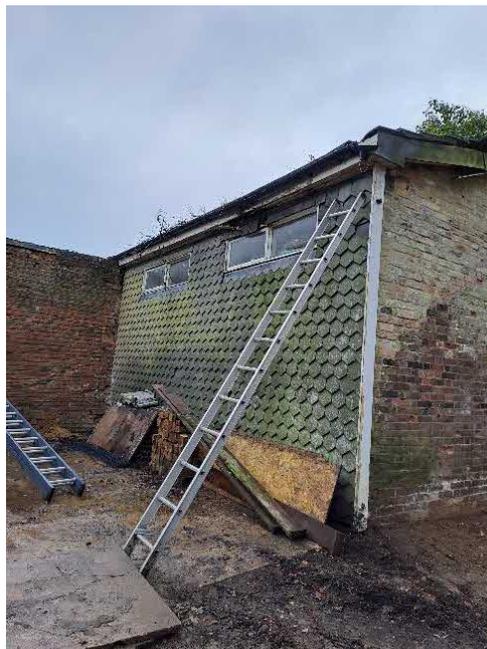
This is a single boarded roof structure of tiles and plasterboard ceiling. So, there is no loft or other space above, where wildlife and bats in particular could use. A full assessment in line with the Bat Conservation Trusts Bat Surveys, Good Practice Guidelines, 3rd. edition 2016, was therefore not considered necessary. The room and external walls, particularly the dense ivy and other spaces were however inspected. No evidence of bat droppings, discarded meals (insect wings) and investigations of the few openings /cracks were looked for but nothing was found.

As the garden has been mainly recently been cultivated there is only a small area of lawn left. These grasses are basically a close sward of common meadow grass and rye. A monoculture habitat with no selective herb species un-attractive to nectar seeking insects or butterflies. The few shrubs on site, by the boundary wall, were deciduous ornamentals of little use for birds as nest sites, food sources (winter berries), singing posts etc. and no birds were observed on the survey. On the British Trust for Ornithology (BTO) guidelines the site would be classed as of low for Avifauna potential.

As most of the original vegetation had been removed, no runs or other indication of animal activity (mole hills) were evident. [REDACTED]

[REDACTED]. As there are no water courses in the area, amphibians such as frogs, toads and protected species like Great Crested Newt (GCN) would not be encountered. A GCN Suitability Index was therefore not considered necessary.

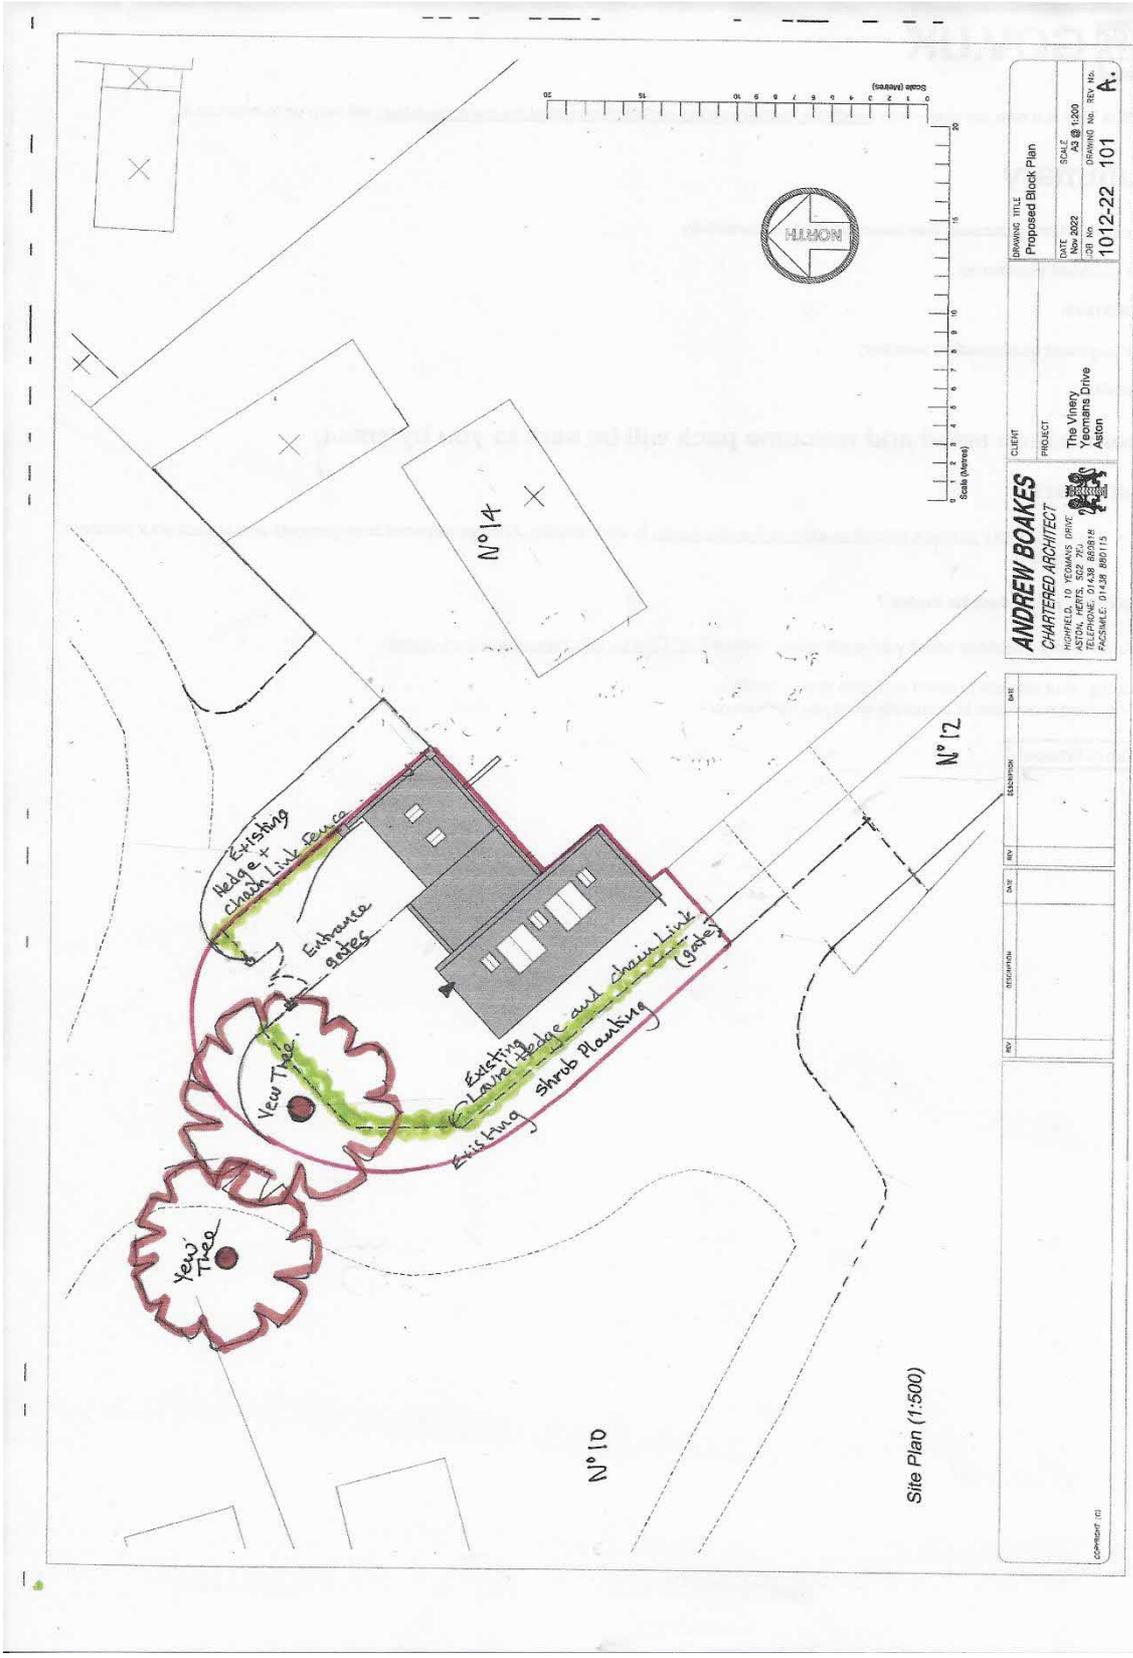
Site Plan (1:500)

DRAWING TITLE	Proposed Block Plan
DATE	Nov 2022
SCALE	A3 @ 1:500
JOB No.	1012-22 101
DRAWING No.	101
REV No.	A.
