Preliminary Ecological Appraisal

Munden Parva, Hertfordshire

1.1 The Ecology Partnership was commissioned by Cousins and Cousins to undertake a Preliminary Ecological Appraisal (PEA) at Munden Parva, Hertfordshire, SG12 0PD (Figure 1).

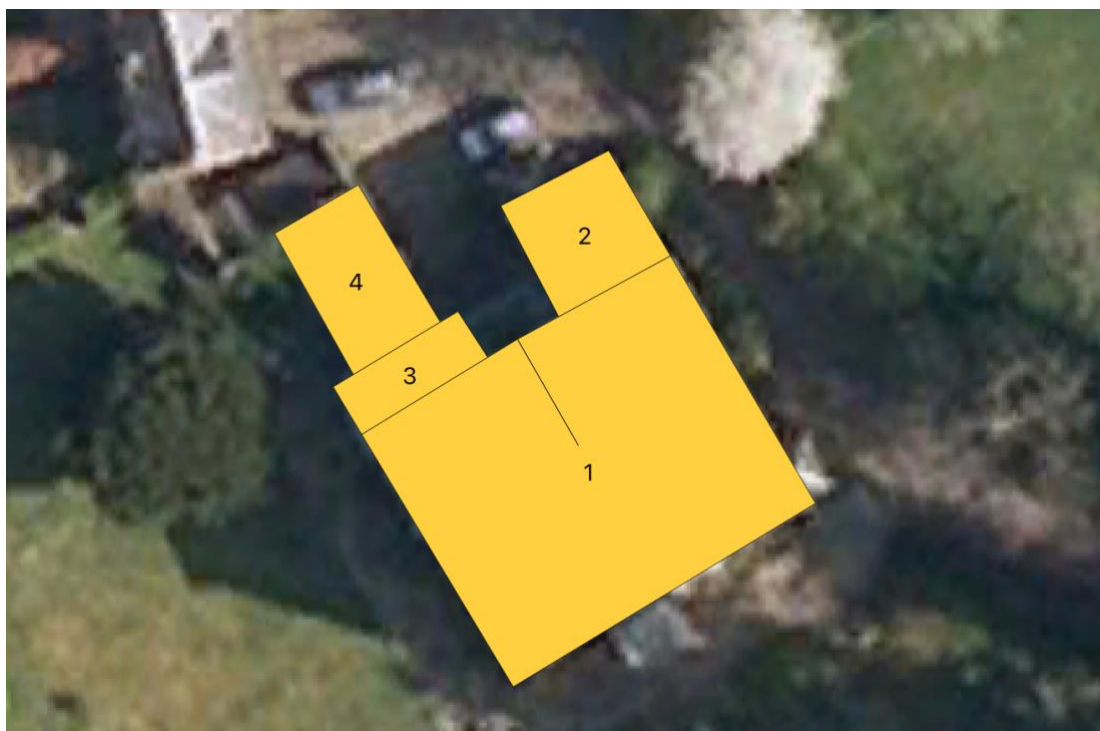
Figure 5: Arrangement of loft voids

- 3.14 There was one three-storey residential dwelling on site. The entirety of the roof was slate-tiled, and mainly in good condition. Four separate roof voids were able to be accessed and assessed at the time of the survey, and are labelled in Figure 5 below.

- 3.15 The voids all have a thick layer of insulation on the floor, supported by wooden beams. The voids contained piping and wiring of various amenities for sections of the house, but were otherwise empty.

- 3.17 Void 1 was a large, u-shaped void and contained a large number of larger bat droppings, that were scattered throughout the void, with three concentrated piles along the north eastern ridge.

- 3.18 Void 2 was a smaller void, with felt lining in mostly good condition, with minor gaps at seams and joints. A light scattering of small bat droppings was present throughout.

- 3.19 Void 3 was a small void, which supported a new felt lining. A low number of scattered bat droppings were recorded throughout the void. There was a clear gap in the soffit to the east, which provided clear access into the void.

- 3.20 Void 4 was a large, long void. The felt lining was older than the previous voids, but retained good condition with only minor gaps at seams and joints. The void includes a low number of scattered bat droppings.

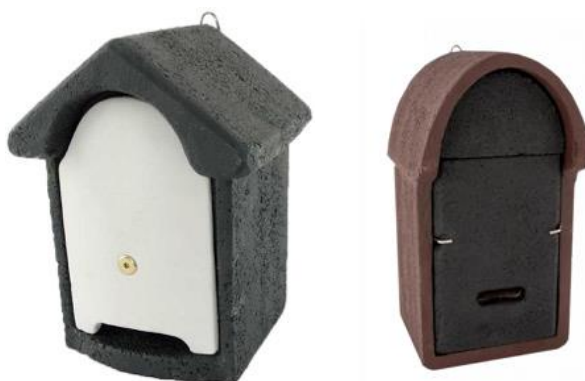
Figure 5: Vivara Pro WoodStone Bat Box (left) and Large Multi Chamber WoodStone Bat Box (right)

- Vivara Pro WoodStone Bat Box – A general purpose bat box that supports a range of species (Figure 5). These can be hung on trees in a variety of heights and aspects in order to provide a variety of micro-climates.
- Large Multi Chamber WoodStone Bat Box – This is a multipurpose box designed for larger colonies and a range of bat species including pipistrelles, noctules and brown long-eared bats. These should be hung on mature trees around the site (Figure 5).

- 4.32 Bat boxes should be hung on mature trees or buildings around the site to create new roosting opportunities on site. Recommended boxes include:

4.33 The siting of bat boxes is important and have the best rate of occupancy when they are situated within or adjacent to bat-friendly features, such as treelines. The bat boxes should be situated where they are sheltered from strong winds and should be exposed to the sun for most of the day, therefore southern aspects are favourable. Multiple boxes may be hung on one large tree, facing different aspects. Bat boxes should be hung as high as possible, preferably around 5m high, although lower boxes may also be used by brown long-eared bats.

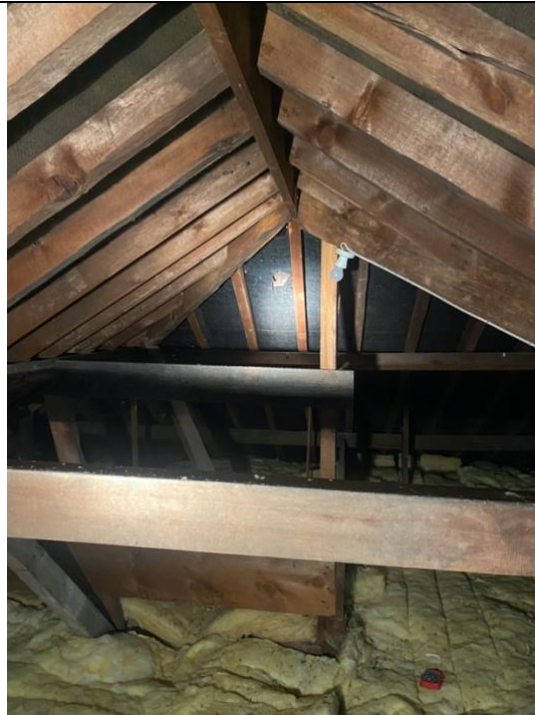
Photograph 1: Small hole in felt inside roof void 1

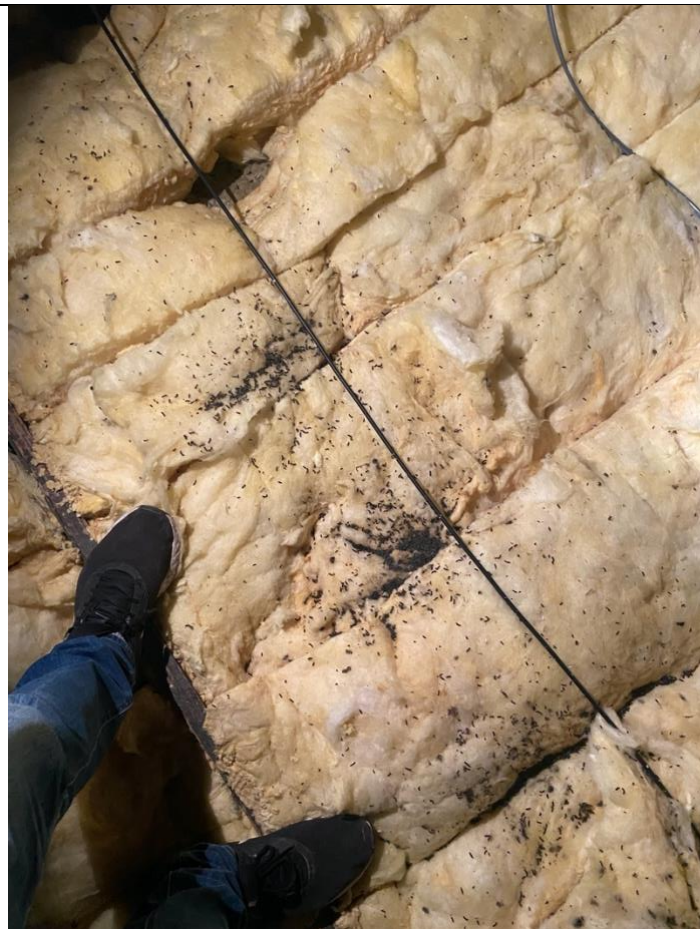
Photograph 2: Bat droppings inside roof void 1

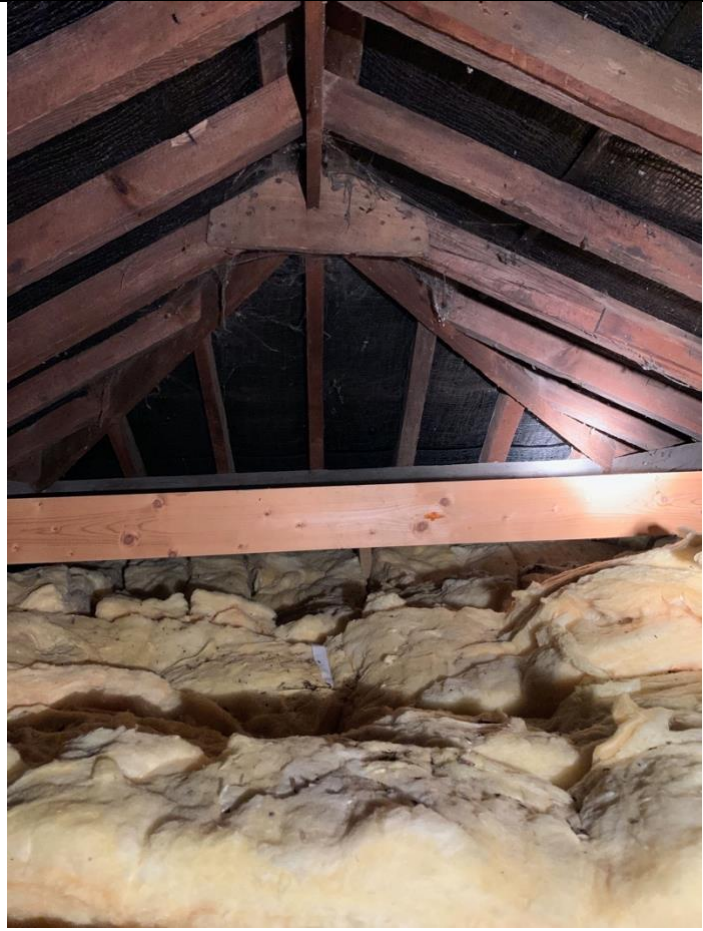
Photograph 3: Inside roof void 2.

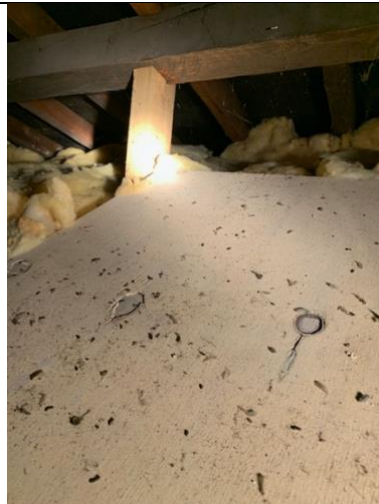
Photograph 4: Inside roof void 2.

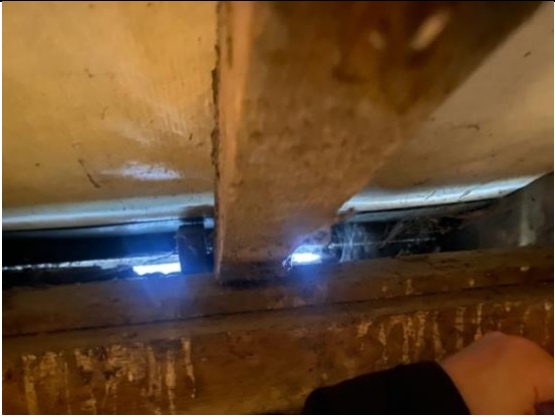
| <p>Photograph 5: Gaps in soffit inside roof void 3.</p> | A photograph showing the interior of a roof void. The focus is on the soffit area, which appears to be made of concrete or plaster. There are several dark, narrow gaps or recessed areas where blue light is being shined, highlighting the texture and potential issues. The overall lighting is dim, with the primary light source being the blue flashlight beams. |

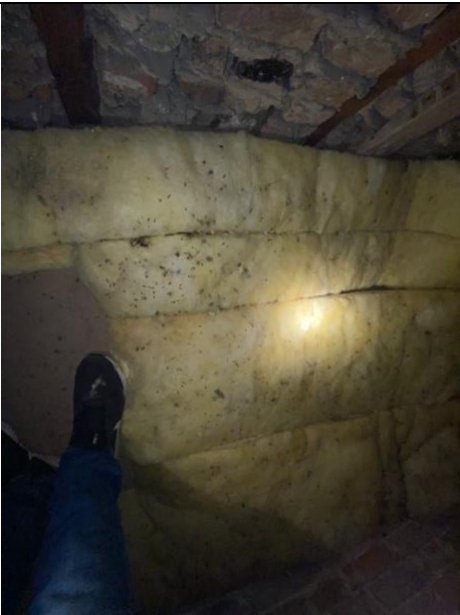
| <p>Photograph 6: Inside roof void 3.</p> | A photograph showing the interior of a roof void. The walls are made of concrete or masonry, showing some discoloration and texture. A person's leg and foot, wearing a blue boot, are visible in the lower left corner, indicating the person is standing in the void. A bright light source is illuminating the wall, creating a strong contrast and highlighting the surface details. |

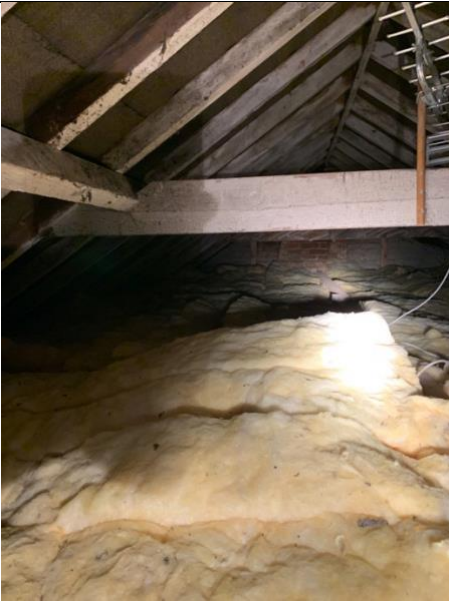
| <p>Photograph 7: Inside roof void 4.</p> | A photograph showing the interior of a roof void. The structure consists of wooden rafters and a concrete or masonry soffit. The lighting is focused on the soffit area, which shows some texture and discoloration. The rafters are visible above, and the overall scene is dimly lit, with the primary light source being a bright flashlight beam. |

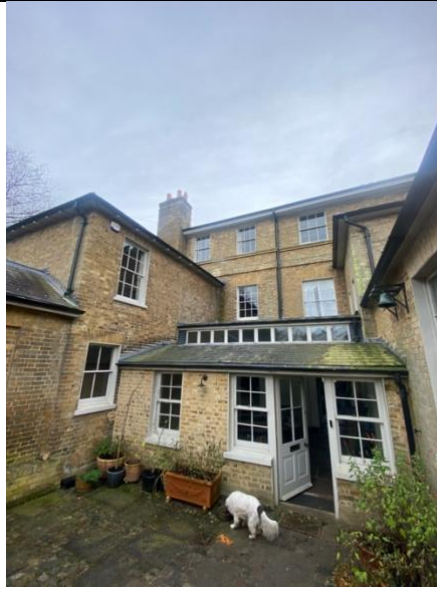
- 3.16 The majority of the house has a slate tiled roof that is in good condition. A small area of flat lead roof was present on the north western face. Externally, there was one area of raised lead flashing, at the peak of the roof, in the south western corner. Otherwise some small gaps were present in various places between the soffits and the brickwork,

Photograph 9: Gaps between soffit and brick on north western most face.

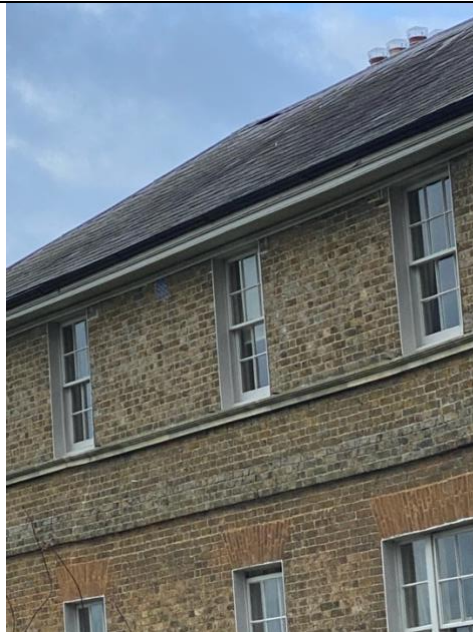
Photograph 10: South western face, with lifted lead flashing
