Ecological Impact Assessment and Bat Risk Assessment

EAST HOUSE COTTAGE, CHESWICK

AUGUST 2022

Ruth Hadden, BSc. MCIEEM
Ryal Soil and Ecology
Ryal
Northumberland

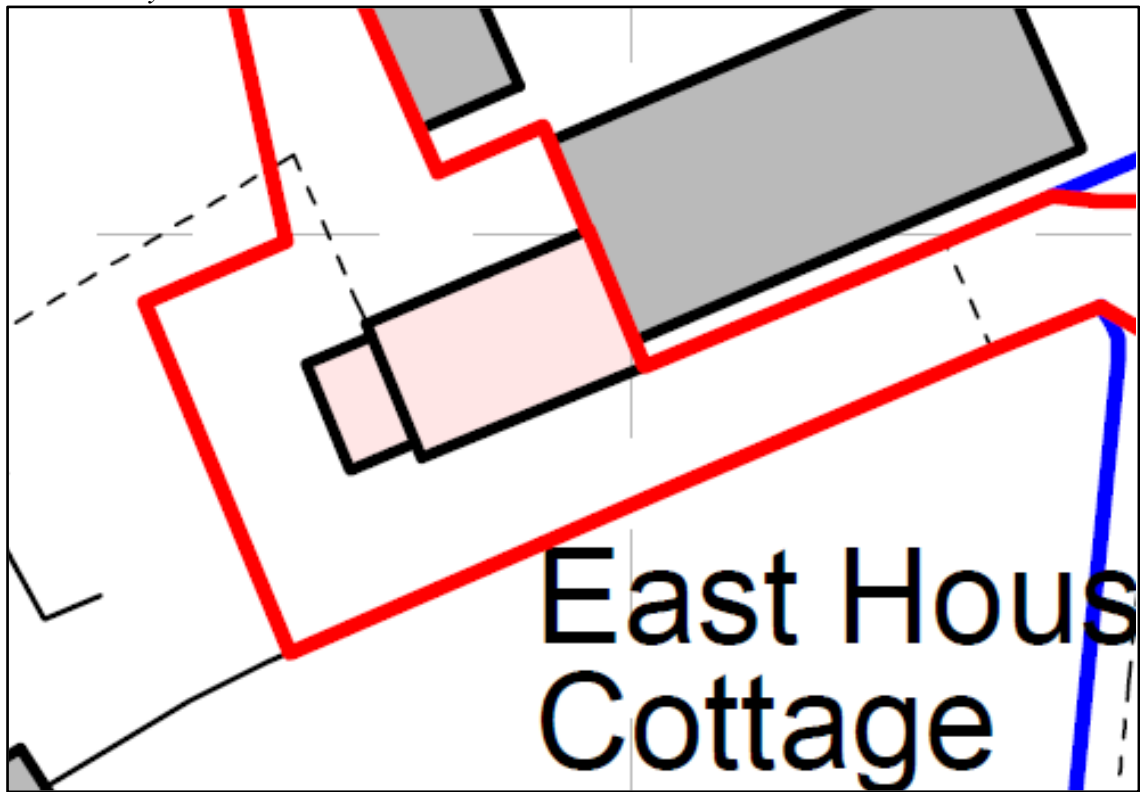
Figure 2. Survey area.

The survey area covered the building as shown within Figure 2 and included searching for signs of any wildlife using the site with the key aspects listed below.

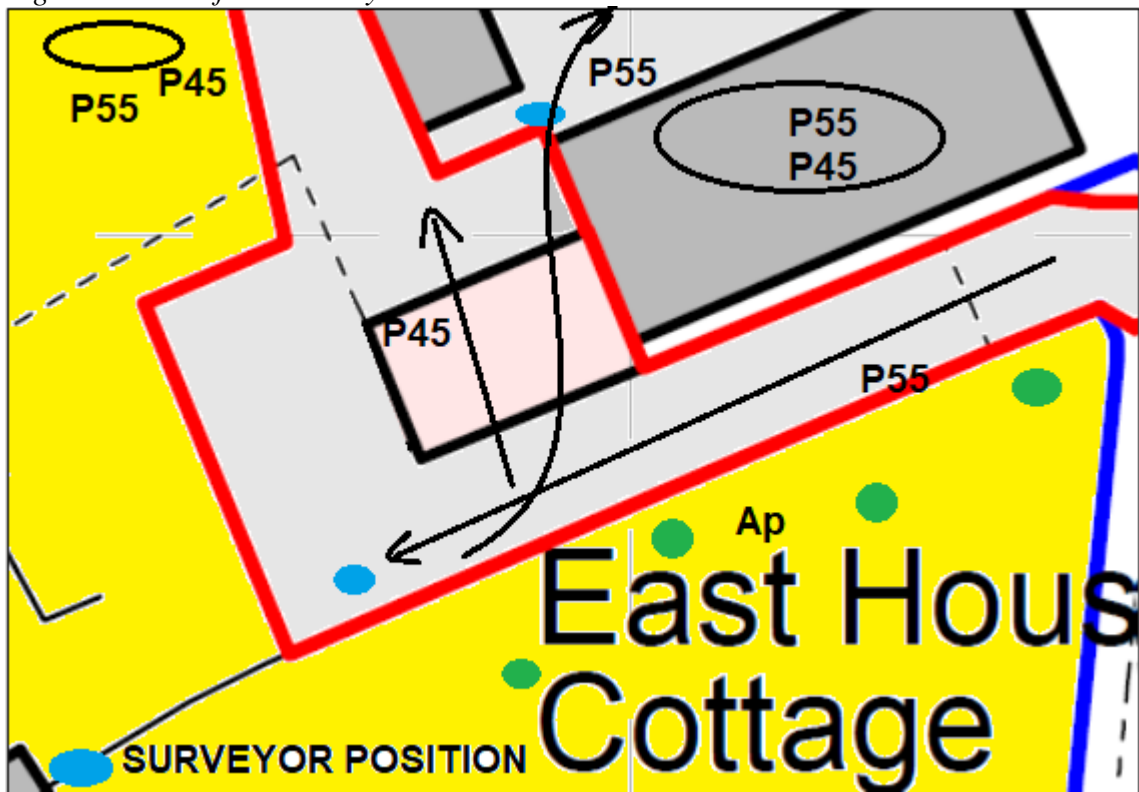
Figure 4. Plan of Bat activity

The emergence survey confirmed no emergence of bats from the building. The occasional Pipistrelle 55kHz and Pipistrelle 45kHz bat commuted past the building and were noted foraging in the adjacent metal barn, that gives sheltered foraging, throughout the survey. Please see Appendix 2 for further details.

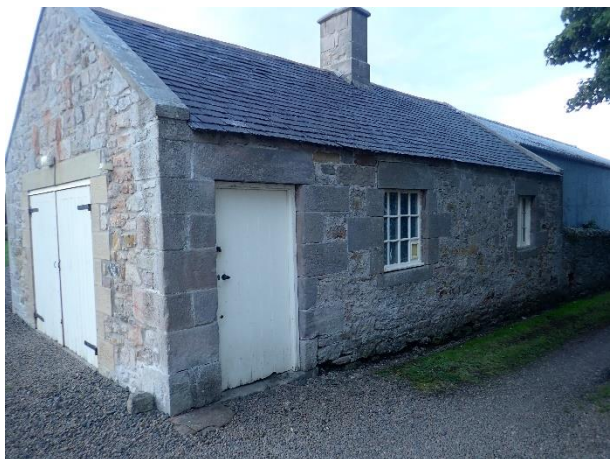
The building is stone built, single storey and has a pitched slate roof, with no sarking and open wall tops. The building is enclosed with the roof cobwebby at the ridge. Sections are plastered with one section with no ceiling allowing all the void to be observed. The floors are concrete and no bat droppings were located within. Externally the occasional slipped or raised slate is present with the occasional crevice at the south eaves though this side is shaded by a tree to the south of the access road. The north eaves are obscured by a wood store, which will deter bats. No good potential roost crevices were identified and no further

The building from the southwest

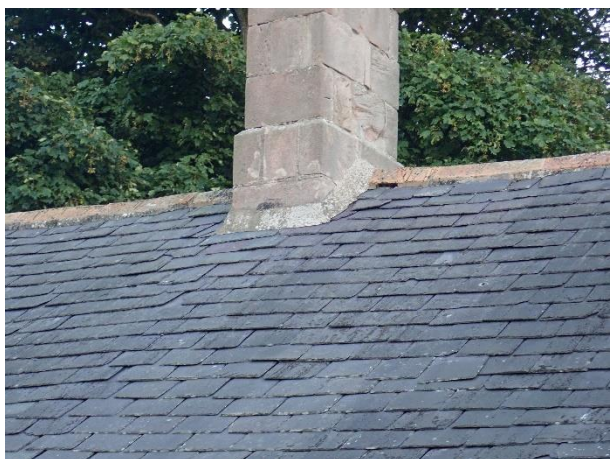
Gap near the chimney

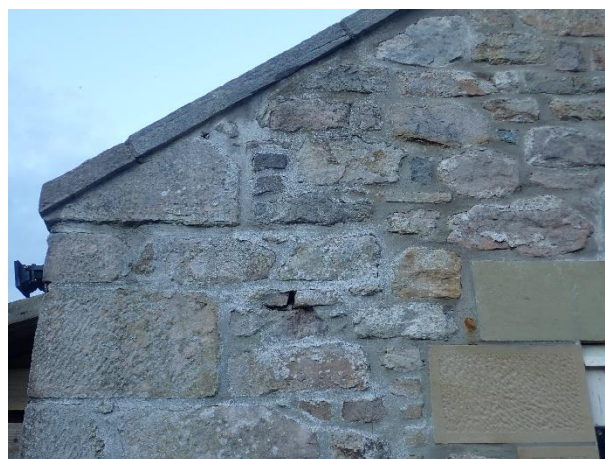
West gable wall recently repointed, with crevice

One integrated Build-in WoodStone Bat Box to be built into the west gable wall at 500mm below the wall top in the new extension building. Please see plan below for locations (Figure 6) and Appendix 2 for diagram.

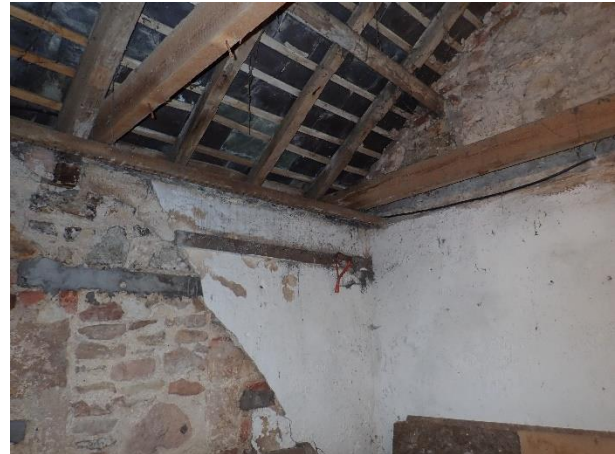
Interior

Plastered walls in places

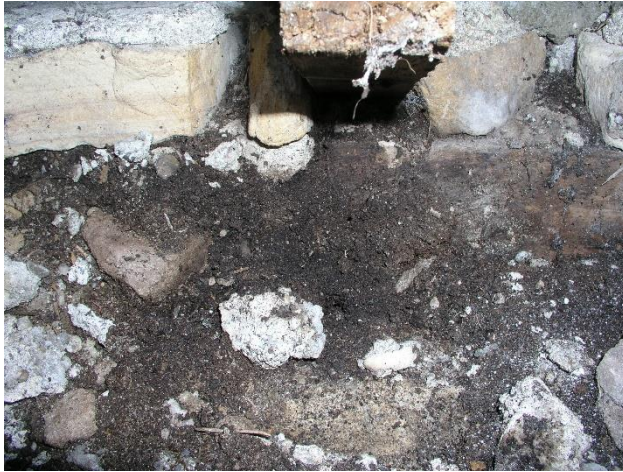
Other traces that can indicate a past presence of bats are their droppings. These resemble mouse droppings but unlike mouse droppings can be crumbled to dust between finger and thumb. Droppings may be found on wall tops and beneath slates and tiles on top of any sarking.

Photo showing disintegrated bat droppings beneath coping stones. If examined carefully, in the black dust exoskeletons of insects can be seen shining.
