Ecological Impact Assessment and Bat Survey

BROKENHEUGH HALL, HAYDON BRIDGE

Summer 2022

Ruth Hadden, BSc. MCIEEM
Ryal Soil and Ecology
Ryal
Northumberland

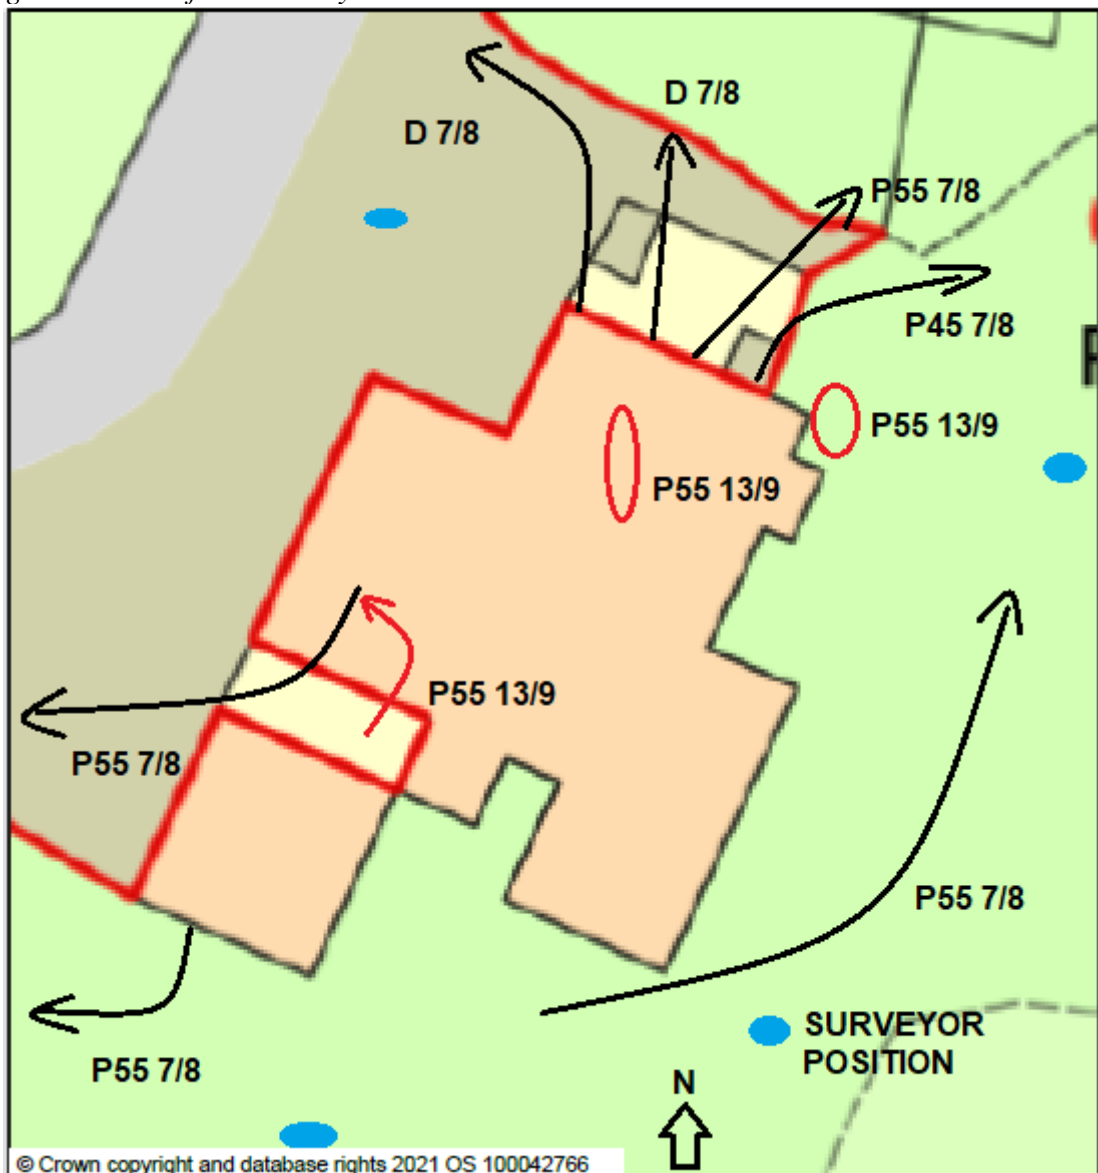
Figure 5. Plan of Bat activity

The emergence survey confirmed bat emergence of one maternity colony (count 181 bats) of Pipistrelle 55kHz bats from the western chimney stack and occasional Pipistrelle 45kHz, Pipistrelle 55kHz and Daubenton's bats emerged from the northeast gable. (Total of 12 bats). A Brown long-eared bat was heard social calling.

During the dawn survey c.30 Pipistrelle 55kHz bats returned to the chimney roost and Noctule bats were also heard. Please see Appendix 2 for detail.

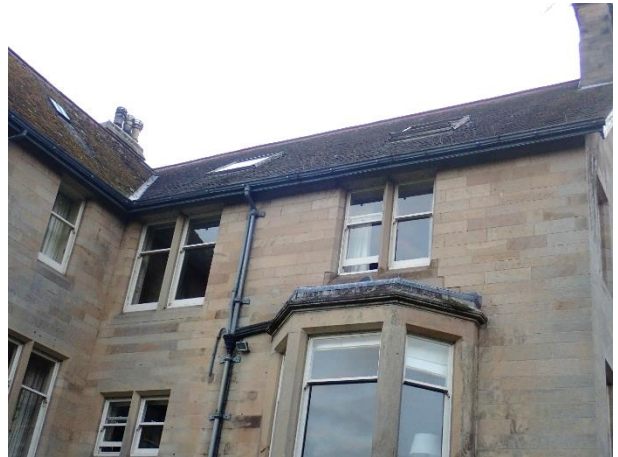
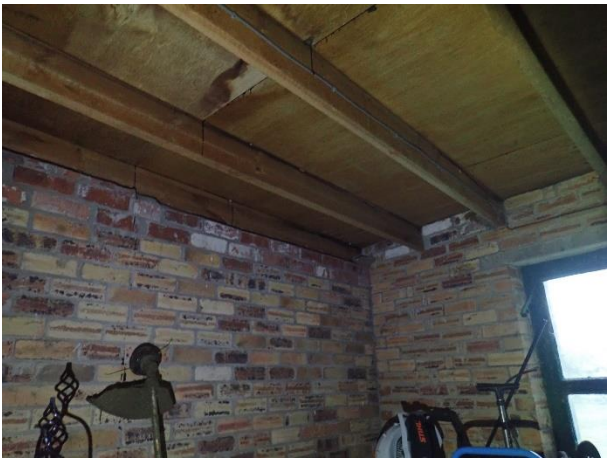
Barge boards to be replaced, northeast gable where bats emerged from beneath the slates

Southern wall top where the occasional bat was present

All bat roost crevices to be retained as at present below the slates on the northeast gable wall top when the bargeboards are replaced.

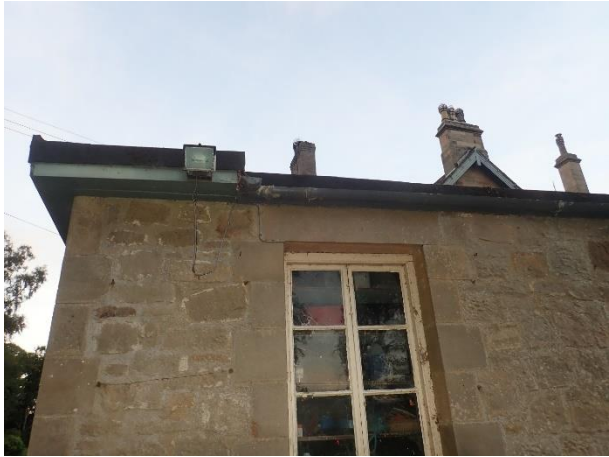
Wall top of garage where the occasional bat emerged

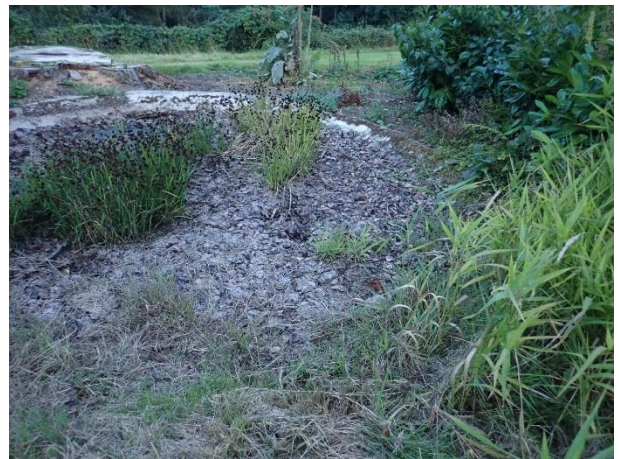
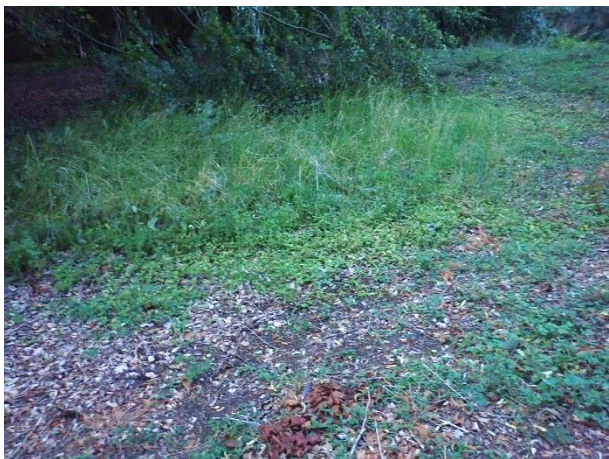
Garden pond, 25m to the northeast, dry

Pond 50m to the northwest, dry.

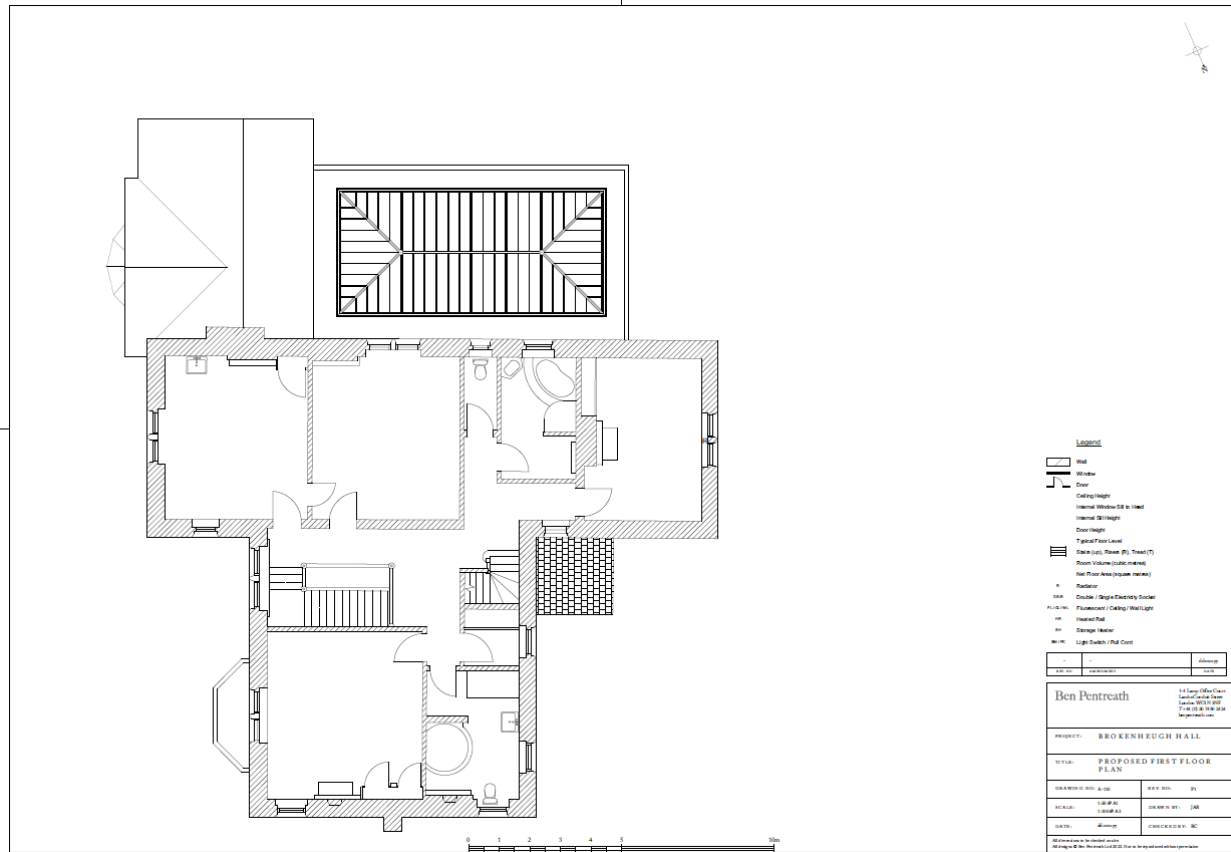
Figure 5. Proposed Works

The proposals are to demolish the garage and courtyard and small outbuildings/room and to extend the to the north with an orangery opening out to a terrace. Two rooflights will also be replaced with dormer windows. Barge boards to be replaced with a decorative board.

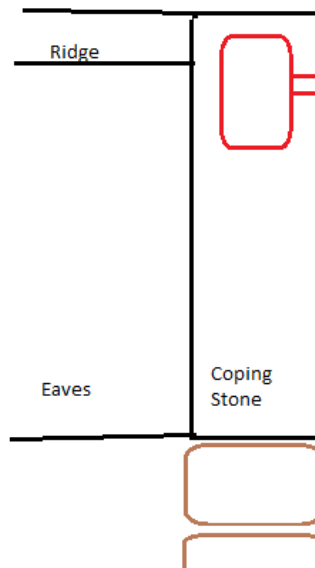
Gable wall crevice

Cavity for bats
100x200x 20mm with
access 15 x 20+mm
