Woodrising, Hillside Road, Bleadon

Bat & Bird Scoping Report

Prepared for: Dowlas Property Group Ltd

Date: October 2022

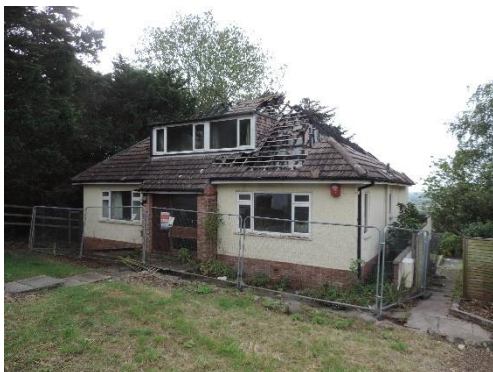
Plate 1: North-eastern Aspect

Woodrising was largely destroyed by fire in November 2019 and has since stood derelict and unoccupied (Plates 1 - 3). The remains of the dormer bungalow were largely open to the elements. The external walls were intact and constructed from red brick, which was partly rendered. The doors and windows were also intact. Wooden soffit boxes were present at the walls tops. The soffit boxes were coming away from the wall in the east and included a damaged section in the west. Both areas were accessed using ladders and inspected using an endoscope; no signs of bats were recorded.

The central roof was largely destroyed although sections nearer the wall tops and a dormer window remained. These remaining sections were clad in double-roman tiles. The roof lining had been entirely destroyed by the fire.

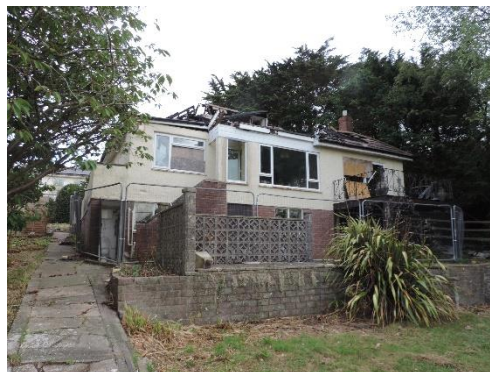
Plate 2: South-western Aspect

The remaining structure did not include any loft voids or sheltered areas that weren't exposed to the elements. Overall, the House was assessed as having Negligible BRP.

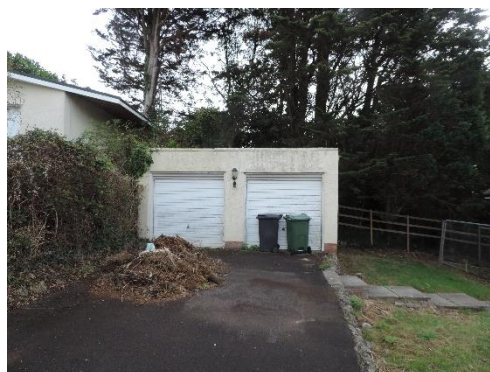
Plate 4: Garage

A detached garage was located to the north of the structure (Plate 4). The walls of the garage were rendered externally. Well-fitting garage doors were located on the western aspect. The roof was flat and clad in bitumen felt. The garage did not include any external potential roost features nor any access to the building's interior. No signs of bats were recovered from within the building. Overall, the Garage was assessed as having Negligible BRP.
