PRELIMINARY BAT ROOST ASSESSMENT

THARBIES FARM, SAWBRIDGEWORTH, HERTFORDSHIRE

Report Number: ASW/AD/031/26/2022
July 2022

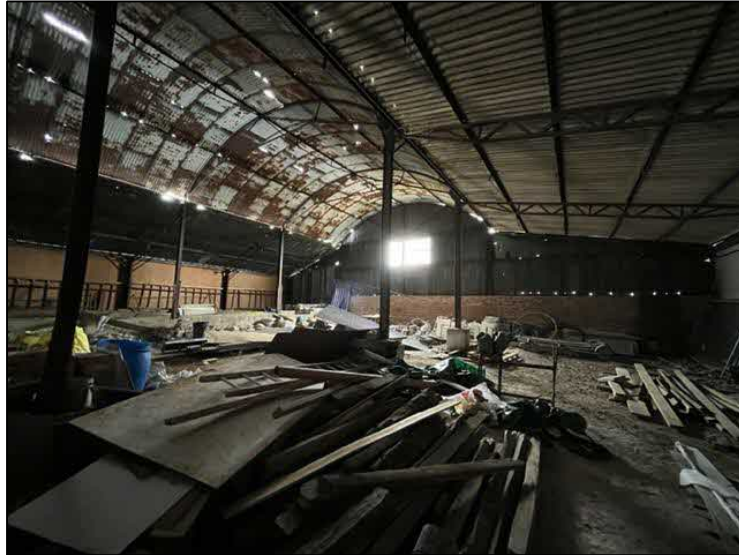
Photograph A
B1 – There was no bat roost potential in the Storage Barn

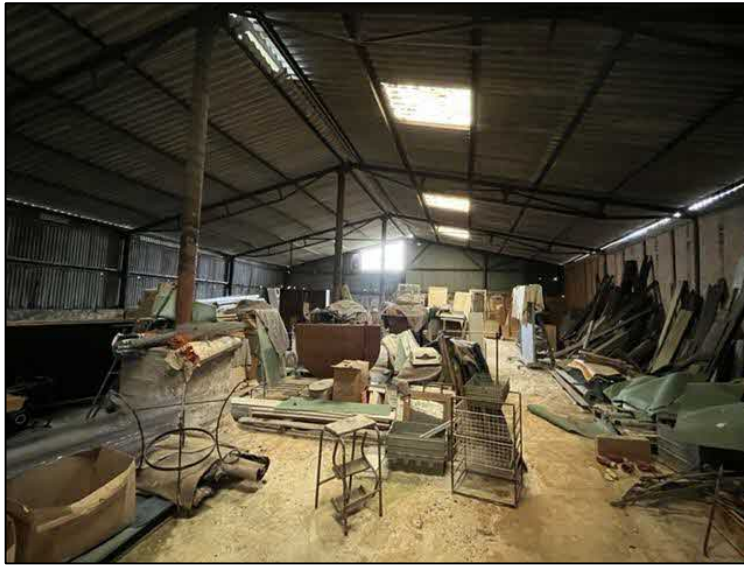
Photograph B

B2 – There was no bat roost potential in the Barn associated with the Embroidery Business

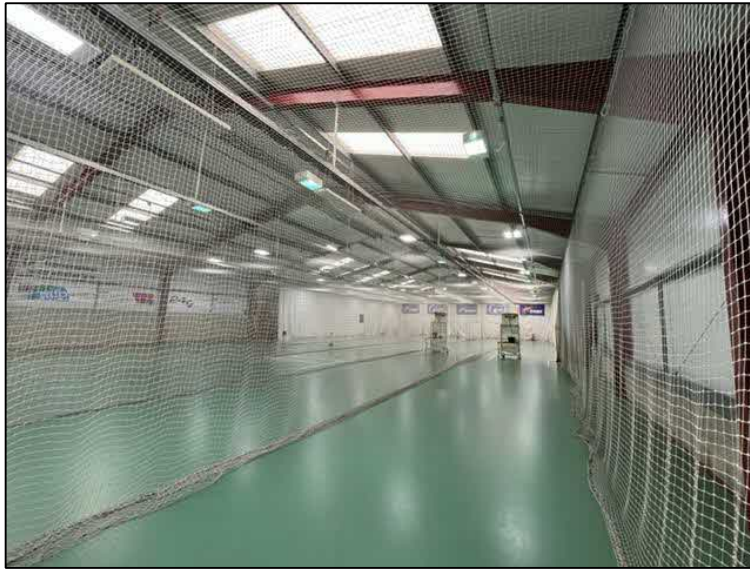
Photograph C

B3 – The Cricket School was too lighted and had no access for bats, hence with no value for bats at all

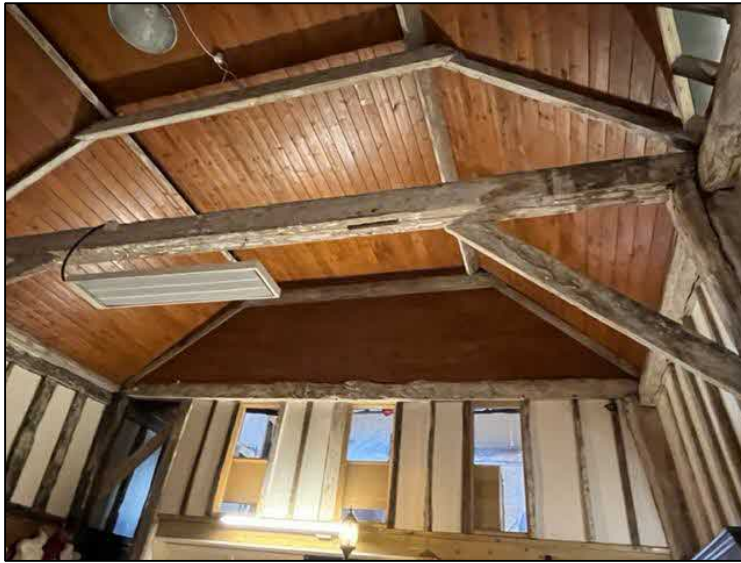
Photograph D

B4 – The Barn associated with the Cricket School had limited bat roost potential, with a low loft present above the roof shown, with possible access for bats

The Listed Barn will therefore require 3x bat dusk survey visits in total. The Barn associated with the Cricket School will require just 1x bat dusk survey visit.

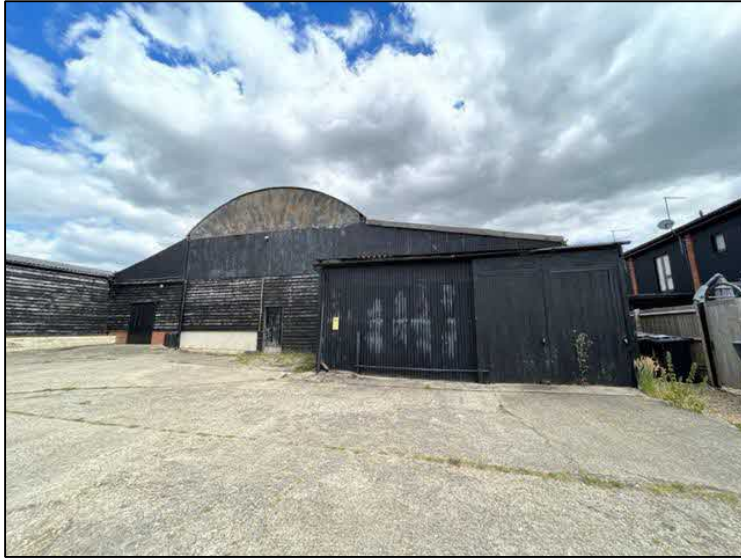
Photograph E

B1 – There were no high quality external features for bats to use for roosting purposes

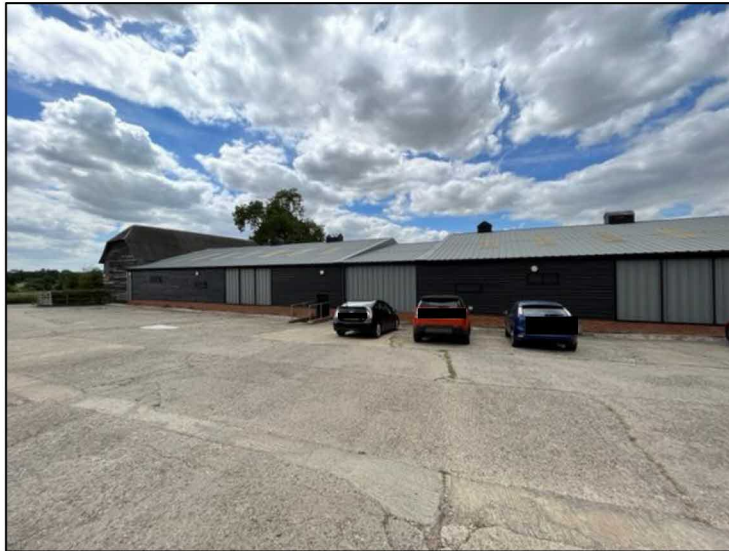
Photograph F

B3 – There were also no external features here for bats to use for roosting

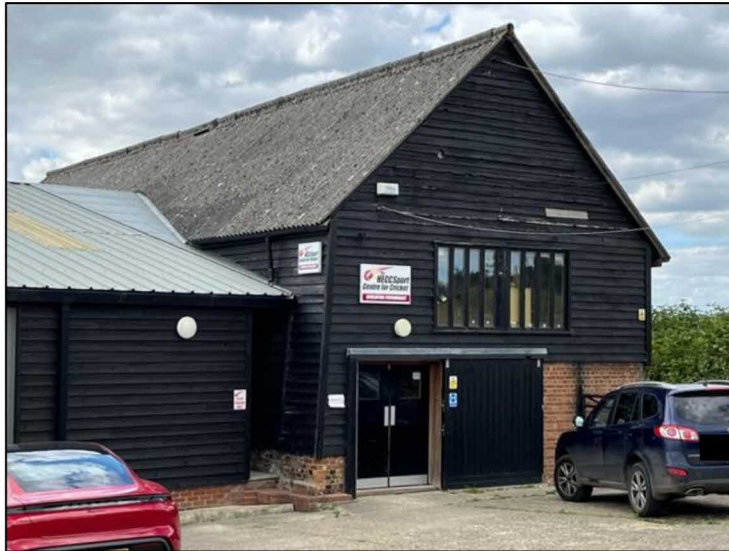
Photograph G

B4 – There is a crevice below the ridge, especially since daylight was seen above the ridge beam in the loft space

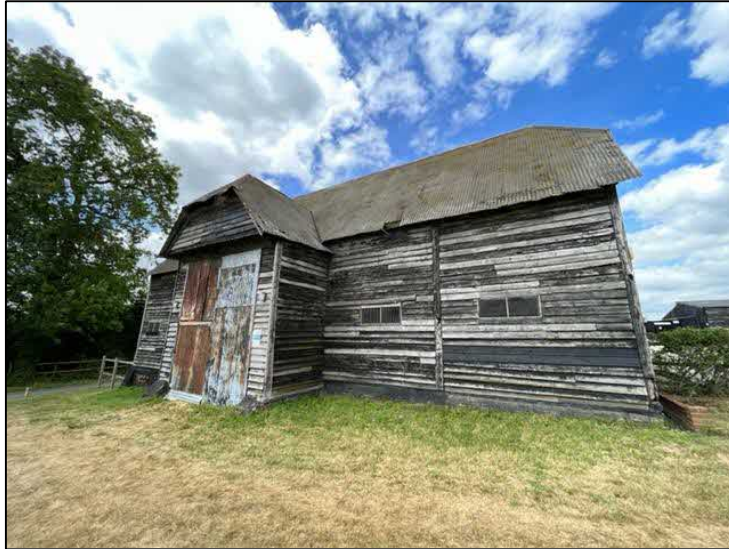
Photograph H

B5 – There are various access points present around this barn, leading into the interior

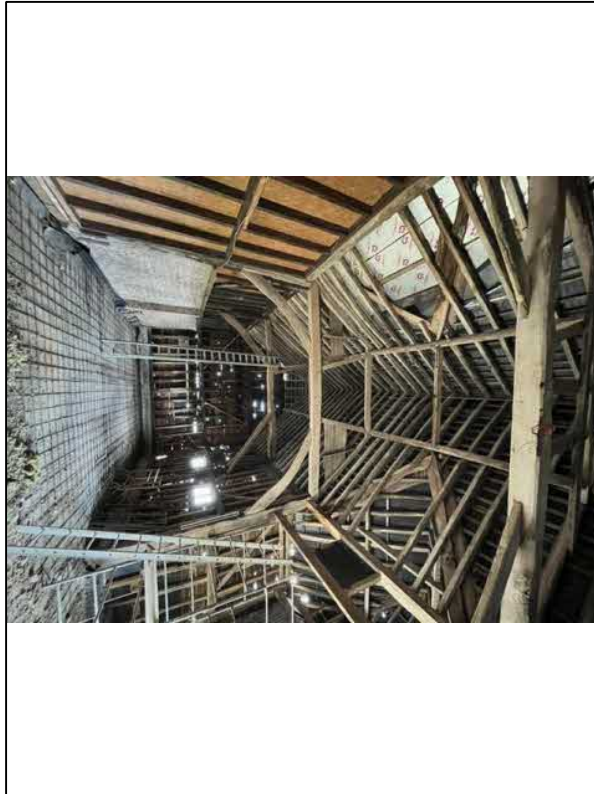
Photograph I

It is likely that the Listed Barn is being used as a day roost by both of these species, especially since internal features such as mortise joint slots and crevices between timbers are present still.

B5 – This large thresher barn was found to be spacious, with various niches for roosting bats including mortise joint slots

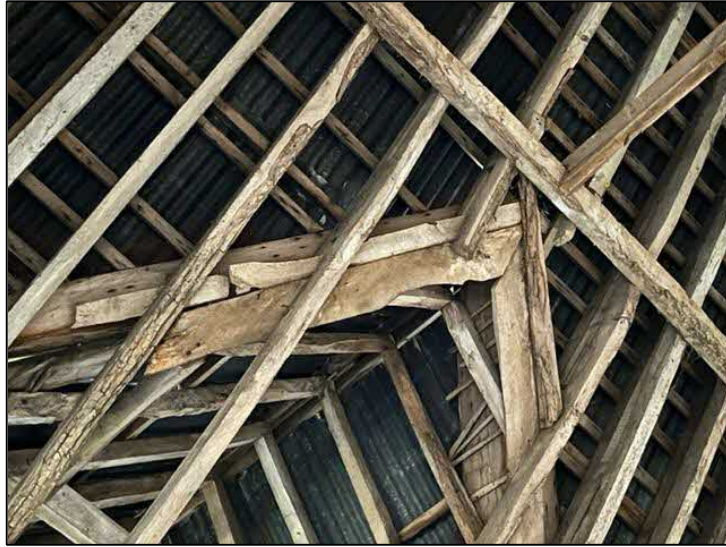
Photograph J

B5 – This barn also had crevices present where timbers have been fixed together

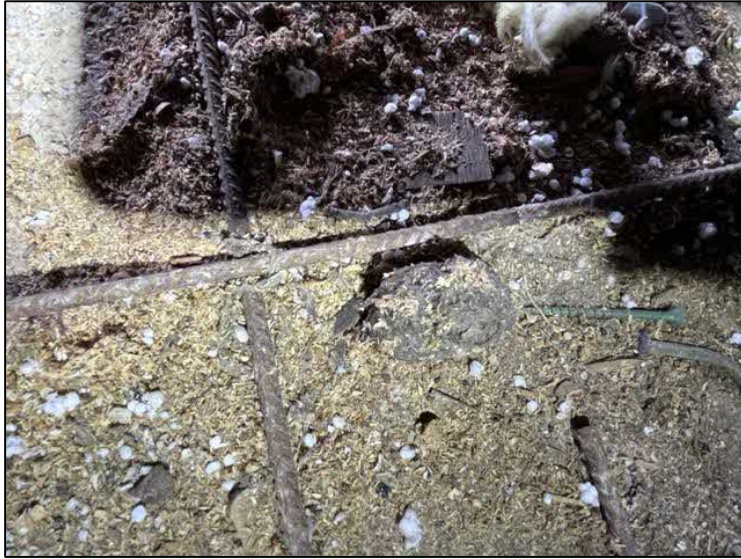
Photograph K

Nesting bird evidence was noted in two of the buildings including old nests belonging to wren and doves. There was also an old barn owl pellet, derived when this species had roosted in the Listed Barn previously. There was no fresh barn owl evidence and no indication that barn owl had nested here.

B5 – A barn owl pellet was present in the barn, although this was an old pellet

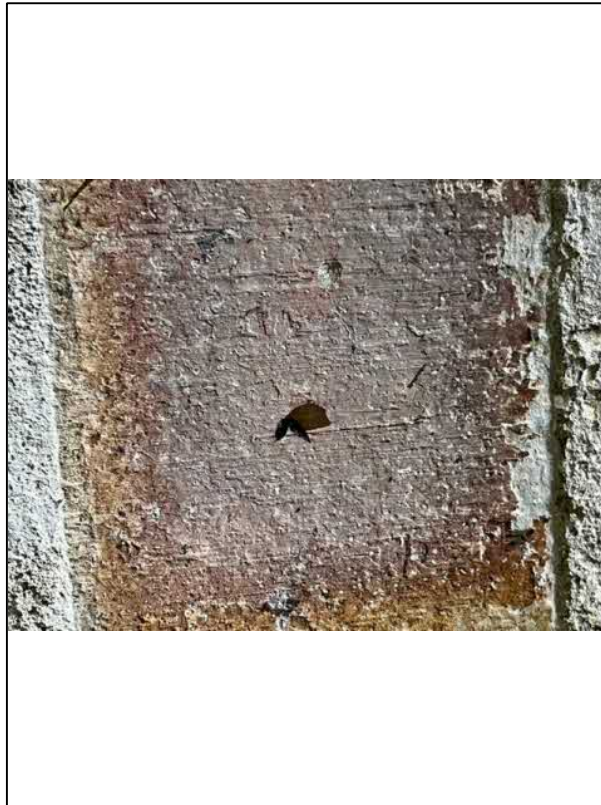
Photograph L

There was bat evidence found within the Listed Barn, with a small number of both pipistrelle and brown long-eared bat droppings on a side wall.

B5 – A small number of pipistrelle bats droppings were found adhered to the rear wall, showing that common pipistrelle most likely is still roosting here

Due to the presence of bat evidence in the Listed Barn and some bat roosting potential at the Barn associated with the Cricket School, it is recommended that a standard follow-up bat emergence survey is undertaken at the application site, in suitable weather conditions.

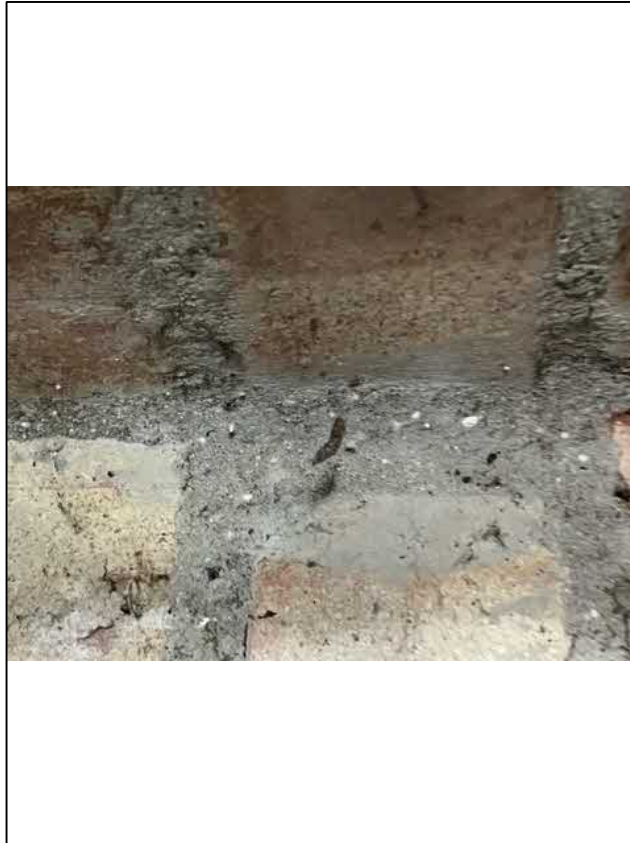
Photograph M

B5 – A very small number of brown long-eared bat droppings were also present on the rear wall showing that this species is still here roosting

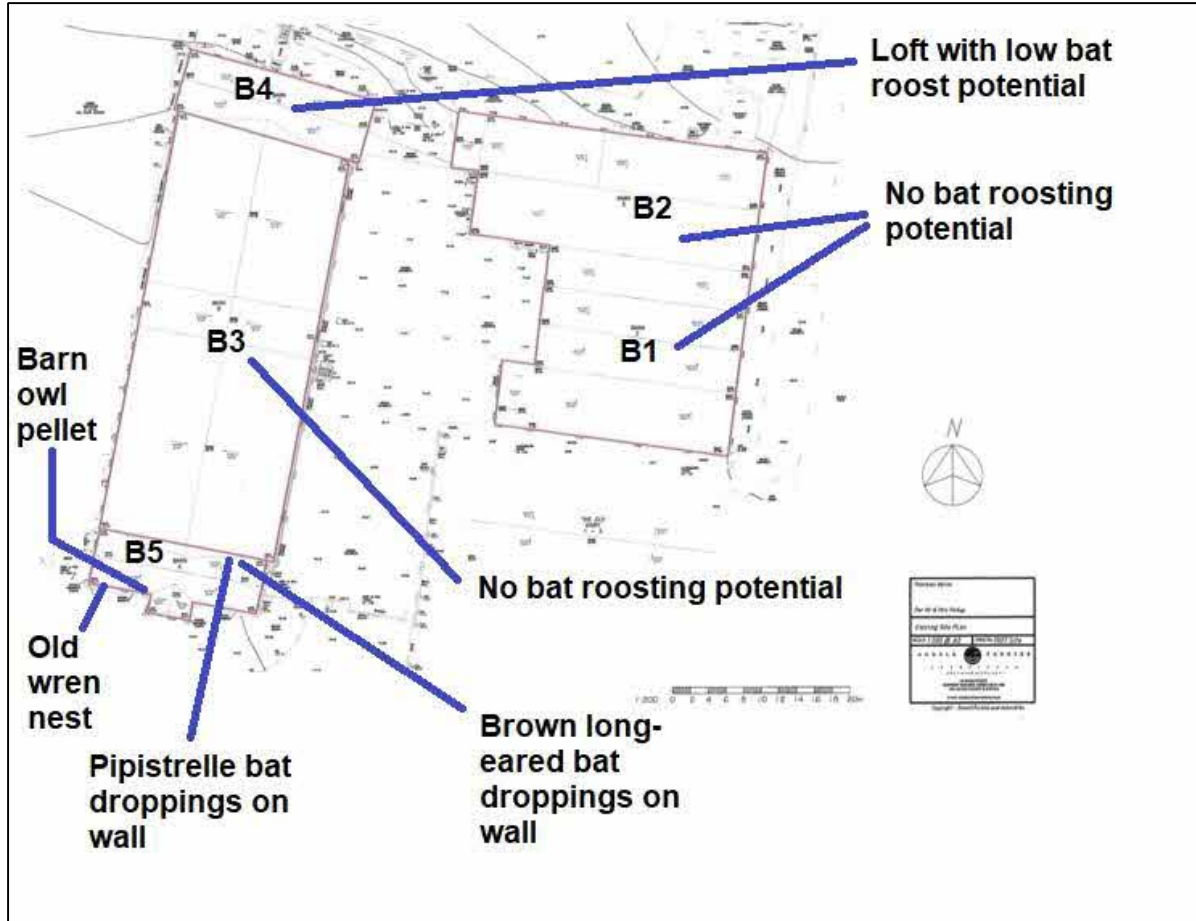
Map A – Bat related target notes for Buildings 1-5 at Tharbies Farm

3.1 Buildings 1-5 – Please see Map A in Appendix 2 for the locations of the buildings described below
