Bat Risk Assessment of:

8 Olive Street
Waldridge
DH2 3SQ

Job Ref: Carter_8OliveSt_Bat1.1

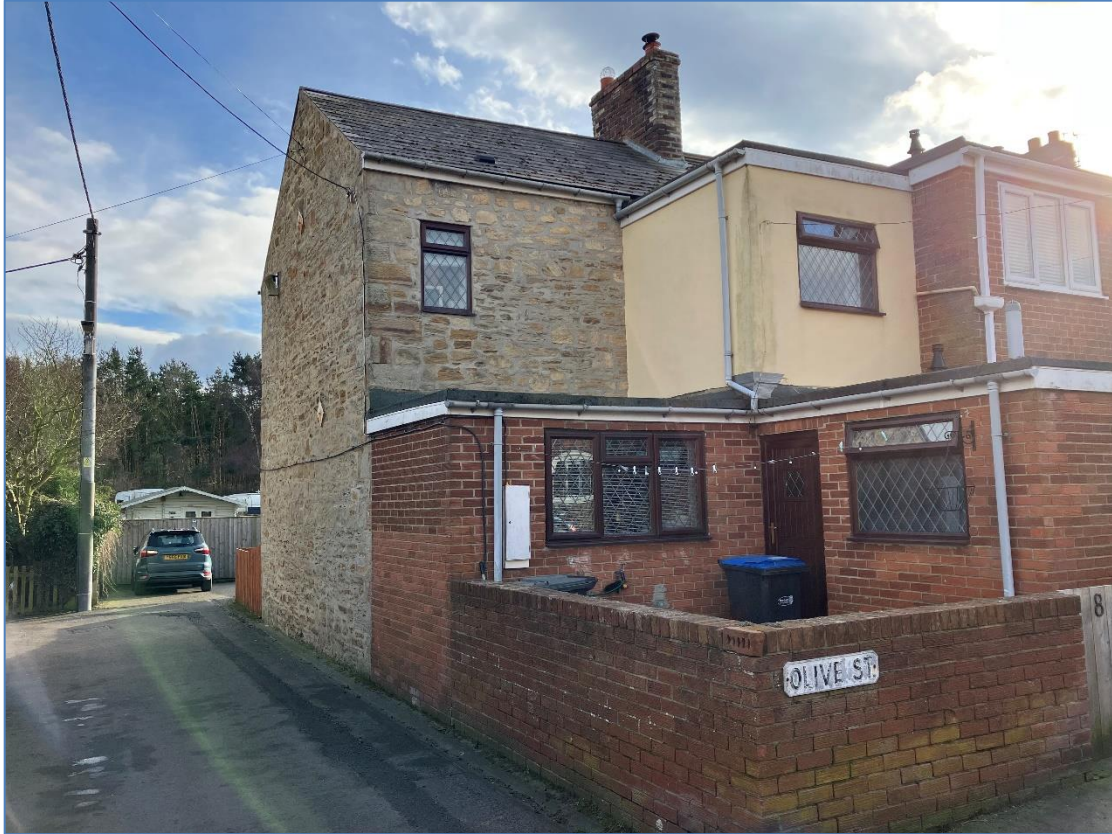
3.4.1 The property consists of a two storey end terrace with one and two storey extensions on the rear elevation (photograph 1). The roof of the main section is pitched and covered with slate. The slates and ridge were in good condition with no obvious gaps present. The pointing between the roof and gable wall was in excellent condition with no gaps (photograph 2). The flat roofed sections were covered with felt and there were no obvious gaps between the roofs, soffits and walls (photograph 3). Fascias on the front and rear elevations did not seal well to the walls and gaps were present (photograph 3). No evidence of bats was found during the external inspection.

Photograph 1 – Northern elevation of property to be extended

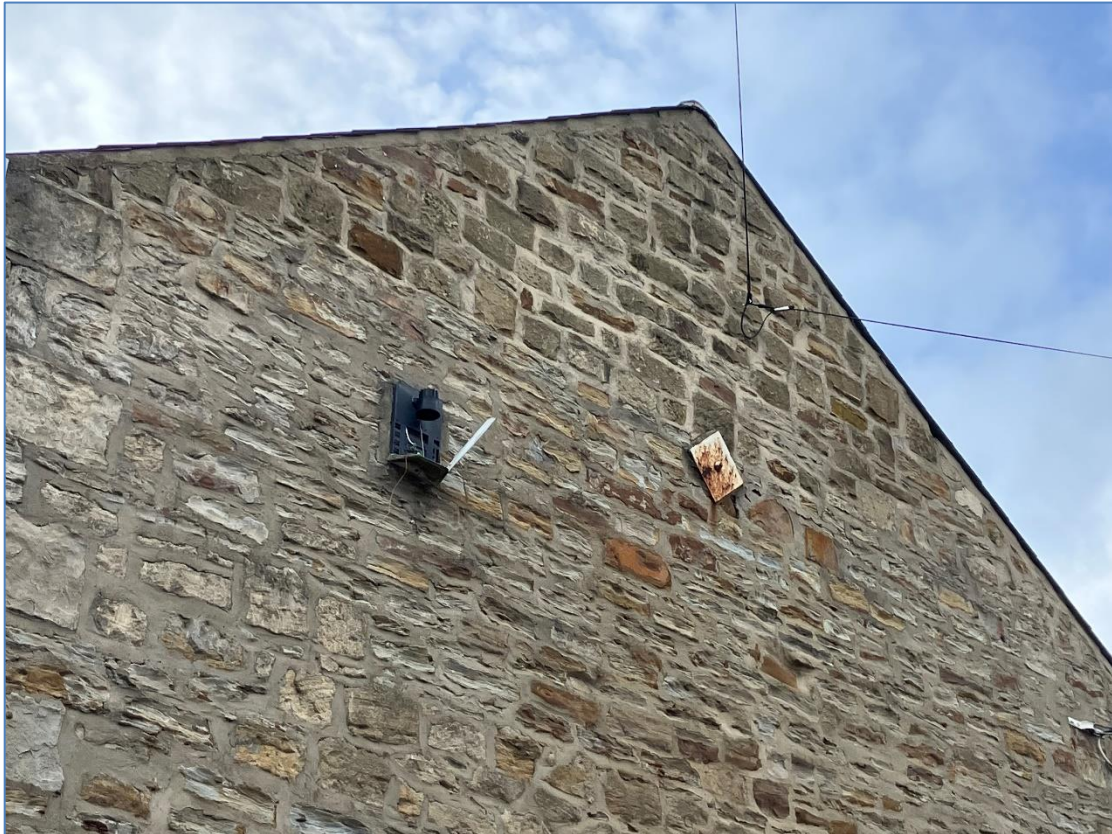
Photograph 2 – Pointing between slates and wall at gable end in good condition

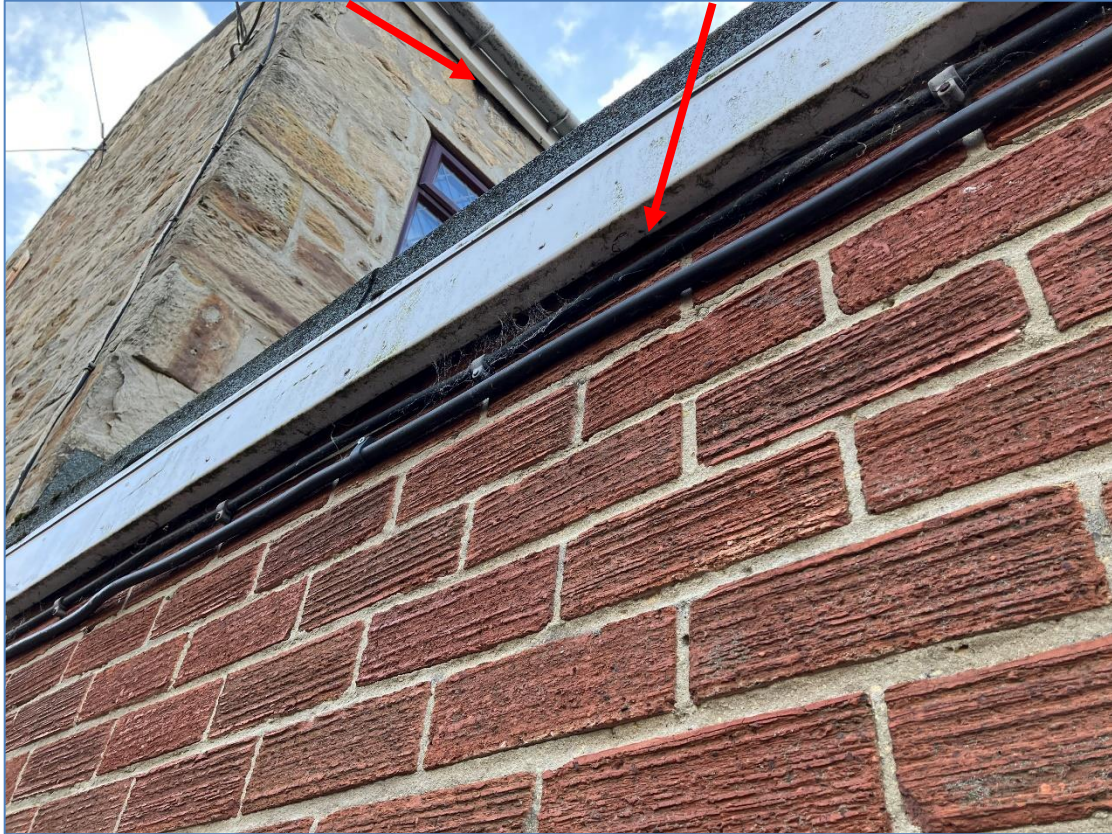
Photograph 3 – Gaps visible at first floor soffit. No gaps at ground floor extensions

4.2.2 The building contains gaps at the front and rear elevations which could be used by bats. Access to the roof void was unrestricted and bats had the potential to get through the felt into the void. No potential for access by bats was present in the flat roofed extensions. No evidence of use by bats was found externally or internally.

5.0.1 The building has been classified as having a low risk of containing roosting bats under current industry guidelines. In such circumstances the best practice guidelines state that the project ecologist should use their best judgement to decide how to proceed. In this instance we do not recommend further surveys but we do recommend supervision of the works when the new extension is being tied into the existing roof line on the northern elevation. No restrictions on the timing of the works are deemed necessary with regards to bats.

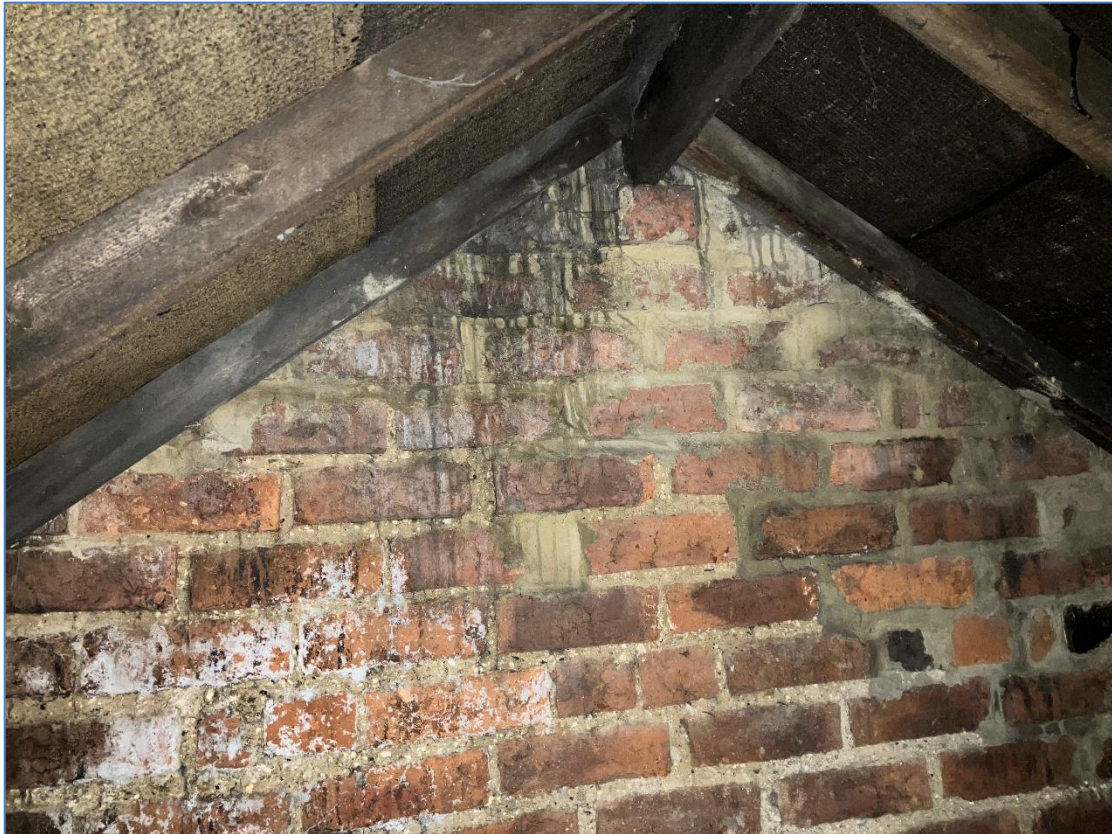
3.4.2 Internally, the main roof void was accessible via a loft hatch. The roof was lined with bitumen felt and were heavily draped with cobwebs (photograph 4). Small plastic tubes have been placed between the felt layers (photograph 5) which would allow bats access into the actual void itself. No evidence of bats was found during the internal inspection.

Photograph 4 – Internal view of roof void

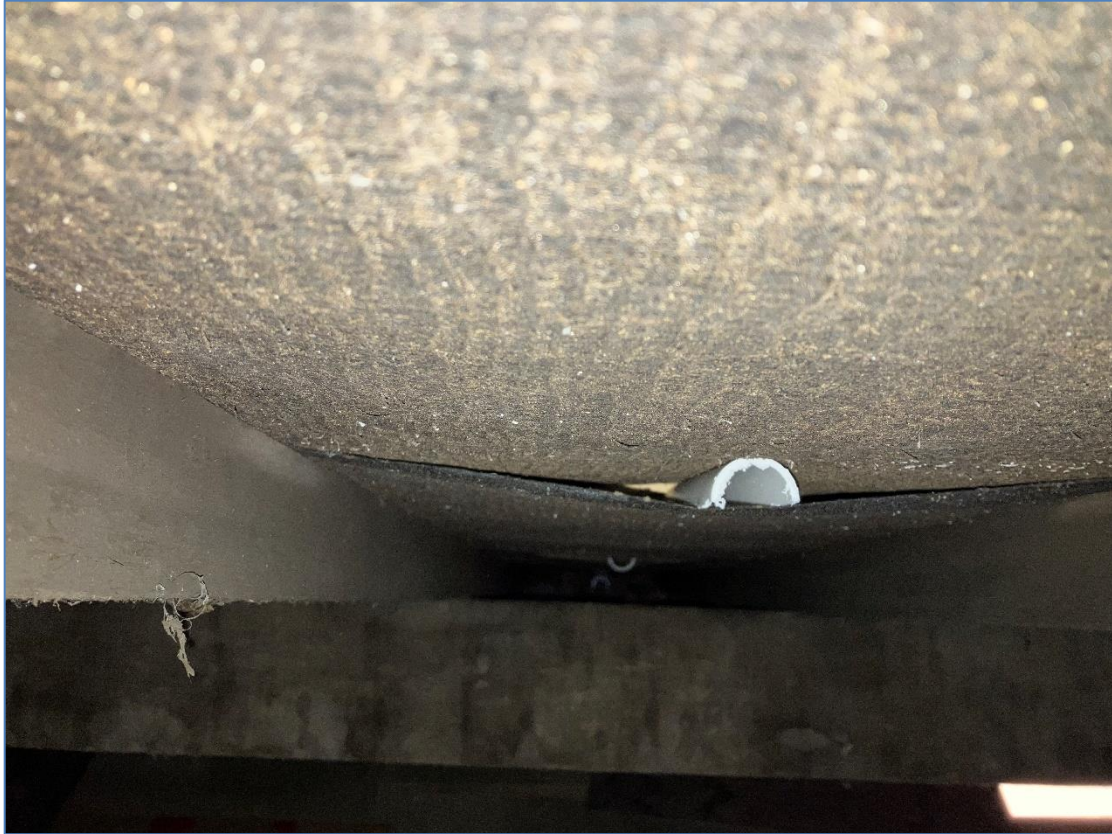
Photograph 5 – Ventilation in the roofing membrane which would allow bats access to the roof void
