Repair and where necessary replacement of five bar pedestrian entrance gate. This will extend to the realignment and repair of the gate posts and enclosure as required.

Fence + Gate Viewed From B1067
As Proposed @ 1:50
Item 1. on Drawing no. 100

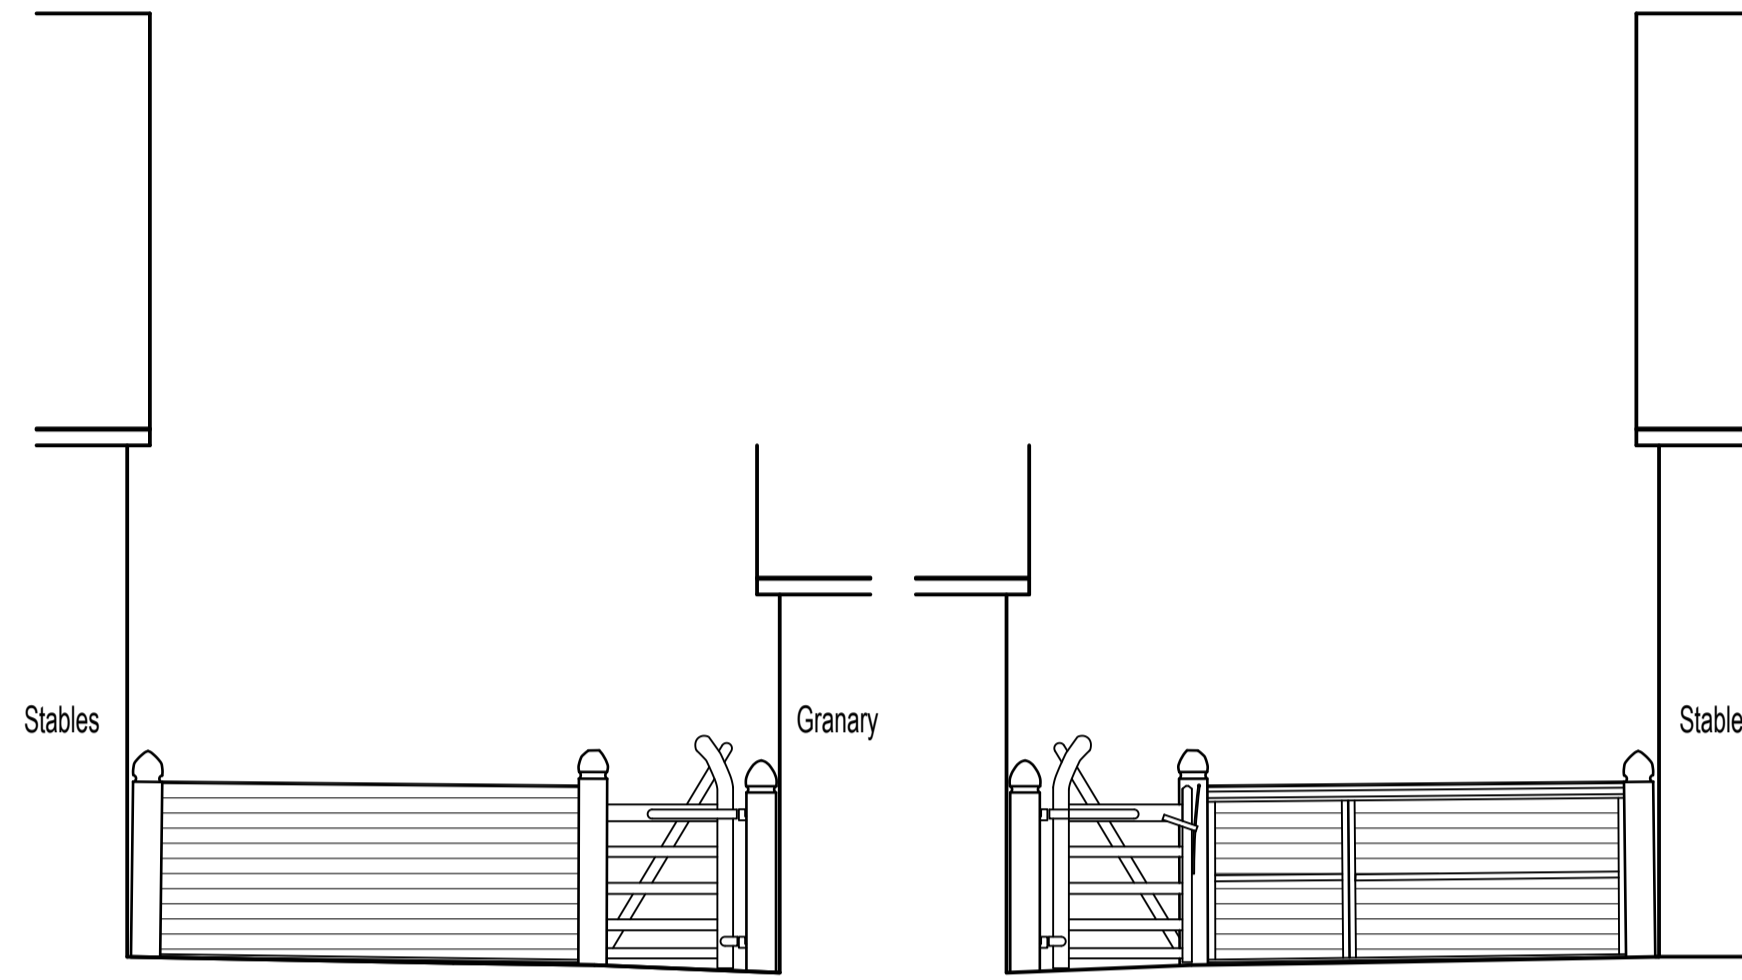
The height, layout and alignment of the gate, posts and enclosure will remain unchanged.
The style and appearance of the five-bar gate will also remain unaltered.

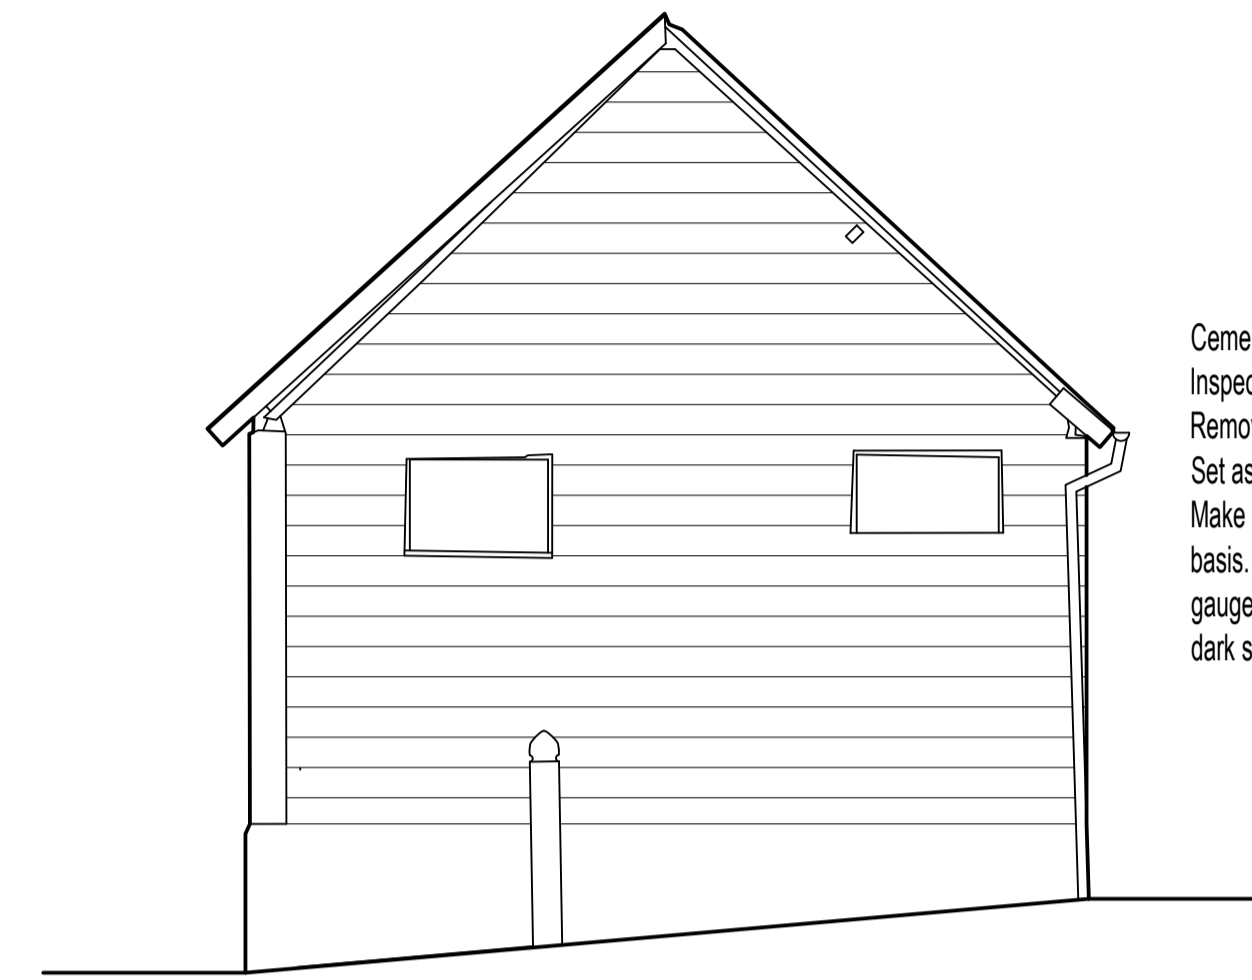
South West / Gable Wall to Stables As Proposed @ 1:50
Item 3. on Drawing no. 100

Cement render to be removed.
Inspect condition of weatherboarding
Remove damaged, broken and rotten boards.
Set aside any boards which can be reused / salvaged.
Make good masonry using lime mortar on a like for like basis. Reinststate weatherboarding using matching gauged and suitably seasoned timber. Treat with a dark stained finish.
