Ecological Impact Assessment and Bat Risk Assessment

CROSS COTTAGE, GLANTON, NORTHUMBERLAND

SUMMER 2022

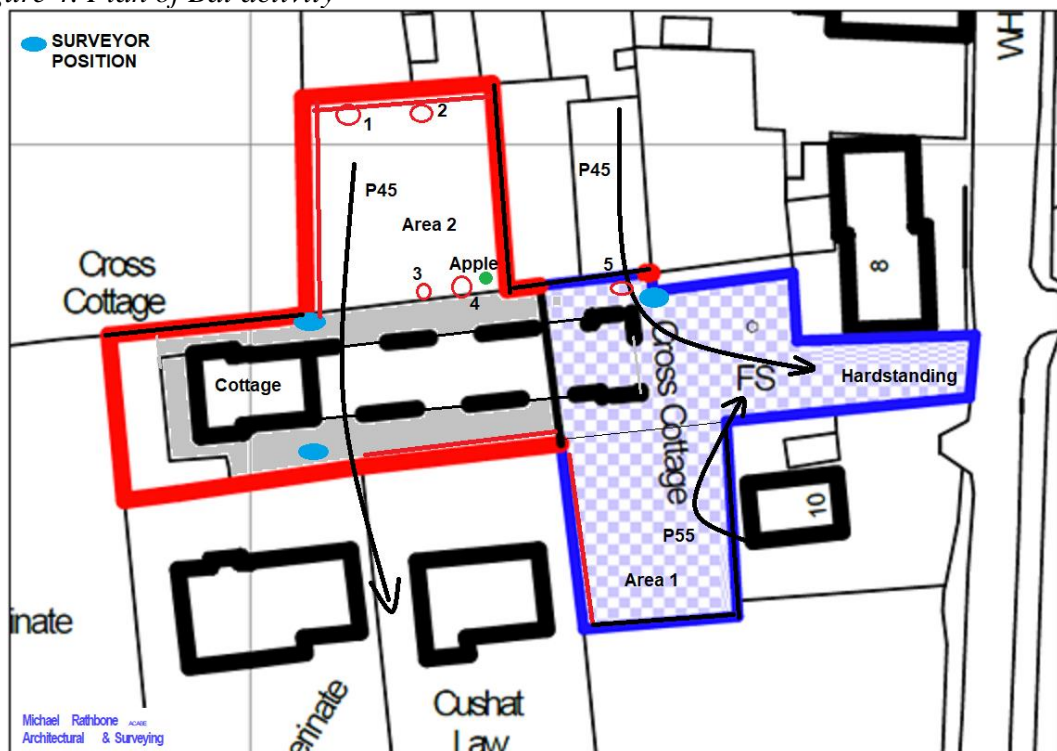
Figure 4. Plan of Bat activity

The emergence survey confirmed no bat emergence from the property though after sunset small numbers of Pipistrelle 45kHz and Pipistrelle 55kHz bats were noted passing over the site to the south. Please see Appendix 2 for further details.

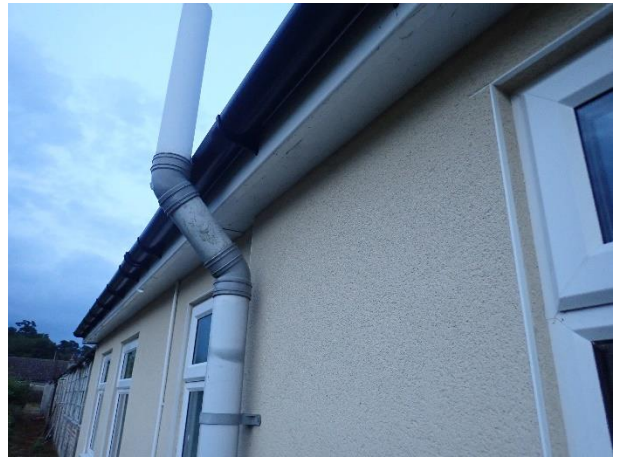
Soffits well sealed.

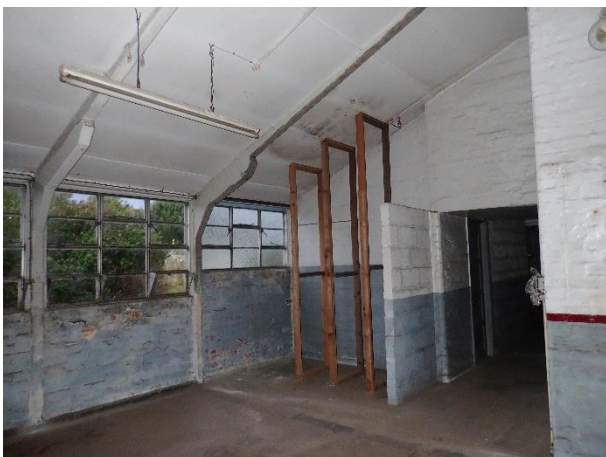
No loft area, roof lined

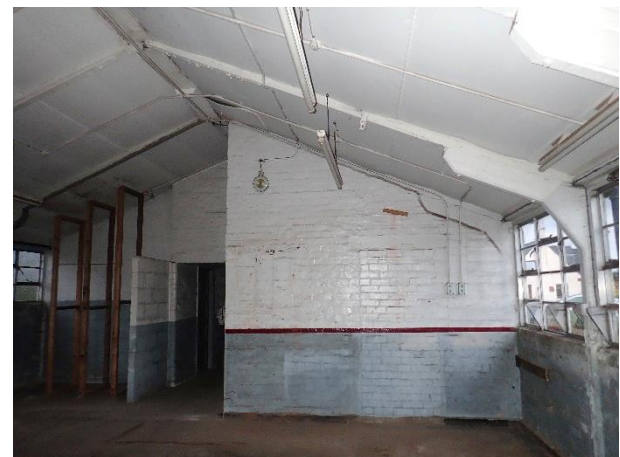
Gap in the ceiling showing the corrugated asbestos roof

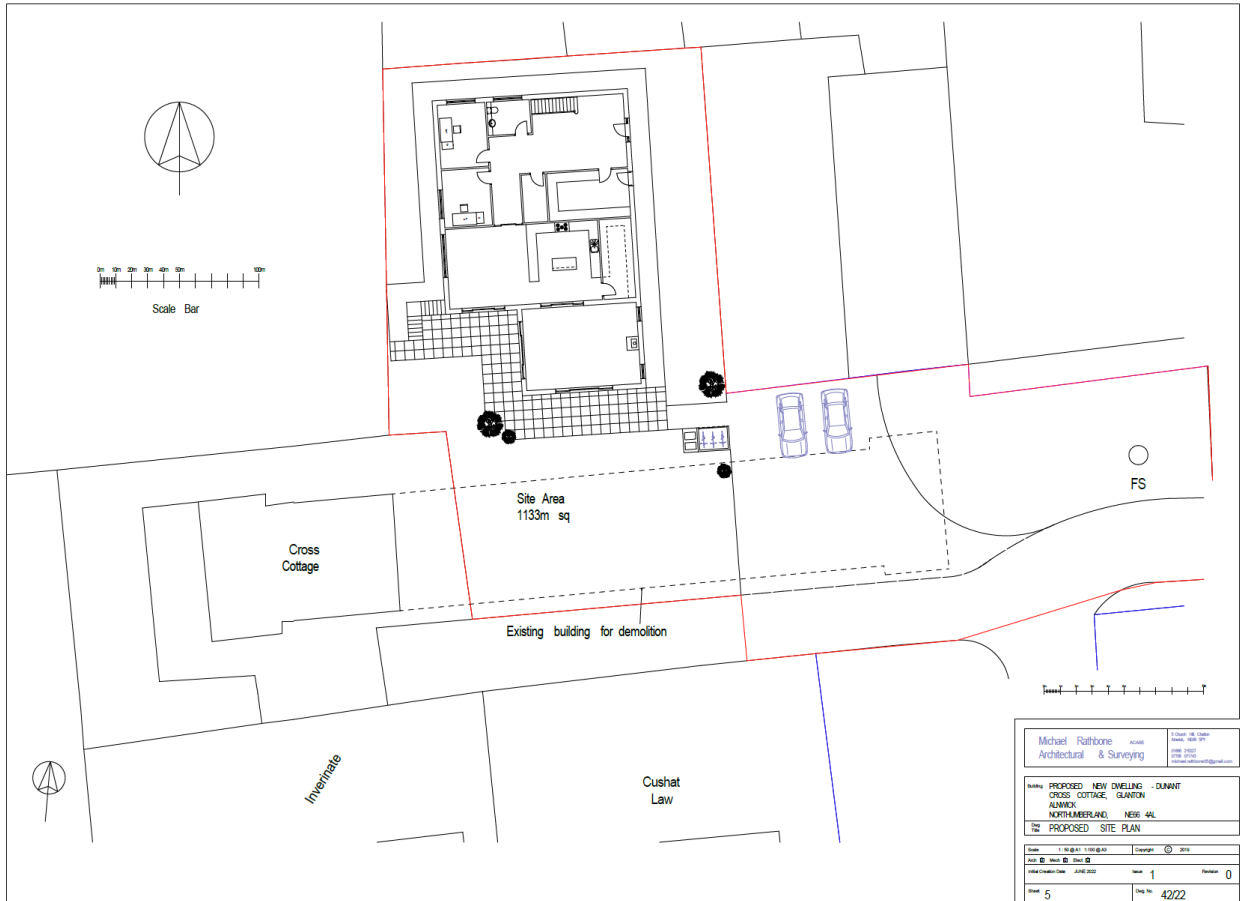
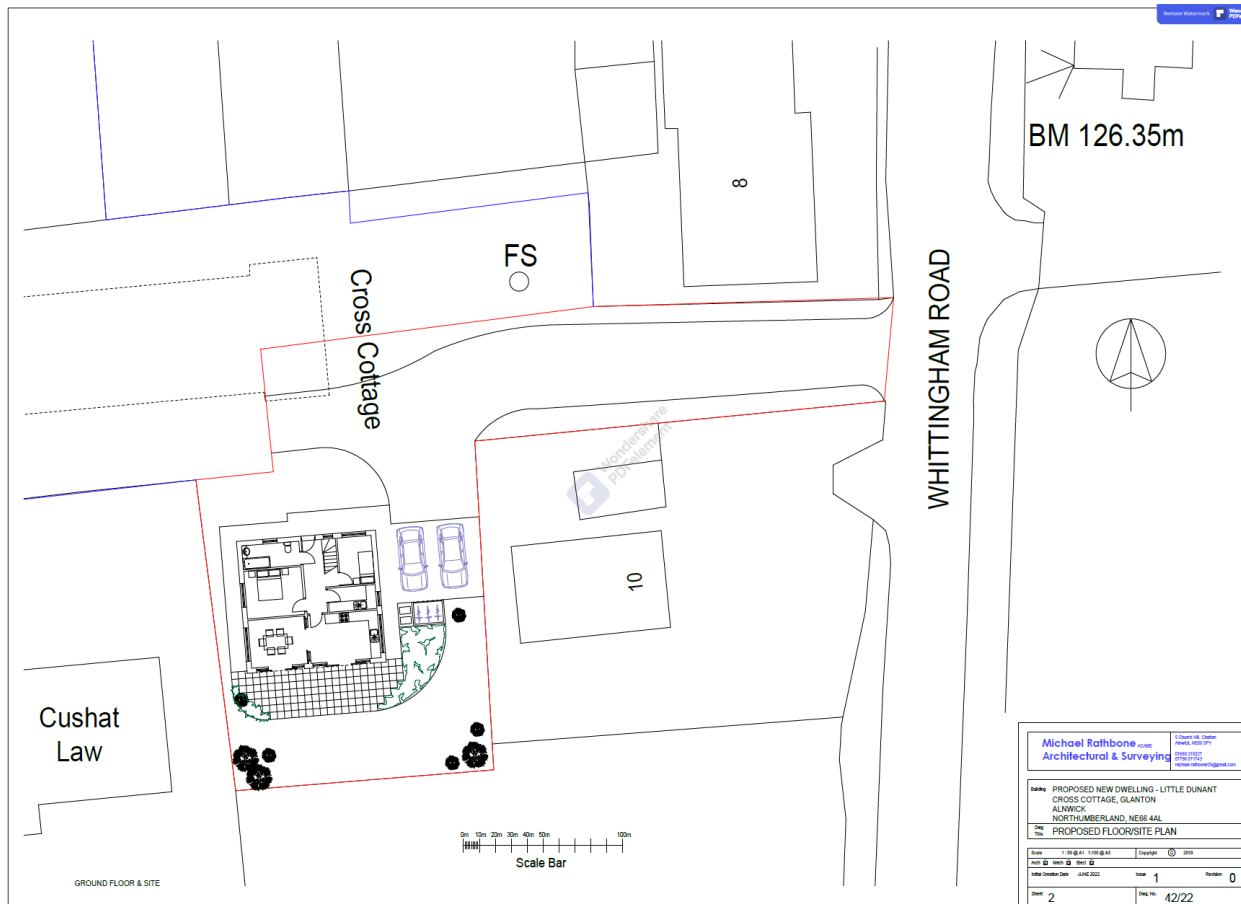
Figure 5. Proposed Works

The proposals are to demolish the building and to build two residential properties on the site. This will entail removing the timber log building to the north of Area 2.

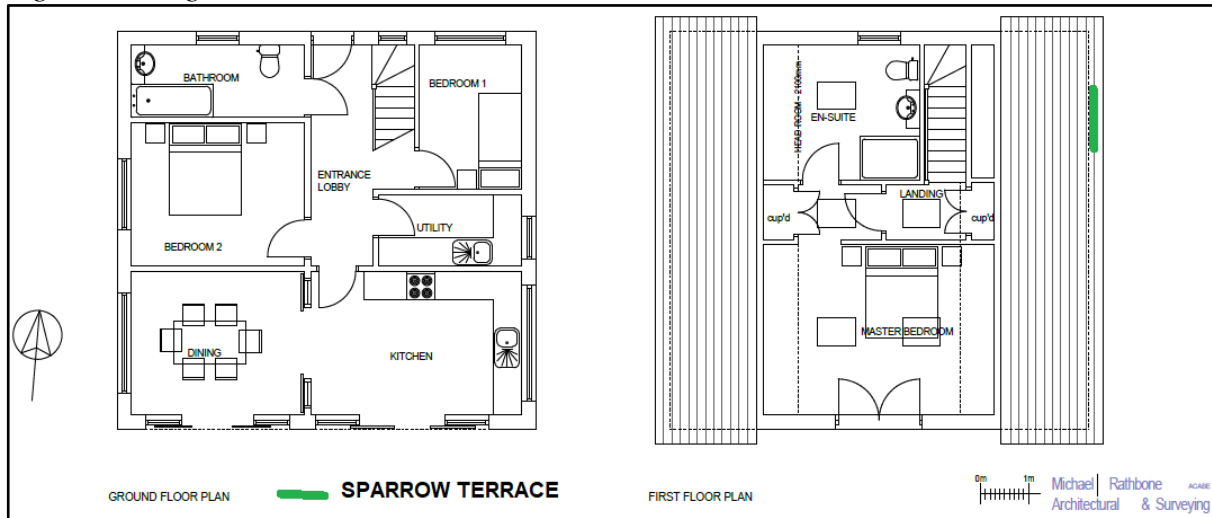
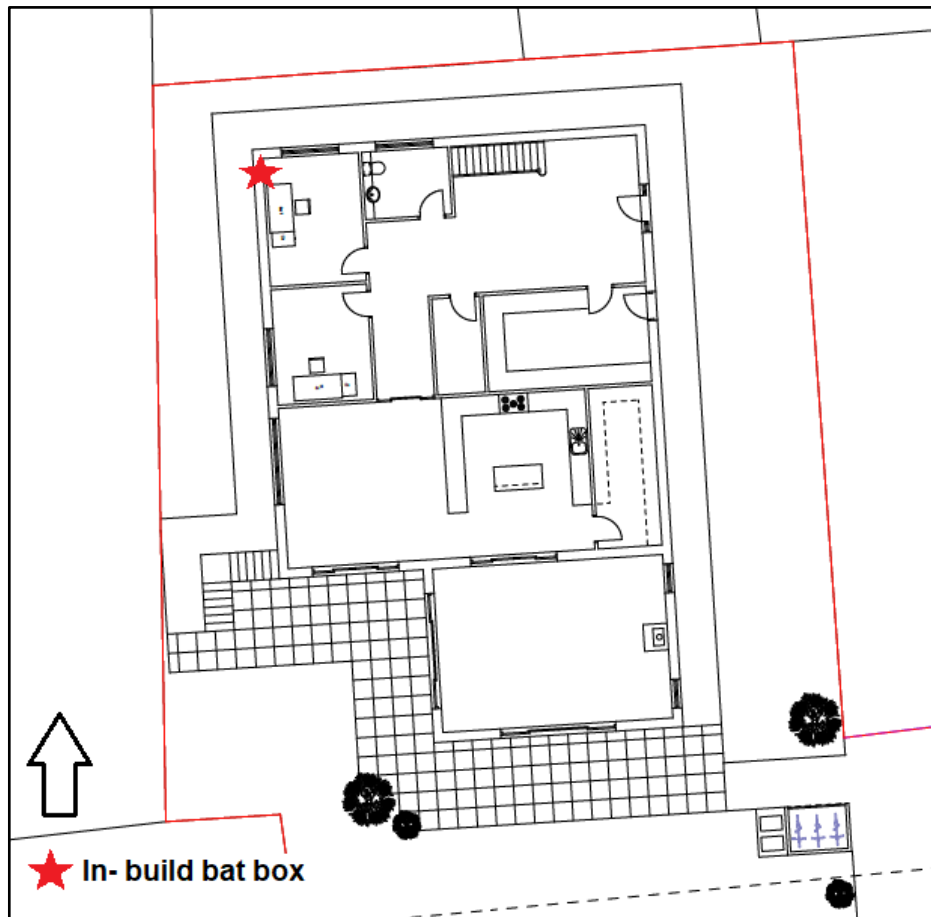
Figure 6. Mitigation Locations – Little Dunant

One integrated Build-in WoodStone Bat Box to be built into the west wall at 500mm below the wall top in the new build, Dunant. Please see plan below for locations (Figure 6) and Appendix 3 for diagram.

Two Vivara Pro WoodStone sparrow terraces to be positioned together below the eaves on the east facing wall of Little Dunant. Please see plan below for location (Figure 6) and references for detail.

Location	Mitigation Type
Dunant, west wall	One integrated Build-in WoodStone Bat Box,
Little Dunant east wall	Two sparrow terraces, adjacent to each other, to be sited at the eaves.

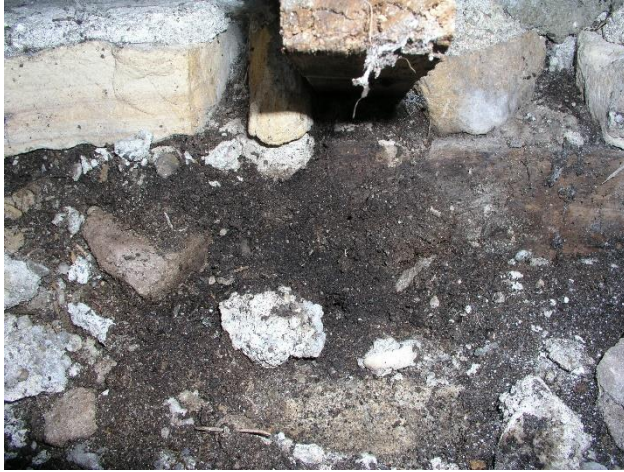
Photo showing disintegrated bat droppings beneath coping stones. If examined carefully, in the black dust exoskeletons of insects can be seen shining.
