Report prepared for: Stephen Allen

For the Site of: 3 Orchard on the Green Croxley Green Rickmansworth Herts WD3 3HS

Preliminary Roost Assessment (PRA)

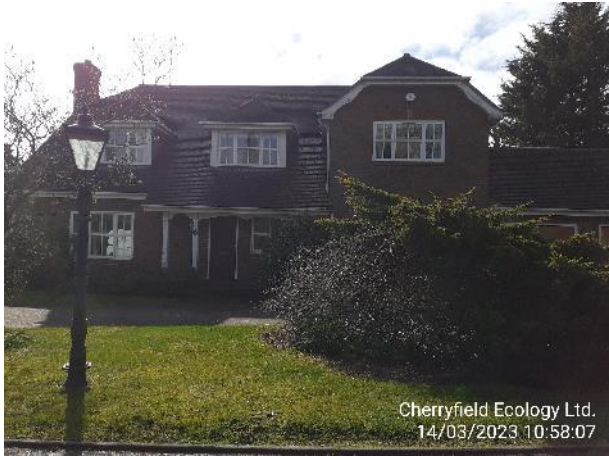
Building/Tree/Structure Number	Description
B1	<p>External</p> <p>B1 is a large, detached, two-storey dwelling. The building has a Dutch gable roof structure with a catslide section, two large, hipped dormers and a cross Dutch hip to the front. A bay window with a hipped roof is found to the east and a large conservatory to the rear. To the west B1 has an attached double garage, with a hip and valley roof structure. The building is brick built, with clay composite roof tiles. B1 has a single brick, built chimney with wooden soffit boxes and plastic rainwater goods.</p> <div data-bbox="672 663 1276 1115" data-label="Image">

<p>Cherryfield Ecology Ltd. 14/03/2023 10:58:07</p> </div> <p data-bbox="721 1161 1214 1192">Figure 2: Front (northern) elevation of B1</p> <div data-bbox="665 1224 1268 1677" data-label="Image">

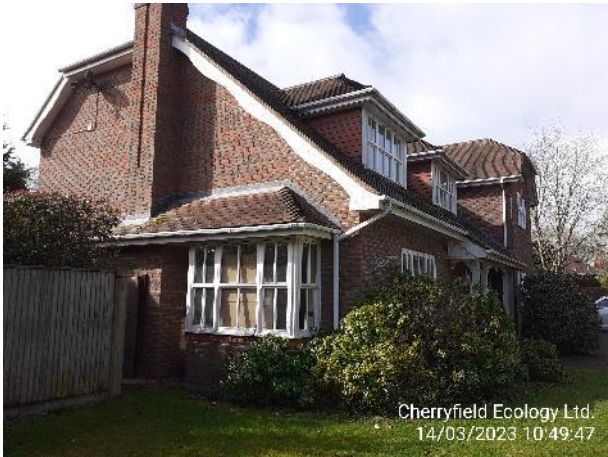
<p>Cherryfield Ecology Ltd. 14/03/2023 10:49:47</p> </div> <p data-bbox="743 1724 1192 1755">Figure 3: Eastern side elevation of B1</p>

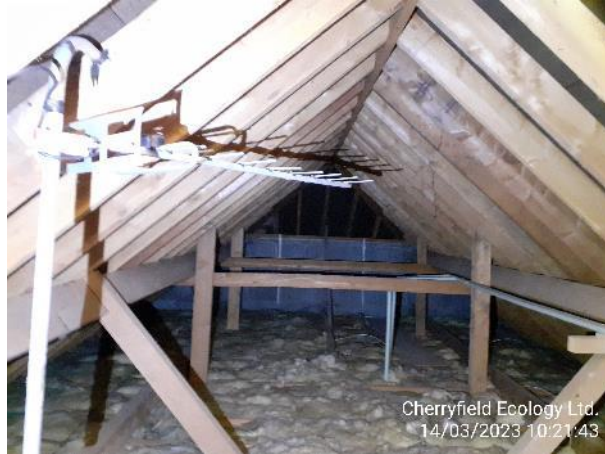
Internally B1 has one large, continuous loft void which has a modern beam structure. The roof is lined with a bitumen felt and is boarded in the centre with insulation found at the ends and across the dormer sections. The loft contains the water tank and associated infrastructure.

Figure 6: Internal loft void (eastern end)

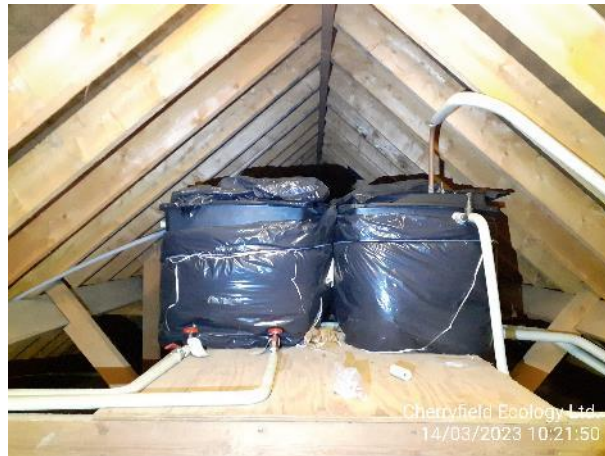
Figure 7: Internal loft void (western end)

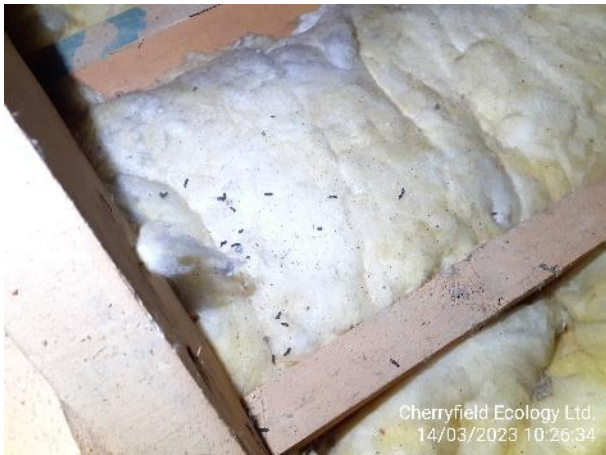
Bats found	No bats were found at the time of the survey.
Evidence of bat use	<p>Evidence of bat use was found on site in the form of approx. 50 bat droppings scattered across the loft void floor and surfaces, predominantly beneath the ridge (see figures 8 and 9).</p> <div data-bbox="690 619 1291 1071" data-label="Image">

<p>Cherryfield Ecology Ltd. 14/03/2023 10:26:34</p> </div> <p>Figure 8: Example of bat droppings found (eastern end)</p> <div data-bbox="682 1186 1282 1638" data-label="Image">

B1 is a confirmed bat roost due to the presence of bat droppings. A small number of potential access points were also identified across the building including gaps in roof tiles around the chimney and along the ridge of the building, and via a hole in the brickwork (see figures 10 and 11).

B1 - Full roost characterisation surveys will be required to determine species, population and the entry/exit points used (three surveys, a minimum of two weeks apart).

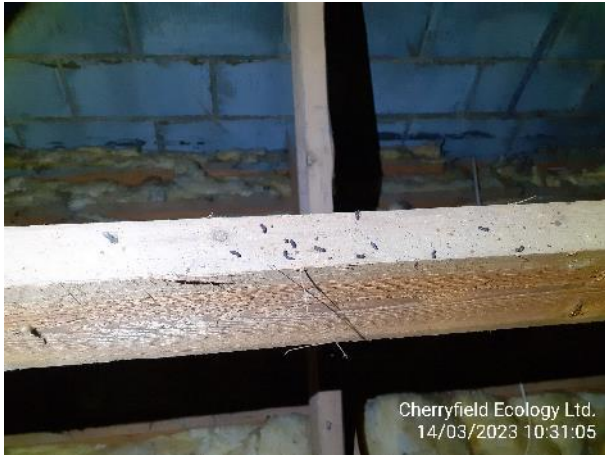
<p>Cherryfield Ecology Ltd. 14/03/2023 10:31:05</p> </div> <p>Figure 9: Example of droppings found (western end)</p>
Potential for bat use	Level of likelihood of presence - B1 - Confirmed

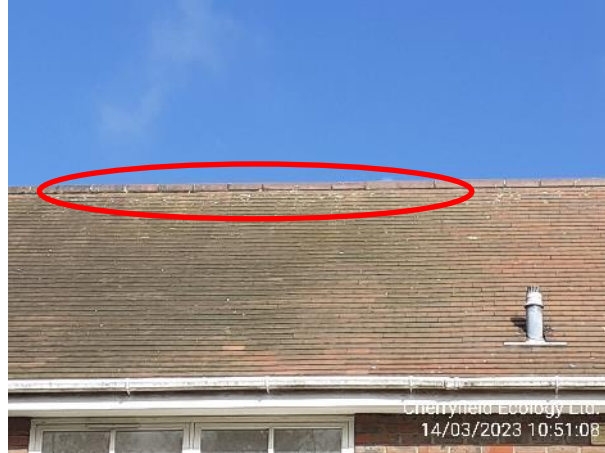
Figure 10: Example of small gaps along ridge where mortar is missing

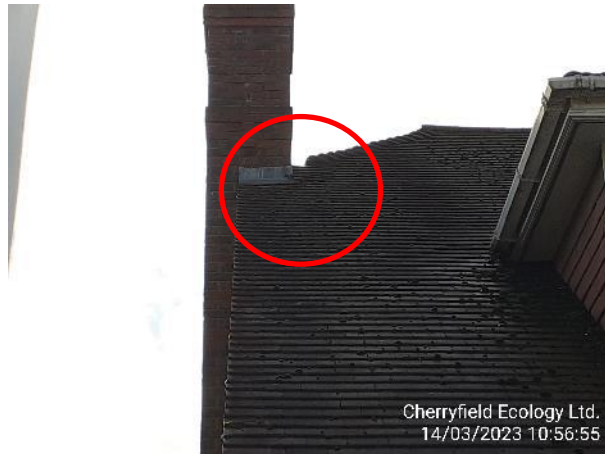
Figure 11: Example of loose tiles around chimney
