VILLAGE FARM, VILLAGE STREET, BLANKNEY, LN4 3BB

STATEMENT OF HERITAGE SIGNIFICANCE

March 2022 & February 2023

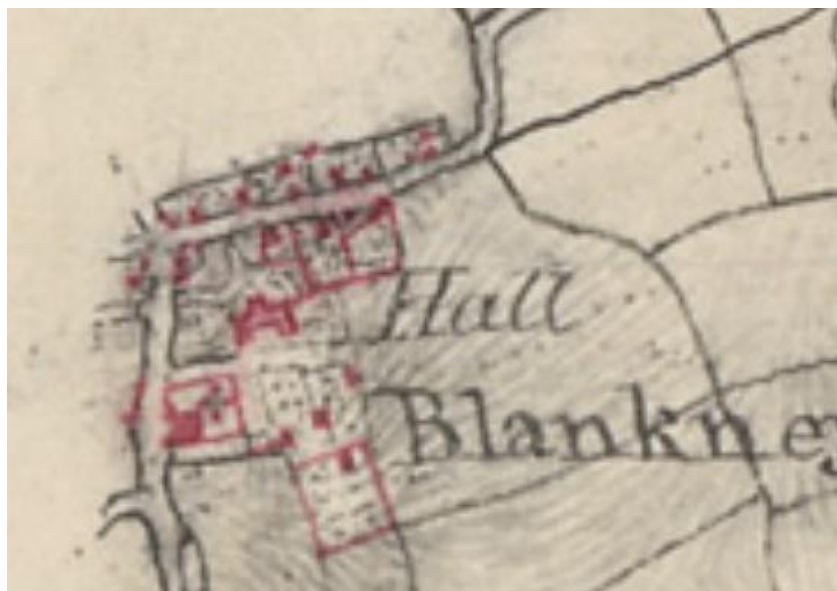
Fig 2, 1818 Ordnance Survey Drawings, the northern side of Village Lane is well developed. A Georeferenced overlay shows that some of the farm buildings may have been developed, but the map is not sufficiently detailed cartographically to provide any firm details.

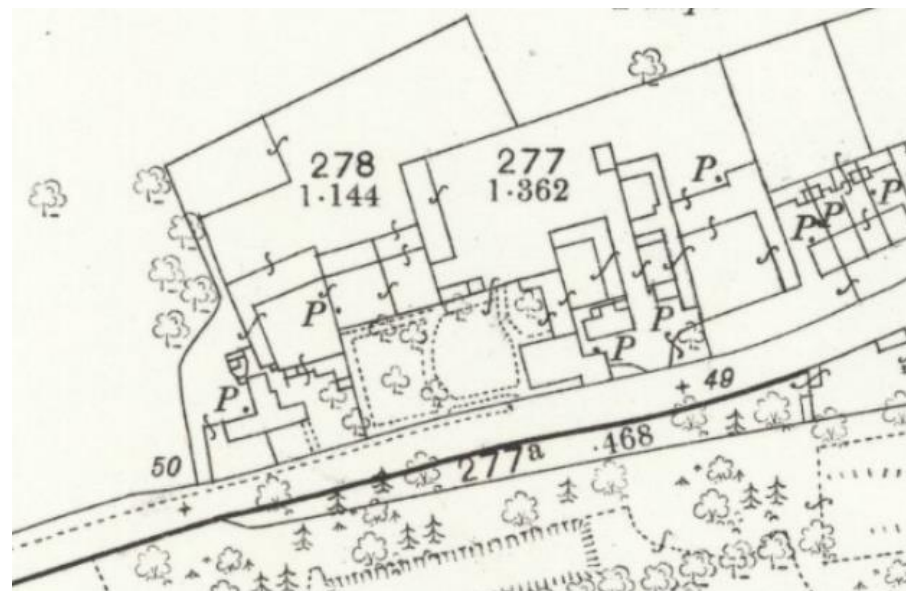
Fig 3, 1888 OS Map, surveyed in 1886, shows Village Farm with the house extended to an L plan and a range of farm buildings and structures have been added between 1818 and 1886.

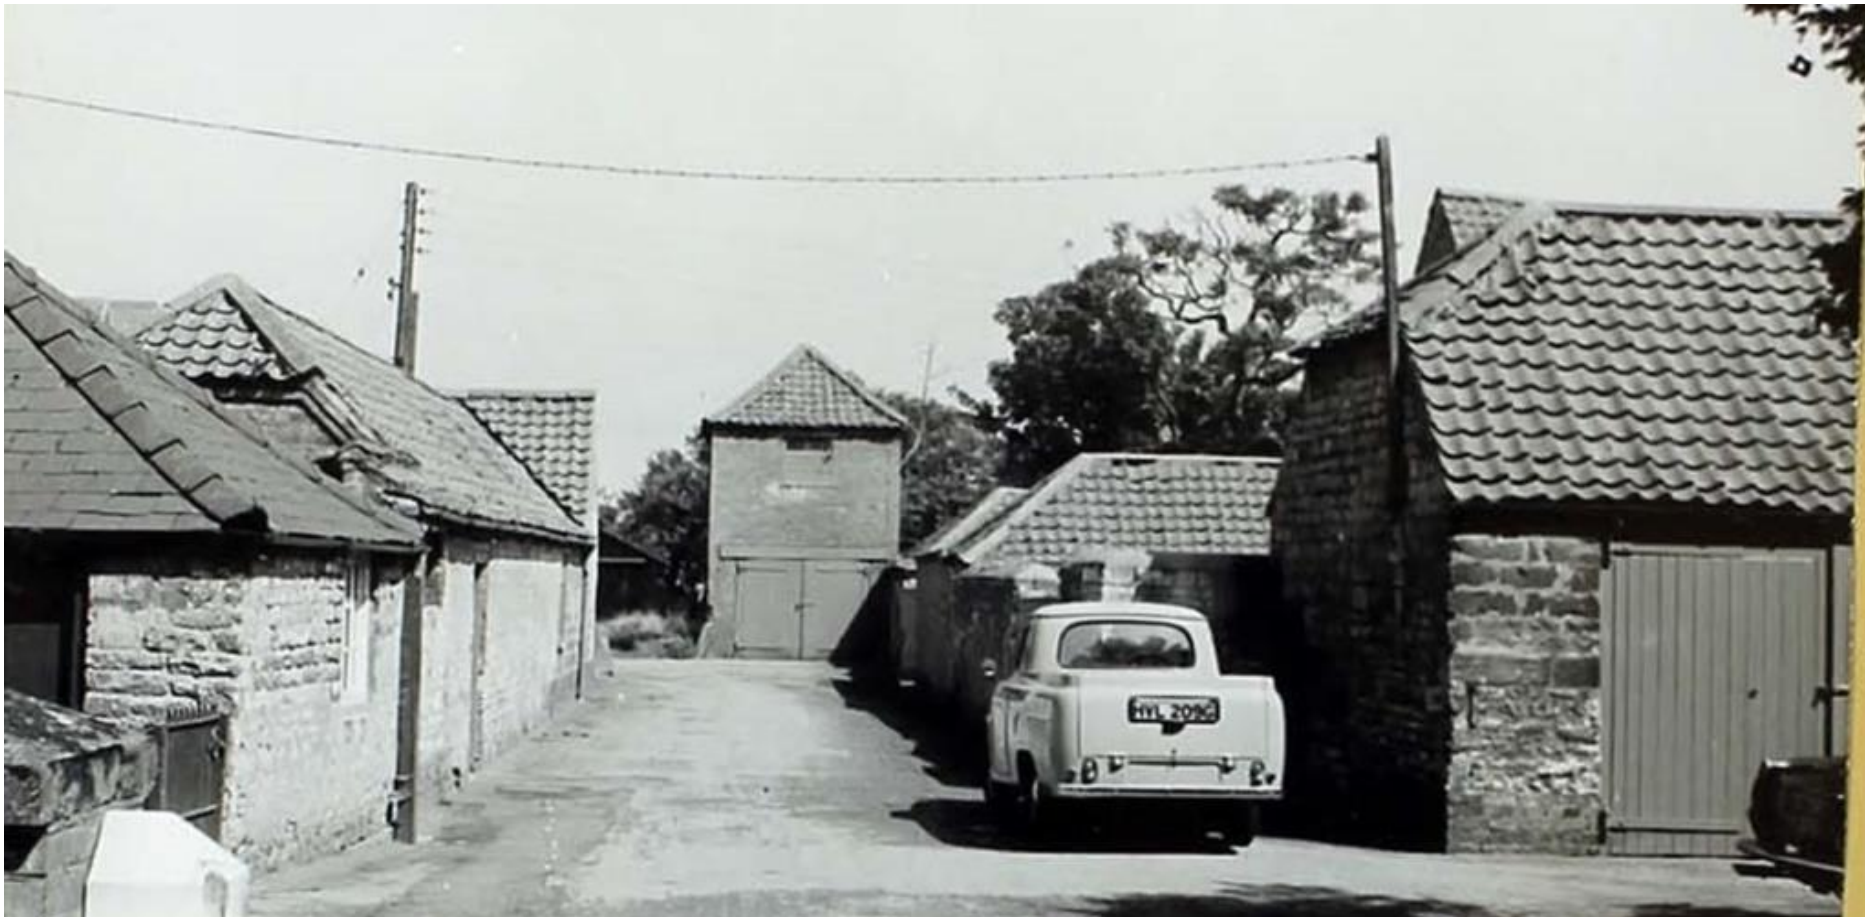
Fig 5, a photo of circa 1968 (G reg number plate on the van is 1968) of Village Farm. There is a pyramid roofed tower as a focus seen along the drive into the farm. Peeping above the half-hipped roof on the right, a two-storey linear range existed (see old maps) and this an E-W ridgeline. Two smaller single storey outbuildings also existed with hipped pantile roofs, again, their plan is seen on the old maps. The two-storey tower building is very likely to be a dovecote and forms an eye-catching building. This has since been demolished and the entrance is now wide open with views to fields beyond behind a wide automated security gate. To the side of the tower is seen a smaller black coloured building, perhaps of blackened timber cladding?

The circa 1968 photograph demonstrates that much change has occurred in the late 20th C (post 1968), which saw the expansion of Village Farm. A number of large timber frame buildings and other steel framed extensions have been installed, some of these located in place of, or directly affixed to historic buildings, some of which have been partly demolished or altered. Three free standing post 1956 agricultural buildings have a named manufacturer, English Brothers Limited, of Wisbech.³ Two of the three are timber framed structures

View 7, entrance to Village Farm, now open, but compare this with the circa 1968 photograph (Fig 5) showing a tower formed a view stop.

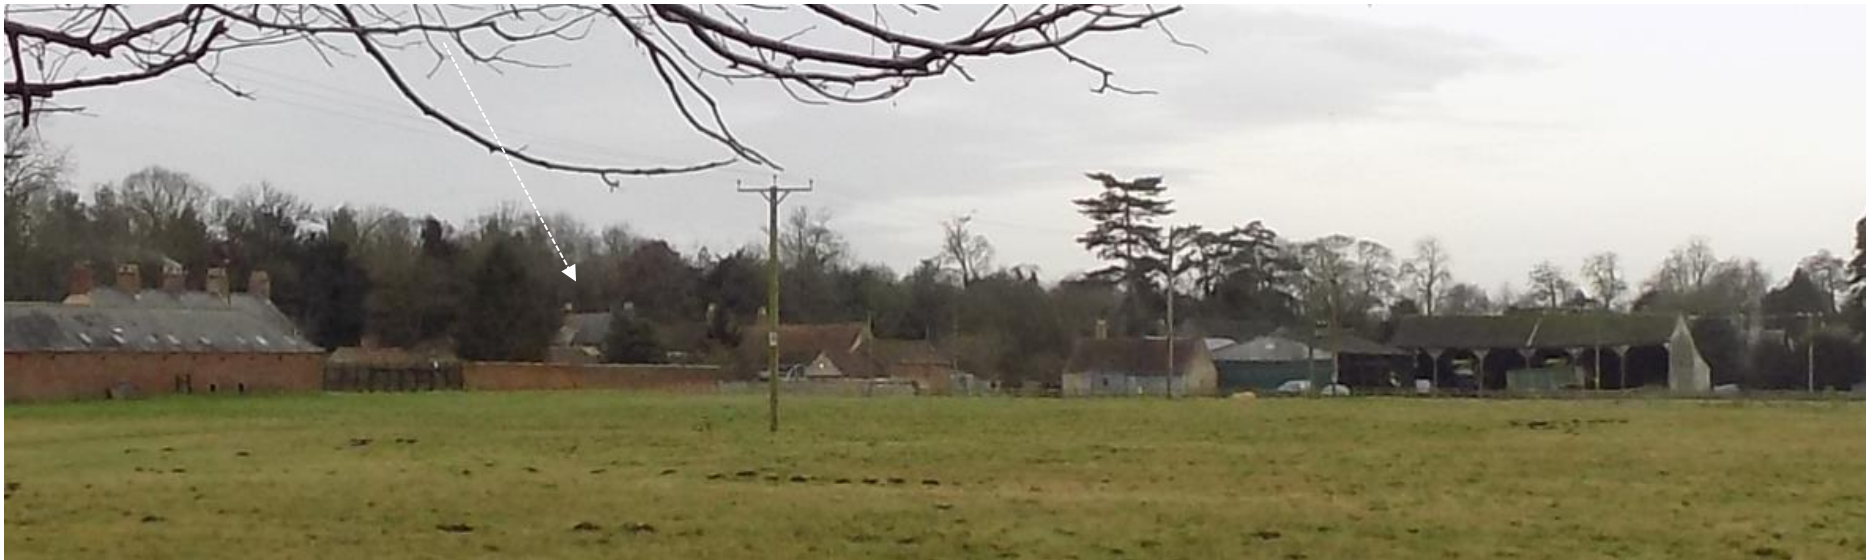
Long View 1 – looking towards Village Farm from the easterly end of Village Lane (where the road forks) and the northern boundary of Blankney Conservation Area. This is a predominantly agricultural setting with few domestic buildings in view. White arrow indicates Village Farmhouse.

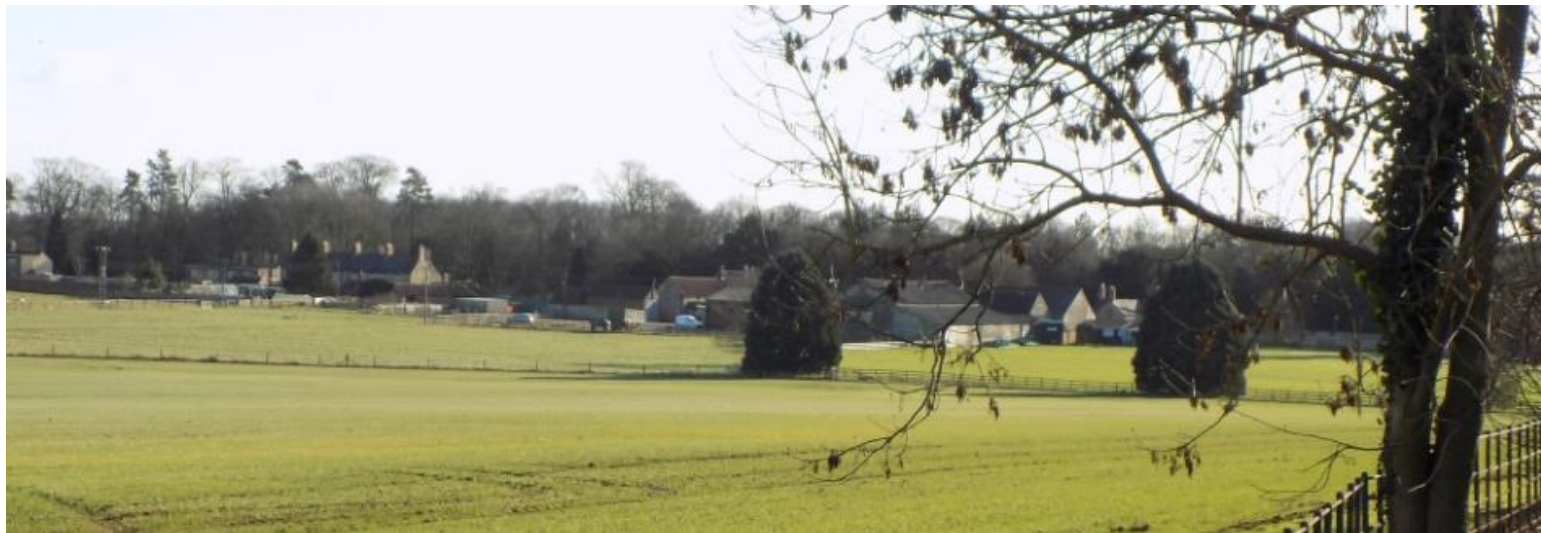
Long View 2, from the B1188, looking towards Village Farm and the northern boundary of Blankney Conservation Area, again agricultural in character. Village Farm is seen as a close-knit complex of large buildings from the B1188 with no clear view of Village Farmhouse at all.

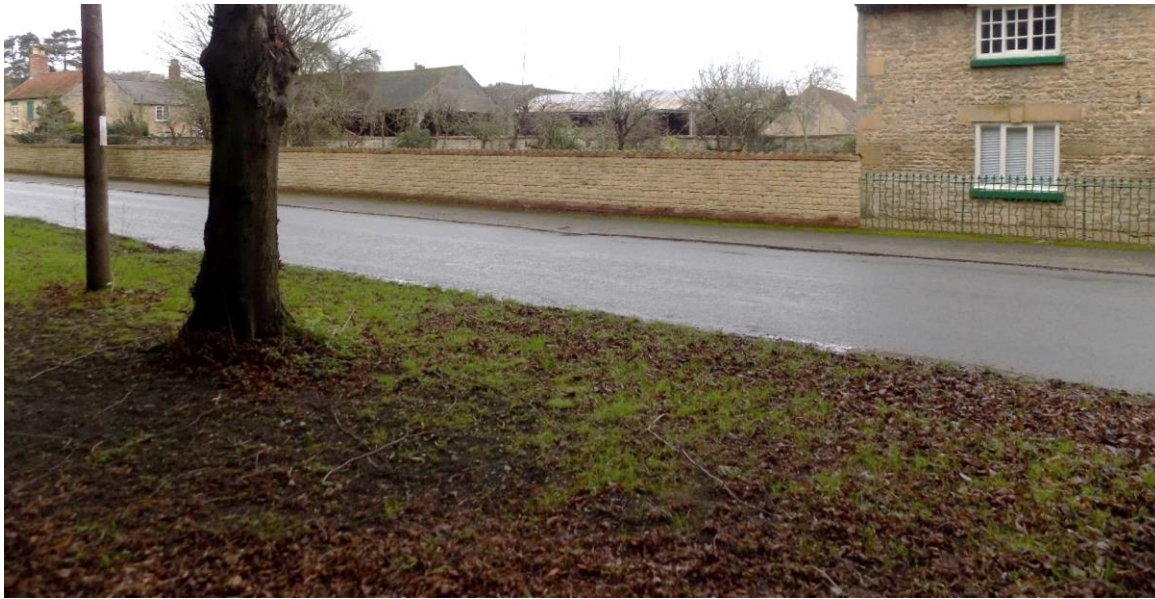
View 3, looking towards the farmstead, over the garden of Village Farmhouse, the gable end of the early 19th C farm building of Barn 6 can readily be seen.

The early 19th C threshing barn is obscured totally by the timber framed modern structure. The scene is generally one of large modern industrial buildings.

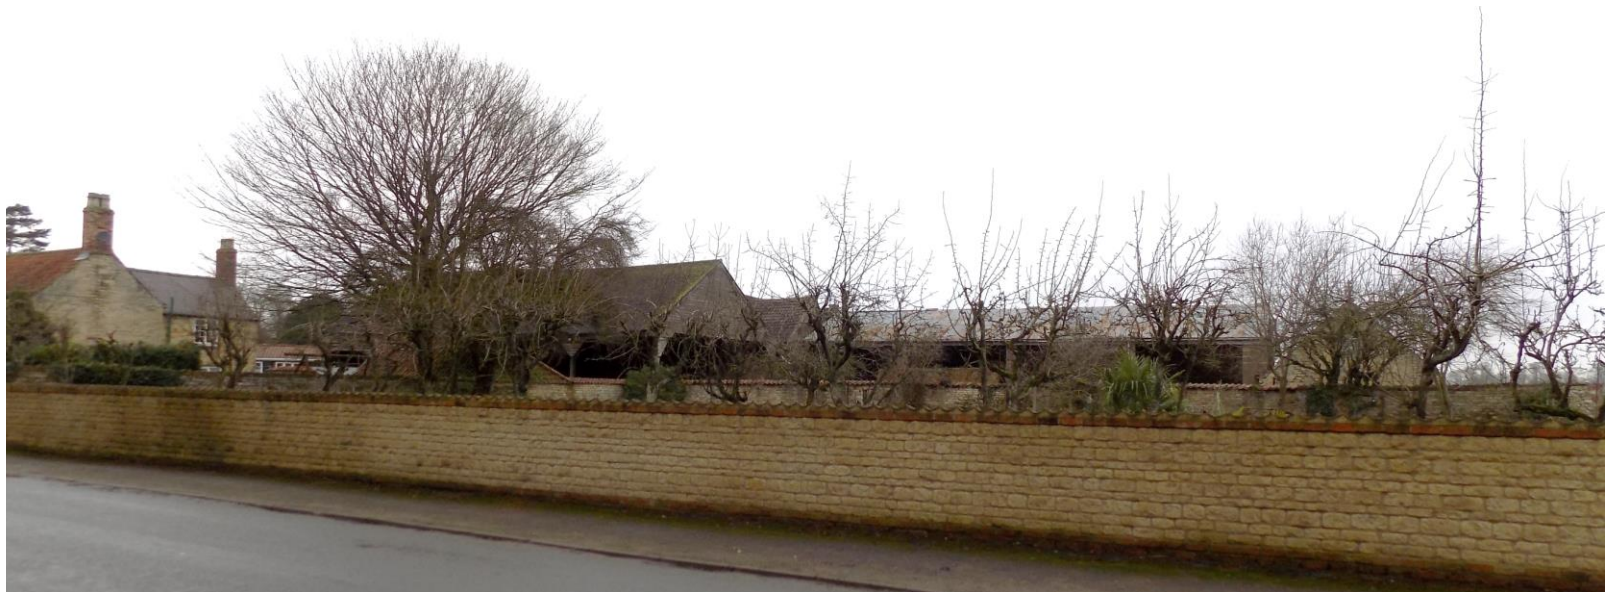
Fig 5, view towards modern farm buildings over the enclosed walled garden of Village Farmhouse.

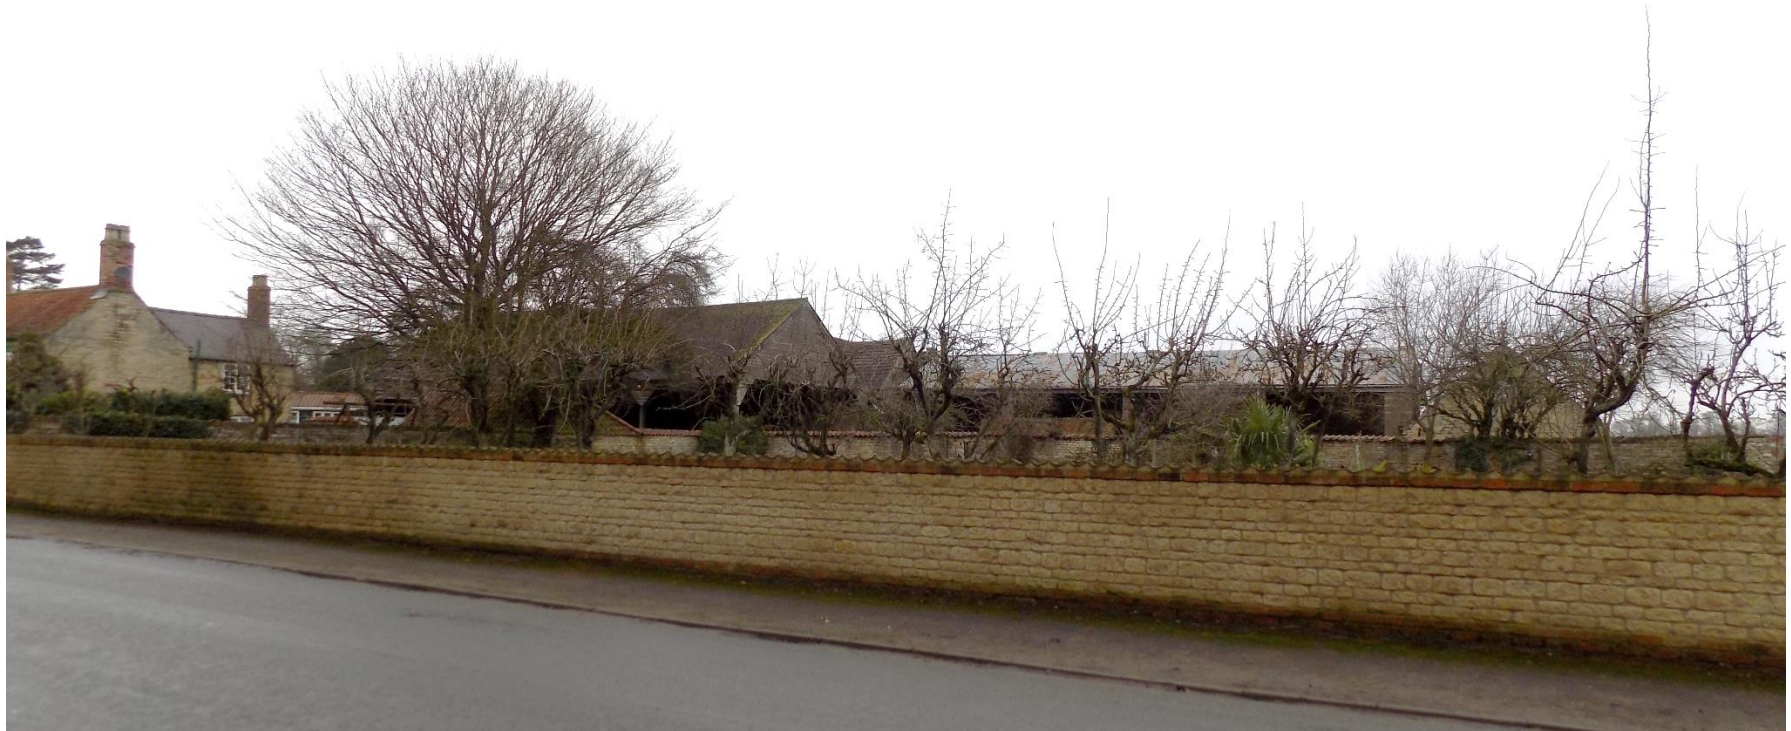
View 6, view from Drury Street, looking towards the historic farmstead, modern roof coverings dominate the site.

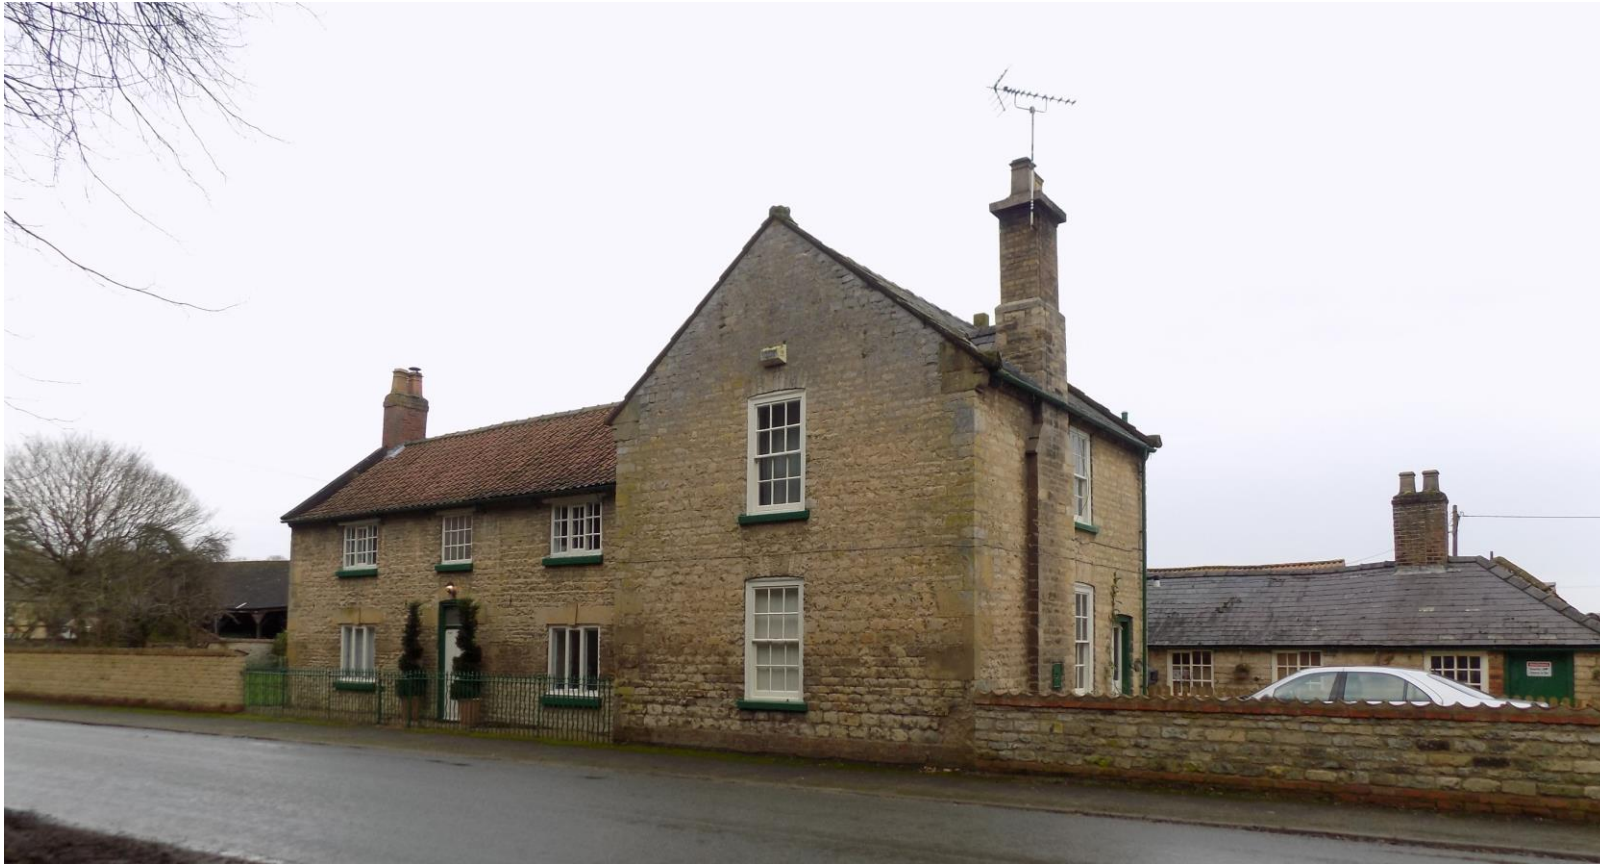
P1 – South (principal) elevation of Village Farmhouse, gates and railings, grade II listed building.

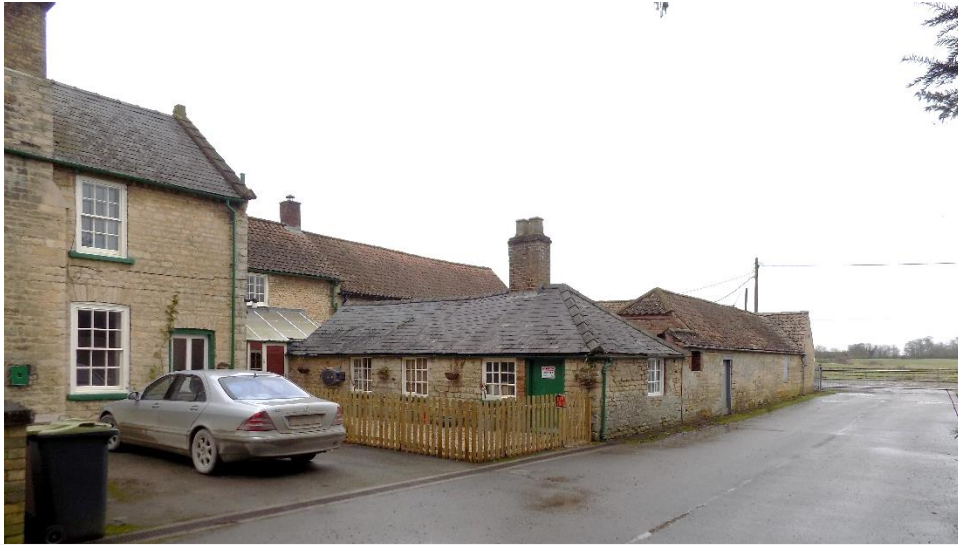
P2 – east elevation of Village Farmhouse with attached stable of 1799 (Barn 8) and courtyard outbuildings.

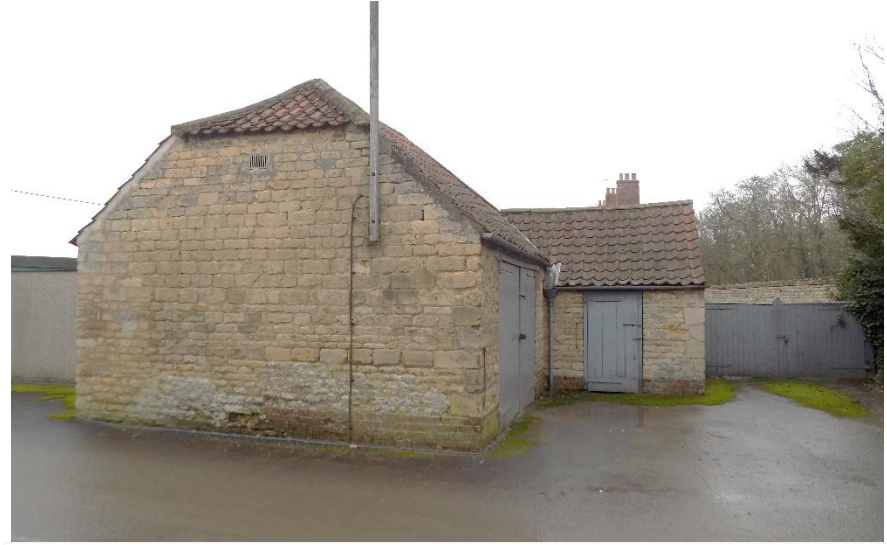
P3 – west elevation of Barn 3 with gates to enclosed courtyard beyond.

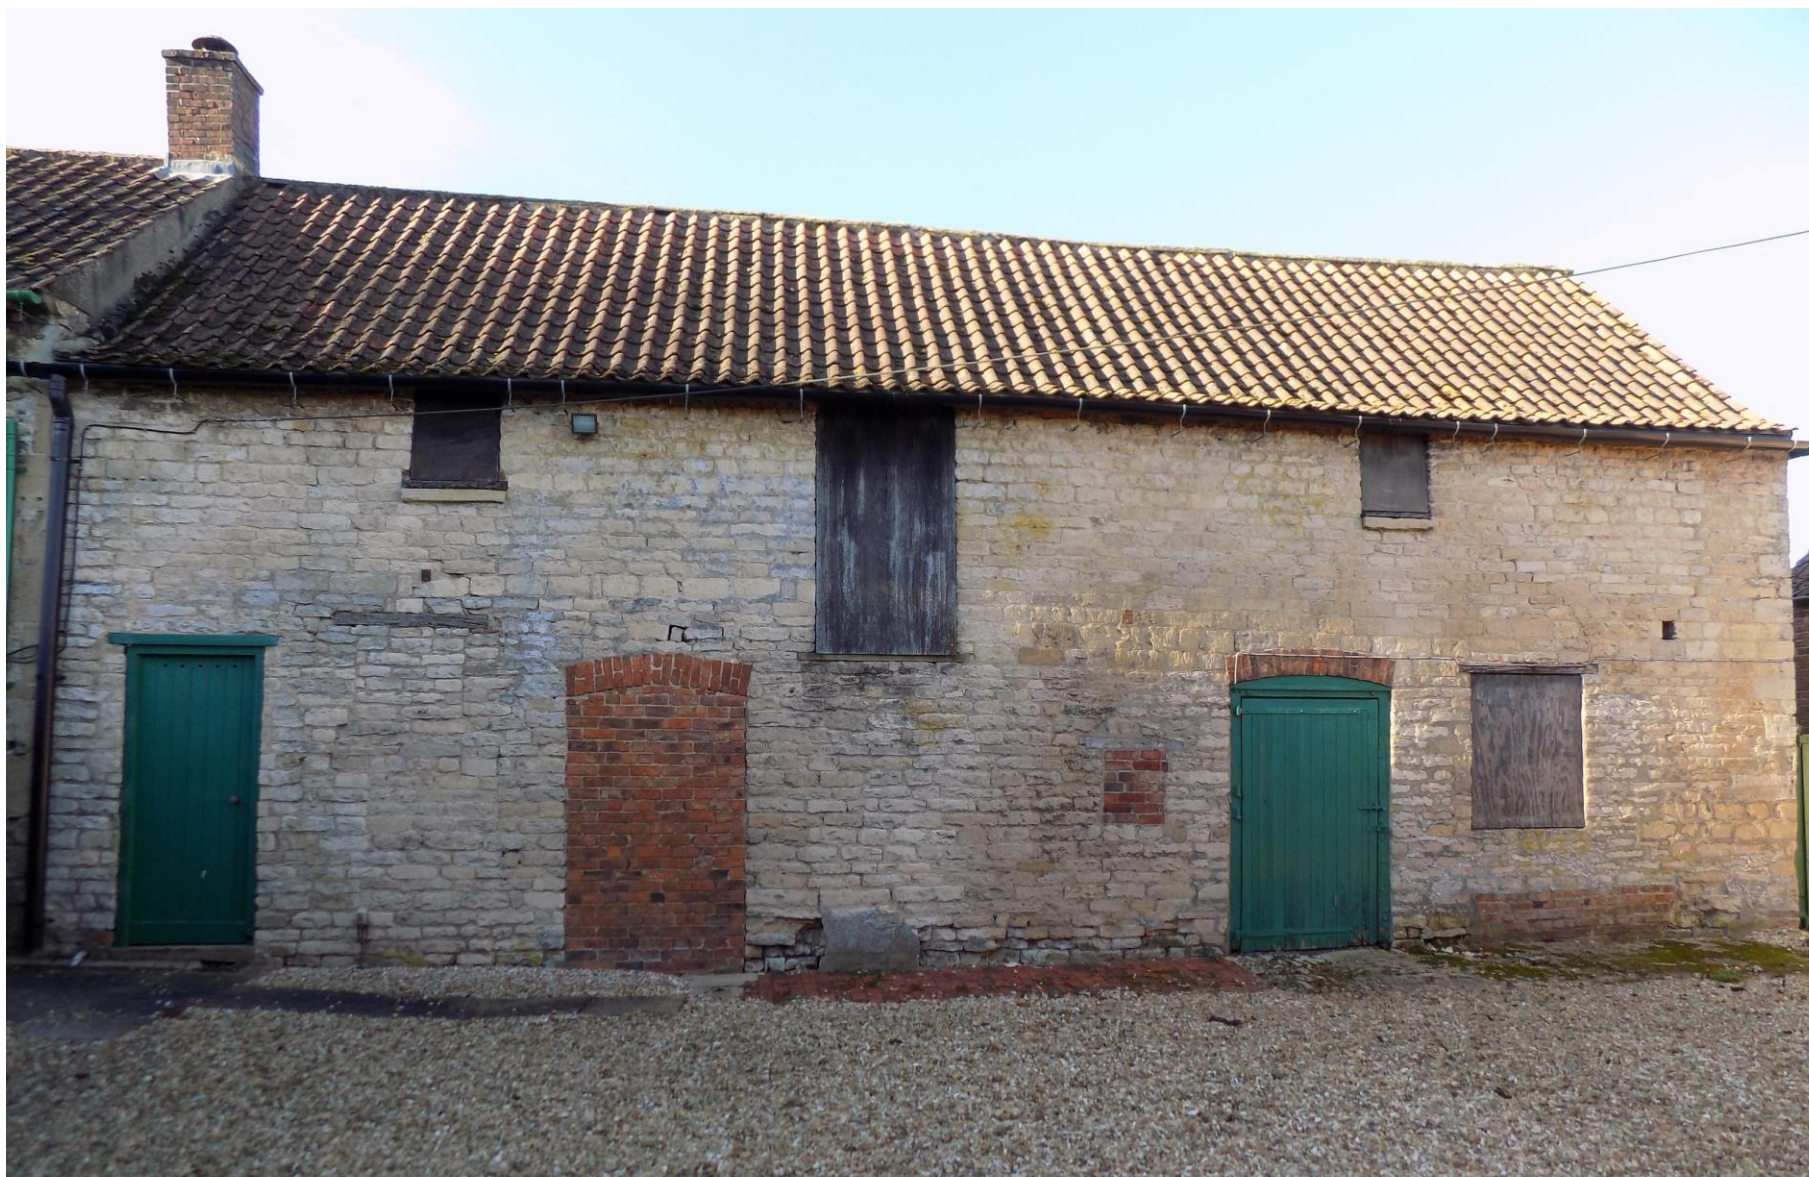
P4 – east elevation of stable attached to Village Farmhouse.

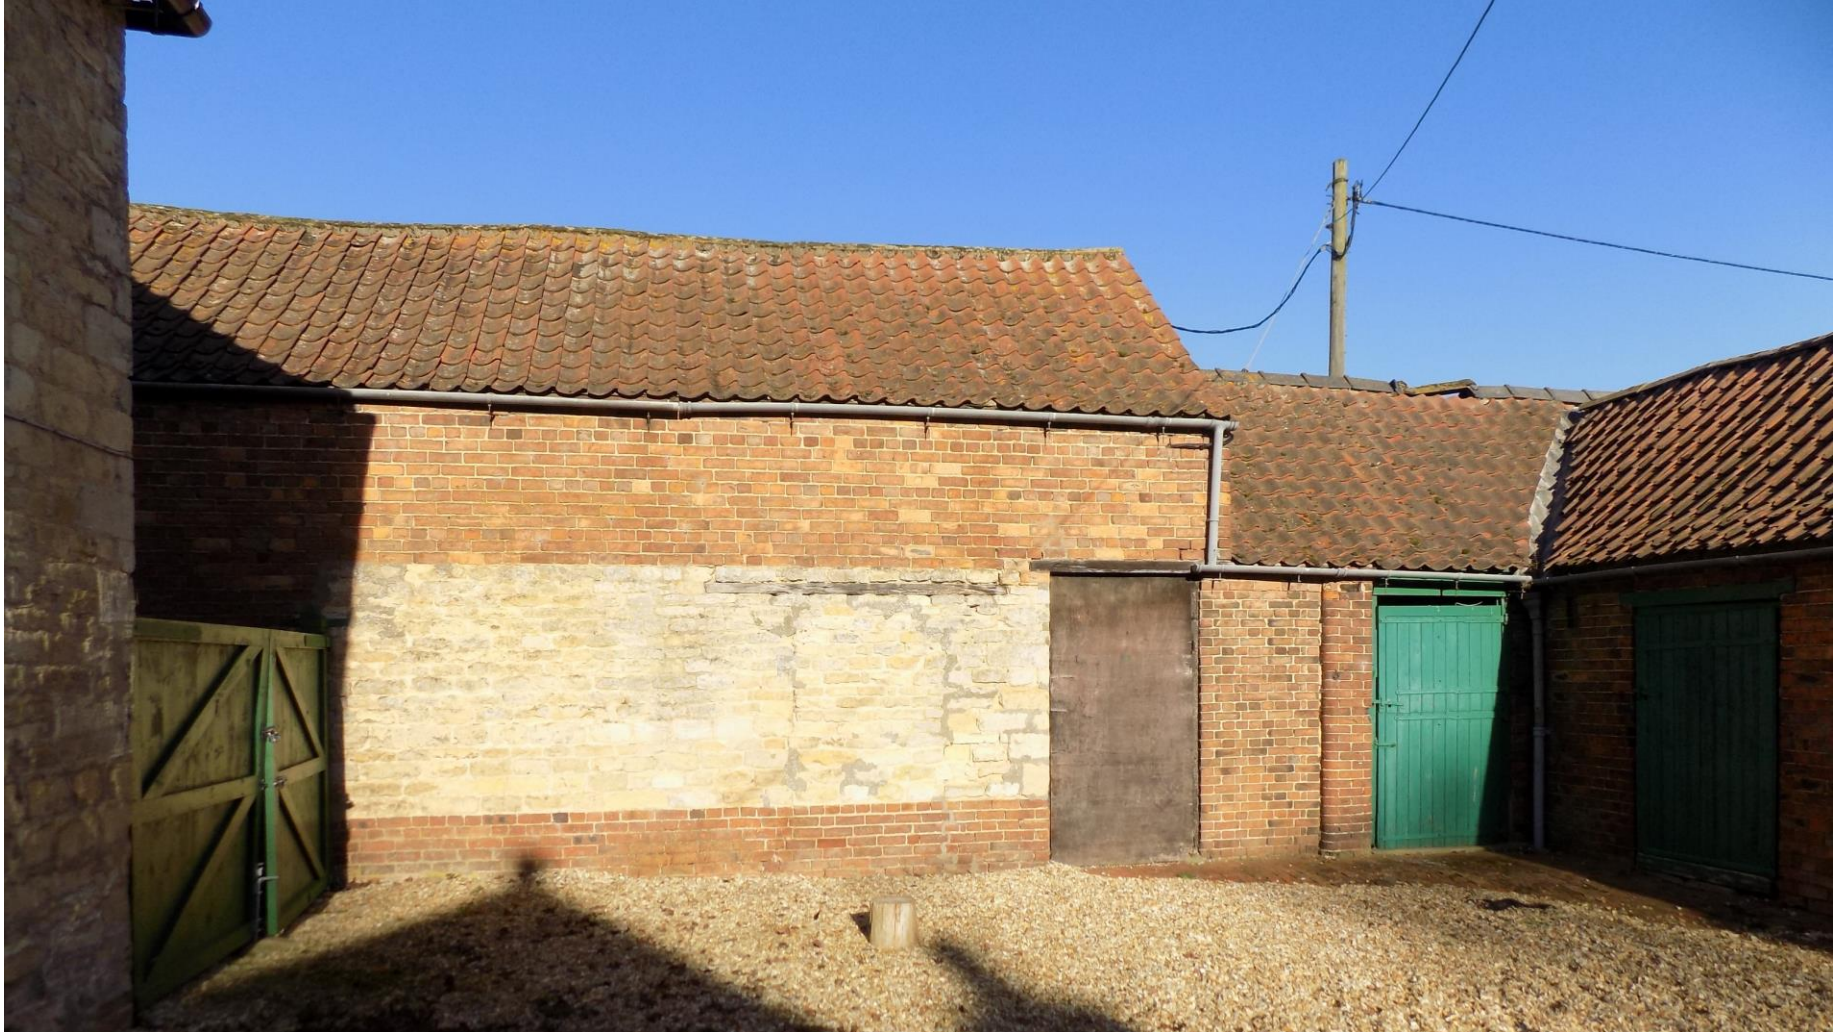
P5 – south elevation of Barn 7, facing courtyard to Village Farmhouse. Note the stone and brick construction.

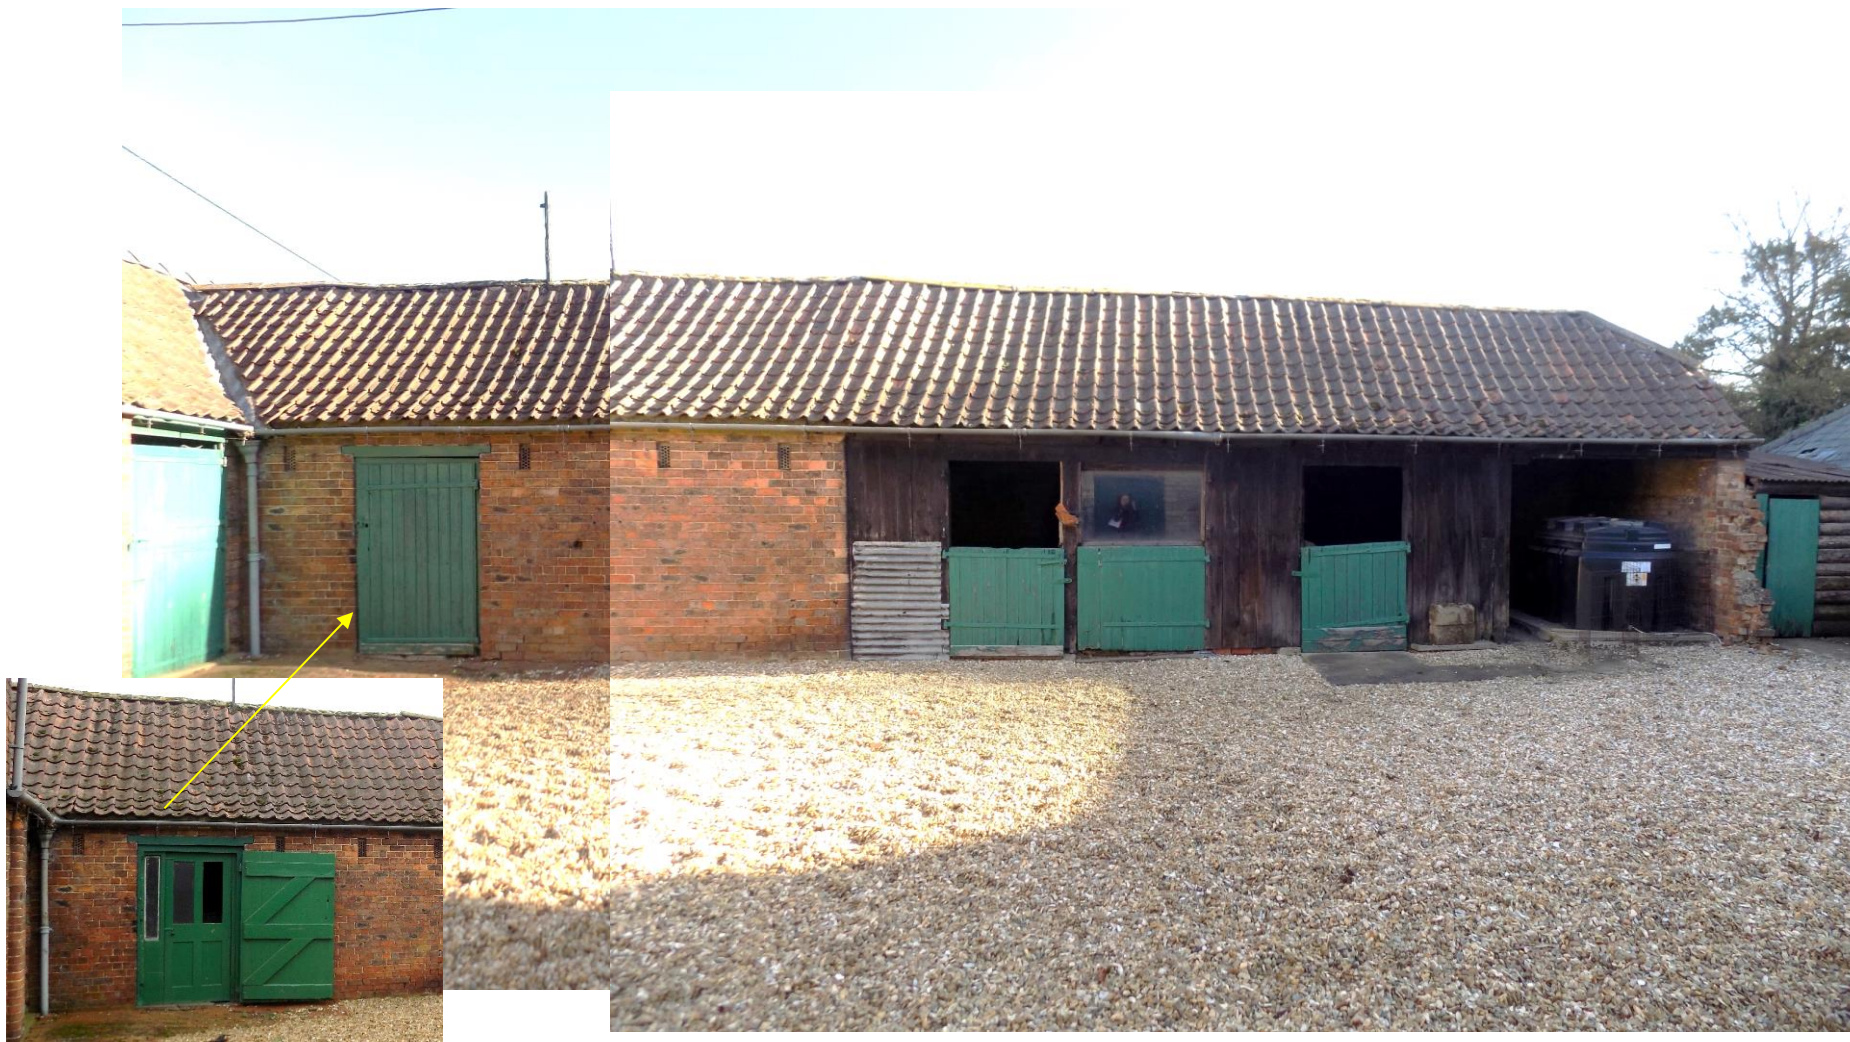
P6 and P7, composite photo showing west elevation of Barn 7 facing courtyard of Village Farmhouse. The right-hand side was four open bays. Behind the replacement plank door on the left is a 19th century four panel door and inset.

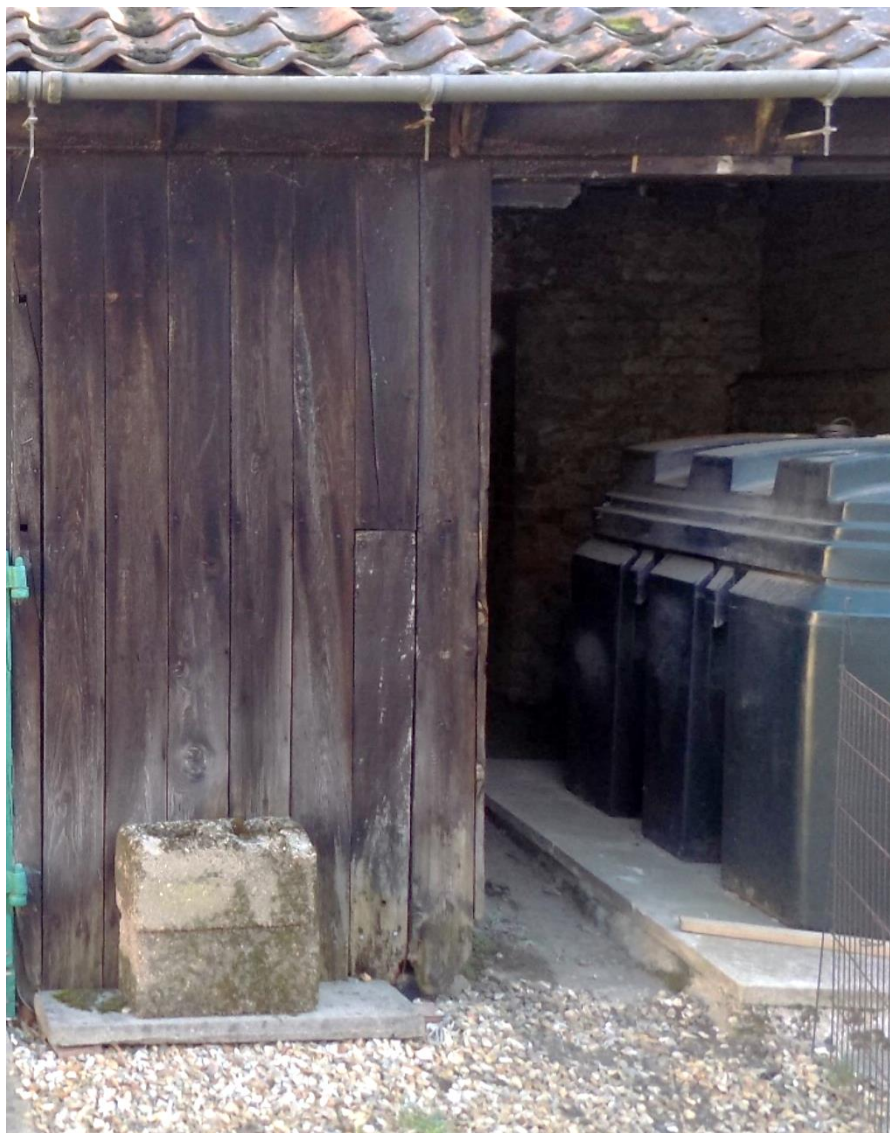
P8, left, timber stanchion of Barn 7 open cart shed with later timber infill.

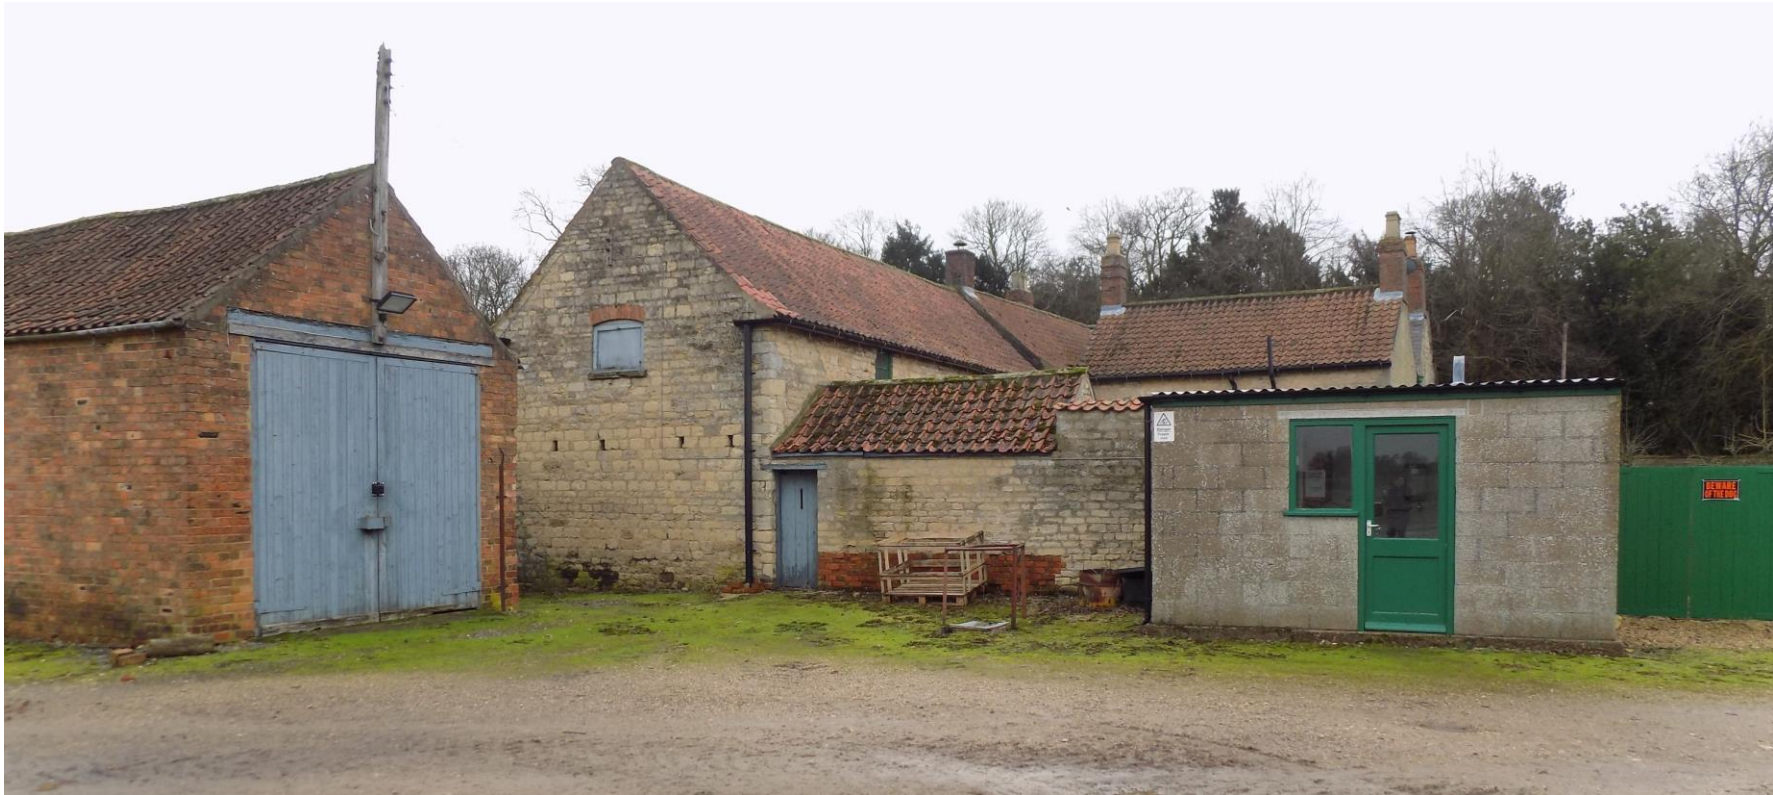
P11 – looking south towards Village Farmhouse and attached stable (Barn 8) from the farmyard. Note the breezeblock structure (Barn 2) detracts from the setting of Village Farmhouse.

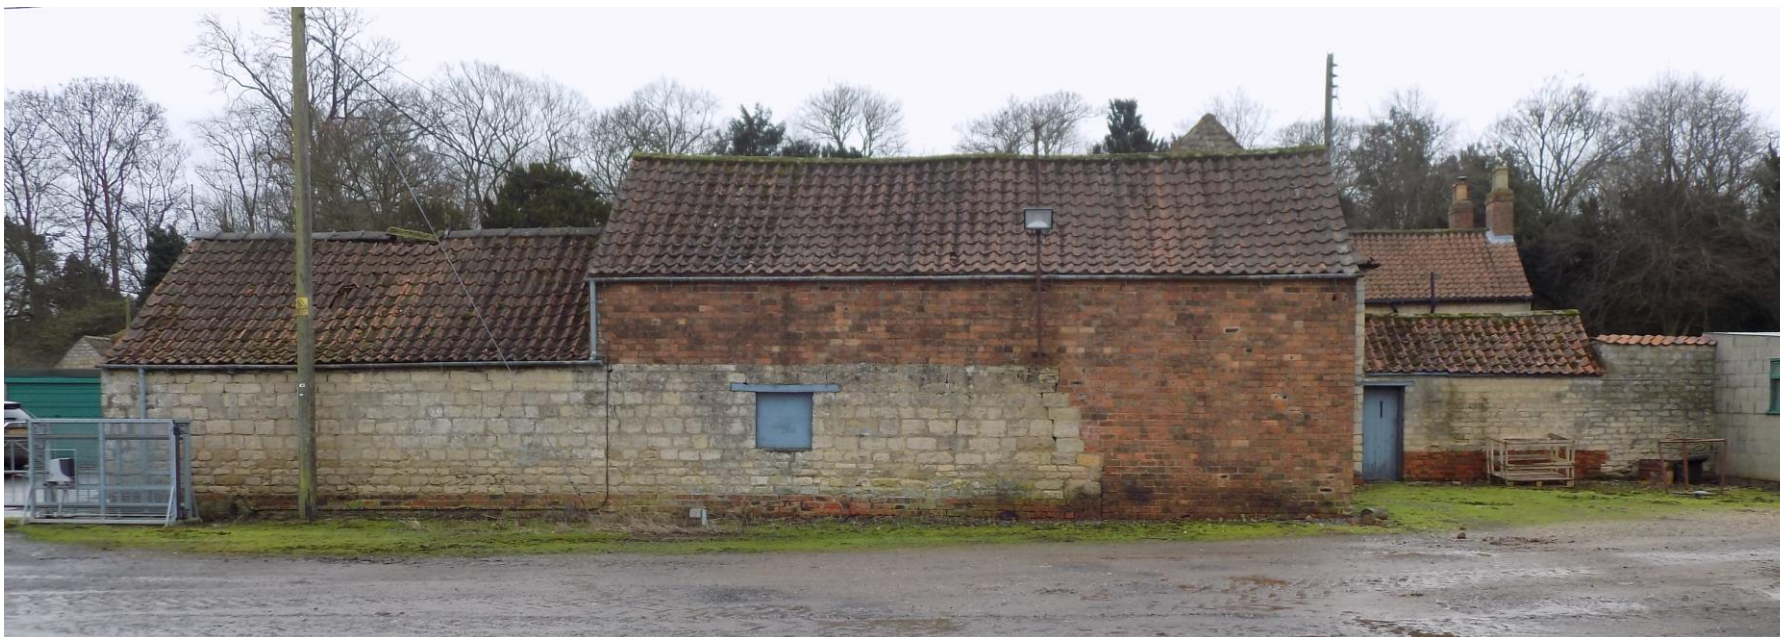
P12 – looking south from the farmyard towards the north elevation of Barn 7, which although shown on the 1799 Enclosure Award Plan has been substantially overbuilt with brick.

Barn 7	<p>Barn 7 consists of the remnants of a building from 1799, now much reconstructed in the mid-19th century by overbuilding with red brick. Stone additions of the mid-19th century also, form an L plan, forming an enclosure with Barn 8. Constructed of stone (exterior walls) and a mixture of brick and stone (courtyard elevations), the single storey easterly range has open cart shed with timber stanchions and later timber infill. The interior contains historic hay racks.</p>	<p>Barns 7 and 8 to become <u>Plot 5</u>, converted for residential use, a new linking structure is proposed to the internal courtyard between barn 7 and 8. Barn 8 retains its external appearance without any further new openings (all elevations), and an existing door opening is covered with the new link. However, this is fully glazed and the original door opening will still be visible (and should allow for some retention of spatial quality inside Barn 8 by linking Barn 7 for bedroom space). New hardwood joinery is proposed for windows (elements of one ground floor window is still extant behind boarding and should be used to inform any replacement joinery). The north elevation contains a small chunky</p>

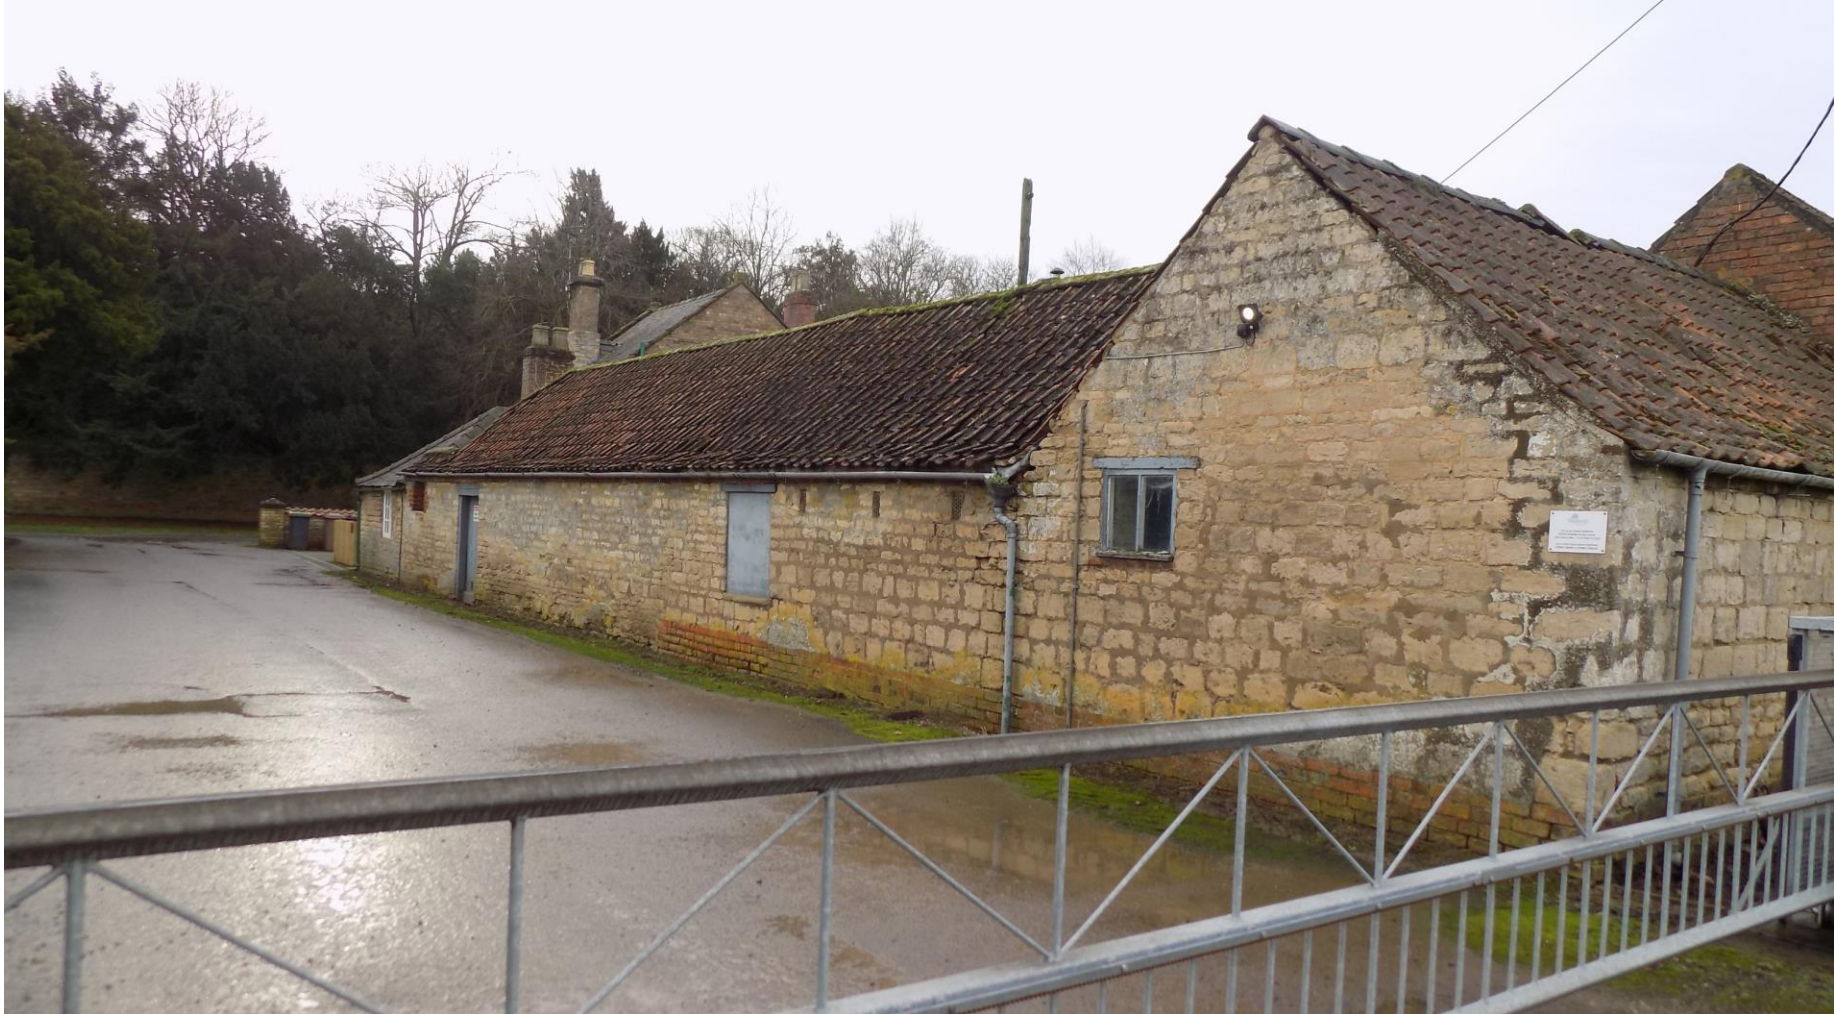
P13 – East elevation of Barn 7, Village Farm.
