VILLAGE FARM, VILLAGE STREET, BLANKNEY, LN4 3BB

STATEMENT OF HERITAGE SIGNIFICANCE

March 2022 & February 2023

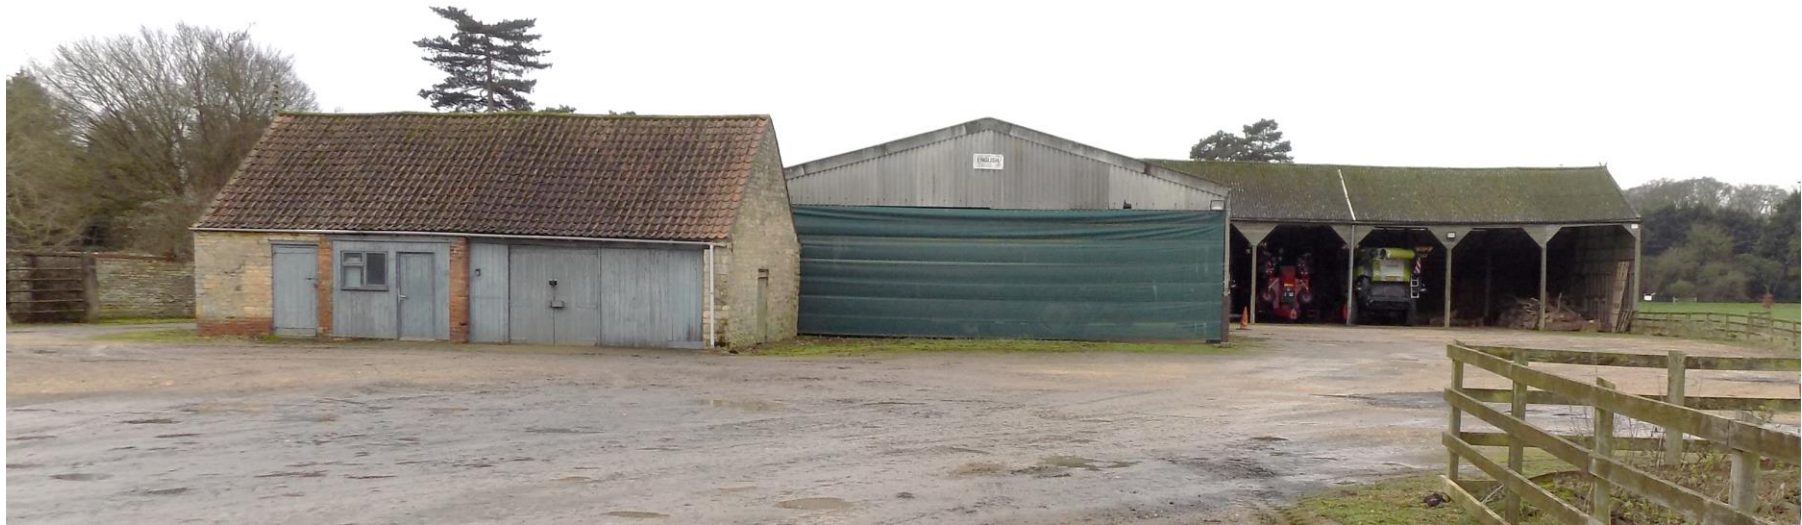
P14 – east elevation of Barn 6 (section 1, early 19th C), to its right, section 3 of Barn 6, a modern portal frame building of post 1956, and far right, a timber framed agricultural building of post 1956, both the latter by English Brothers, Wisbech.

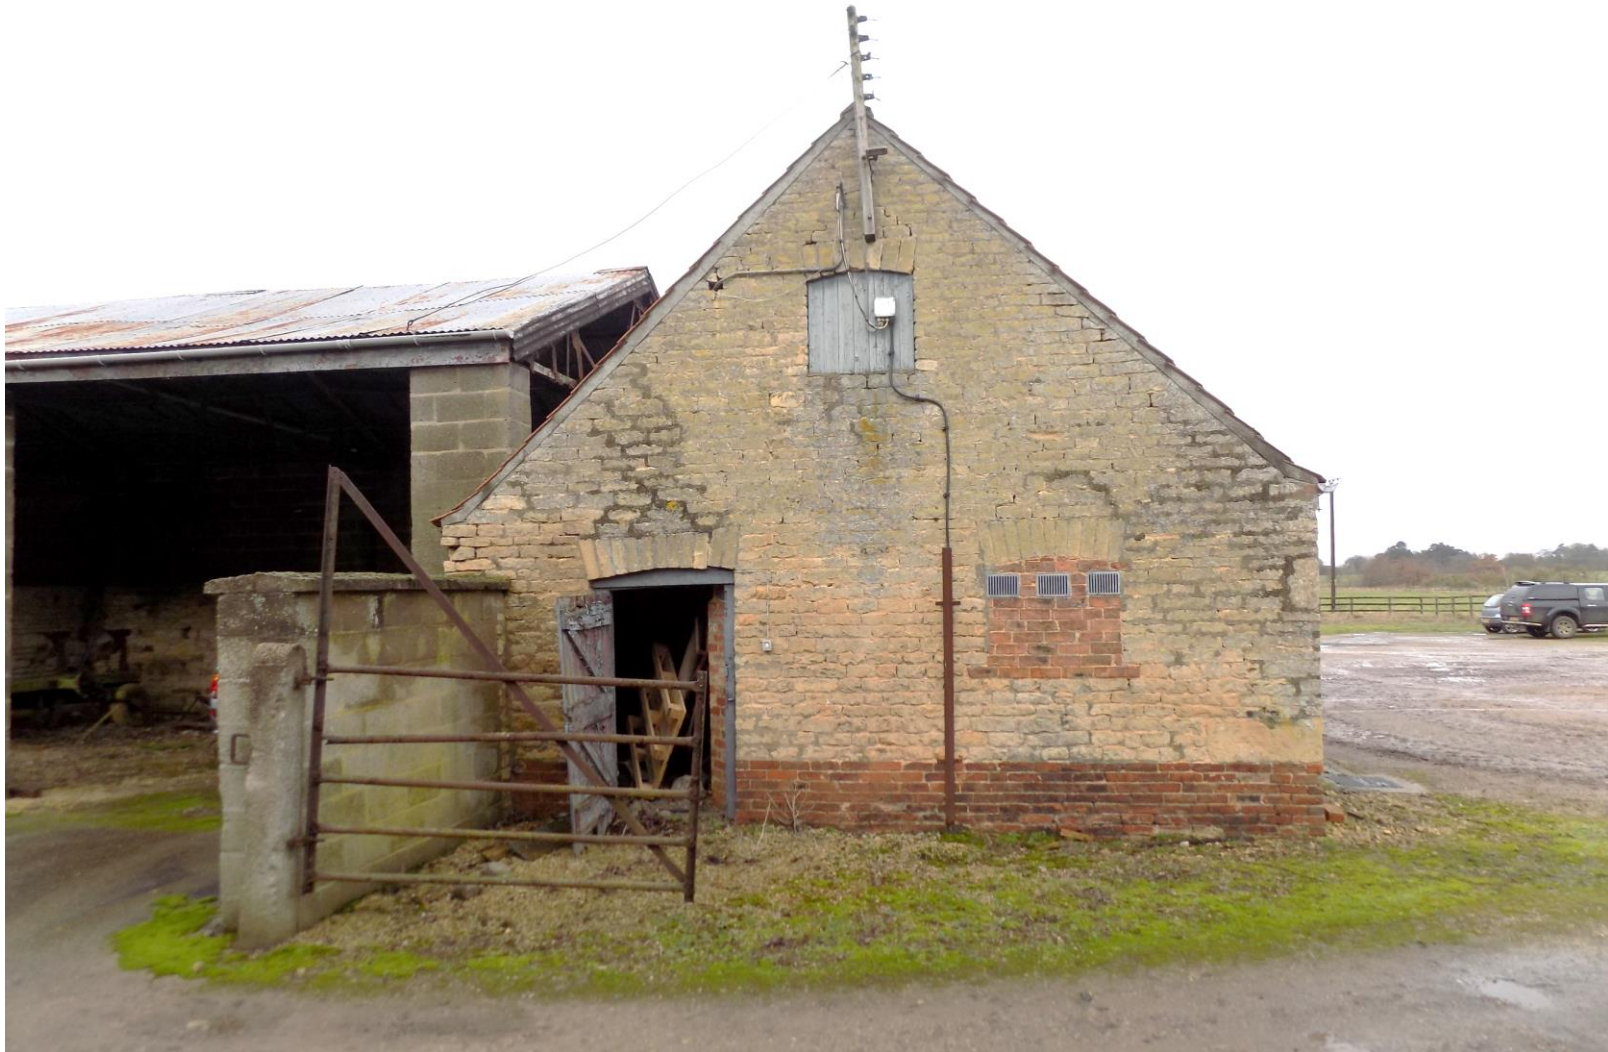
P15 – south gable of Barn 6 (section 1 early 19th C), brick base, and roughly course limestone above. A modern open fronted shed sits in close proximity.

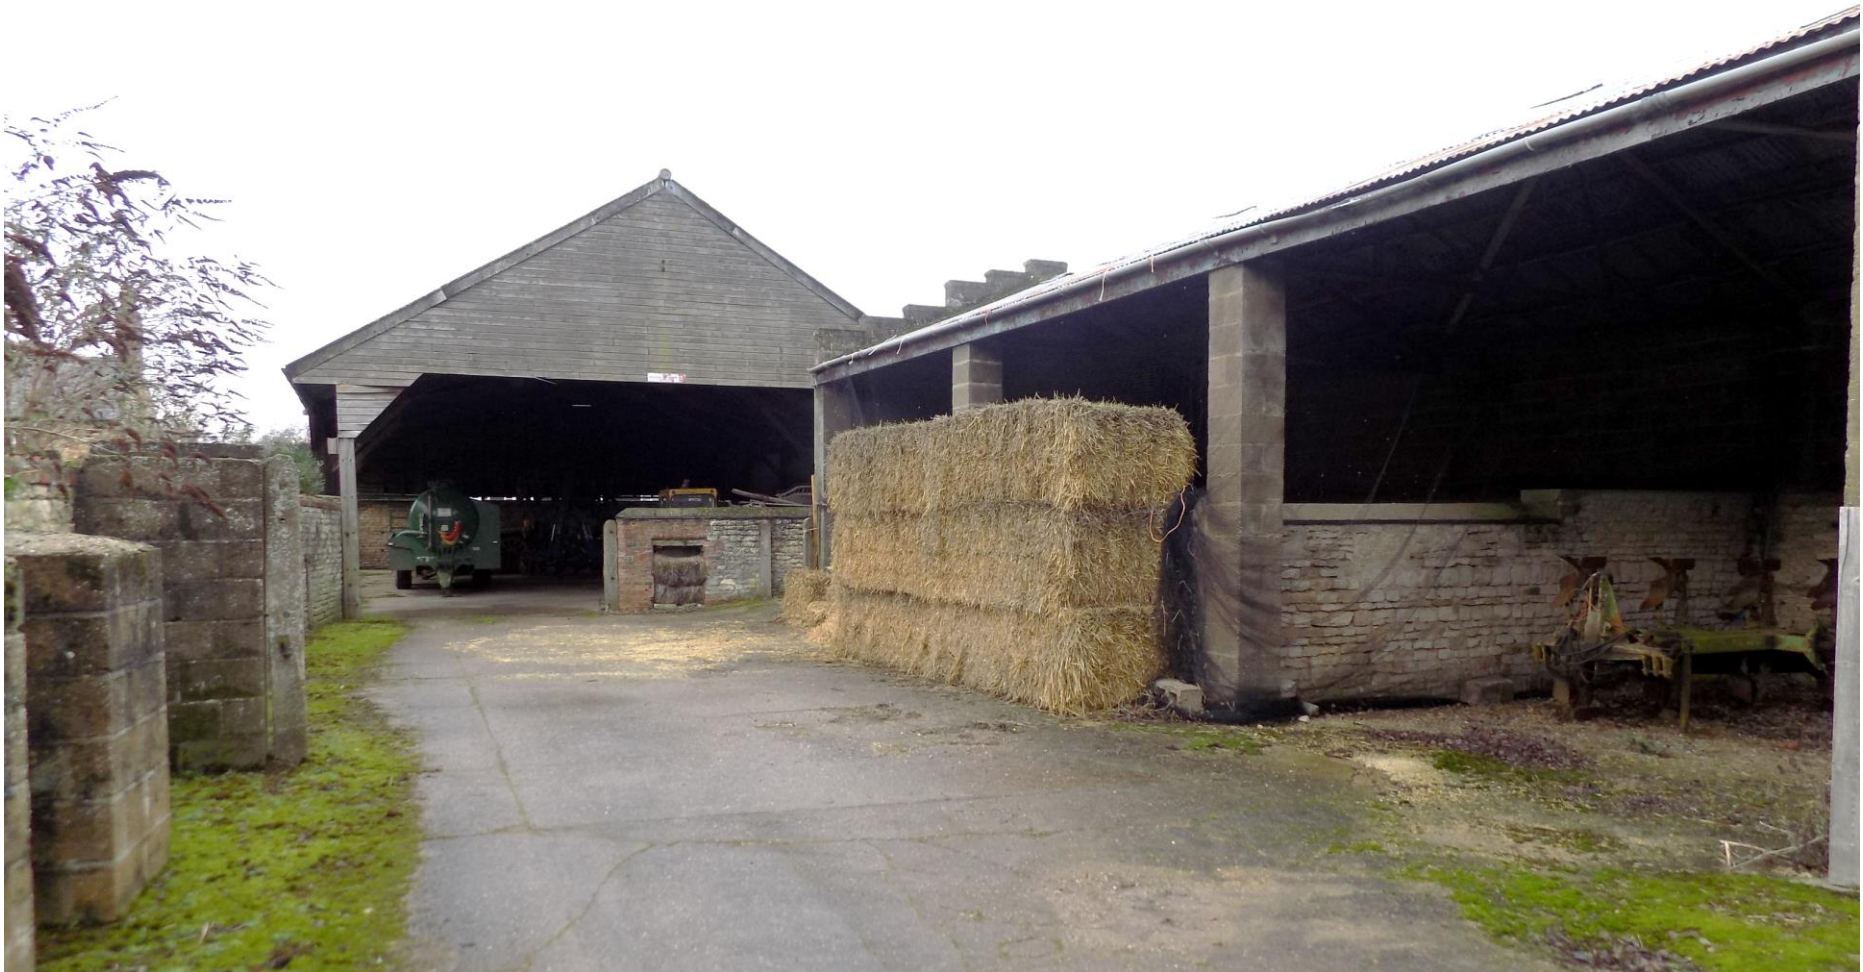
P16 – right of photo, open fronted modern shed forming part of Barn 6, possible re-used local stone walls internally. Left, English Brothers of Wisbech open sides timber shed, post 1956.

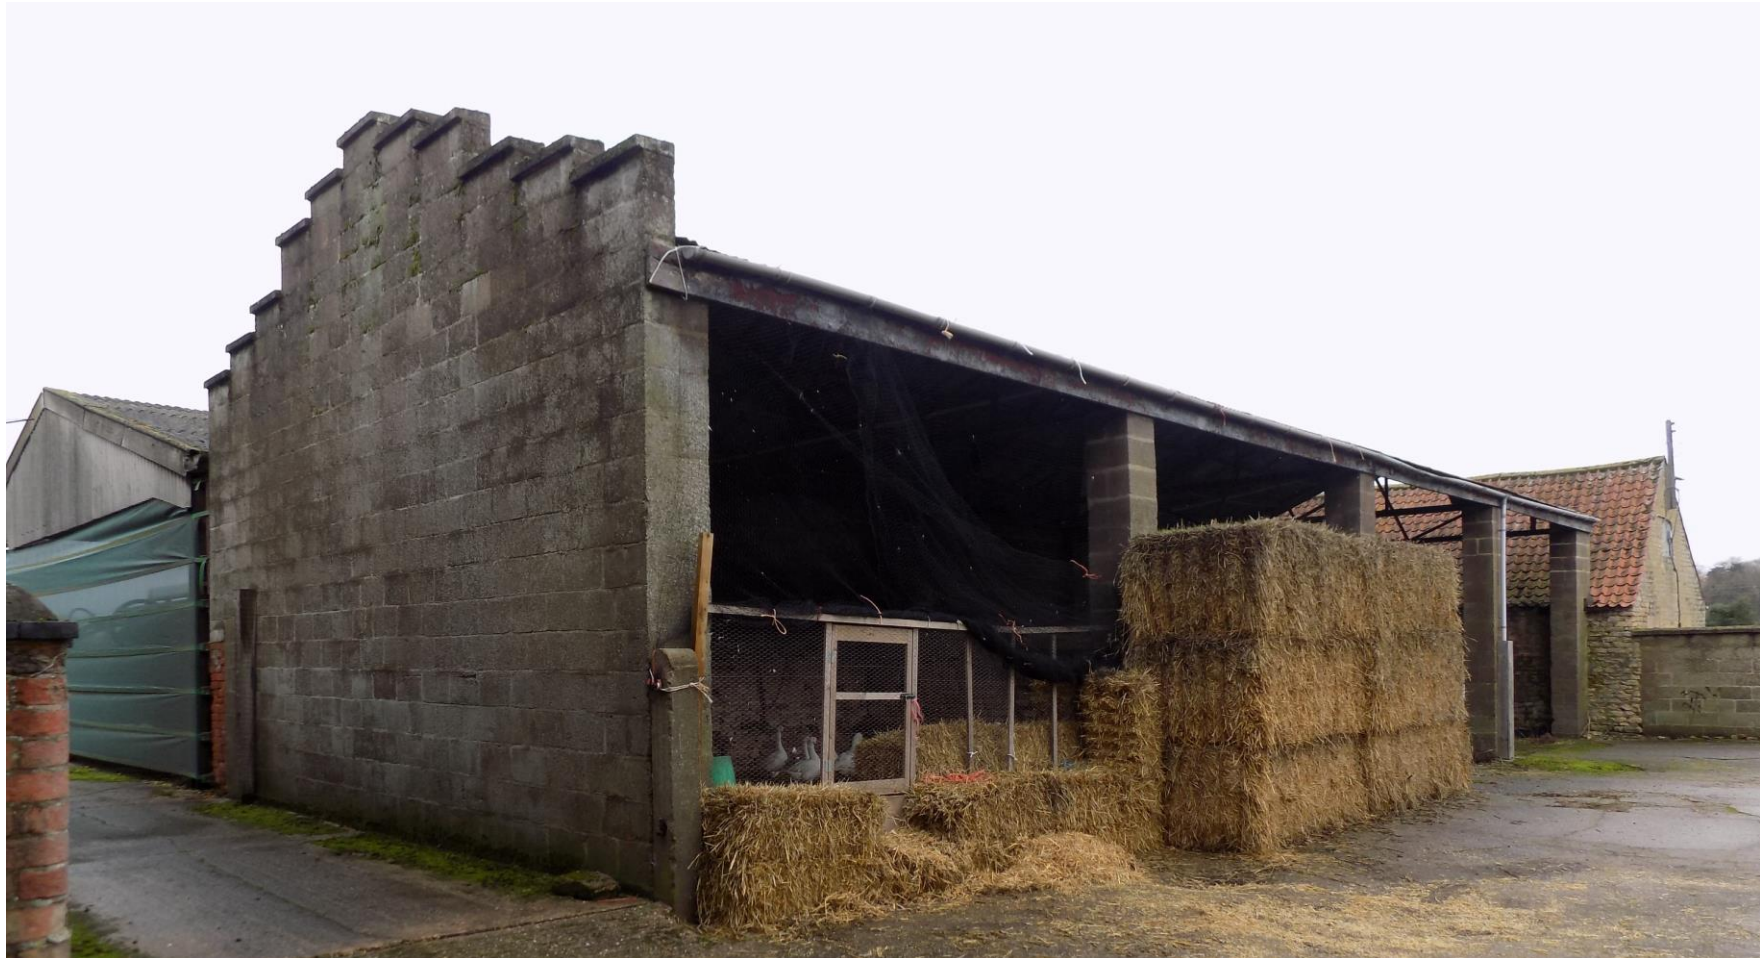
P17 – west gable of Barn 6, post 1956 section, with coped, stepped and raised gable.

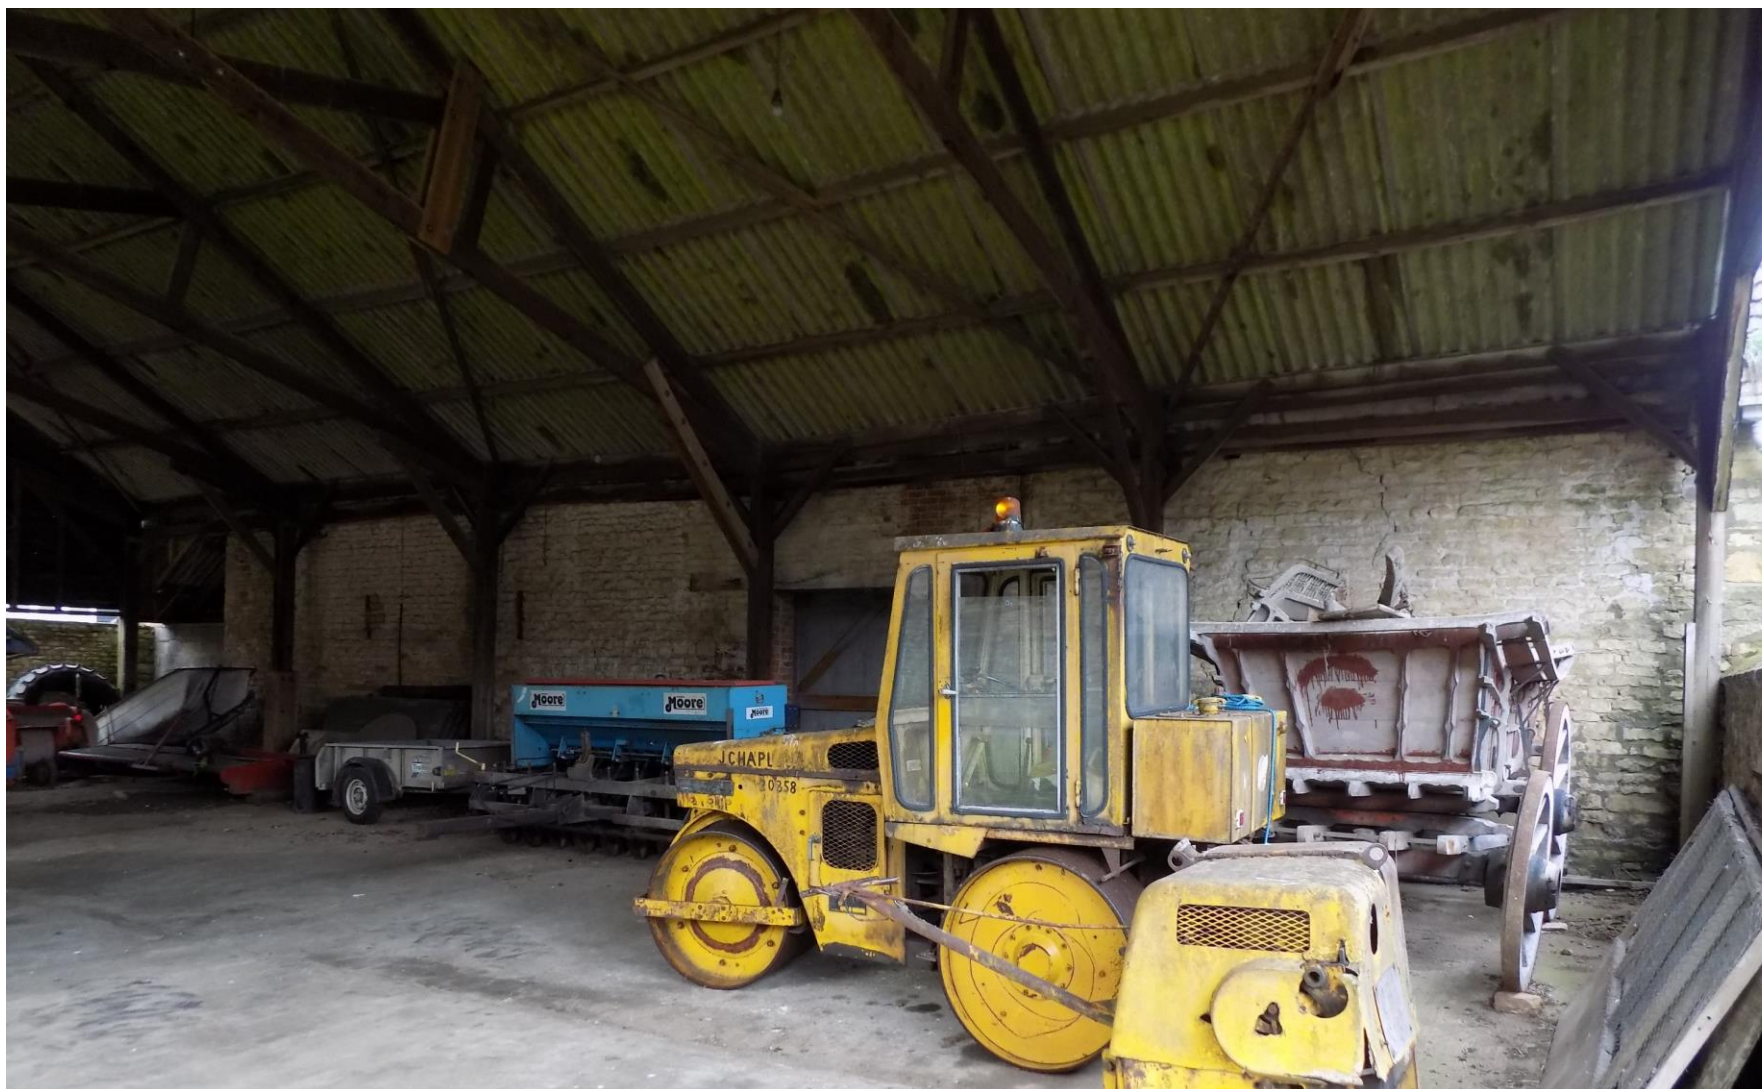
P18 – post 1956 English Brothers timbe frame roof, unusual construction, set directly beside the south elevation of the early 19th C threshing Barn.

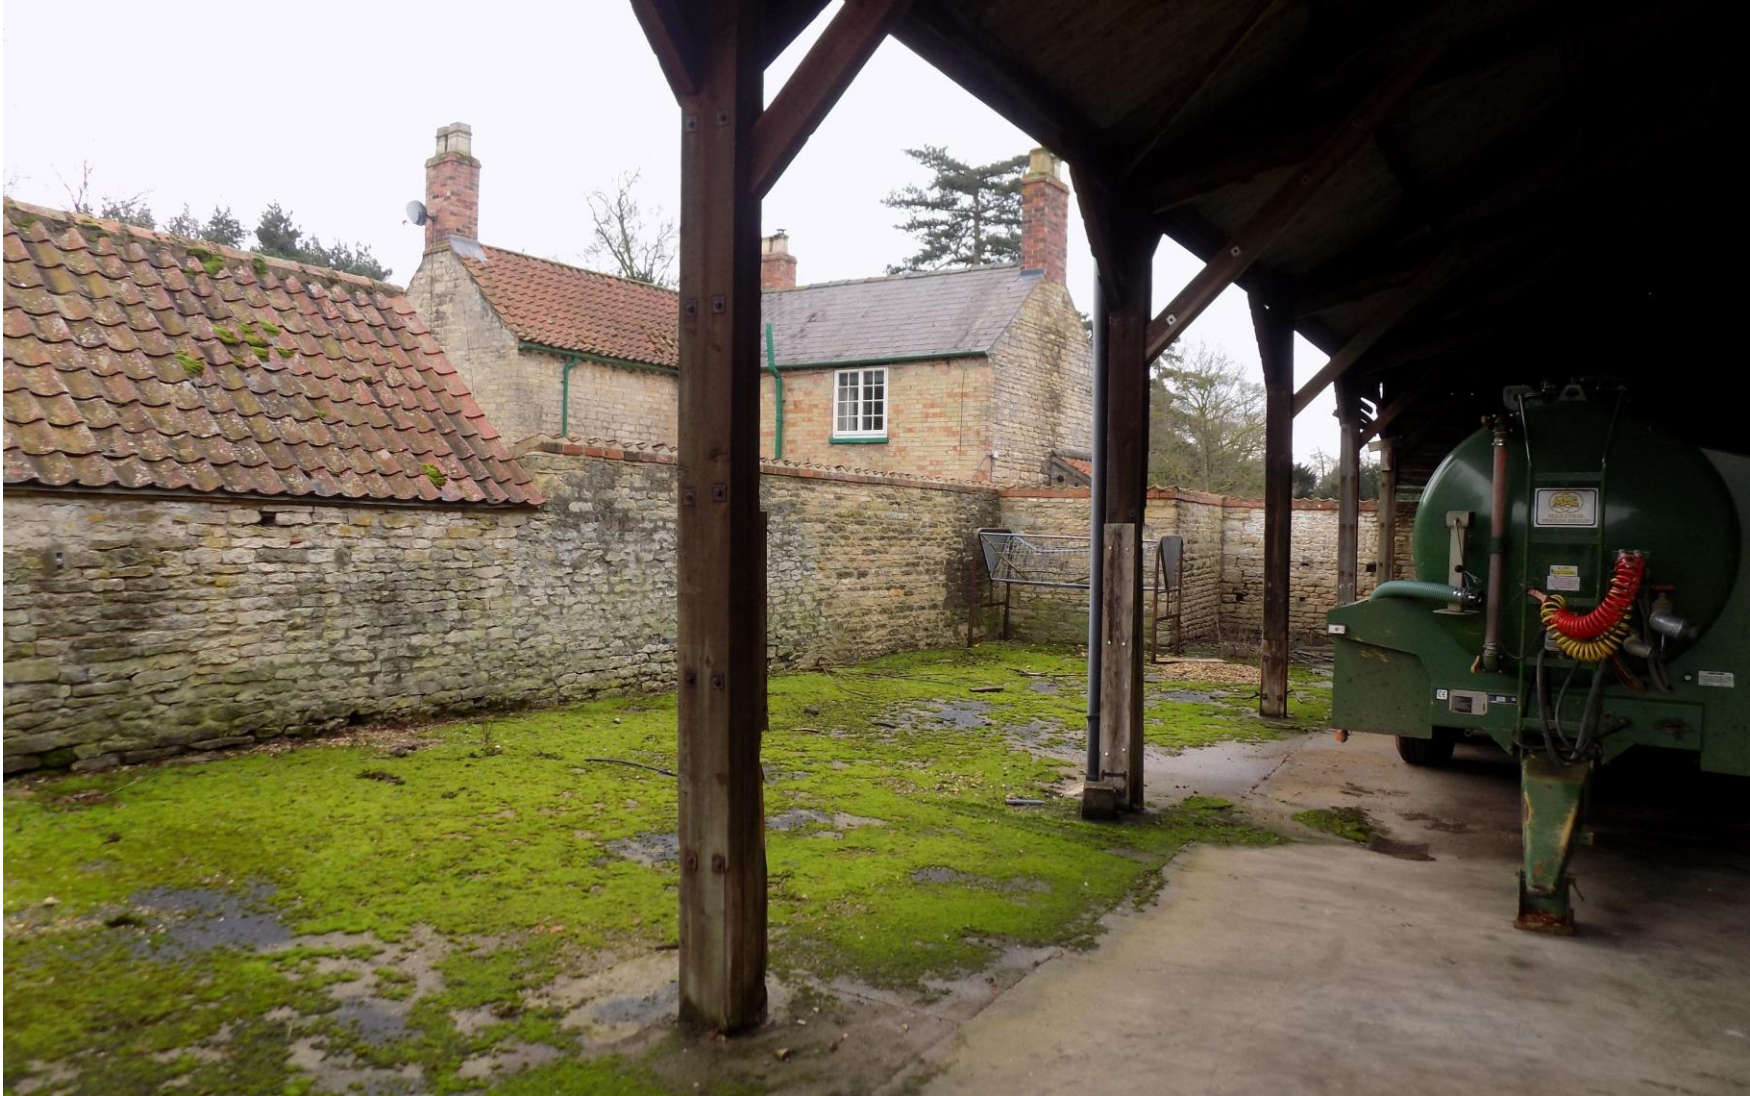
P19 - Shepherd's Cottage, seen from the rear, with tall stone walled enclosure of Village Farmhouse and farm, noting the proximity of the post 1956 timber framed barn.

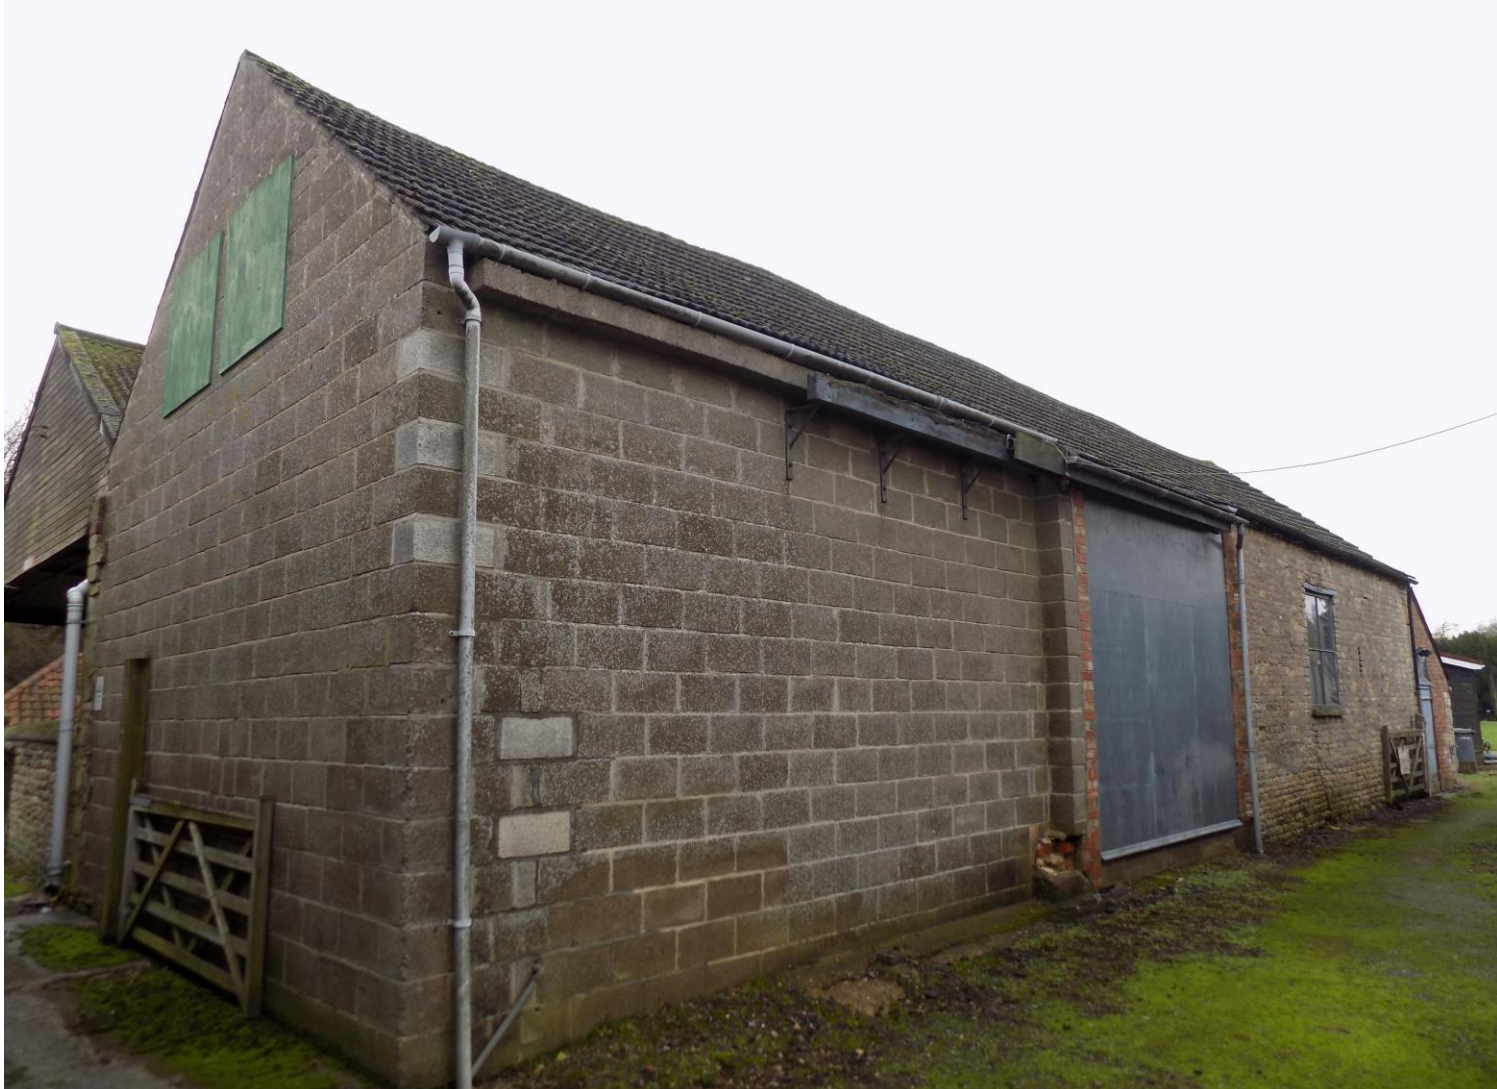
P21- east gable and part of north wall of the early 18th C threshing barn have been rebuilt with breeze block in the late 20th C, however, tradition form is maintained

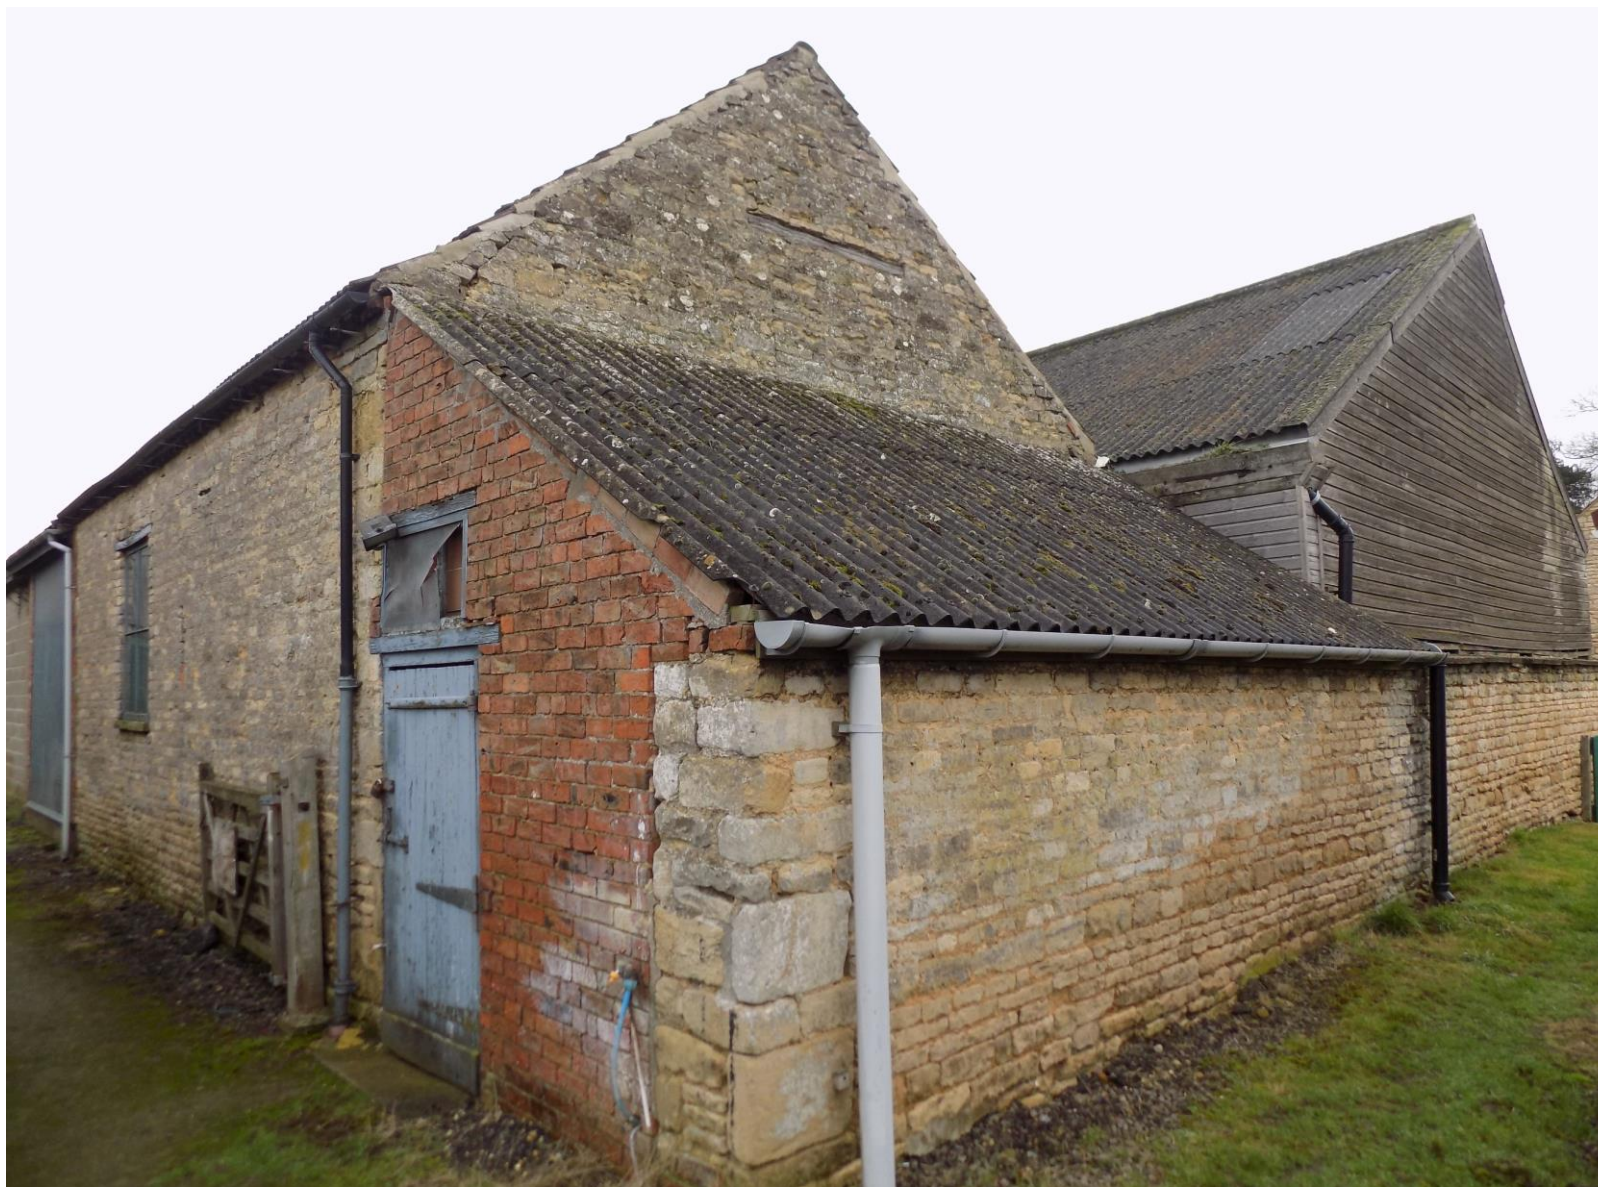
P22 – north west corner of the early 19th C threshing barn, with a slightly later lean-to with red brick infill.

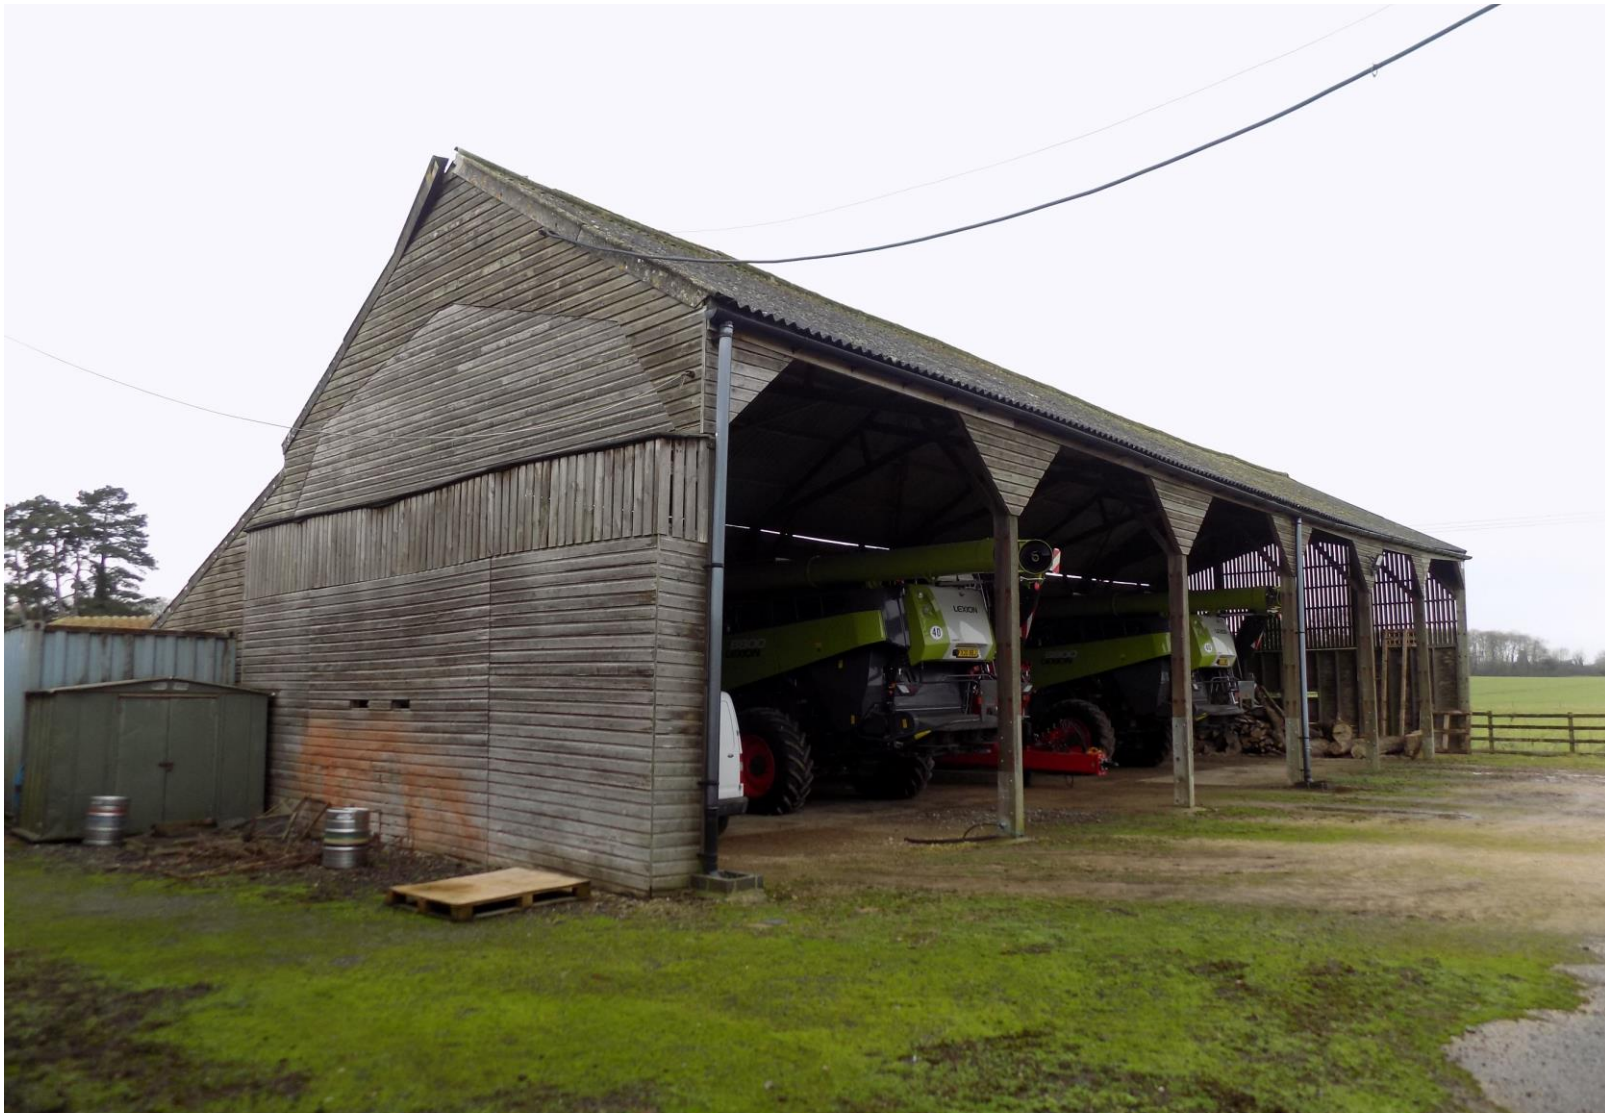
P23 – post 1956 - Barn 5 is timber framed rather than steel, six open bays, once open all round (note the later timber infill on the side), designed by English Brothers, Wisbech. A more traditional form and a catslide roof make the building distinctive.

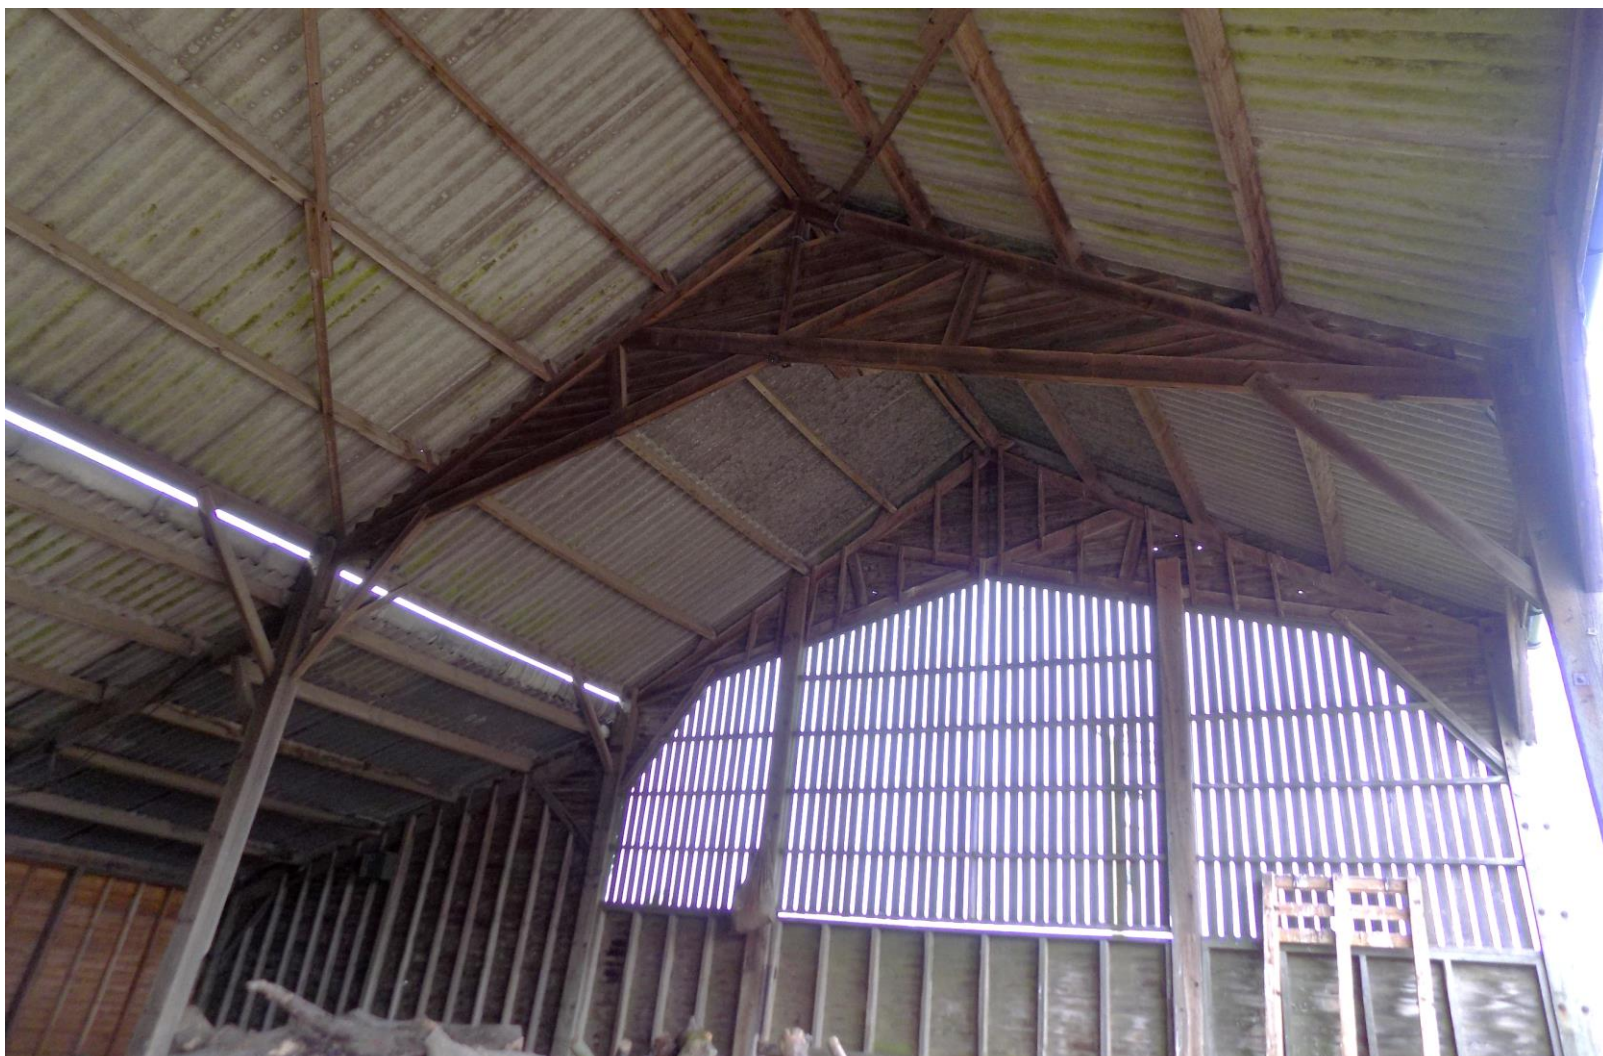
P24 – Interior of Barn 5 has a complex structural timber frame. English Brothers have, since the early 1900's produced structural timber buildings of innovative design. This structure is not without some merit for a building of its type.

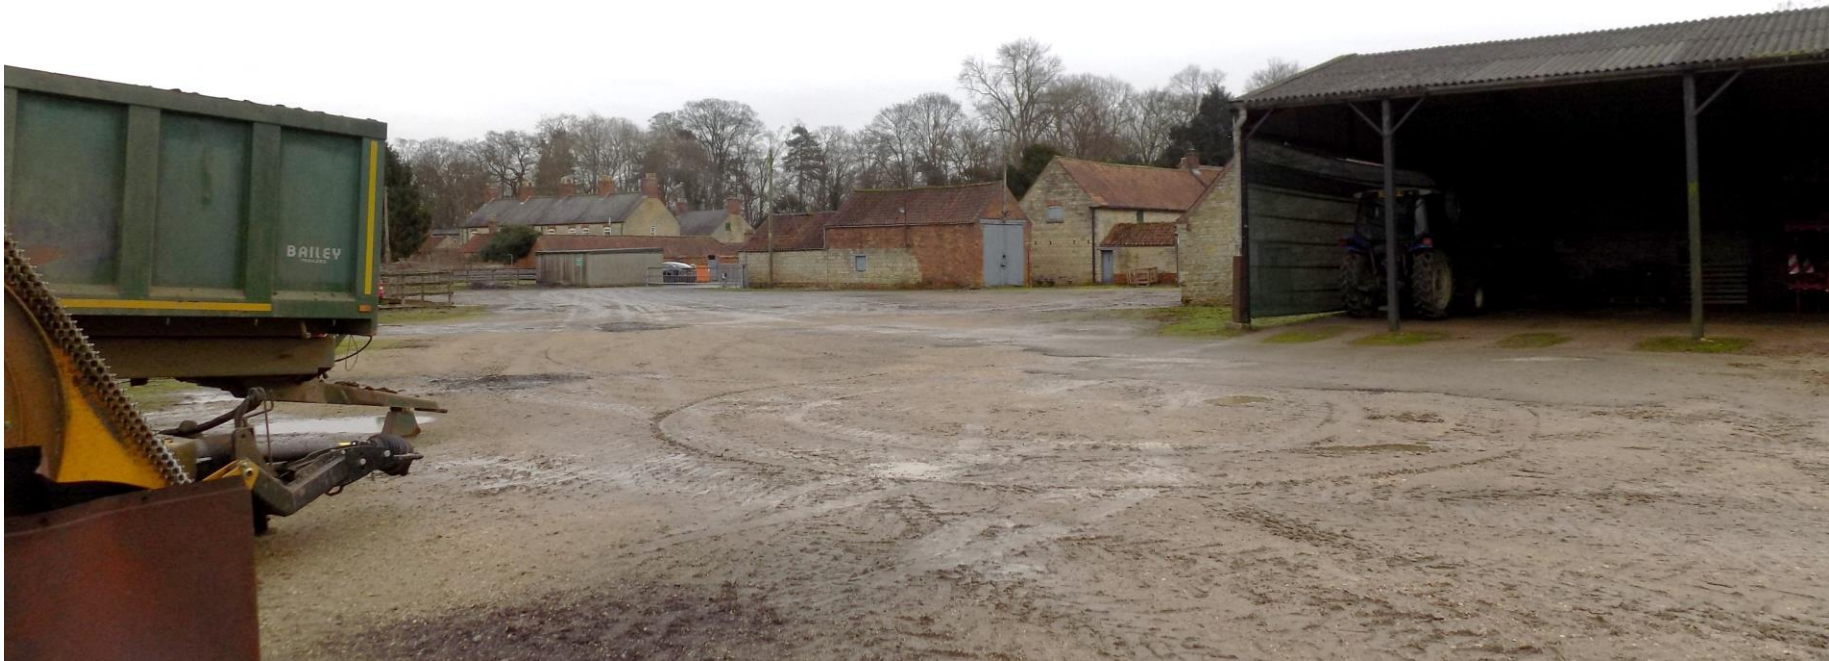
P25 – View of Village Farm from NW of site, looking towards Village Farmhouse and the conservation area (a row of 19th C stone terraces). Barn 5 and part of its open front seen on the right.

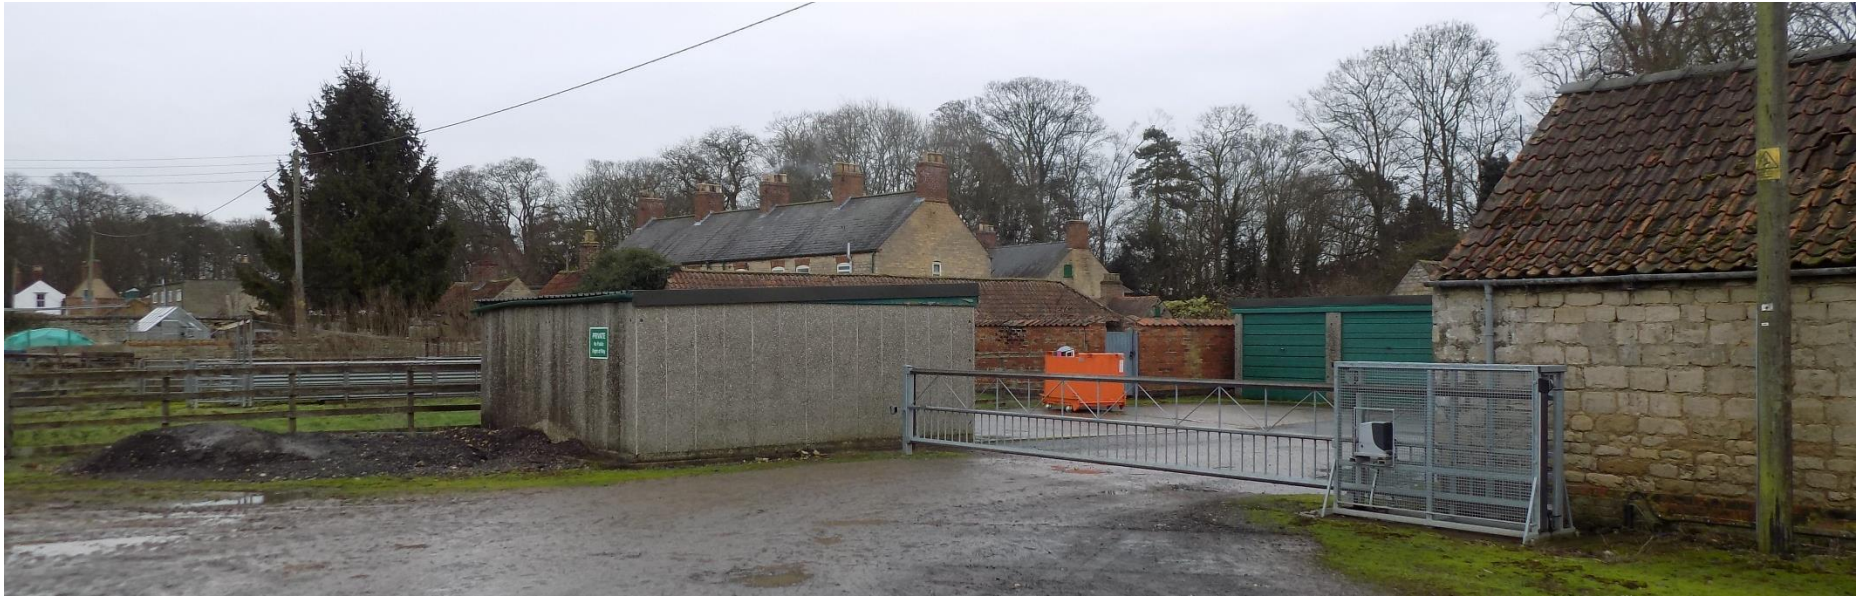
P26 – top, modern pre-cast concrete garages replaced part of the historic farmstead.

P27 - red brick wall and Barn 3 form a courtyard. The modern garages are an inappropriate intrusion to the historic farmstead.

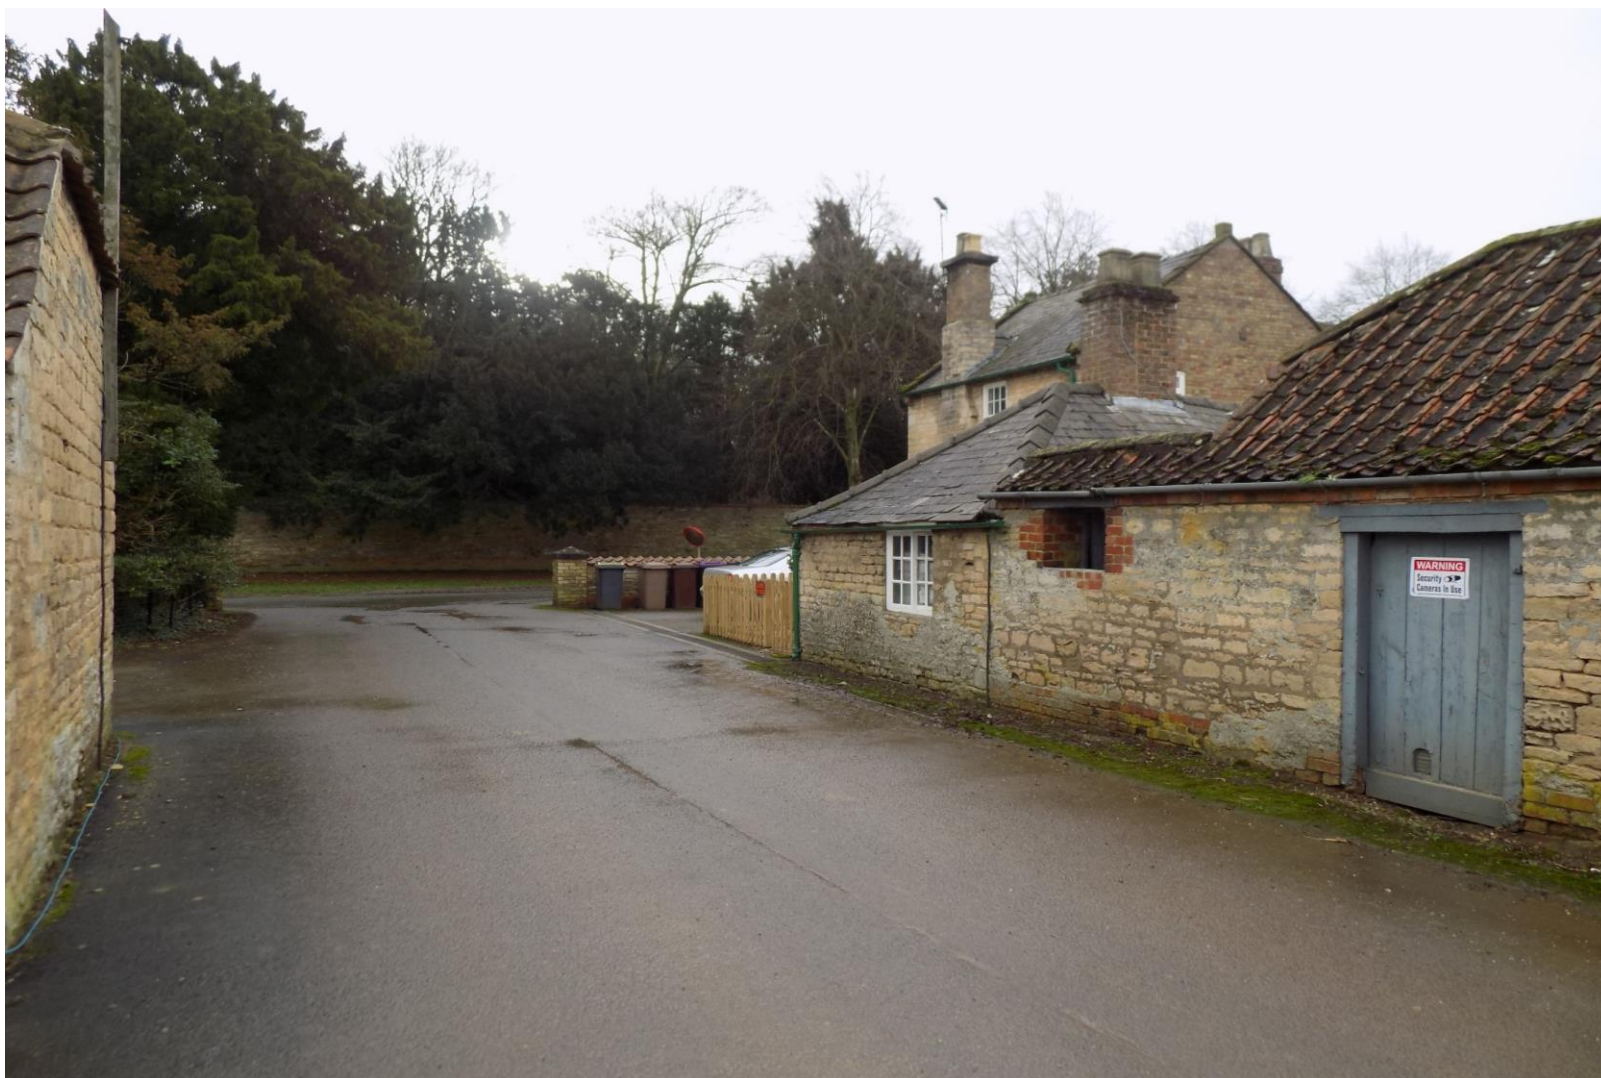
P29 - entrance to Village Farm with single storey range and Village Farmhouse on the right.

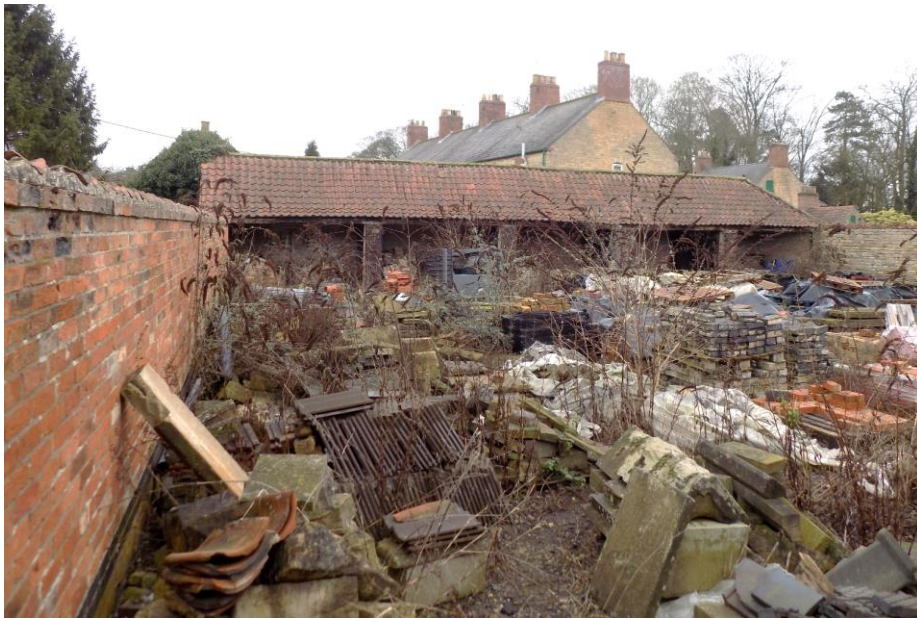
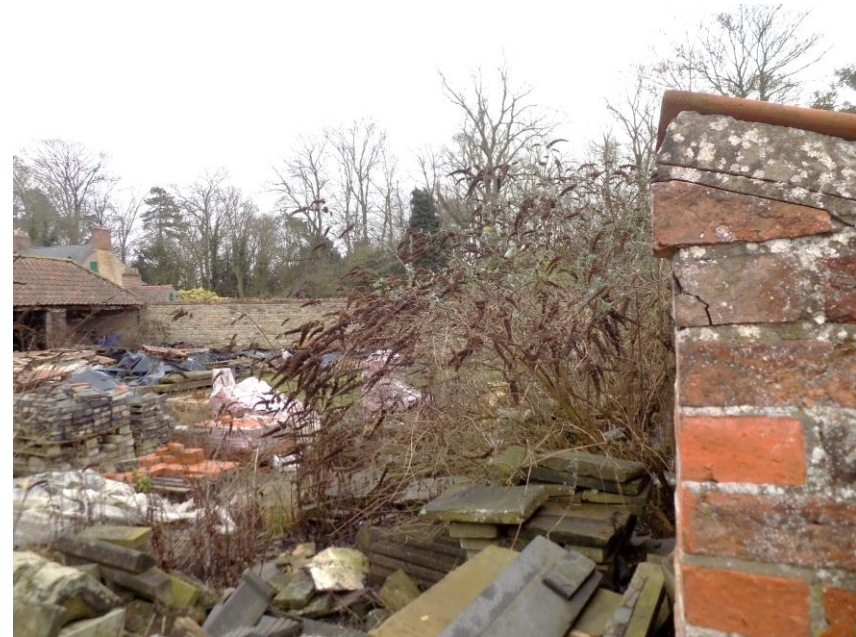
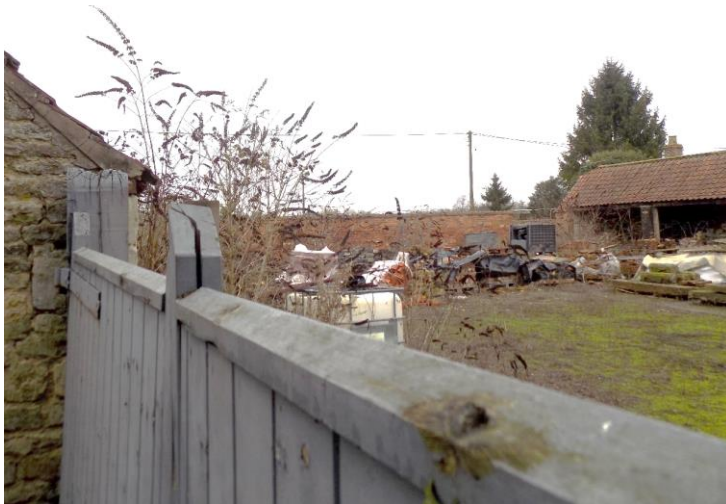
P30 - top left, Barn 4, is a five bay open fronted cart shed (? – not accessible) lies at the eastern end of Village Farm and forms a part of a historic courtyard arrangement with Barn 3. The enclosing wall seen on the left of the photo may have formed part of a two-storey building (just seen on Fig 5) shown on old maps.

P31 – top right, looking over the courtyard to the tall external stone wall that bounds Village Farm on its southerly side.

P32 – bottom left, looking into the courtyard from the gates adjoining Barn 3.
