VILLAGE FARM, VILLAGE STREET, BLANKNEY, LN4 3BB

STATEMENT OF HERITAGE SIGNIFICANCE

March 2022 & February 2023

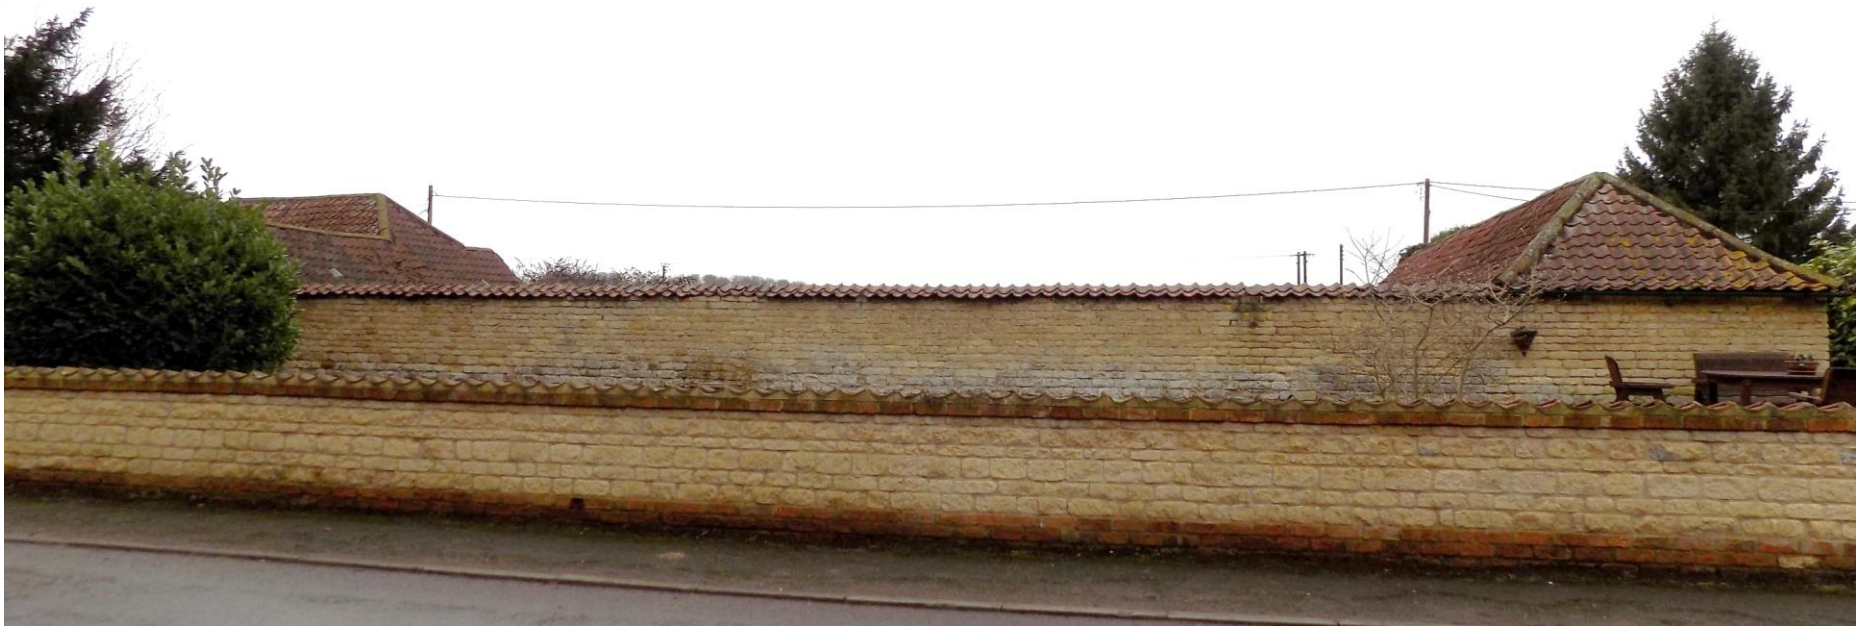
P33 – low stone boundary wall of Village Farm, and beyond the taller stone walls of the courtyard. The hipped roof on the right is Barn 4, and the pantile roof on the left is Barn 3.

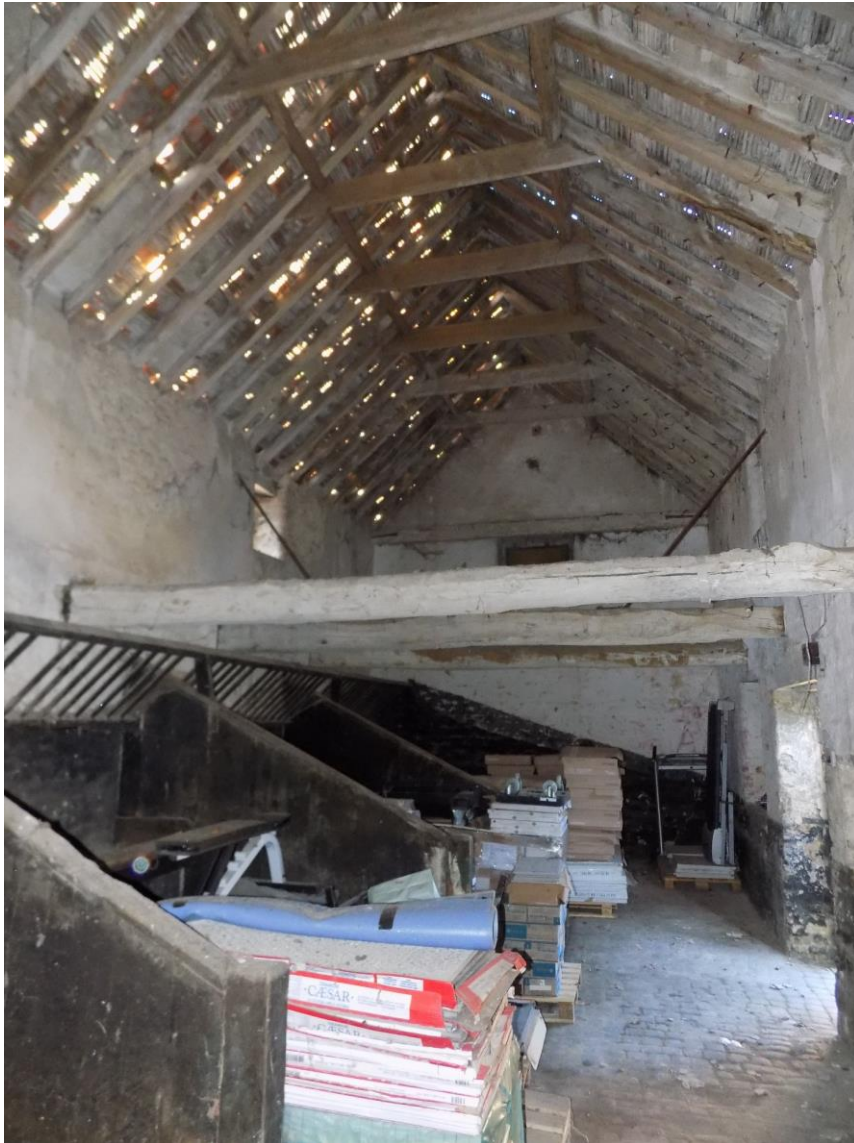
P34 – left, Interior of Barn 8, noting the three large roughly squared beams and the timber stalls and feeding racks and troughs. Original paviers to the floor covering and original joinery survive intact.

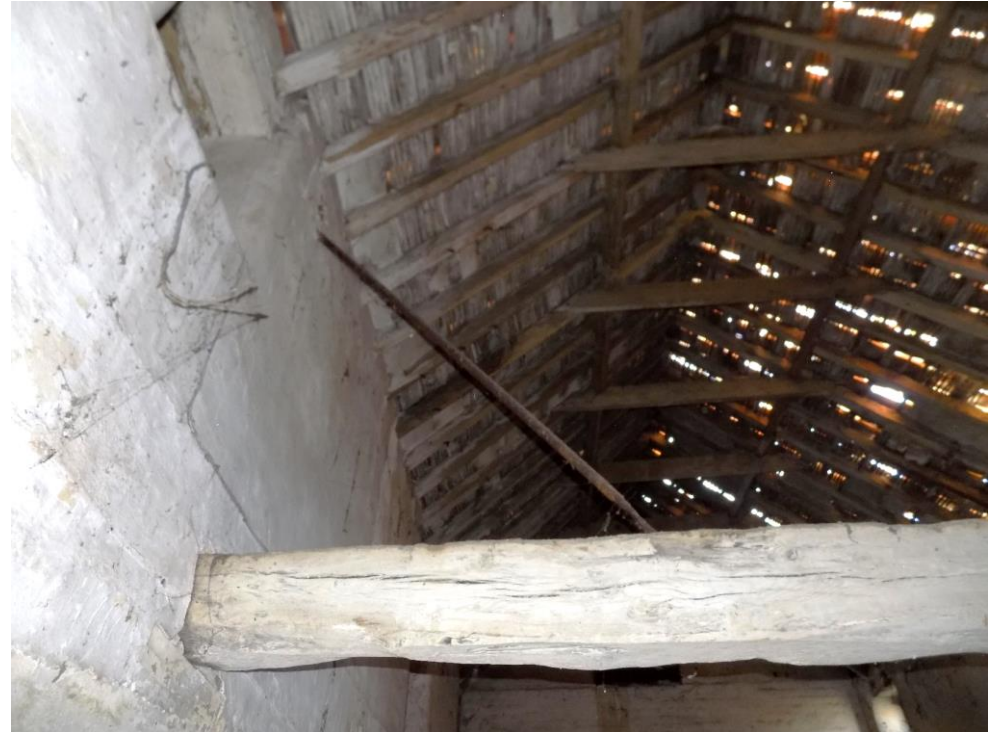
P35 – top right, beam and cast-iron tie, interior of Barn 8.

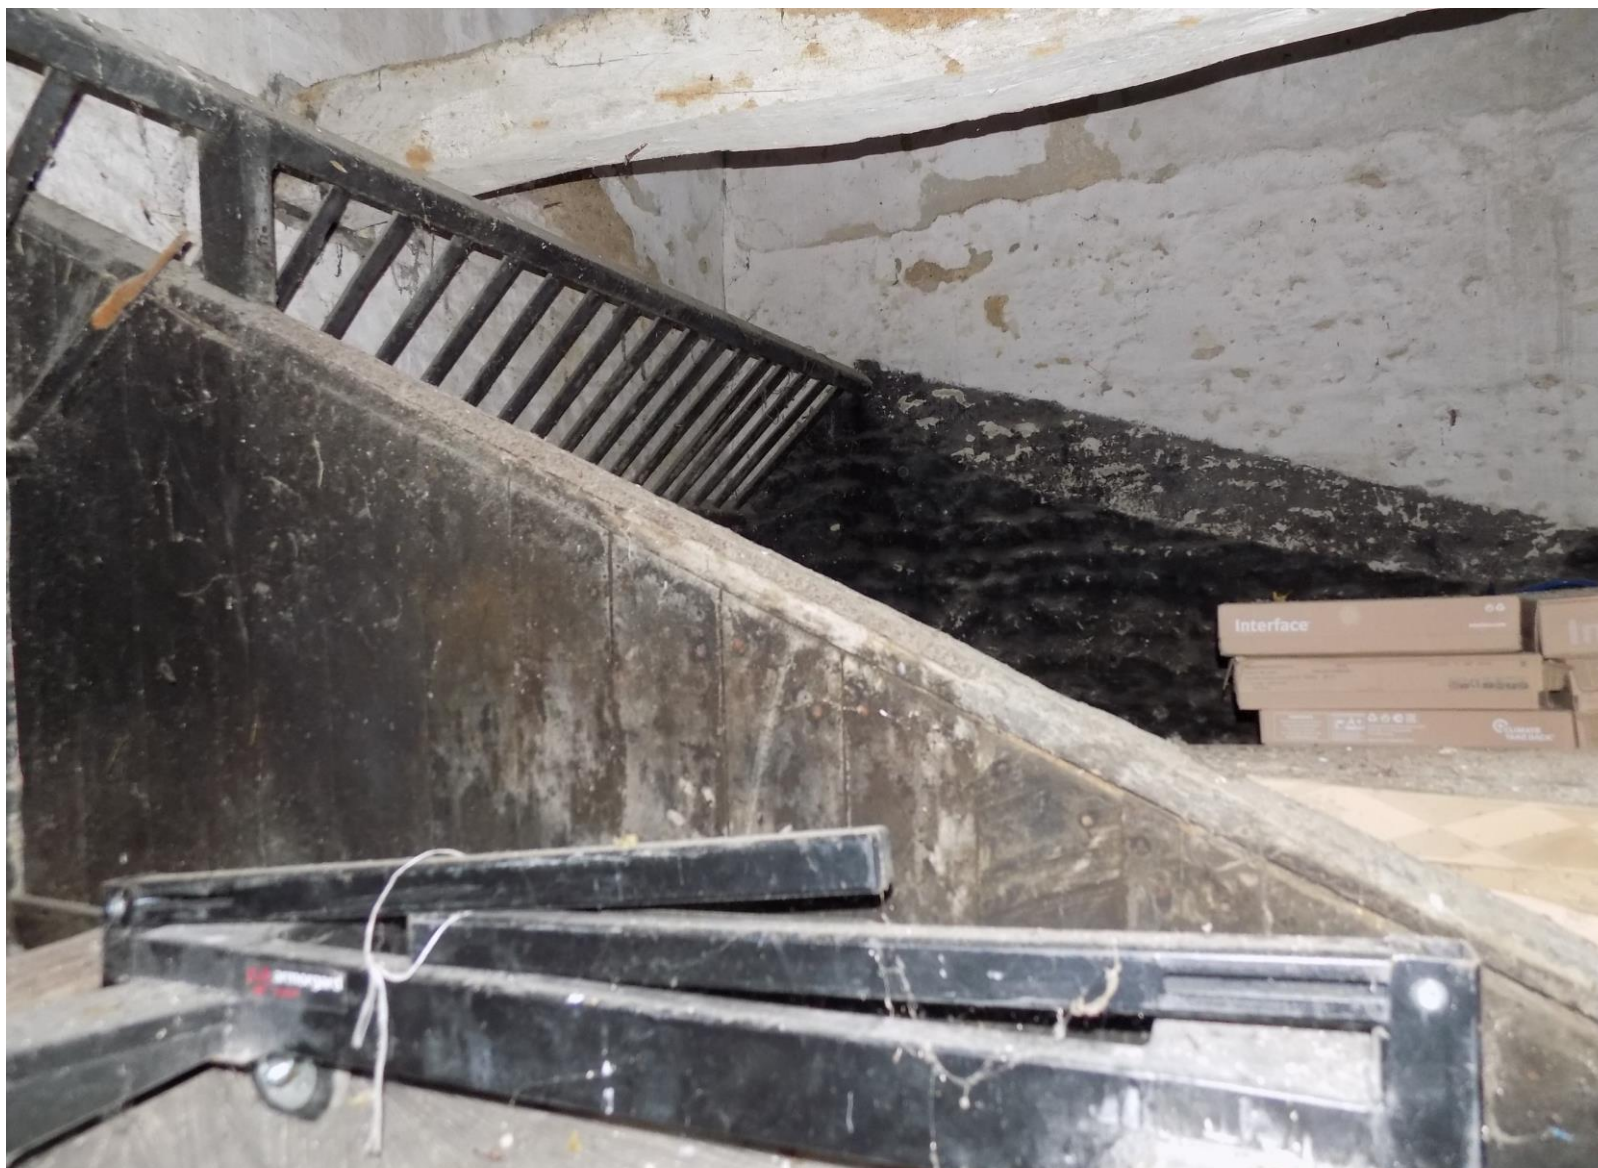
P36 – timber stalls and feeding racks, Barn 8.

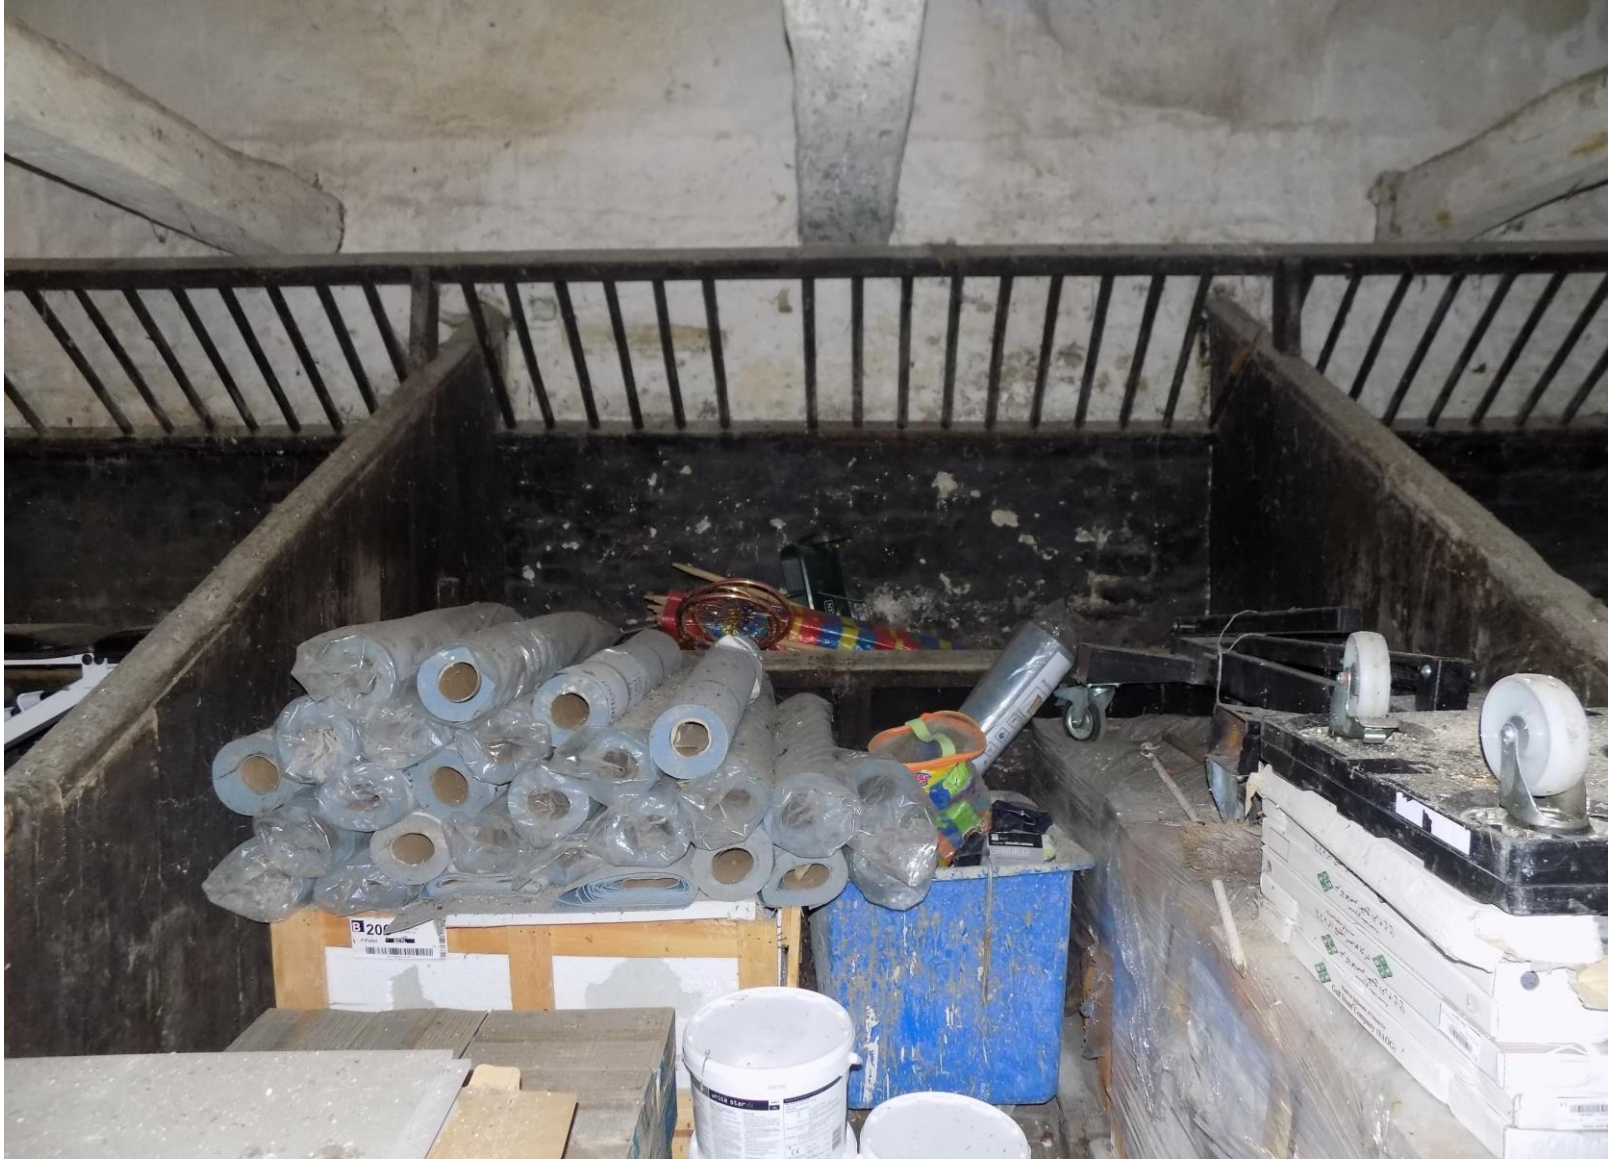
P37 – timber stalls, feed racks, and black painted walls. Detritus obscures brick feeding trough behind.

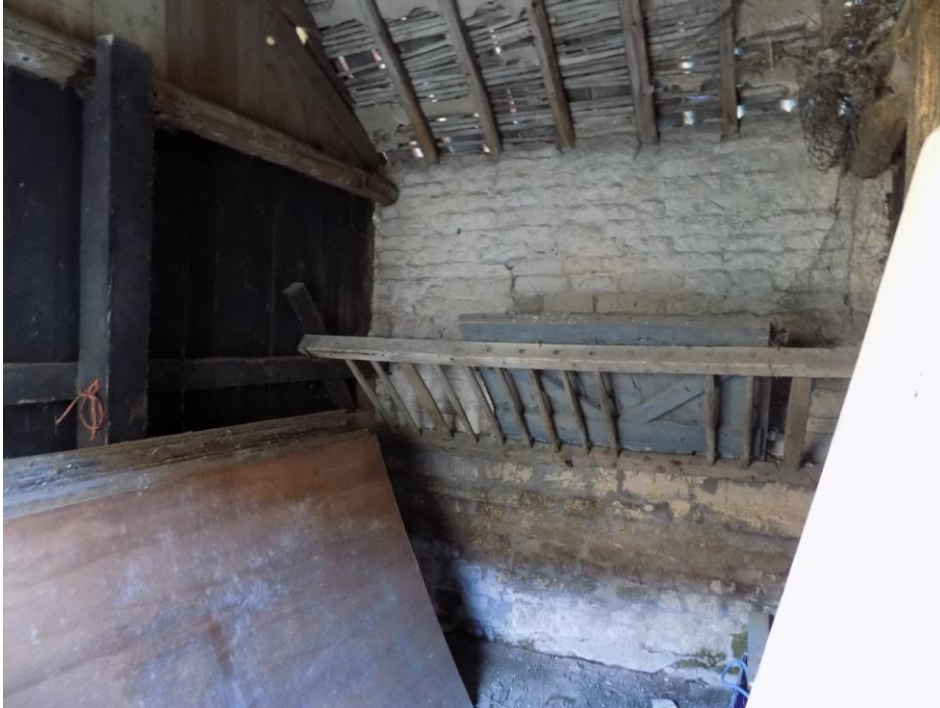
P38 – brick feeding trough and timber feeding rack above, interior of Barn 7.

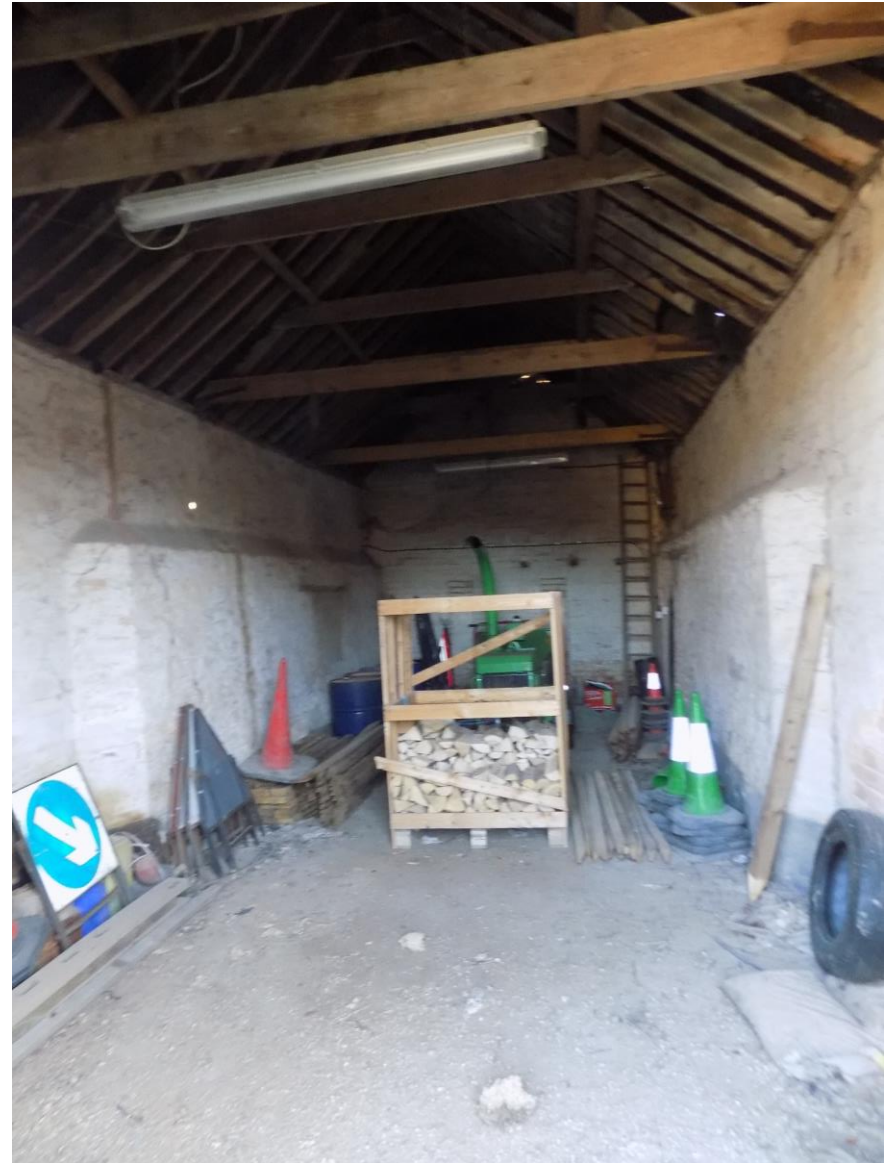
P40 – left, interior of Threshing Barn, has a replacement roof structure (authentically detailed).

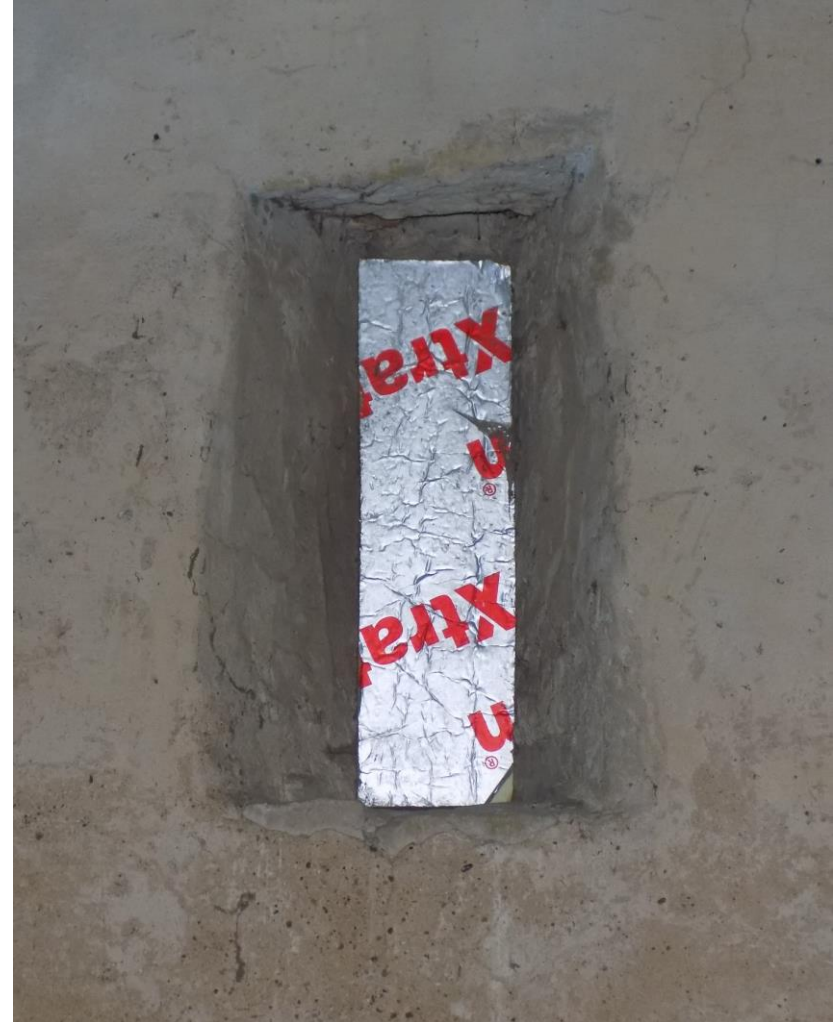
P41 – canted ventilation slot, interior of Threshing Barn.

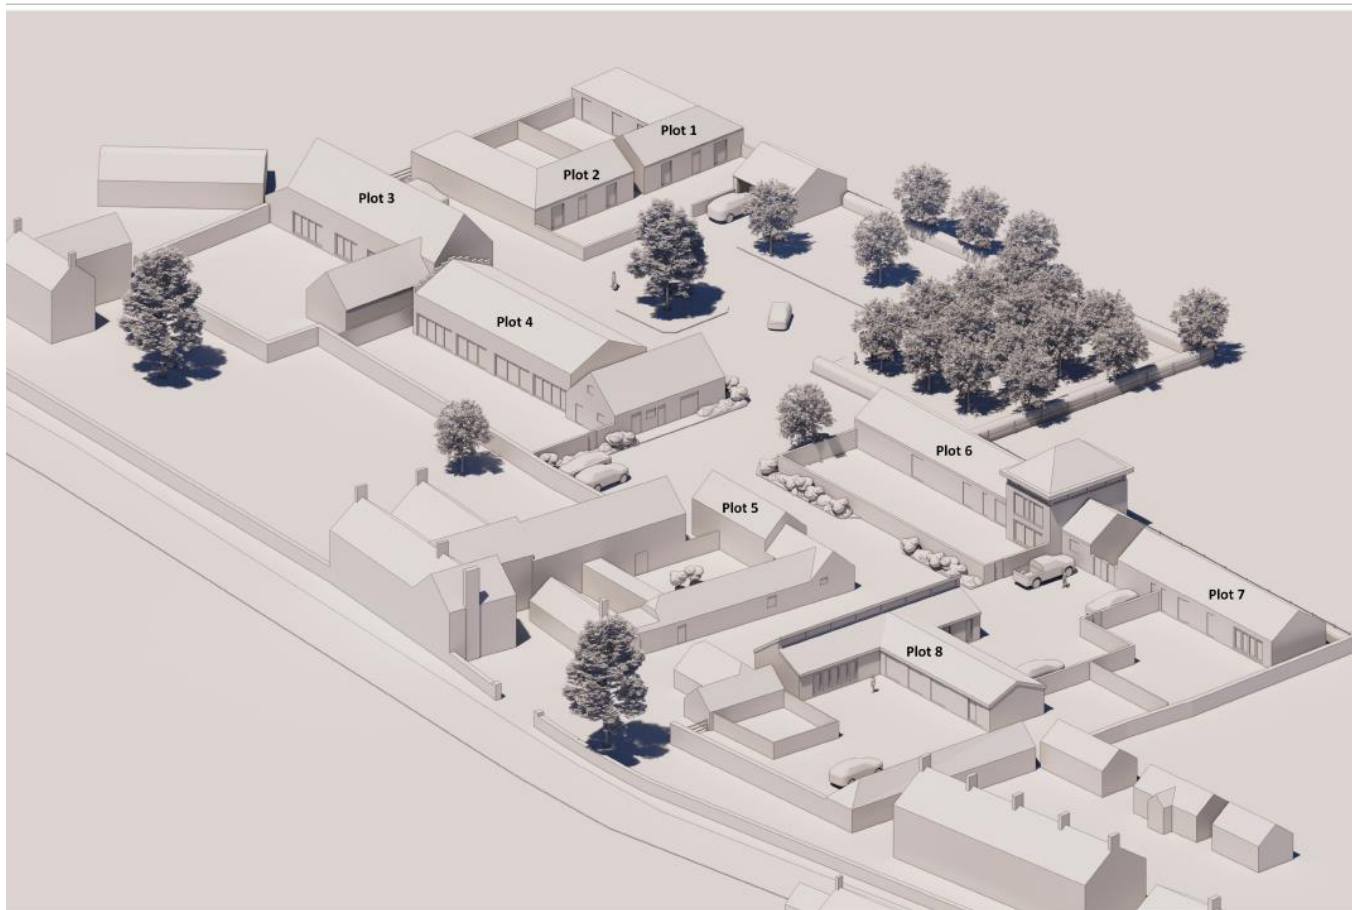
DWG No 1290-6-VS02 – Site Massing – As Proposed.

Plots 1 and 2 - are based on traditional agricultural design with a small enclosing courtyard replacing Building D.

Plot 3 - retains historic barn, removed modern Building A with a traditional single storey added.

Plot 4 retains historic barn and part of modern building with contemporary alterations.

Plot 5 is conversion of historic barns attached to Village Farmhouse.

Plot 6 – a new build based partly on historic maps and photos of a former dovecote.

Plot 7 – a new dwelling in agricultural style with contemporary glazing.

Plot 8 – a new dwelling in agricultural style based on historic map evidence of previous structures.

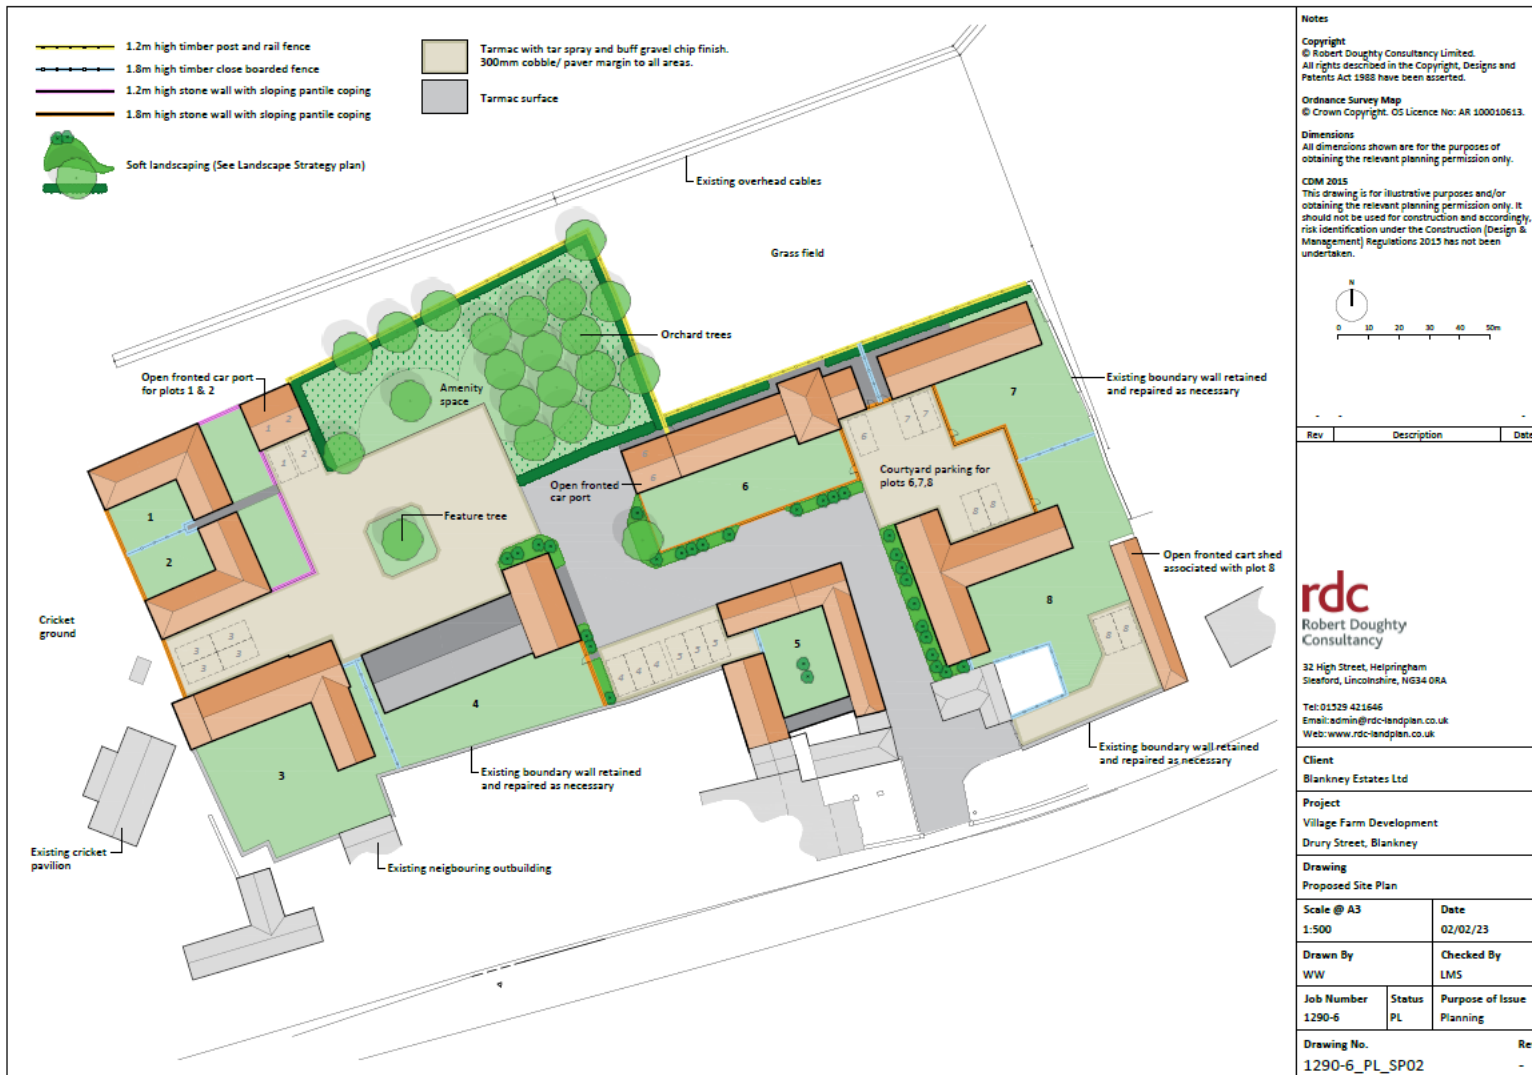
DWG no 1290-6-PL-SP02 showing proposed site plan with landscaping and boundary treatments. Open cart sheds (building C on 1290-6-PL-SP01 is not converted but retained as part of Plot 8.
