CPAT Report No. 1930

Barns at Bodaioch Hall, Trefeglwys, Powys

Historic Building Recording

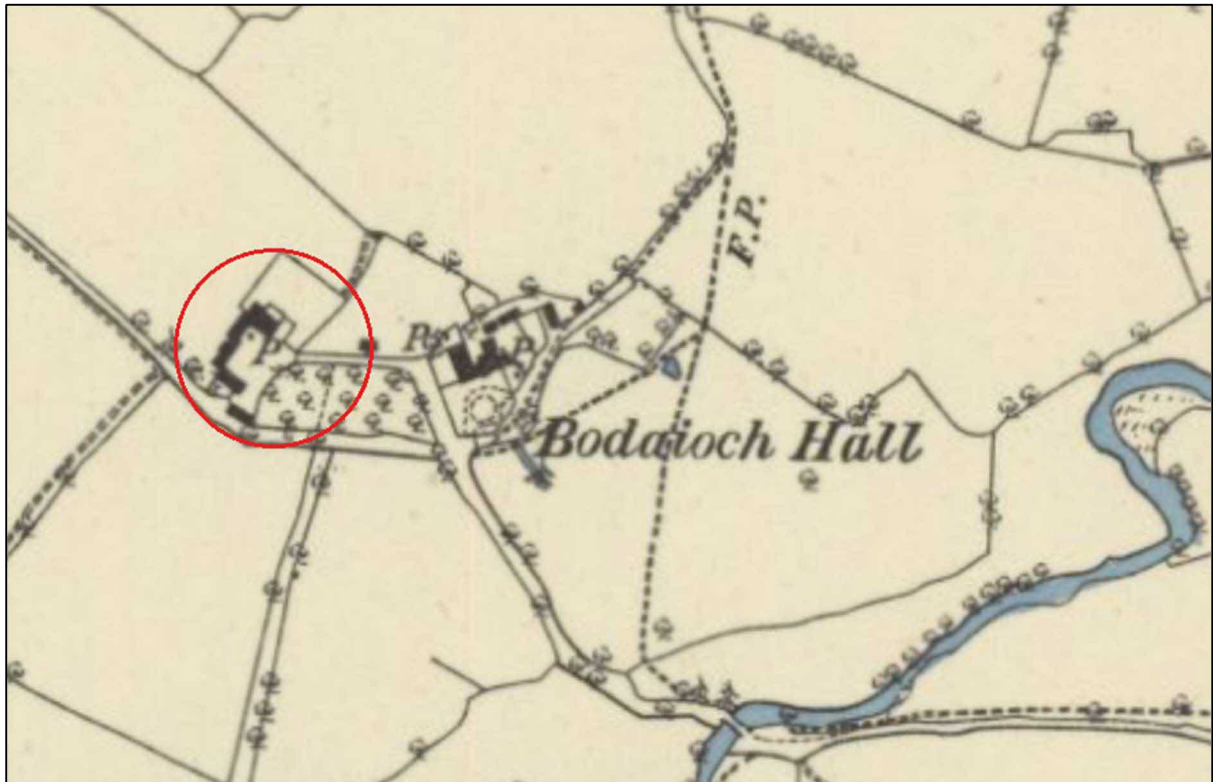
Fig. 3 Extract from the 1885 Ordnance Survey map

- 2.3. The depiction of the farm on the Tithe map does not appear to be particularly accurate, and may be considered to simply indicate the approximate number and location of the buildings on the farm without depicting their orientation and positions relative to one another.
- 2.4. The farm is more accurately depicted on the Ordnance Survey map of 1885 (Fig. 3). This shows a contiguous range of buildings arranged around the south, west and north sides of a yard, accessed via an entrance opening onto the lane to the south and also via a driveway running east to the hall. There are stock pens and a paddock located to the north of the farm and an orchard to the east. A building or range depicted to the north of the farmyard on the Tithe Map is not recorded on the 1885 map.

- 4.3. Outbuilding 2 was originally a byre or possibly a linhay, which had later been boarded up and converted into a cowhouse or two boxes. It was probably built in the 18th or earlier 19th century, and had remained in use until the mid-late 20th century. Historic mapping (Figs. 3 & 4) indicates that the north-west corner of the building was formerly attached to or abutted an adjacent building which was subsequently demolished, possibly accounting for the brick repairs in this location.

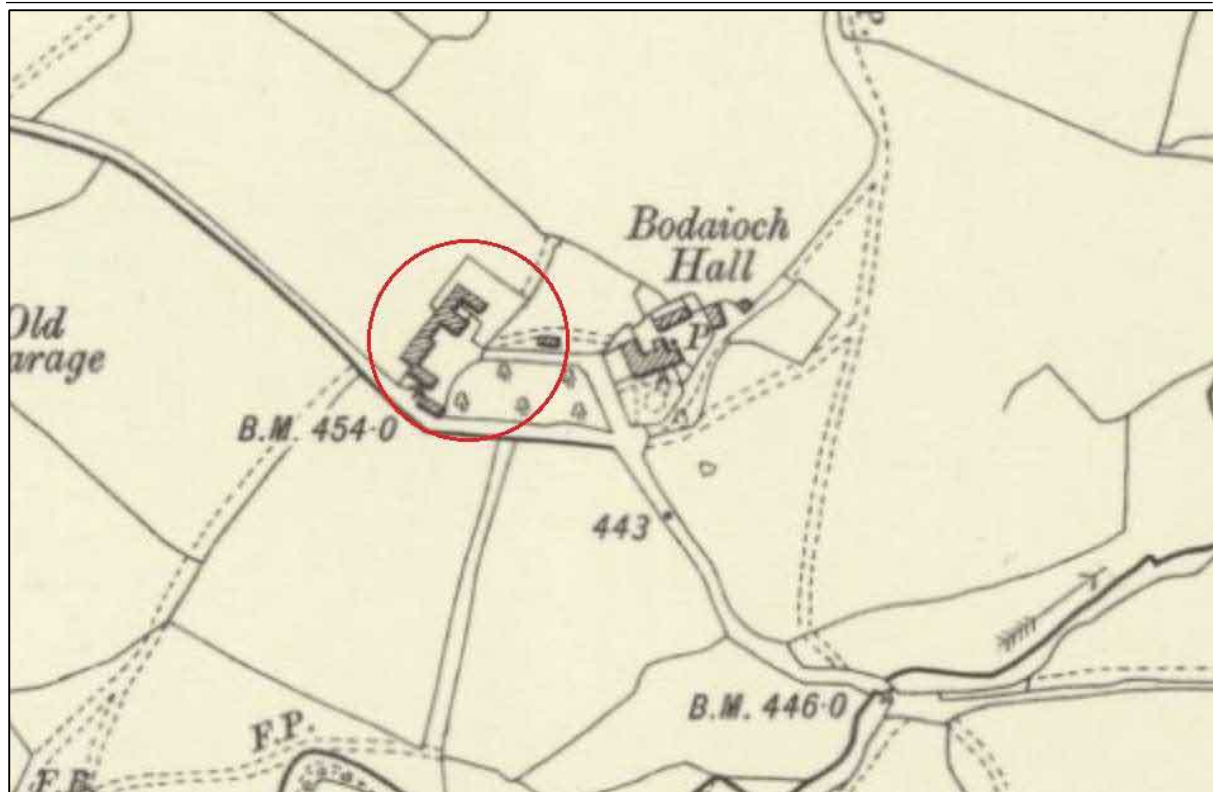
Fig 4. Extract from the 1903 Ordnance Survey Map

- 2.5. The 1903 map records the construction of a second linked range constructed parallel to the existing north range of the farmyard (Fig. 4). Subsequent mapping from 1953 records no further changes in the layout of the farm during the intervening period.

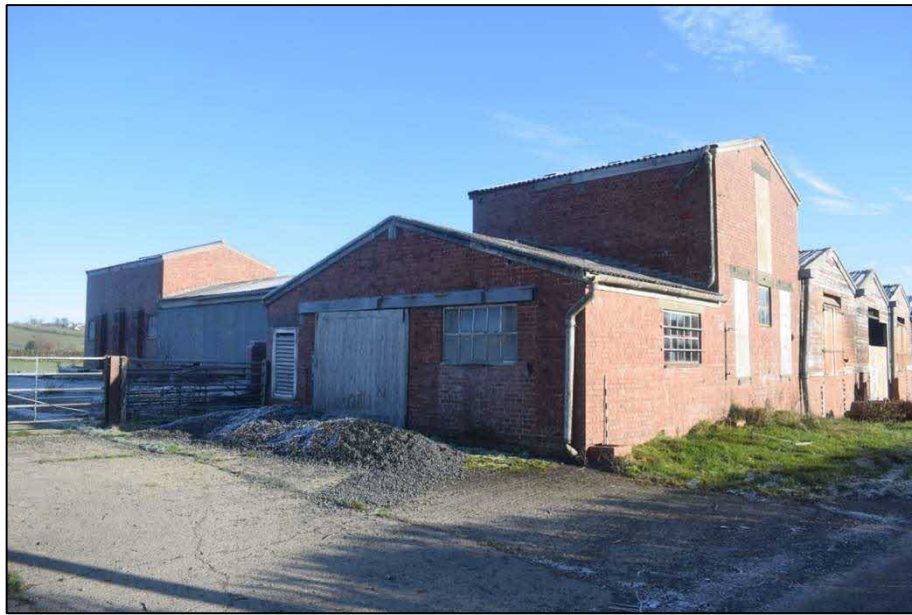
- 3.2. Outbuilding 1 (measuring 37.5m x 5m) formed the western side of the barn complex. It was constructed largely from brick with corrugated iron or asbestos roofing and comprised four elements, a holding area, two milking parlours and a plant room (Dwg. 2).
- 3.3. The covered holding area was located centrally and was accessed via a ramp on the western elevation. At either end of the holding area were similar but not identical milking parlours (see Dwg. 2), fitted with Alfa Laval milking equipment of post war date. There was a loft above each of the parlours, accessed via doorways on the gable ends.
- 3.4. A plant room containing the milk storage tank was located against the west elevation of the southernmost milking parlour

- 3.5. A large stock shed was located adjacent to Outbuilding 1 on the east side but, whilst broadly contemporary, appeared not have been built at the same time, as the brick coursing was not contiguous.

Fig. 5 Outbuilding 1 viewed from the west with the plant room in the foreground and the stock shed to the rear. Photo CPAT 5036-001

- 4.1. Outbuilding 1 comprised two identical milking parlours, linked by a central holding area, with an attached plant/tank room. Historic mapping suggests that it was constructed post 1953. The design was unusual and would have required at least two operators if both parlours were in use simultaneously. The loft over each of the parlours was another unusual design feature, they appeared to be rather small for hay or fodder storage and somewhat inaccessible for stores.

- 4.2. It seems most likely that the stock sheds were built slightly before the milking parlour building, which would account for the location of the latter, which is positioned some distance from the existing farmyard.

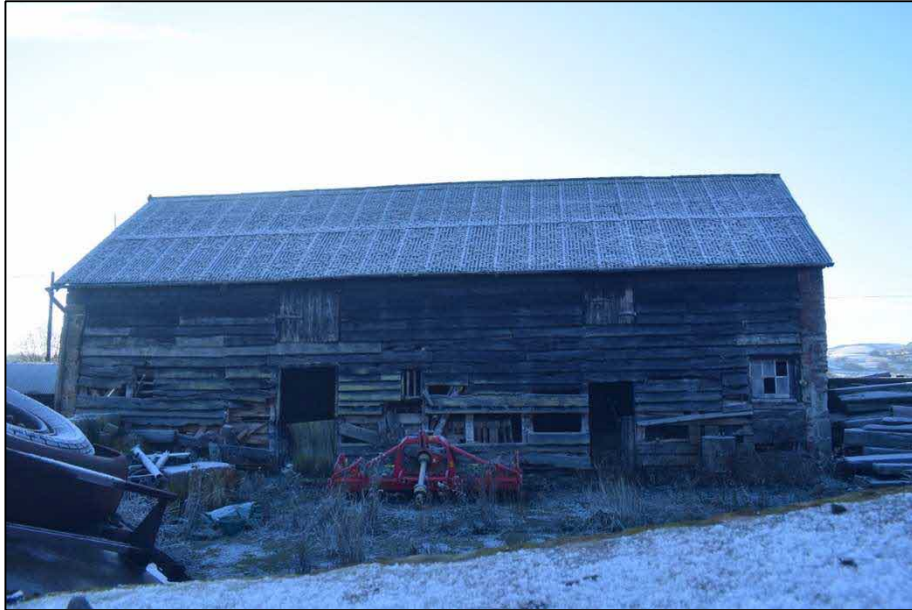
- 3.6. Outbuilding 2 (measuring 15m x 6m) was constructed from lime mortared random uncoursed stone with quoins on the corners. The north-west corner had been repaired with brick, possibly following the demolition of an adjoining building during the mid-20th century. The north elevation and the upper western gable end were timber-framed and sheathed in weatherboards (Fig. 6). A small corrugated iron shed was constructed against the southern elevation.

Fig. 6 Outbuilding 2, viewed from the north Photo CPAT 5036-032

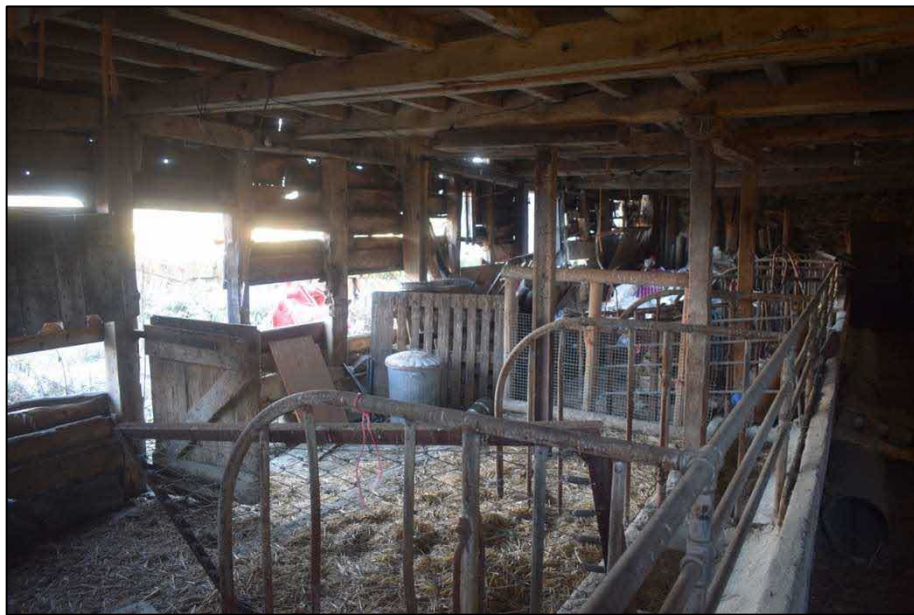
- 3.7. Internally there was a feed corridor running along the southern elevation, accessed via a doorway on the west gable end (Fig. 7). The feed trough was concrete and fitted with modern tubular rails and subdivisions. There were two doorways into the byre, the easternmost was taller and had a stable type split door (Fig. 6). There were three windows inserted in the north elevation, two were simple unglazed openings with wooden rails, one was a later steel framed insertion. There was also an infilled window, with a brick voussoir on the east elevation and a doorway on the south elevation infilled with brick. The floor was concrete throughout.

Fig. 7 Interior of Outbuilding 2, viewed from the west Photo CPAT 5036-034

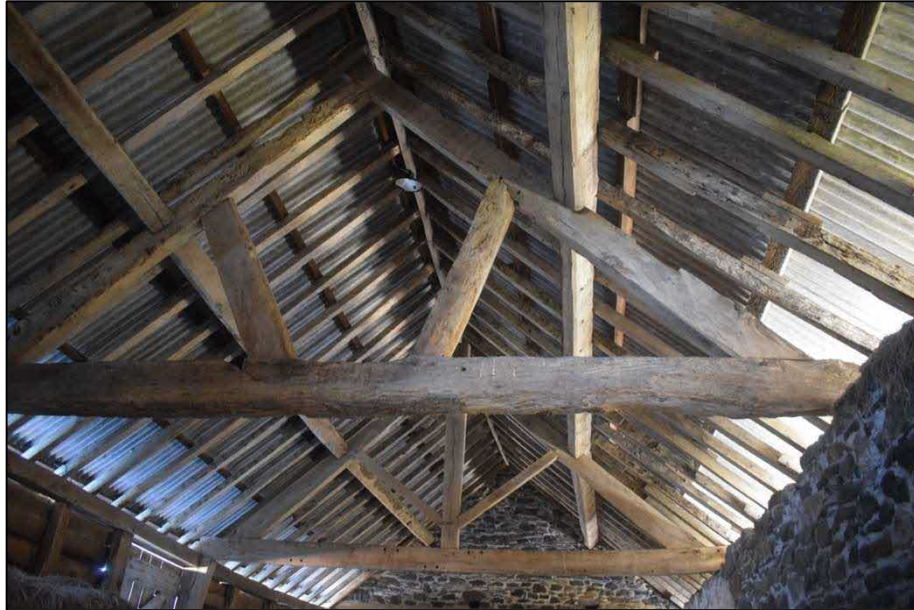
There was a hayloft above the byre, accessed by two small hayloft doors in the north elevation. The roof timber comprised a mix of machine and hand cut timbers, some which had been reused (Fig. 8). The two roof support trusses comprised a queen post truss, the timbers of which were largely hand cut and therefore probably an original feature, and a later machine cut king post truss. The rafters and purlins were all machine made and the roof was sheathed in corrugated iron sheeting.

Fig. 8 Roof trusses within Outbuilding 2 viewed from the west Photo CPAT 5036-035

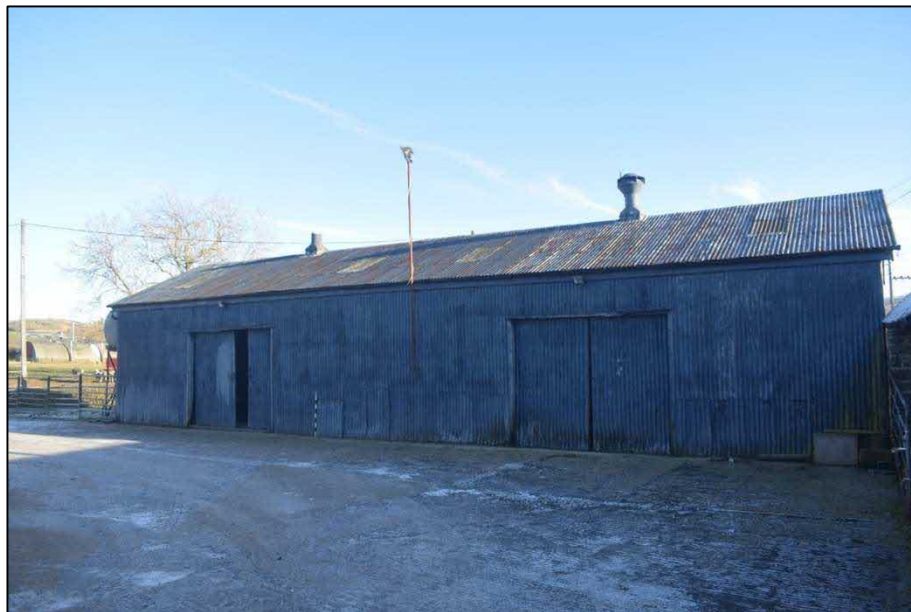
- 3.8. Outbuilding 3 (measuring 18m x 6m) was constructed from a timber frame sheathed in corrugated iron (Fig. 9). Access was via sliding doors on the west elevation. The roof was supported by three trusses, a box frame central truss and two simple collared trusses reinforced by a metal rod and bars (Fig. 10). There were two ventilators on the ridge, one of which had been partially broken.

Fig. 9 Outbuilding 3 viewed from the west Photo CPAT 5036-042

- 4.4. Outbuilding 3 was a prefabricated building of the type used during the First and Second World War for both military and civil purposes. It may have been acquired in the 1950s following the end of the Second World War, when a lot of these buildings were surplus to requirements.

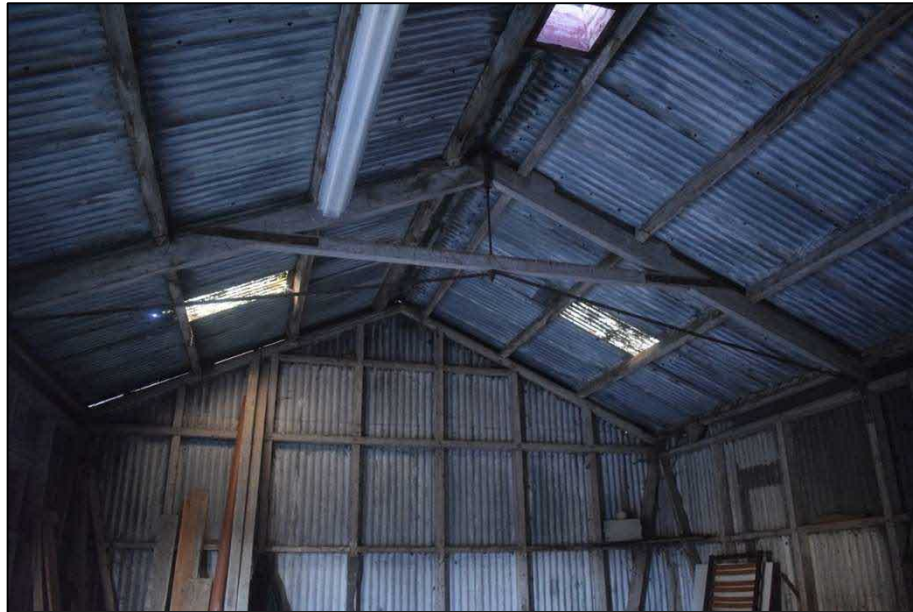
Fig. 10 Metal reinforced roof truss and details of wall frame in Outbuilding 3 Photo CPAT 5036-047

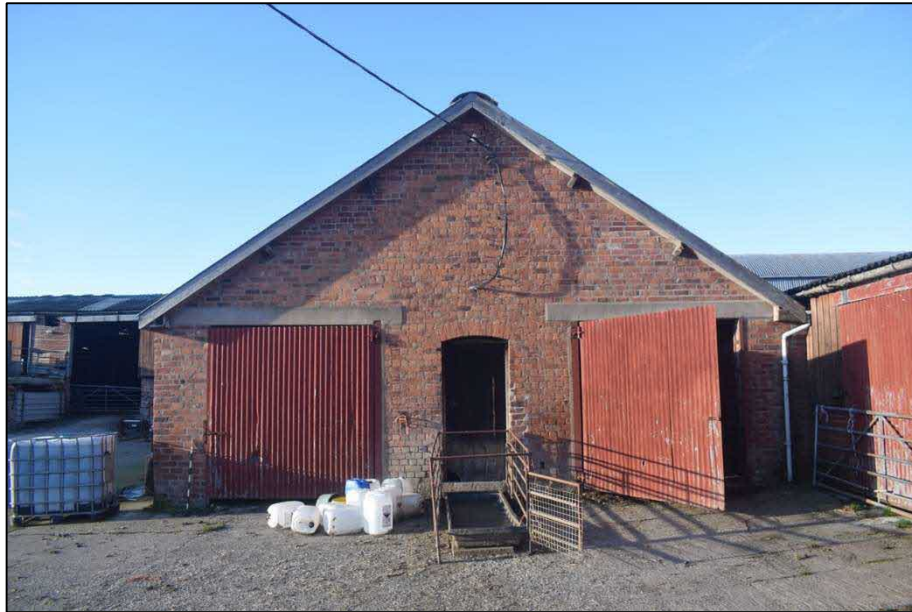
- 3.9. Outbuilding 4 (measuring 17.5 x 10m) was constructed from brick, and comprised a cow shed with a central aisle, accessed via large modern doorways with concrete lintels on the east elevation (Fig. 11) and smaller doorways on the north and south elevation. There was evidence of considerable rebuilding of the eastern gable end, with modern brickwork inserted into the older fabric. Some of the internal brickwork was quite fine and included rounded profile bricks on the doorways and buttresses (Fig. 14)

Fig. 11 Eastern gable end of Outbuilding 4, with modern doorway insertions and later brickwork Photo CPAT 5036-051

-
- 4.5. Outbuilding 4 was an aisled cowshed constructed during the mid-late 19th century. The two storey range at the south-western corner, was taken down in the mid-20th century, when the building was largely rebuilt (Dwg. 2). It was most probably a mixing shed, for storing and mixing/grinding diet feed for cattle, an important development in modern farming practice. The machinery retained within the rebuilt mixing shed is either a proprietary feeder supplied by Massey Feeds, a Cheshire based company, or Massey Harris, a Canadian farm equipment manufacturer.

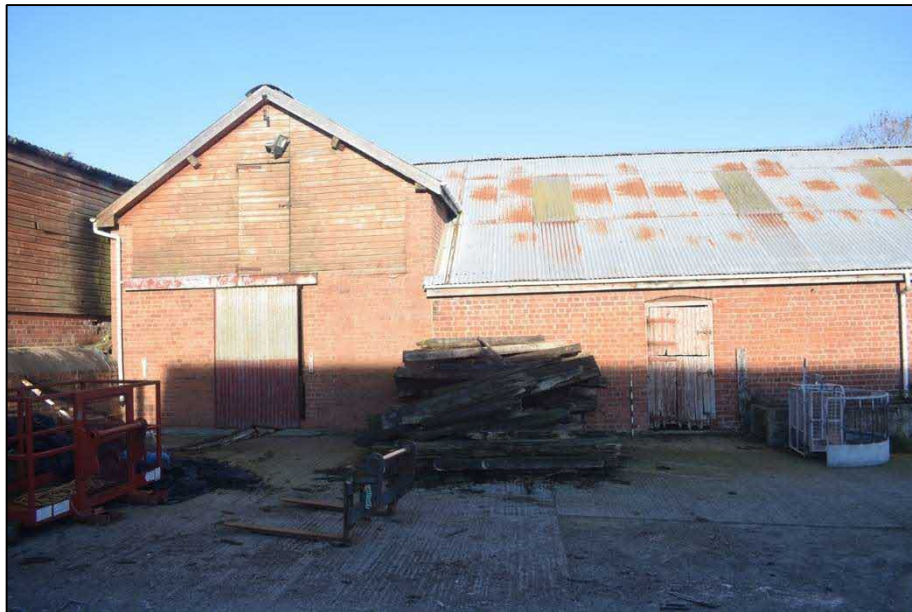
- 3.10. The building had formerly been L-shaped with a two storeyed section located at the south-west extent (Fig. 12), separated from the cowshed by a timber partition, and accessed via a set of wooden steps. This southern projection had evidently been constructed against an existing building on the west extent of the farmyard (Figs. 3 & 4 and see Dwg. 2), and had subsequently been taken down when this building was demolished. The gable for the south range had been rebuilt and the wall infilled. Historically there appeared to have been a second linked cowshed constructed parallel to the north and linked at the west end (Fig. 4). This had been taken down, presumably when a larger modern stock shed was constructed in this location.

Fig. 12 Two storey projection at western end of Outbuilding 4 Photo CPAT 5036-053

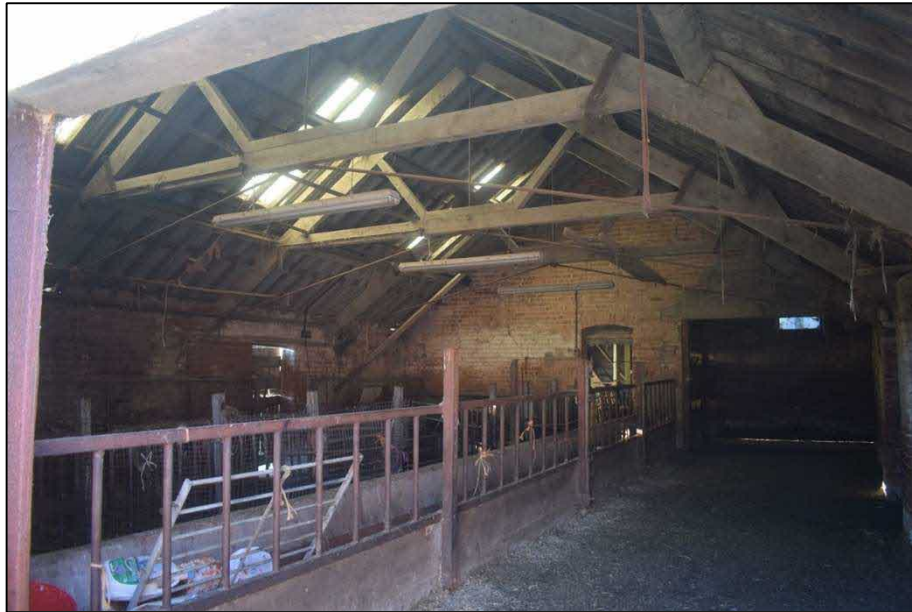
- 3.11. The roof framing in Outbuilding 4 comprised machine-cut timbers (Fig. 13), and simple trusses with braced collars and steel retainers. The rafters were still in situ and the roof itself sheathed in tin. A Massey feed mixer was located in the south-west corner of the building (Fig. 15), with a vacuum pipe leading to an overhead feed storage tank.

Fig. 13 Interior of Outbuilding 4 viewed from the east Photo CPAT 5036-056

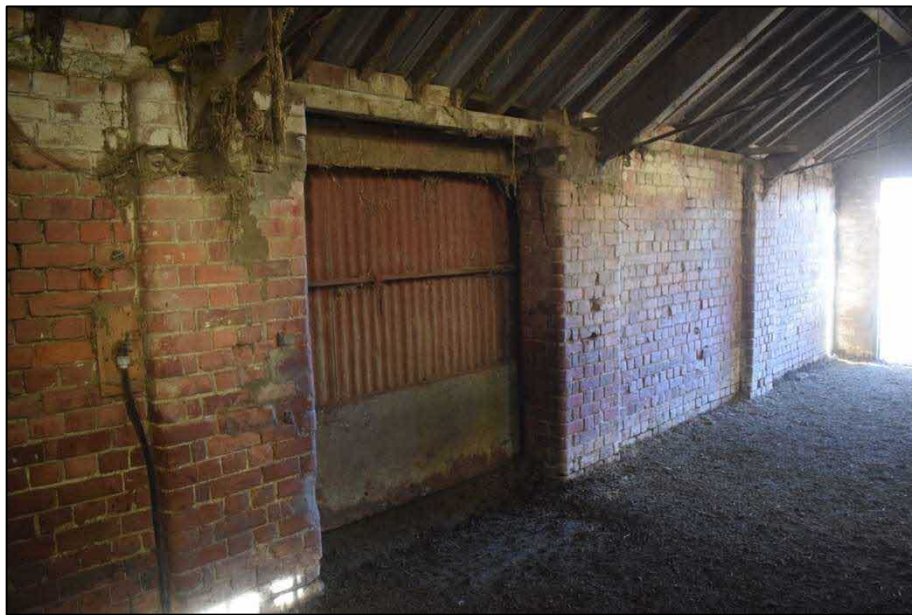
Fig. 14 Brickwork on northern internal elevation of Outbuilding 4 Photo CPAT 5036-058

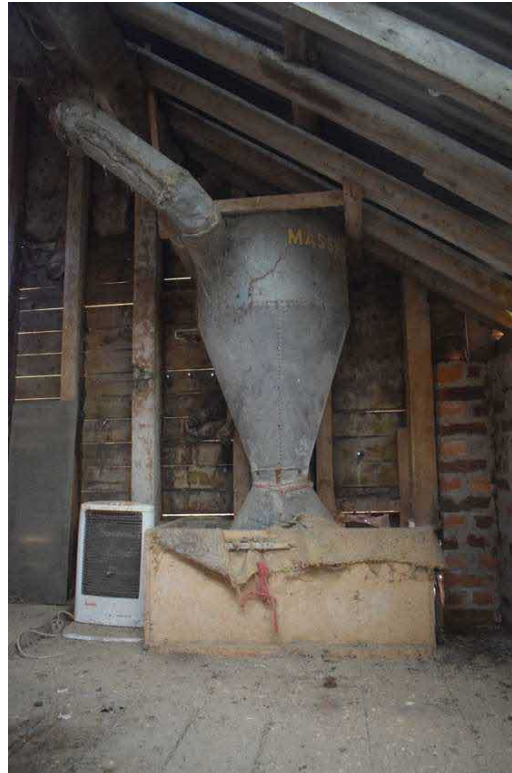
Fig. 15 Feed mixer grinder on the upper floor of Outbuilding 4 Photo CPAT 5036-065

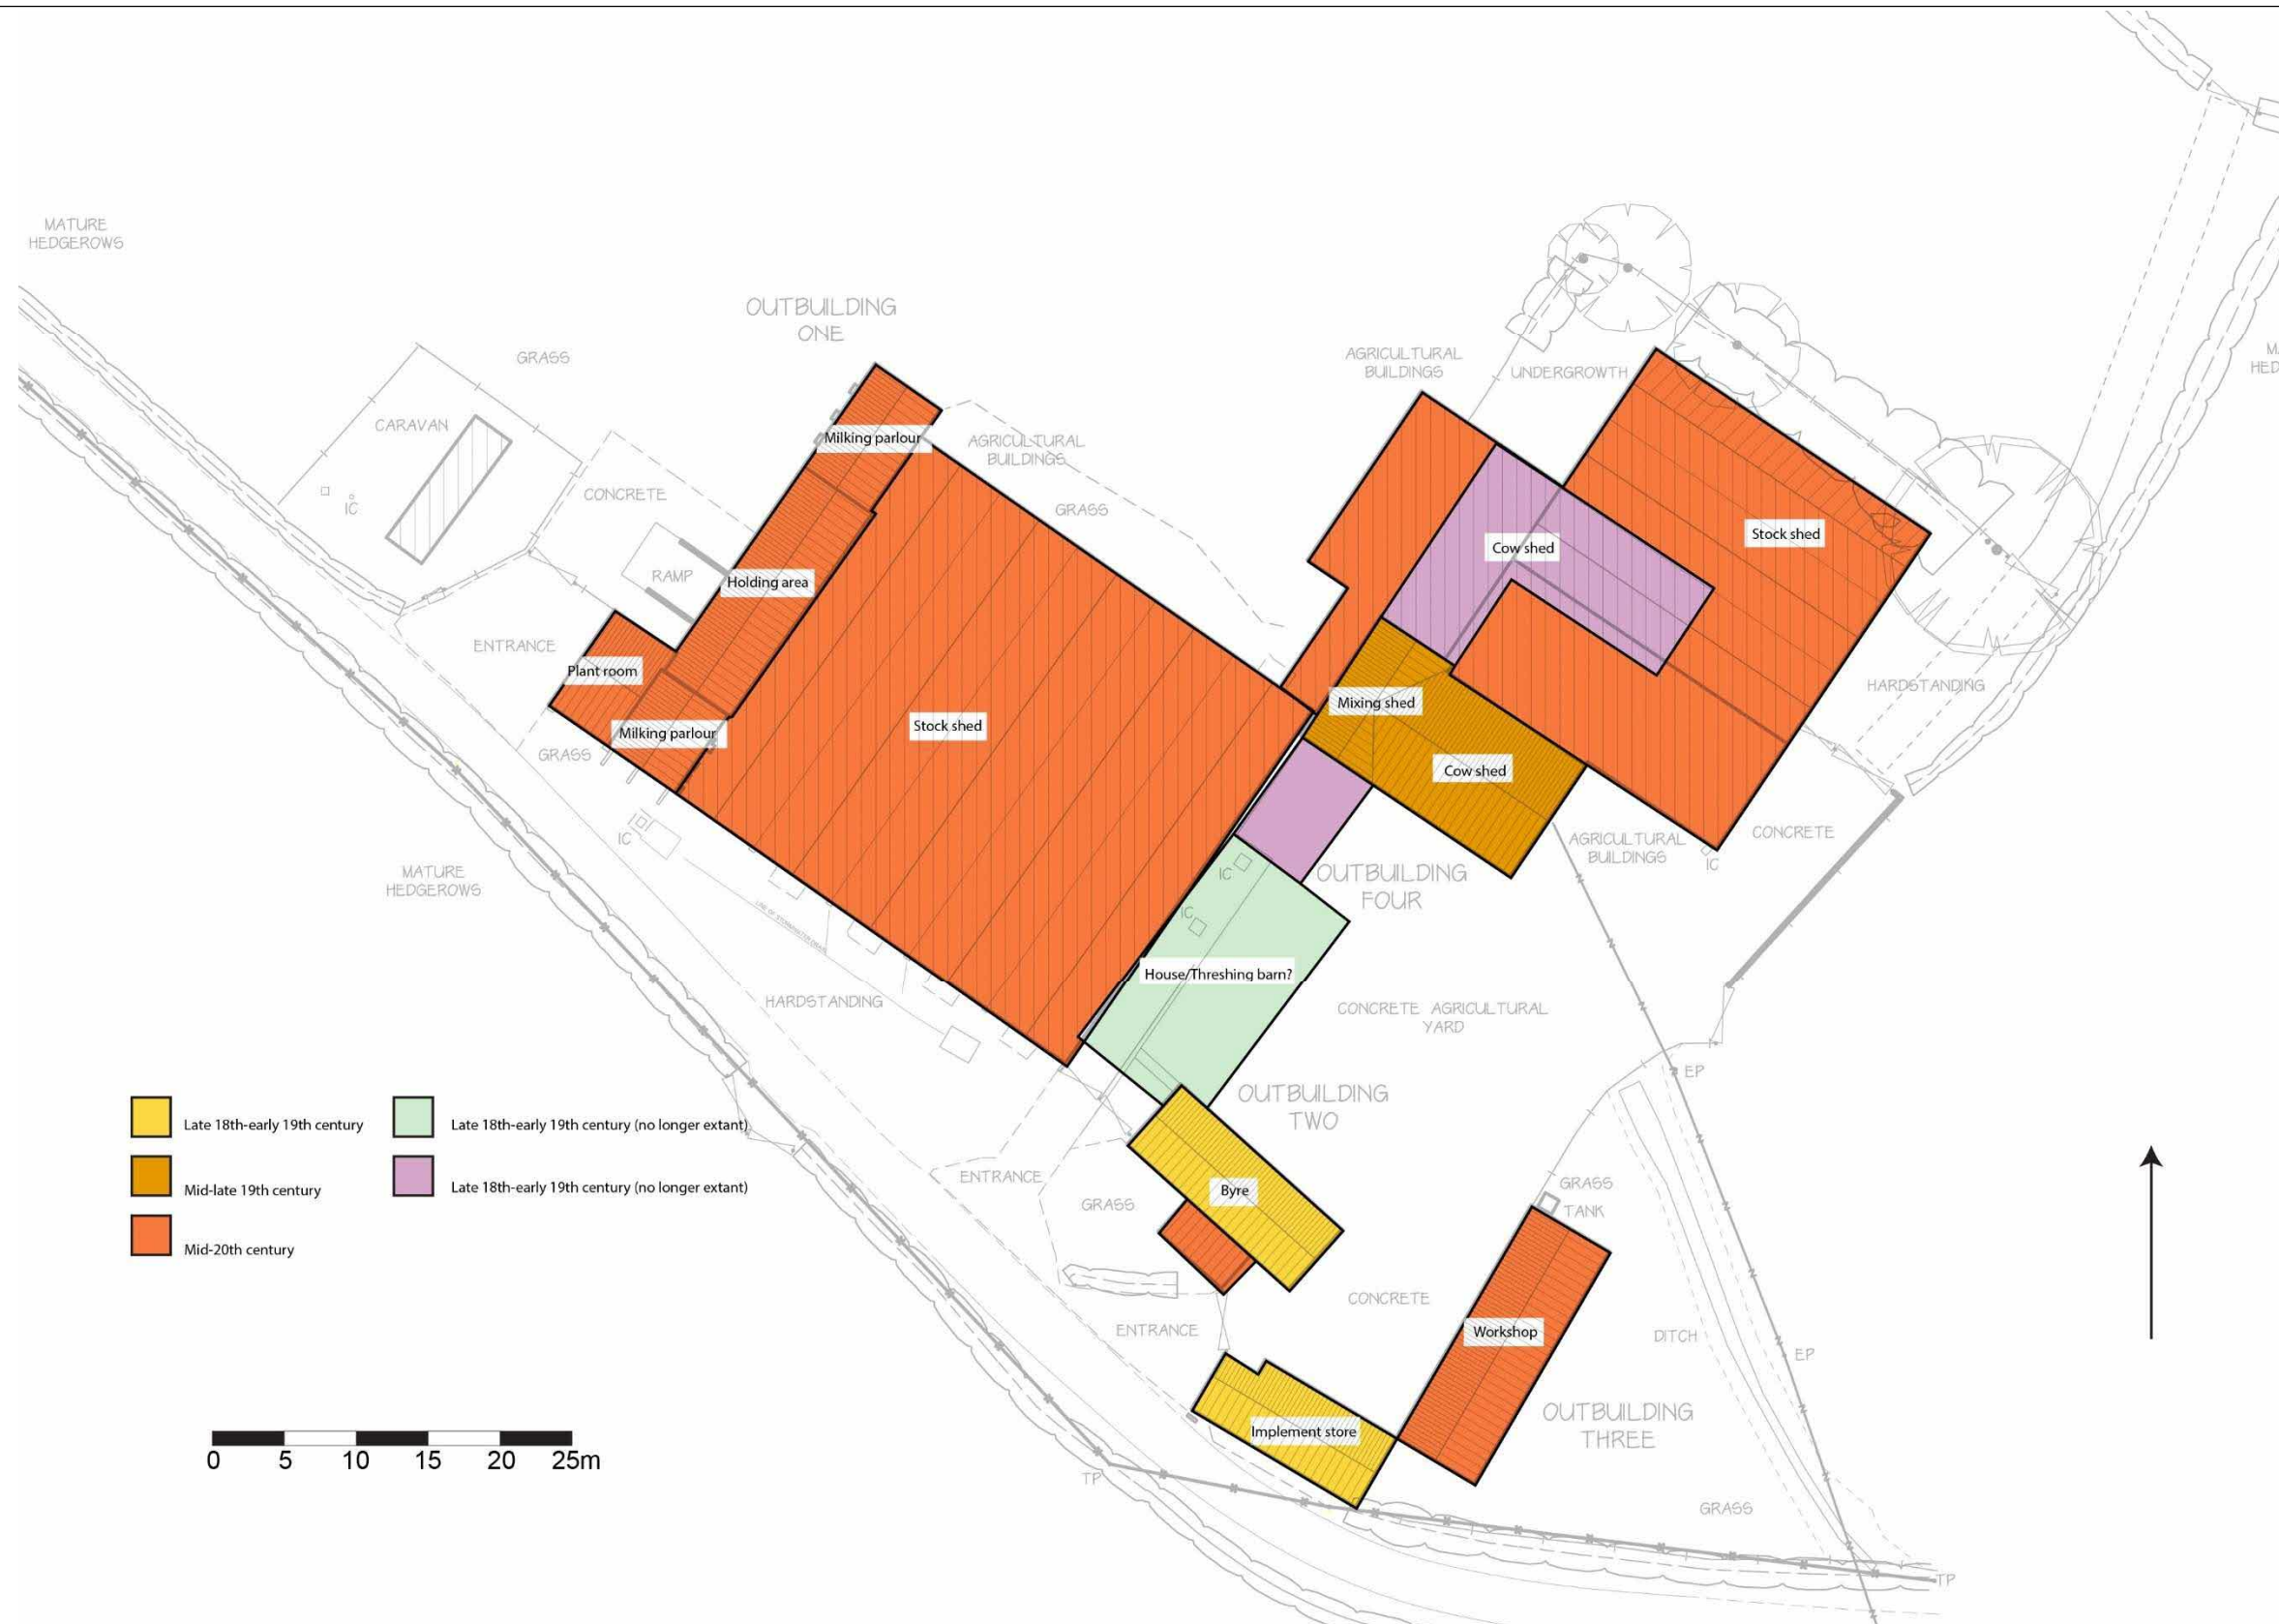
Dwg. 2 Plan showing the approximate date of buildings at the farm, and the locations of the buildings recorded on historical mapping and no longer extant
