**WOOD HOUSE, COANWOOD – PROPOSED DEVELOPMENT  
BAT AND BARN OWL REPORT – SUMMER 2015**

**SECTION 1 BACKGROUND AND SUPPORTING INFORMATION**

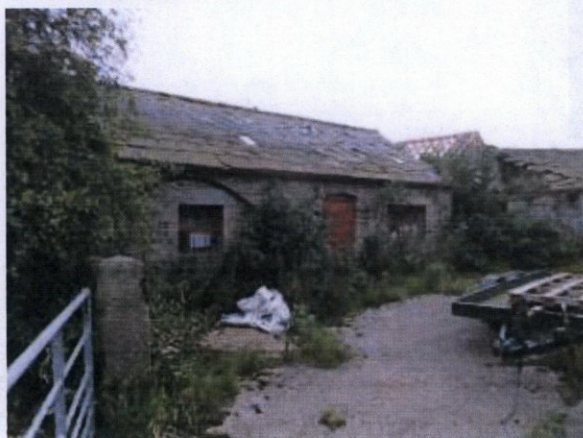
**Building 4 from the southeast**

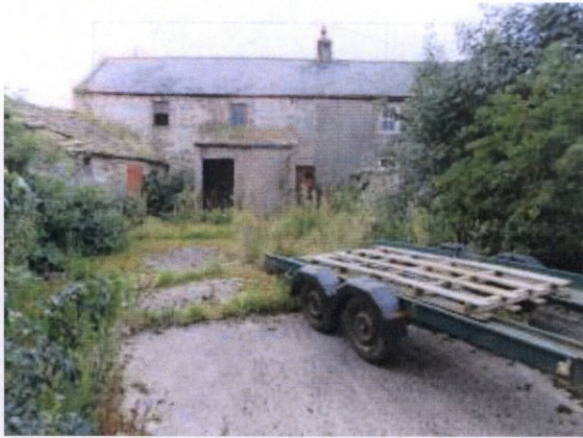
**Building 1, the farmhouse from the southeast**

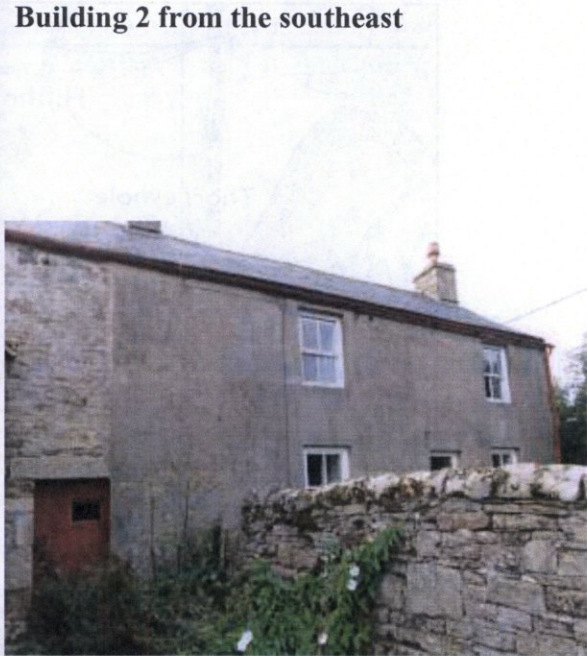
**Building 2 from the southeast**

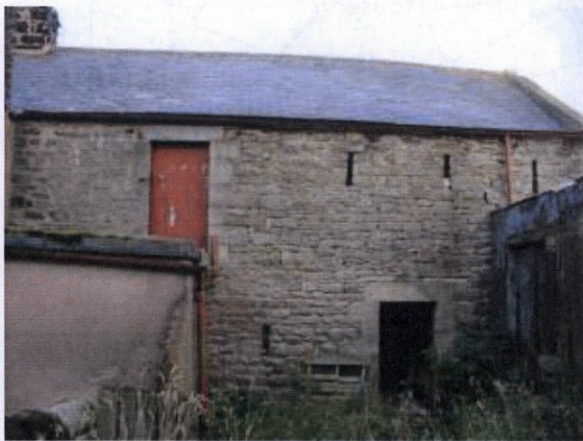
**Building 1 from the west.**

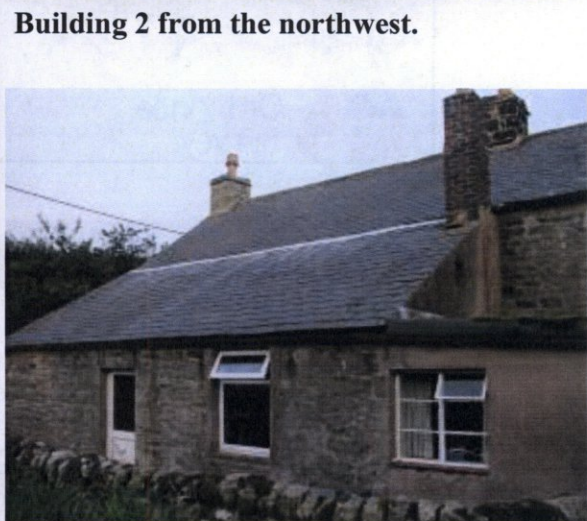
**Building 2 from the northwest.**

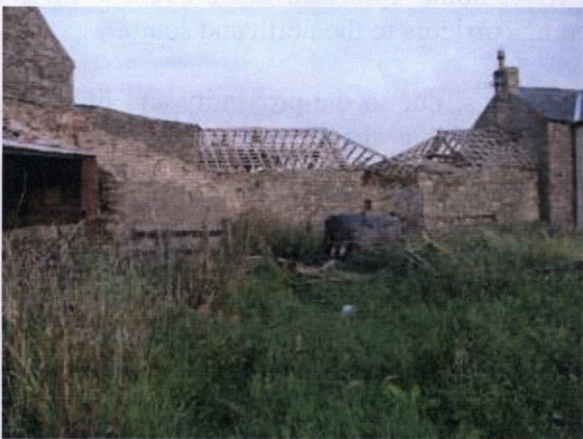
On the August evening survey a Pipistrelle 55kHz emerged from the north gable of Building 4 and Brown long-eared bats were seen emerging from the doorway of Building 2. Pipistrelle 45kHz bats were also seen foraging on site and emerging from a nearby cottage. On the September survey no emergence was noted on site while Pipistrelle 45 kHz bats and Brown long-eared bats were foraging on site in the shelter of an open corrugated metal barn.

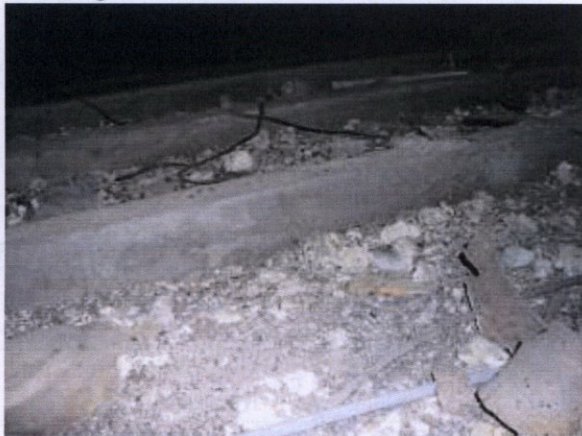
**Farmhouse, Building 1 loft**

**Loft floor of farmhouse (Building 1) with scattering of bat droppings**

The bat loft in the farmhouse (Building 1) will be retained as at present, measuring c.8x5x2m however to ensure bat access is present a lead saddle will be inserted into the north aspect of the roof, also ensuring that access measuring 20 x 20mm through the felt is present. Please see plan at C.1.4 for the locations of mitigation.

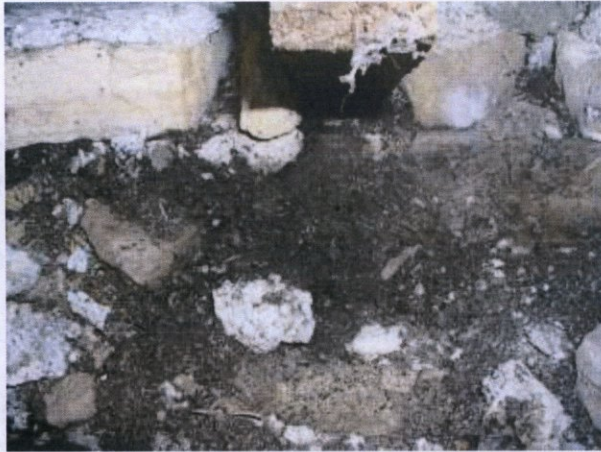
Photo showing disintegrated bat droppings beneath coping stones. If examined carefully, in the black dust exoskeletons of insects can be seen shining.
