# Drayton Manor Lodge, Tring Hill, HP23 4LD

# BS5837 Arboricultural Report, Tree Constraints Plan & Impact Assessment

Surveyor: John Crawshaw M.Arbor.A.

Survey Date: 15 December 2021

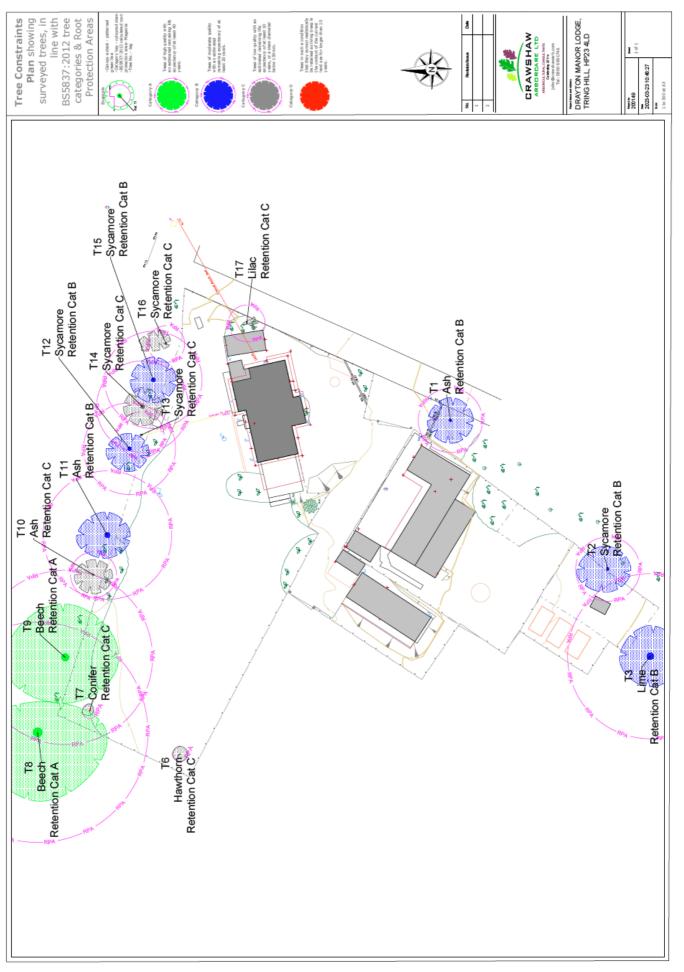
## 4. Tree Constraints Plan

The individual positions of trees and groups of trees recorded in the Tree Survey Schedule. have been shown on the Tree Constraints Plan, in Appendix 2.0. The positions of trees are based on a topographical / land survey supplied by the development and client in dwg. format for the purpose of plotting the trees.

The Root Protection Areas (RPA) to be required by the individual and groups of trees are indicated by the Tree Constraints element of the above plans. The Root Protection Areas are formulated as described below.

Plan below not to scale as PDF. Please refer to original drawing for scaling

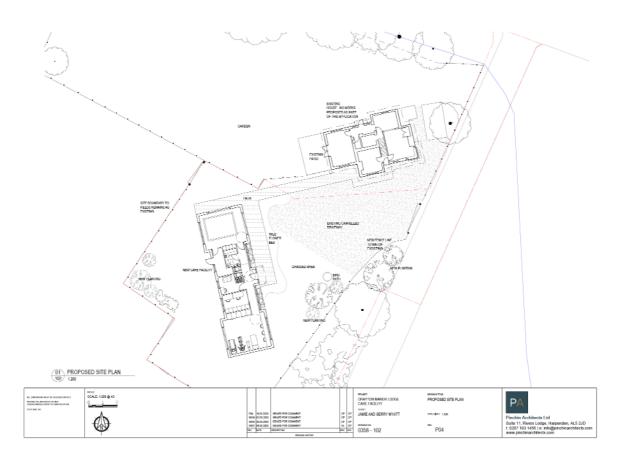
# The proposals are to construct a new care facility as shown below.

The proposals lie entirely outside any RPA. No direct tree impact will result from the proposals shown above.

Protection measures should be set in place during all demolition and construction phases.
