Bat Survey Report for The Old Blacksmiths, Todenham, Moreton-in-Marsh, GL56 9PF

7th April 2023

Report Number: 4508-CWS-01

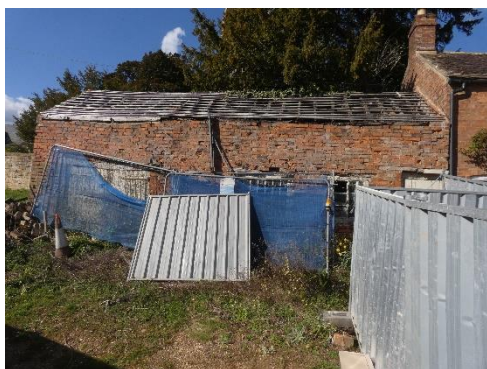
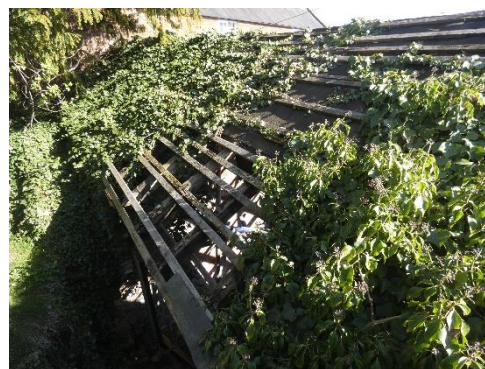
Figs. 1 & 2 Front and rear views of The Old Blacksmiths

The survey site comprised a small, derelict, brick building with no roof covering (Figs. 1 and 2).

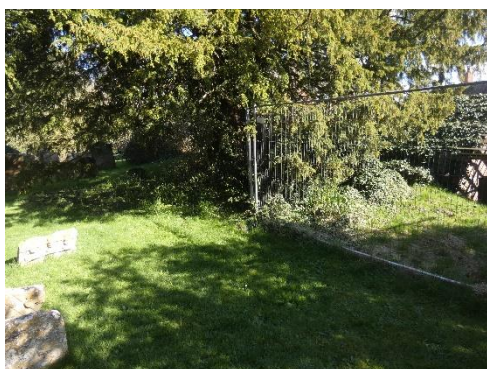
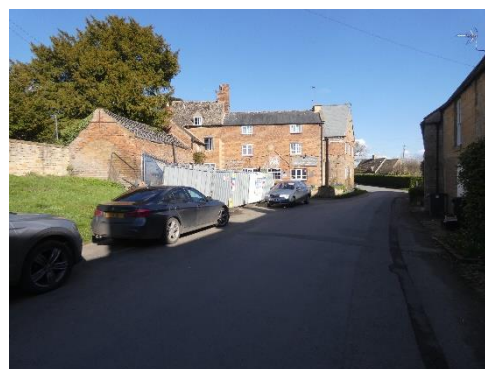
Figs. 3 & 4 Churchyard to rear (L) and road through village (R)

The building was constructed against raised ground on which lay the village church and churchyard (Fig. 3). At the eastern end it adjoined the former Farriers Arms public house, and faced the main road through the village, with just a small area of gravelled hardstanding at the front (Fig. 4).

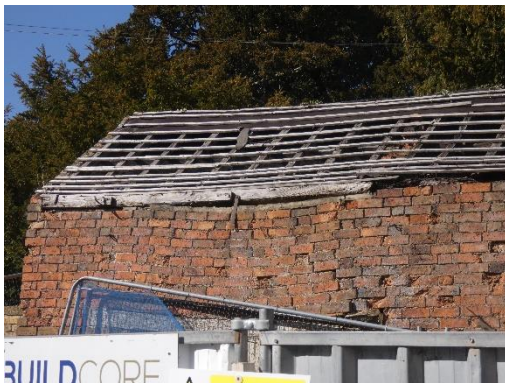
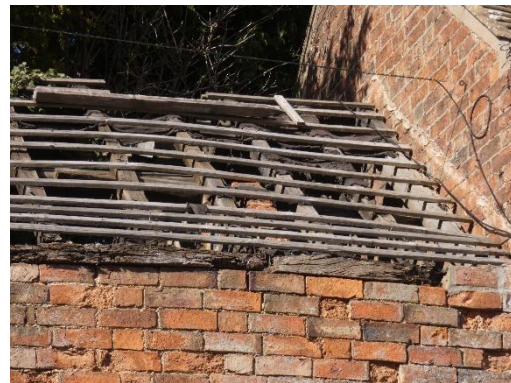
Figs. 5 & 6 Untiled roof at front

The roof of the building was in very poor condition, with no tiles or slates on either roof slope and all the timbers were exposed (Figs. 5-7). In places there were the remnants of a tiled felt lining, but most of this was missing. There were no eaves and no roof verge (Fig. 8).

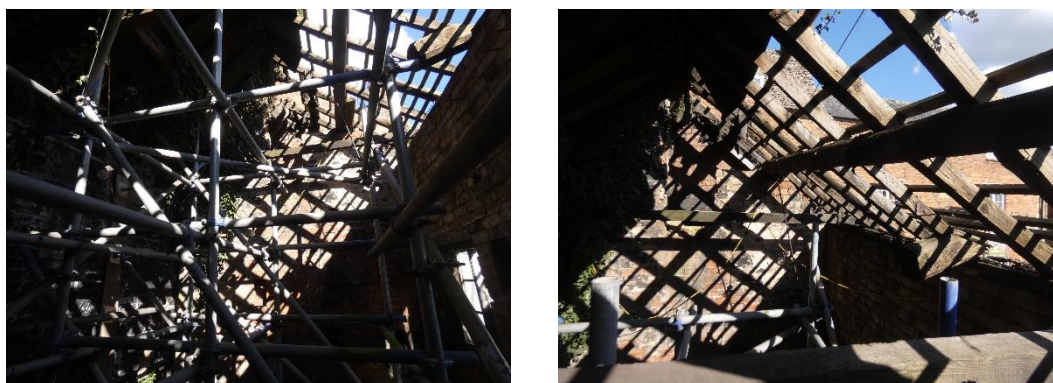
Figs. 9 & 10 Interior of building

Internally the building was scaffolded, this extending into the open roof space (Figs. 9 and 10).

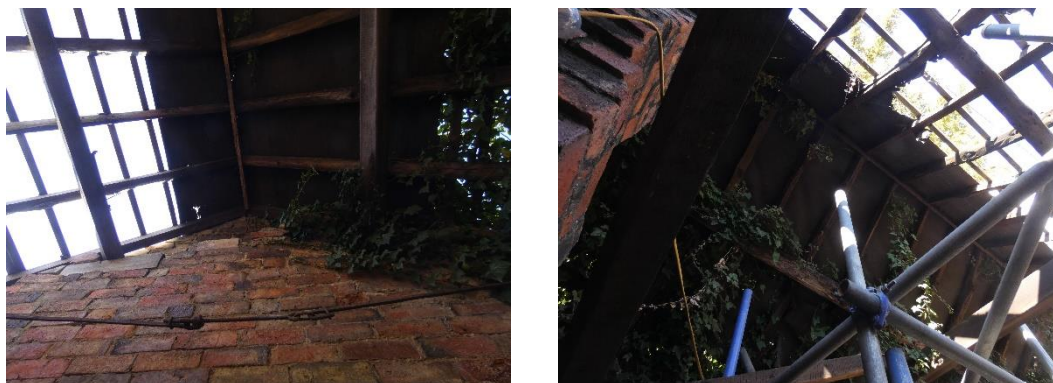
Figs. 11 & 12 Underside of roof of building

The roof was partially lined with the aforementioned tarred felt, and Ivy *Hedera helix* was penetrating from the churchyard (Figs. 11 and 12).

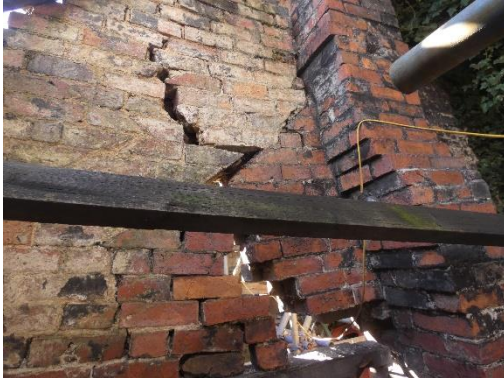
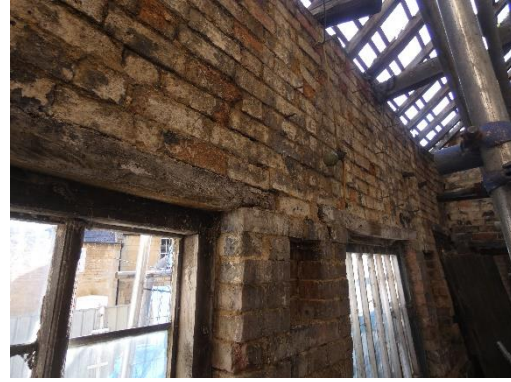
Figs. 13 & 14 Crack in internal wall (L) and windows (R)

The building was separated into two rooms with a full height dividing wall. This contained a wide crack and was in imminent danger of collapse (Fig. 13).

The whole interior was very brightly illuminated by the missing roof covering and through the windows (Fig. 14).

No evidence of bat occupation was discovered inside the building, and it was considered unsuitable for roosting bats.
