PHASE 2: GROUND INVESTIGATION REPORT
PROPOSED RESIDENTIAL DEVELOPMENT
PORTLAND CONSULTING ENGINEERS
EBENEZER CHAPEL
SCALES CRESCENT
PRUDHOE

Project No: 22-1151

Date: 3rd April 2023

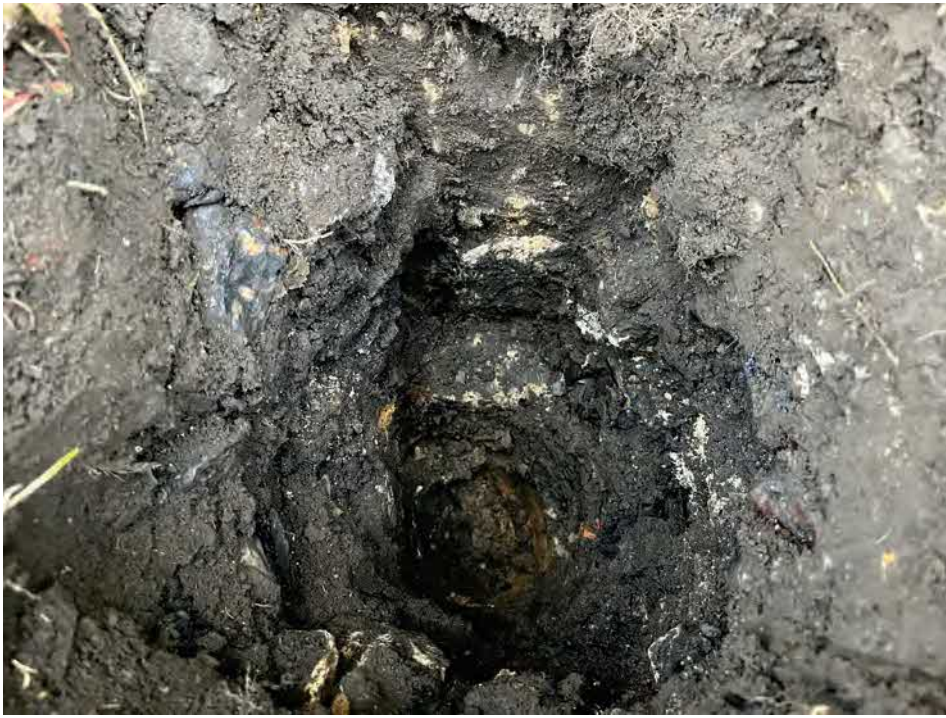
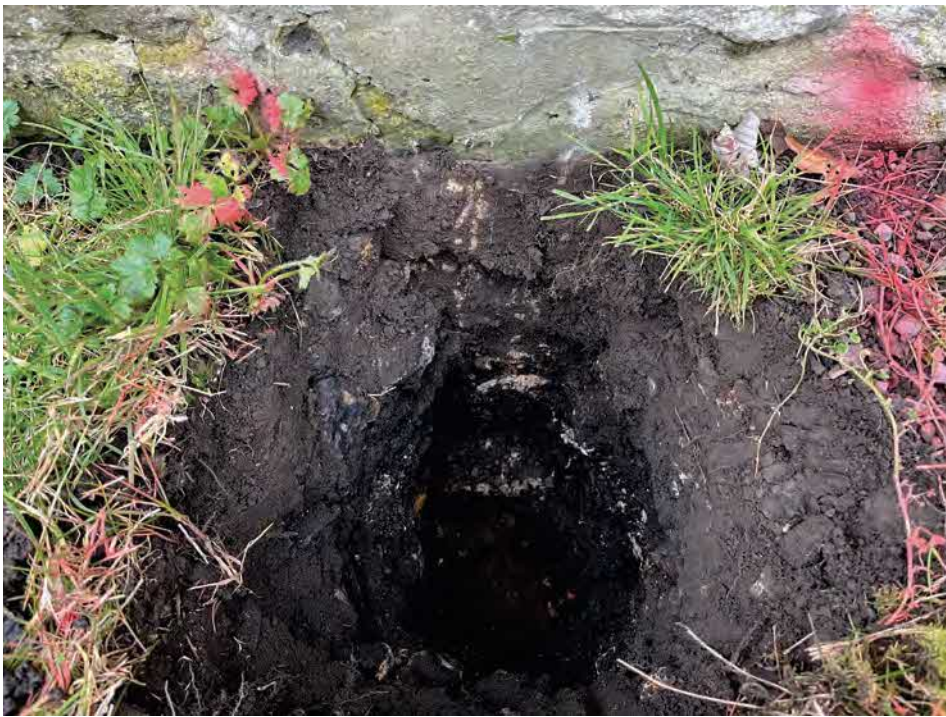
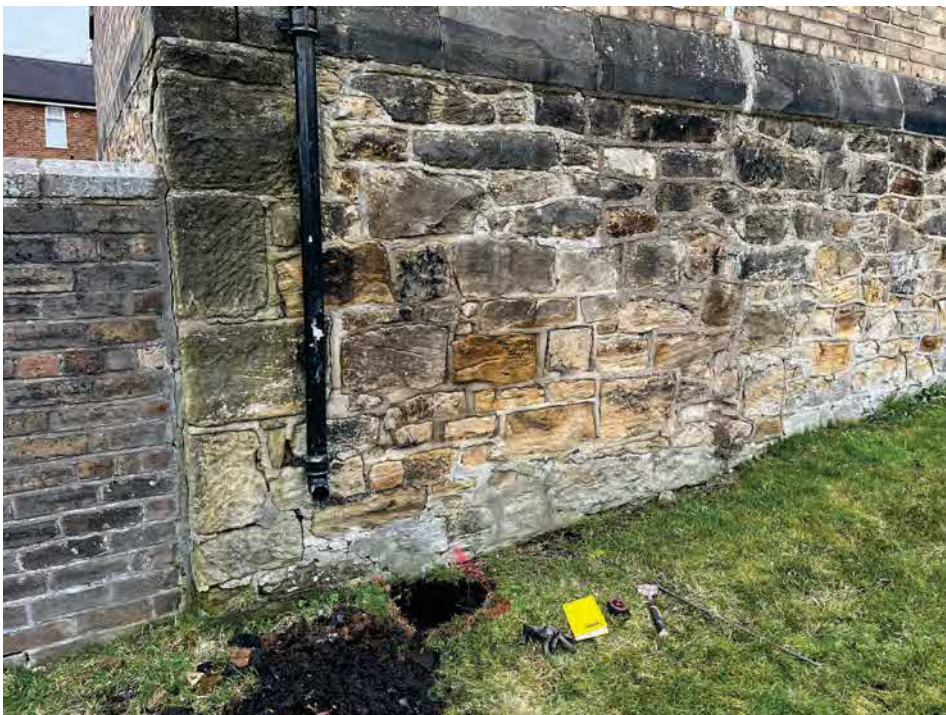
Trial Pit	Description & General Comments
FP01	Sandstone blockwork was recorded to c.0.65m with a c.0.10m projection at c.0.50m and based within soft very sandy gravelly CLAY.
FP02	Brickwork was based on sandstone blockwork from c.0.05m to c.0.45m with a projection of c.0.50m at c.0.30m and based within firm very sandy gravelly CLAY.
FP03	Brickwork was based on sandstone blockwork from c.0.30m above ground level to c.0.45m BCGL with a projection of c.0.05m at c.0.25m BCGL and based within firm very sandy gravelly CLAY.
FP04	Sandstone blockwork was recorded to c.0.50m and based within soft and firm very sandy gravelly CLAY.
FP05	Sandstone blockwork was recorded to c.0.55m with a c.0.10m projection at c.0.15m and a c.0.12m projection at c.0.45m based within soft and firm very sandy gravelly CLAY.

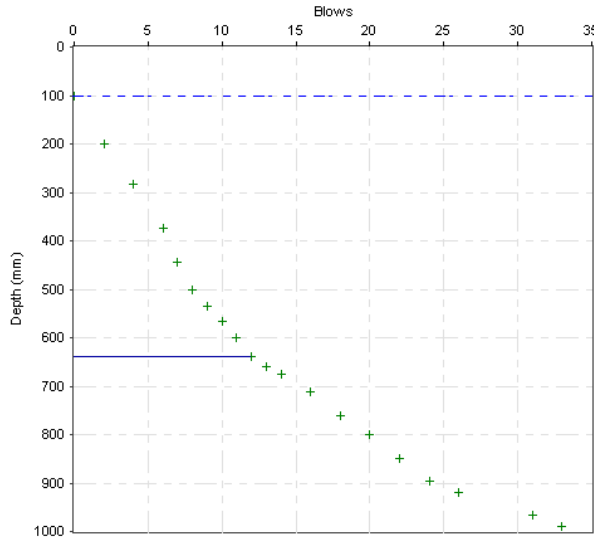
Layer Boundaries Chart

Test Position	Layer	Strata	Thickness of Layer (mm)	Depth bcgl's to Bottom of Layer (mm)	Penetration Rate (mm/blow)	CBR Value (%)
DCP01 (TP03)	1	NS	540	640	44.00	6
	2	NS	350	990	16.67	15

The calculated CBR values for the initial underlying natural superficial deposits range between 6% and 15%.

When considering these results, it is recommended that a characteristic design CBR value of 5% should be taken for the natural superficial deposits.

However, it should be noted that the achievable CBR values may improve under compaction / proof rolling, prior to emplacement of the stone sub-base, which will also help to identify any 'soft spots' that may require re-compaction or digging out and replacement with additional compacted sub-base.

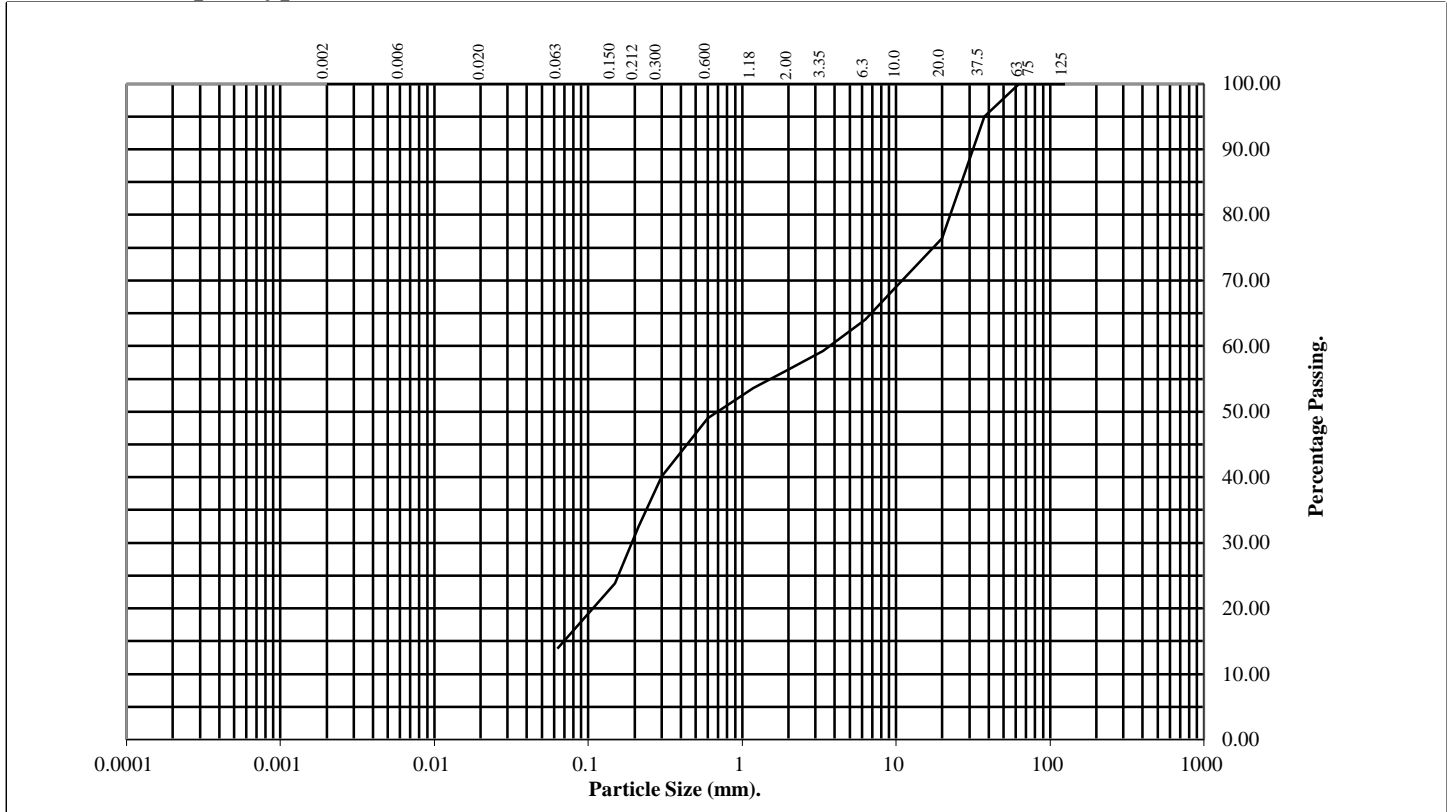
Sample Number: Base Depth(m): **1.00**

BS Test Sieve (mm)	Percentage Passing
125	100
75	100
63	100
37.5	95
20	76
10	69
6.3	64
3.35	59
2	56
1.18	54
0.6	49
0.3	40
0.212	32
0.15	24
0.063	14

Soil Fraction	Total Percentage
Cobbles	0
Gravel	44
Sand	42
Silt/Clay	14

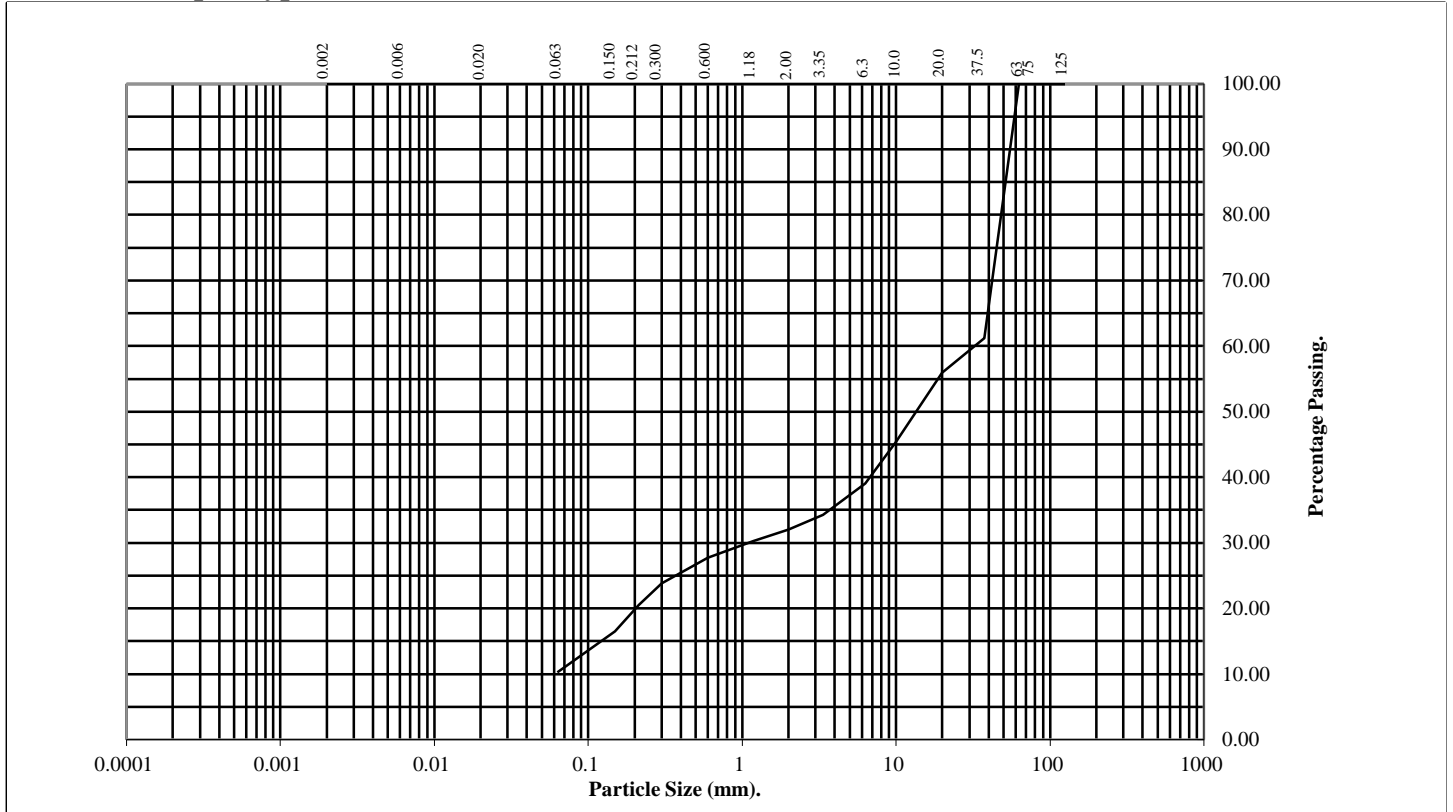
Sample Number: Base Depth(m): **3.50**

BS Test Sieve (mm)	Percentage Passing
125	100
75	100
63	100
37.5	61
20	56
10	45
6.3	39
3.35	34
2	32
1.18	30
0.6	28
0.3	24
0.212	21
0.15	16
0.063	10

Soil Fraction	Total Percentage
Cobbles	0
Gravel	68
Sand	22
Silt/Clay	10

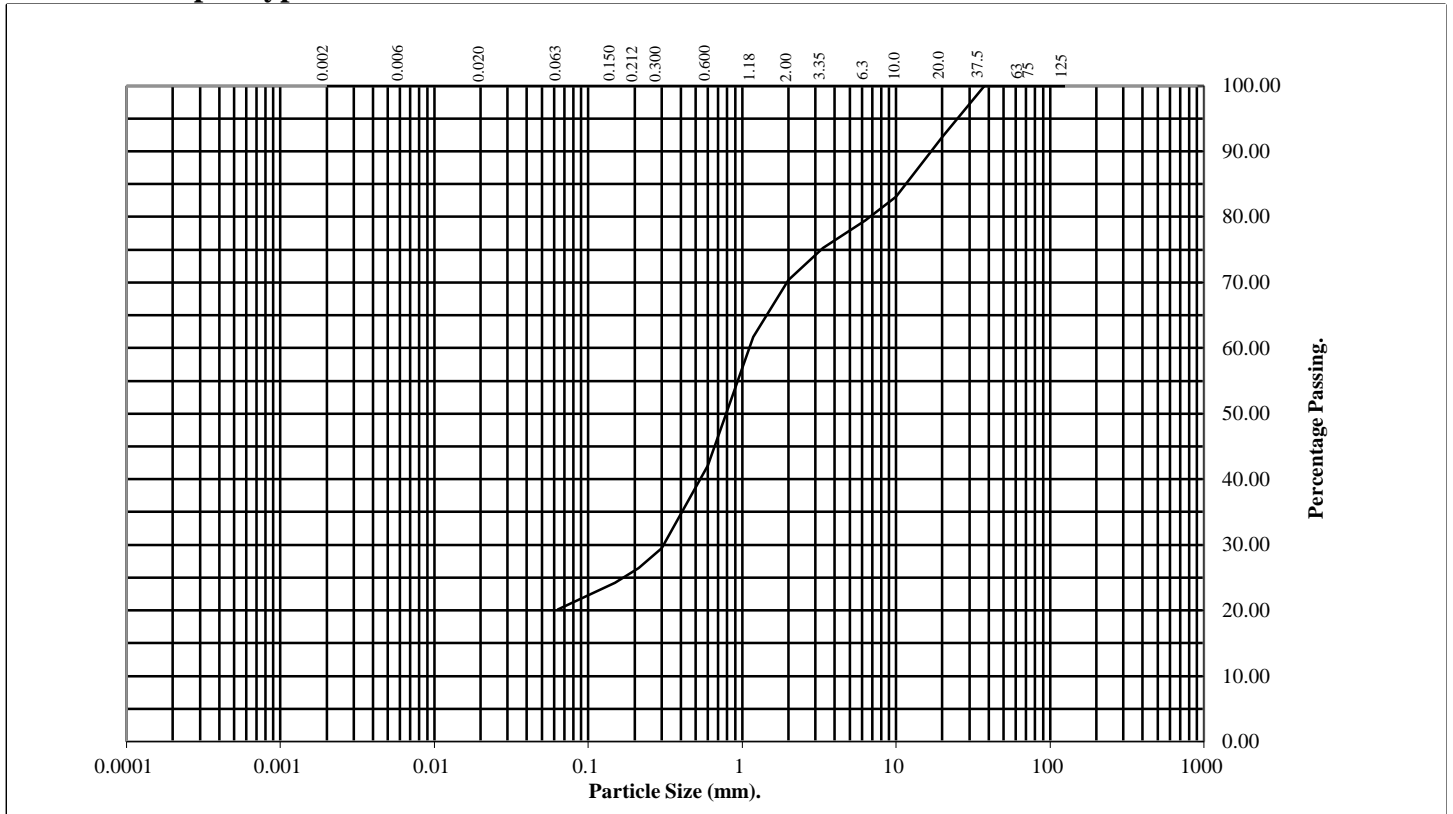
Sample Number: Base Depth(m): **2.00**

BS Test Sieve (mm)	Percentage Passing
125	100
75	100
63	100
37.5	100
20	92
10	83
6.3	79
3.35	75
2	70
1.18	62
0.6	42
0.3	29
0.212	26
0.15	24
0.063	20

Soil Fraction	Total Percentage
Cobbles	0
Gravel	30
Sand	50
Silt/Clay	20

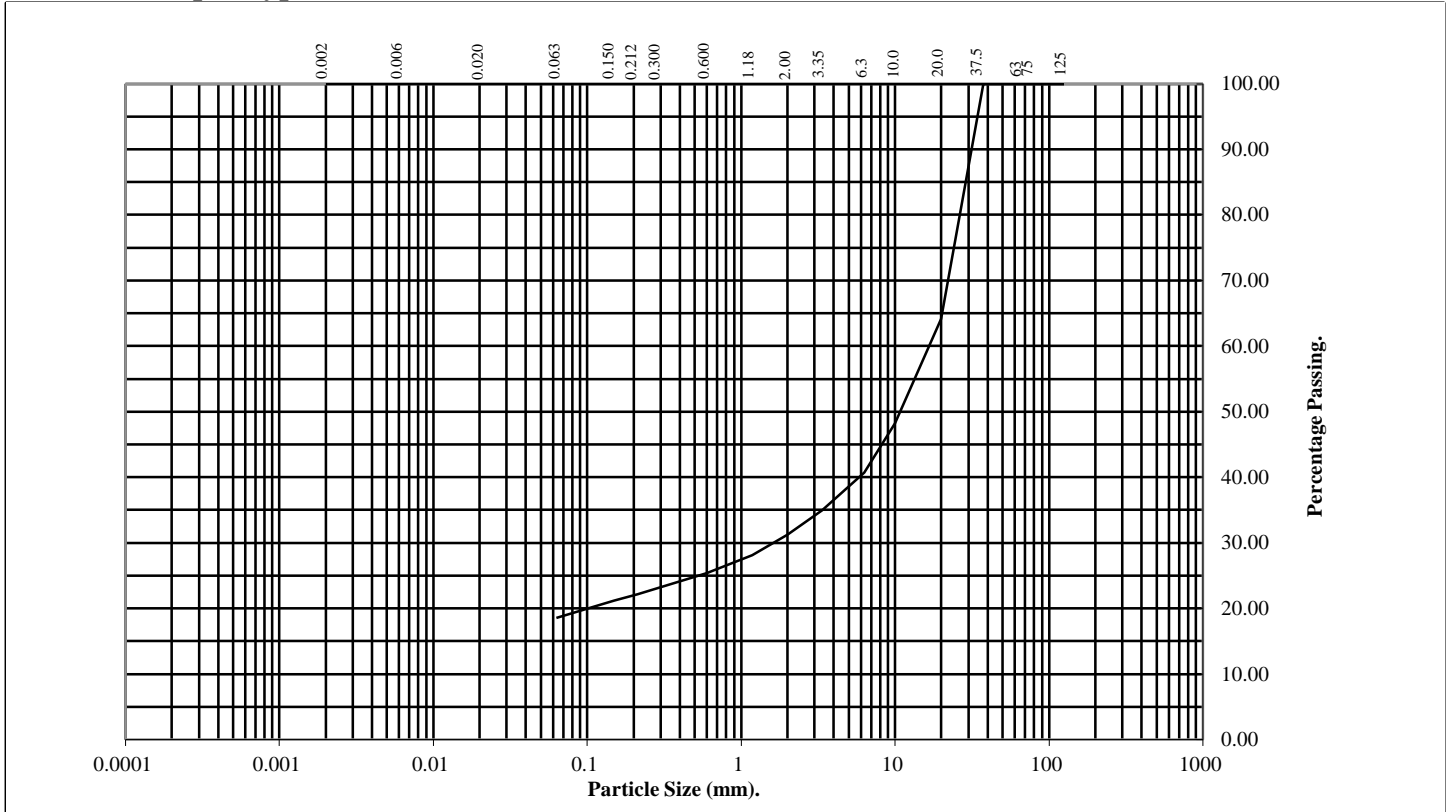
Sample Number: Base Depth(m): **3.00**

BS Test Sieve (mm)	Percentage Passing
125	100
75	100
63	100
37.5	100
20	64
10	48
6.3	41
3.35	35
2	31
1.18	28
0.6	25
0.3	23
0.212	22
0.15	21
0.063	19

Soil Fraction	Total Percentage
Cobbles	0
Gravel	69
Sand	12
Silt/Clay	19

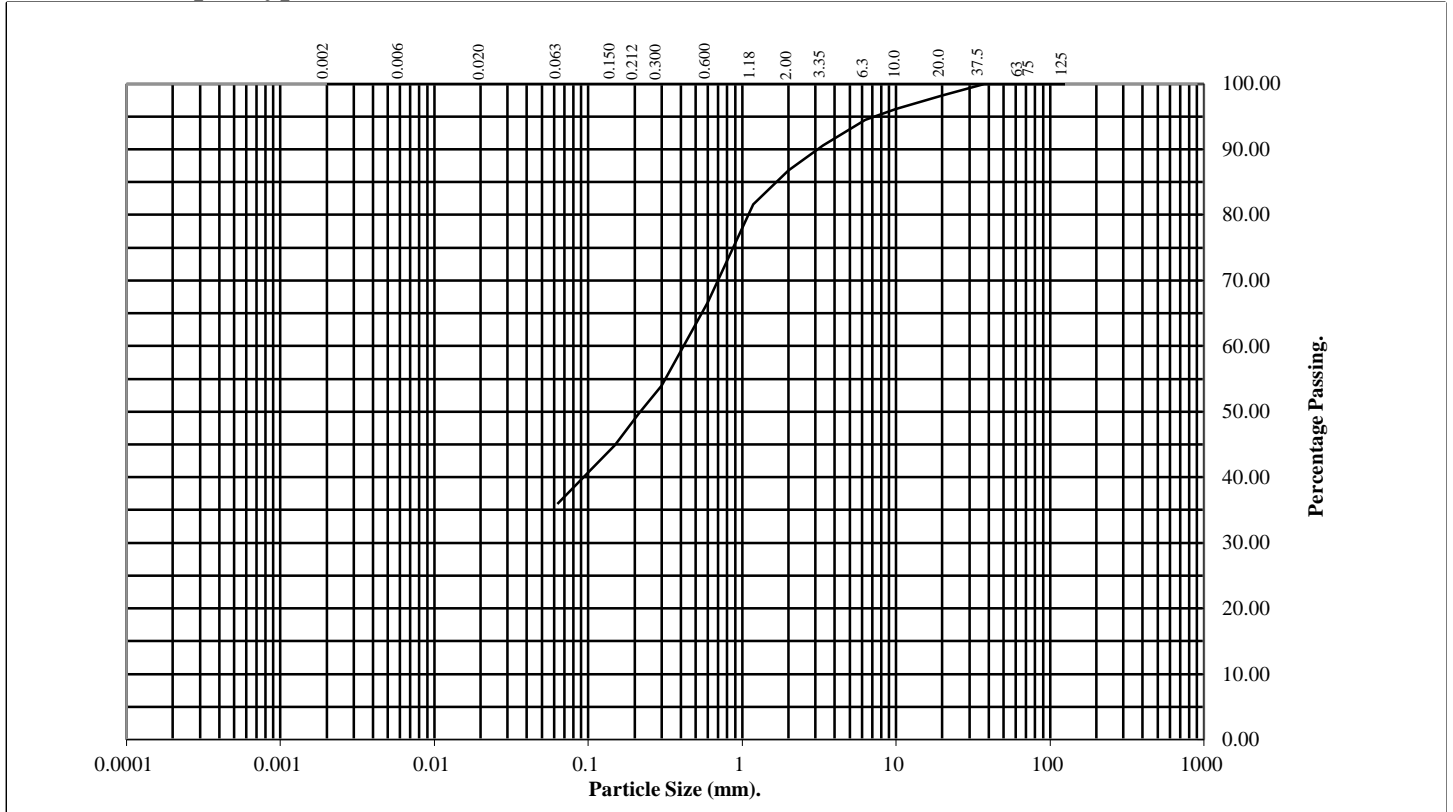
Sample Number: Base Depth(m): **2.70**

BS Test Sieve (mm)	Percentage Passing
125	100
75	100
63	100
37.5	100
20	98
10	96
6.3	94
3.35	91
2	87
1.18	82
0.6	67
0.3	54
0.212	50
0.15	45
0.063	36

Soil Fraction	Total Percentage
Cobbles	0
Gravel	13
Sand	51
Silt/Clay	36
