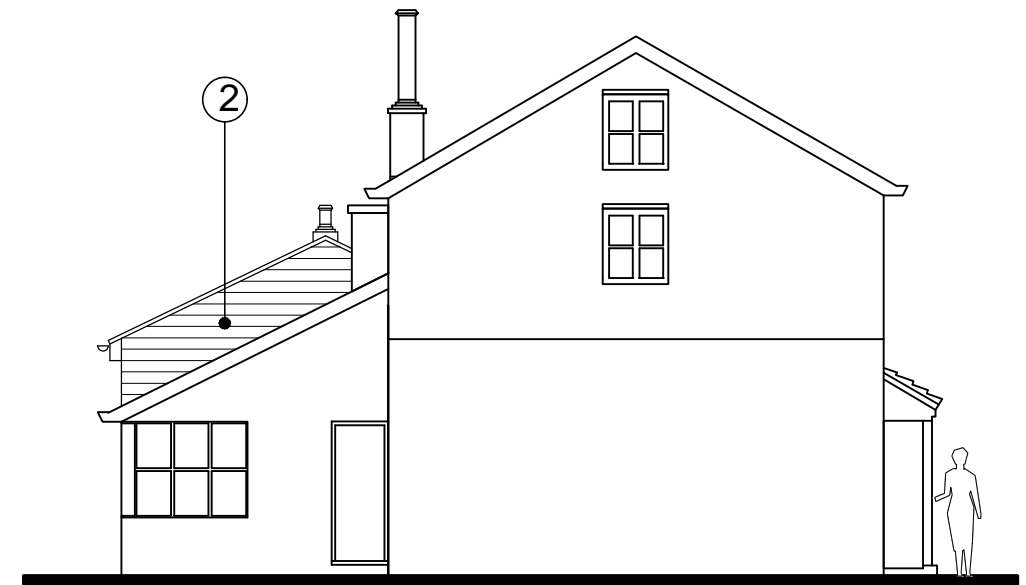
Proposed side elevation

- 1 NATURAL SLATE TO MATCH EXISTING
- 2 STAINED TIMBER WEATHER BOARDING TO MATCH EXISTING
- 3 BLACK PAINTED BRICK PLINTH
- 4 PAINTED TIMBER WINDOWS DOORS
- 5 RED FACING BRICK CHIMNEY
