## Jackdaws Ford, Chelsworth, Suffolk

### Preliminary Ecological Appraisal

**Ref:** 1832

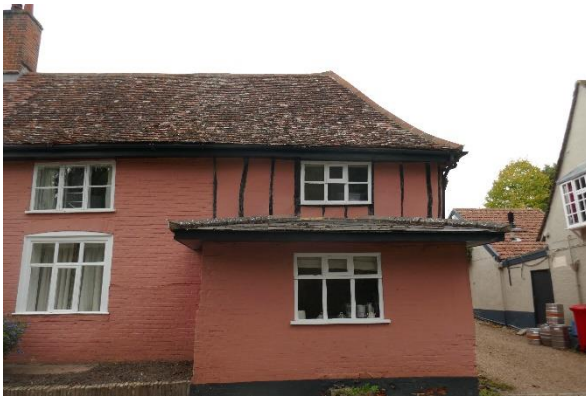
- 4.9 A small single storey extension on the south eastern corner of the house supports a shallow slate covered roof. The slates are closely fitted, with no potential bat access points noted, however they leak and are proposed for re-fitting and / or replacement at a slightly steeper pitch.

Photo 1: South eastern façade of house, with small single storey, slate tiled extension – to be re-roofed

- R1. Butcher's Roof  
E.g. slate roof at approximately 12° pitch with concrete hips is leaking. To be re-roofed with slate with lead roll hips at approximately 24° pitch. Painted cast iron half-round gutters to be added.

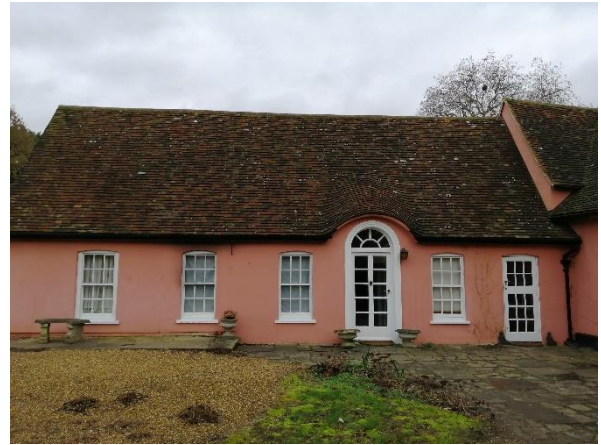
- 4.10 Both southern and northern sections of the roof were replaced around six years ago, with most of the original peg tiles re-laid and the roof lined with a breathable membrane to replace what appears to have been traditional bitumen felt in some parts, and lathe and plaster in others. The ridge tiles are well cemented with no gaps noted, however the handmade and poor fitting nature of the peg tiles creates numerous crevices beneath the tiles which provide potential access for bats. A curved section of roof is present on the western elevation of the northern roof space, above a doorway, which is due to be realigned with a new porch as part of the proposals.

Photo 2: Western façade of northern half of building, showing arched roof over a doorway. To be realigned to match remainder of roof

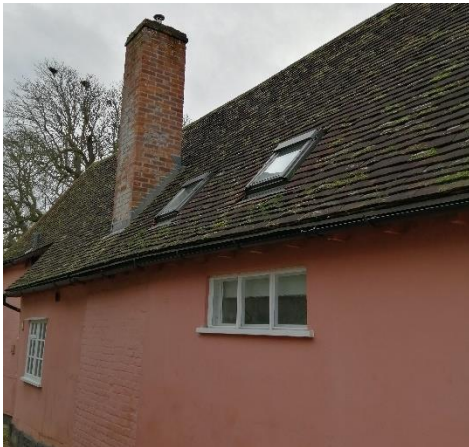
- 4.11 Two existing sky lights are present on the eastern façade of the northern roof space, to be removed as part of the proposals. No apparent gaps which could provide potential roosting opportunities for bats were noted around the skylights. No potential access points for bats were observed around any of the eaves of the building.

Photo 3: Roof lights on eastern façade of northern half of building – to be removed

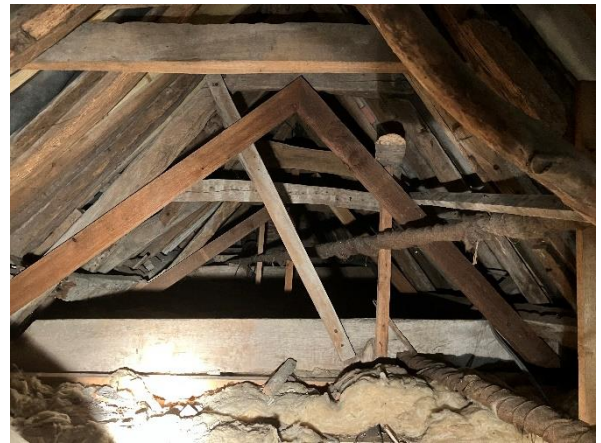
Photo 4: Roof space across southern section of the building – to remain entirely undisturbed

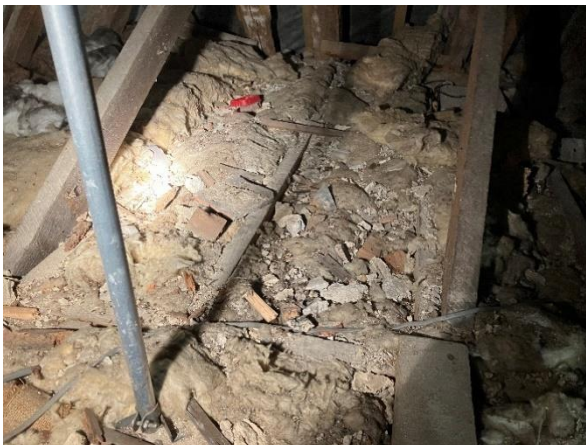
Photo 5: Lime plaster, wood offcuts, general debris and dust typical of floor space in southern loft

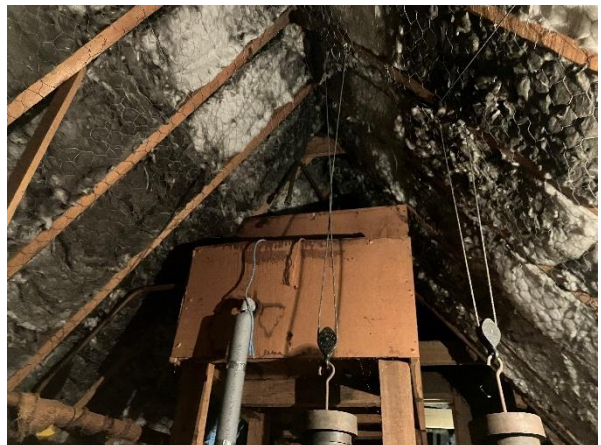
Photo 6: Water tank and insulation between rafters in northern roof space

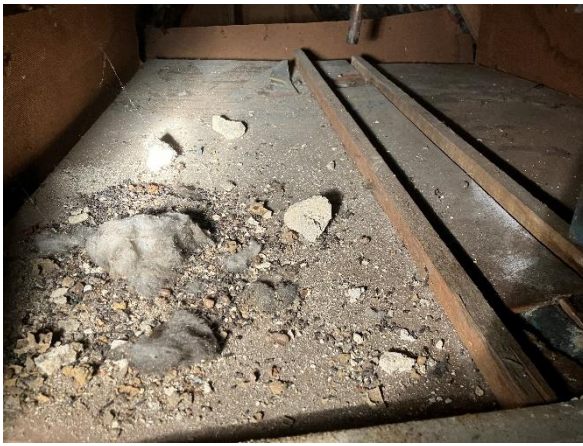
- 4.15 The top of the water tank was found to support around 100 old, dry and very dusty – to the extent that the droppings were grey – likely brown long-eared droppings. See Photo 7, provided later in this report. The droppings were interspersed with dirt and fine rubble debris which is likely to have been created during re-roofing works. A further c.30-40 droppings were recorded on the top of a tie beam, also very dull, grey and dusty – see Photo 8. No bat droppings were recorded across the floor of the loft space, which consists of wooden boards and is used to store suitcases, and no fresh i.e. dark and shiny droppings were recorded. Occasional mouse droppings were present.

Photo 7: Collection of c.100 dry and dusty bat droppings on top of water tank cover, along with rubble and debris likely produced during re-roofing work

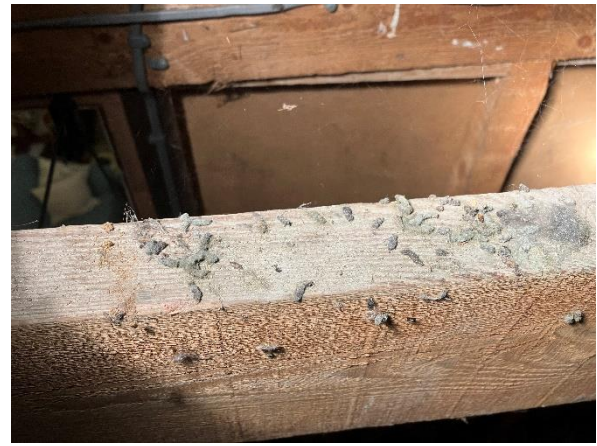
Photo 8: 30-40 dry and very dusty likely BLE droppings on an undisturbed roof beam in northern roof space

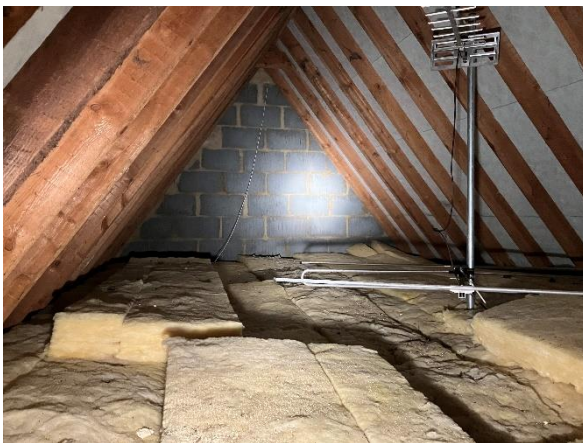
- 4.16 The central roof section is separated from the northern loft space with a breeze block internal wall, and the southern roof space with a timber stud wall; with modern wooden rafters supporting the peg tiles and lined with breathable membrane. It is approximately 3m wide, by 5m long and almost 2m high. Thick fibreglass insulation is present across the floor of the loft, with up to 50 likely old (dull, dusty and crumbly) brown long-eared bat droppings recorded at the southern end when the insulation was lifted in an attempt to locate beams on which to stand. No fresh droppings were found on top of the apparently new insulation, suggesting that bats may have been present prior to re-roofing work.

Photo 9: Internal view of central northern roof section, with new insulation laid across old bat droppings

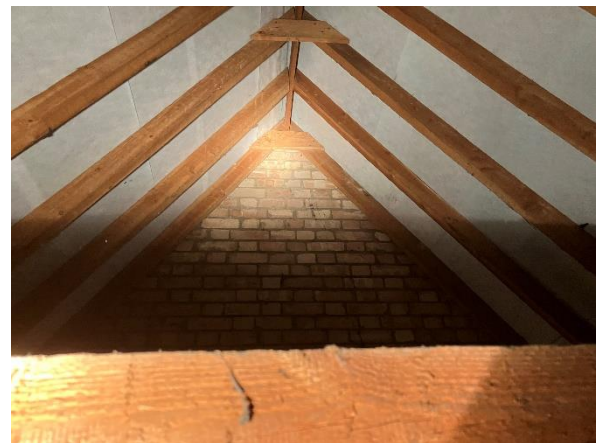
- 4.17 The northern most roof section is a very short (c.3.5m x c.4m), but tall (c.2.5-3m) roof space with a breeze block end wall and a brick end wall, modern wooden beams and a breathable membrane. A small number (20-30) of old likely brown long-eared bat droppings were also found beneath new insulation in this section of the roof, and up to 10 potentially fresher droppings around the loft hatch, however it is not known whether these were disturbed during entry.

Photo 10: Northern gable wall, inside northern most loft of northern roof section. (Loft too short and tall to obtain full field of view with camera)

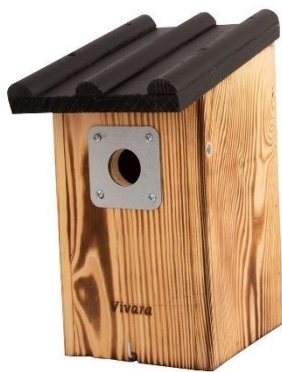
The boxes will each have a 32mm diameter access hole (suitable for use by house sparrows). The boxes will be positioned as close as possible (at least within 300mm) of one another, and at least 2m high or immediately beneath the eaves of the building.

'Travis' style wooden nest box with 32mm diameter hole and predator-proof metal plate.
