# Heritage, Design and Access Statement

**For the proposed roof conservation and restoration works at:**

*HECKFIELD CHURCH OF ENGLAND PRIMARY SCHOOL,  
ODIHAM ROAD, HECKFIELD, HAMPSHIRE RG27 0LE*

The maintenance and/or replacement of the existing good, damaged or failing historic roof tiles.

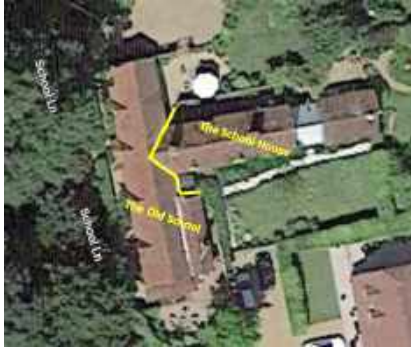
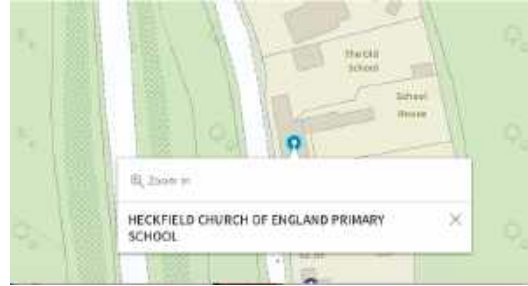
Image 1: Left image (courtesy of Google Maps) and right image (courtesy of Heritage England website listing) showing Heckfield Church of England Primary School as the collective name for The Old School and The School House.

- Heckfield Church of England Primary School always appears as this “T” shape (as per image 1) in all the historic maps. If the school appears, then it is this shape!
  - For interest, the block that appears on the right-hand side of the “T” in the google image was actually the children’s toilets. Boys had the top half, girls had the bottom half.

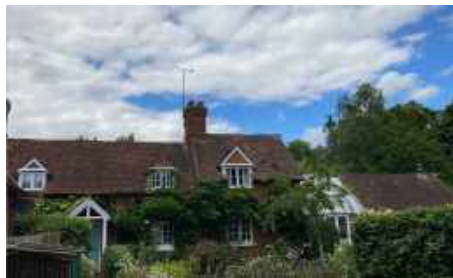
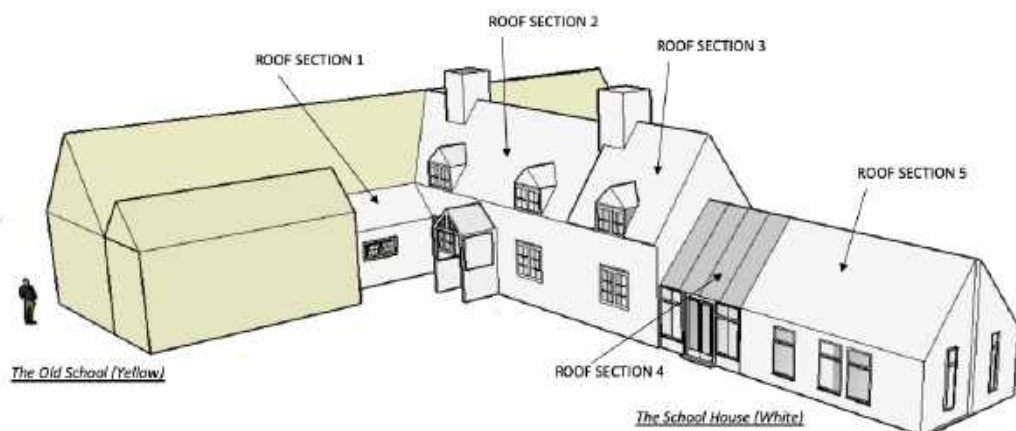
Image 4: The South Elevation

- **Roof Section 1**

- This roof covering is a natural slate and is in good condition, as is all the leadwork.
- No major works required

**PROPOSAL:**

- Check integrity of the slates and flashing, repair as required

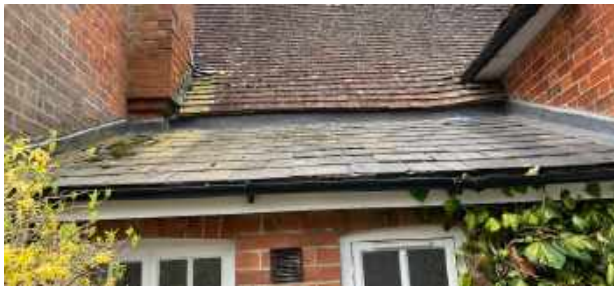
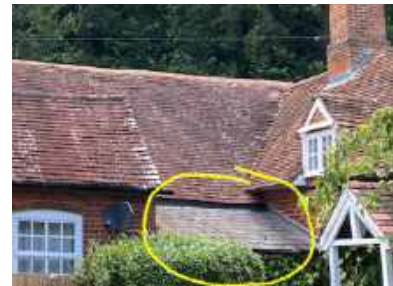
- **Roof Section 2**

- Historic clay peg tiles, handmade, plain
- Estimated 30% of these peg tiles require replacing
- Ridge tiles mortar is non-existent
- May have to strip into the valley
- Some delamination due to frost

**PROPOSAL:**

- Remove all peg tiles and ridge tiles, rescue reusables and set aside
- Inspect timbers, membrane and leadwork, replace as necessary
- Replace with matching reclaimed peg tiles and ridge tiles as necessary

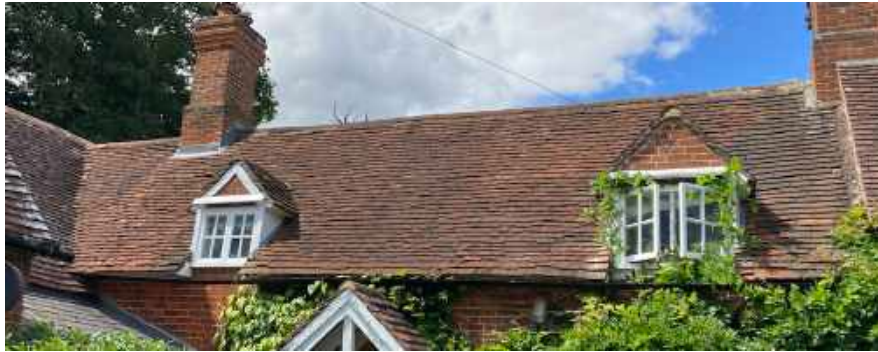
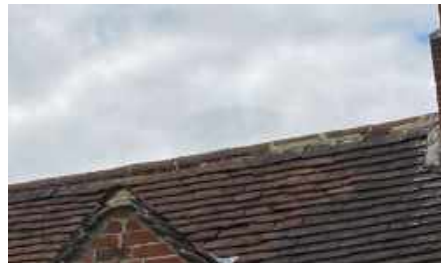
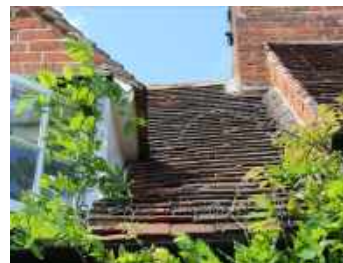
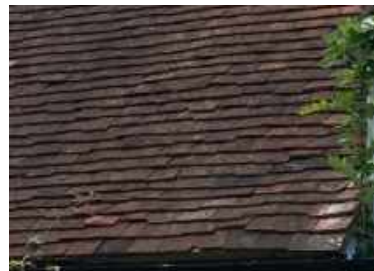
- **Roof Section 3**

- Historic clay peg tiles, machine made
- Different to roof Section 1
- Estimated 50% of these peg tiles require replacing
- Ridge tiles mortar is non-existent

**PROPOSAL:**

- Remove all peg tiles and ridge tiles, rescue reusable ones and set aside
- Inspect timbers, membrane and leadwork, replace as necessary
- Replace with matching reclaimed peg tiles and ridge tiles as necessary

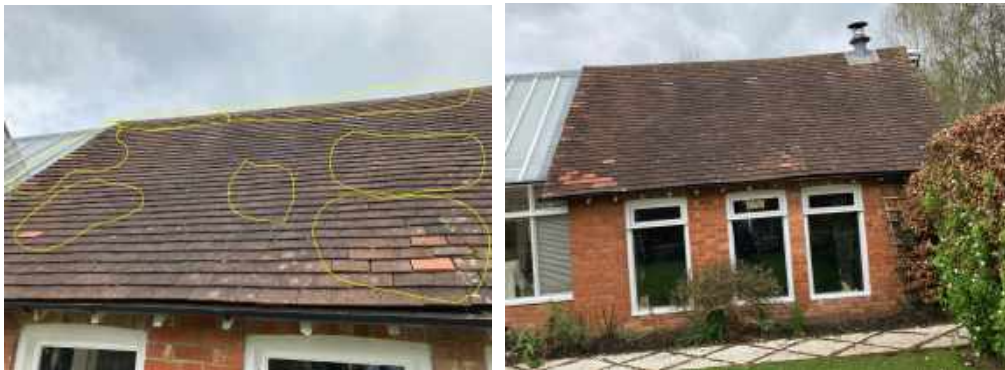
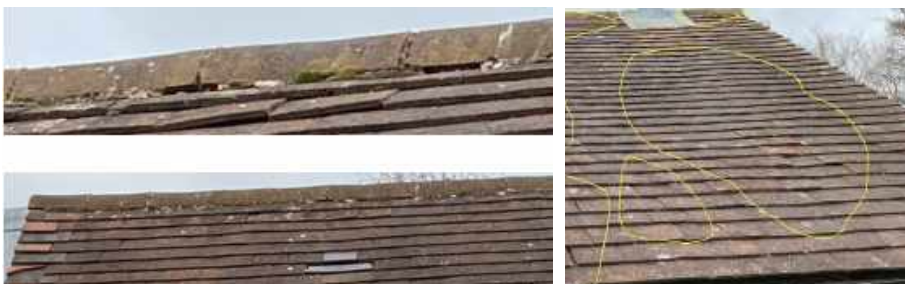
- **Further Works: Dormers**

- The timber side cheeks with flashing underneath and behind

- Remove timber cheeks, set aside
- Replace timber side cheeks like-for-like if required

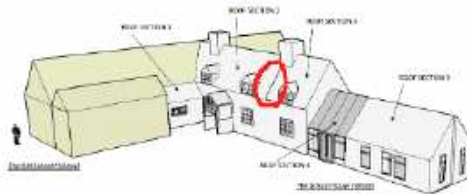
- The tiled fillet strips between roof section 2 and 3 (circled Red in the figure above) are historic tiles. These will be removed as a matter of course, set aside and then re-seated over the replacement roof tiles in exactly the same position and order.

**PROPOSAL:**

- Gently remove fillet tiles by hand and set aside
- Check to ensure the lime mortar pointing of bricks is in good condition on the vertical step-up wall and replace if necessary.
- Reaffix and seat the original set aside fillet tiles and bed them into the fresh lime mortar on both the replaced roof tiles and the vertical step-up wall

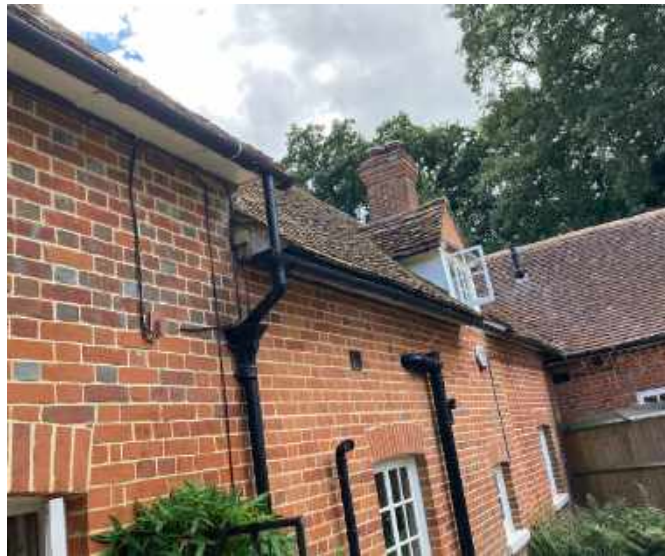
- **Roof Section 5**

- Historic clay peg tiles
- Northern Elevation
- Considerable frost damage to clay tiles
- Expansion damage from freezing wet moss etc
- Estimated 70% of tiles require replacing

**PROPOSAL:**

- Remove all peg tiles and ridge tiles, rescue reusables and set aside
- Inspect timbers, membrane and leadwork, replace as necessary
- Replace with matching reclaimed peg tiles and ridge tiles as necessary

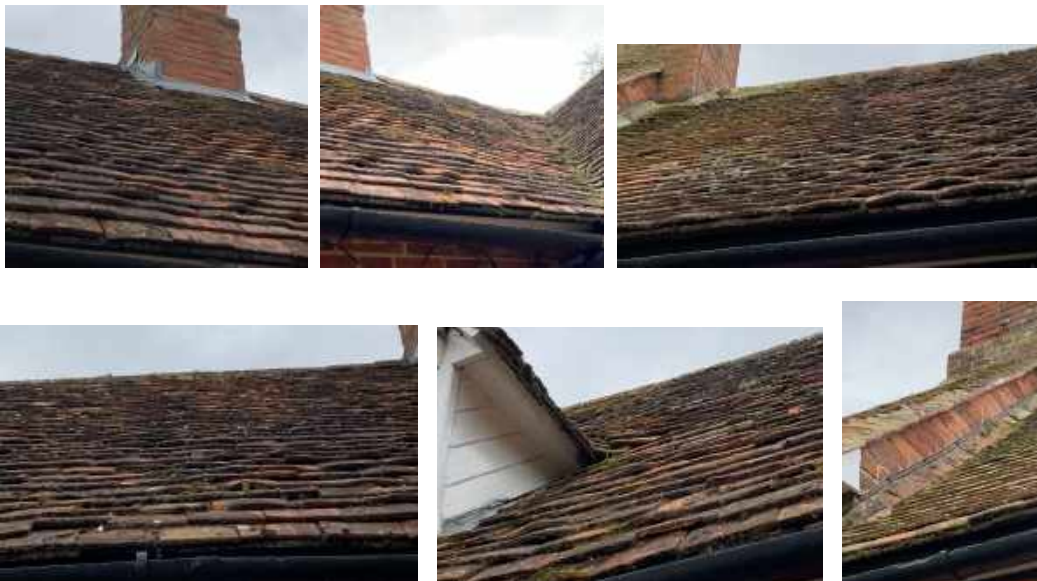
- **Roof Section 6**

- Historic clay peg tiles
- Northern Elevation
- Considerable frost damage to clay tiles
- Expansion damage from freezing wet moss etc
- Estimated 70% of tiles require replacing

**PROPOSAL:**

- Remove all peg tiles and ridge tiles, rescue reusables and set aside
- Inspect timbers, membrane and leadwork, replace as necessary
- Replace with matching reclaimed peg tiles and ridge tiles as necessary

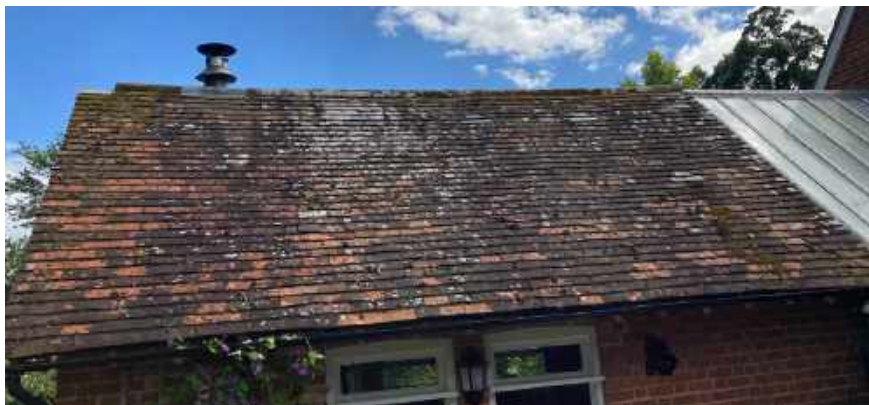
- **Further Works: Dormers**

- The timber side cheeks with flashing underneath and behind

**PROPOSAL:**

- Remove timber cheeks, set aside
- Decorate with white Linseed Gloss for long-term timber protection

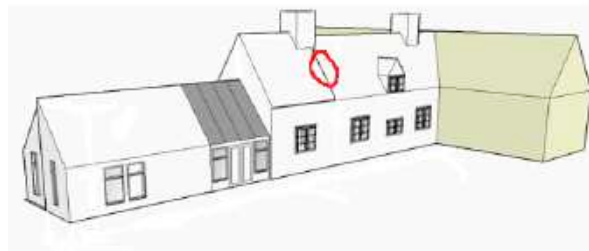
- The tiled fillet strips between roof section 2 and 3 (circled Red in the figure above) are historic tiles. These will be removed as a matter of course, set aside and then re-seated over the replacement roof tiles in exactly the same position and order.

**PROPOSAL:**

- Gently remove fillet tiles by hand and set aside
- Check to ensure the lime mortar pointing of bricks is in good condition on

the vertical step-up wall and replace if necessary.

- Reaffix and seat the original set aside fillet tiles and bed them into the fresh lime mortar on both the replaced roof tiles and the vertical step-up wall

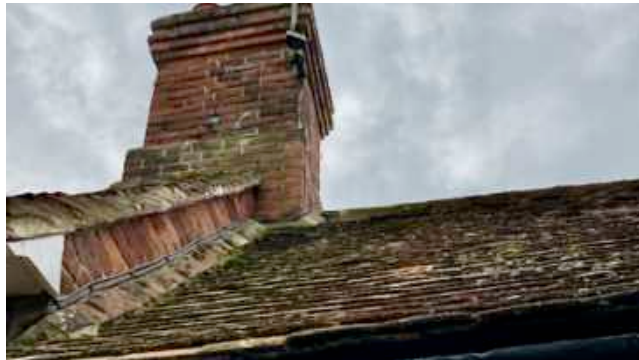
### Further Works: Chimneys

- Chimney 1
  - Appears to be all sand and cement
- Chimney 2
  - Appears to be lime and requires repointing

- **Chimneys**
  - Chimney 1
    - Check to confirm its sand and cement pointing
    - It appears in solid, sound condition
  - Leave it, only repair obviously failed areas
    - Repoint where necessary using mortars as in chimney 2
  - Chimney 2
    - Appears to be a lime mortar.
      - Hydrochloric Acid test to confirm
    - Carefully remove failed lime to a depth of 1.5 times the joint height

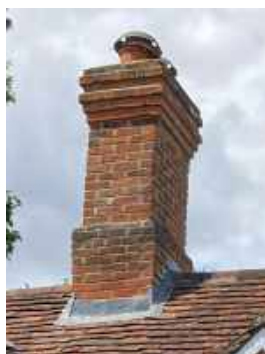
Chimney 1: Front View

- **Chimney 1**
