BS5837 2012 Tree Information Pen-rhiw Bengi Farm

Pen-rhiw Bengi Farm
Pen-rhiw Bengi Lane
Oakdale
Blackwood
NP12 0GZ

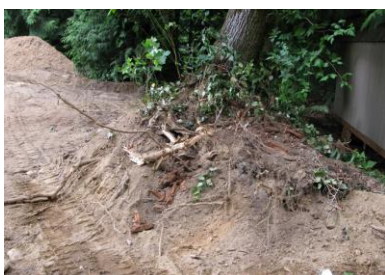
This photo shows a combination of damage. The roots have been severed or damaged in such a way that stability has been lost and this tree was felled. If the same damage had not led to an immediate tree failure the tree would have been sent into an irreversible spiral of decline.

The loss of roots will have caused a lack of structural support, loss of moisture take-up, loss of oxygen take up and a means of the tree storing energy as starch within root structures. This type of root damage causes a slow decline in tree foliage known as crown die back.

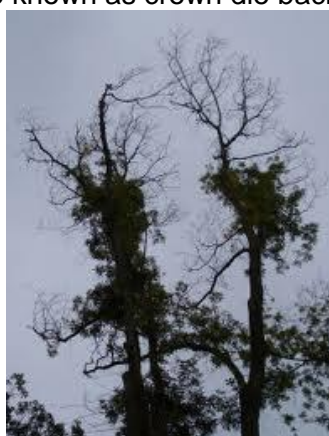
The picture to the right shows the years after the completion of a development site. Machine operators will often mention how driven over them. This is what site.

die back of foliage several years after the completion of a development site. Machine operators will often mention how driven over them. This is what happens once they leave

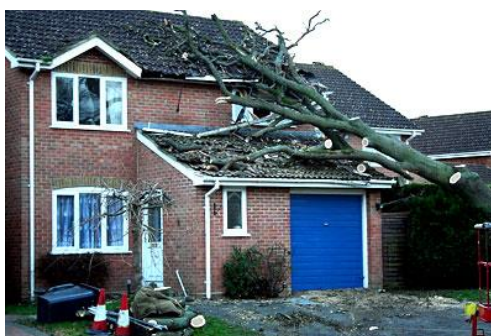
If adequate protection is not given the disaster below is not far behind!

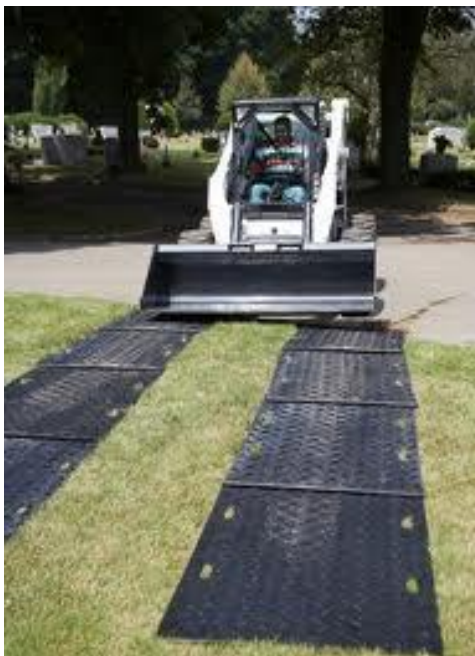
The use of ground protecting boards such as these seen in the adjacent picture should be used. Geo textile and felt may be required beneath these routes to minimize puddling of the soil surface. Should puddling occur, a capped layer may well be formed which will reduce the lateral diffusion of soil gasses and cause significant problems for retained trees.

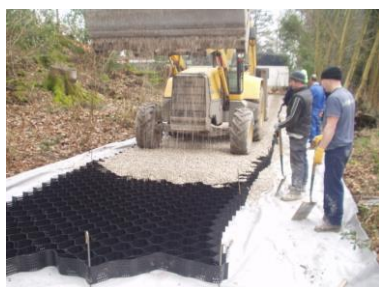
Cellular Confinement and Backfill Material.

Expand the confinement systems 2.56m wide panels to the full 8.1m length. Pin the panels with staking pins to anchor open the cells and staple adjacent panels together to create a continuous mattress. Infill the cells with a no fines angular granular fill (typically 40-20mm) within each open cell. The use of cellular confinement reduces the bearing pressure on the subsoil by stabilizing aggregate surfaces against rutting under wheel loads. Comparisons between cellular confinement and traditional aggregate and geo grid-reinforced structures

demonstrate a 50% reduction in construction thickness of the granular material.

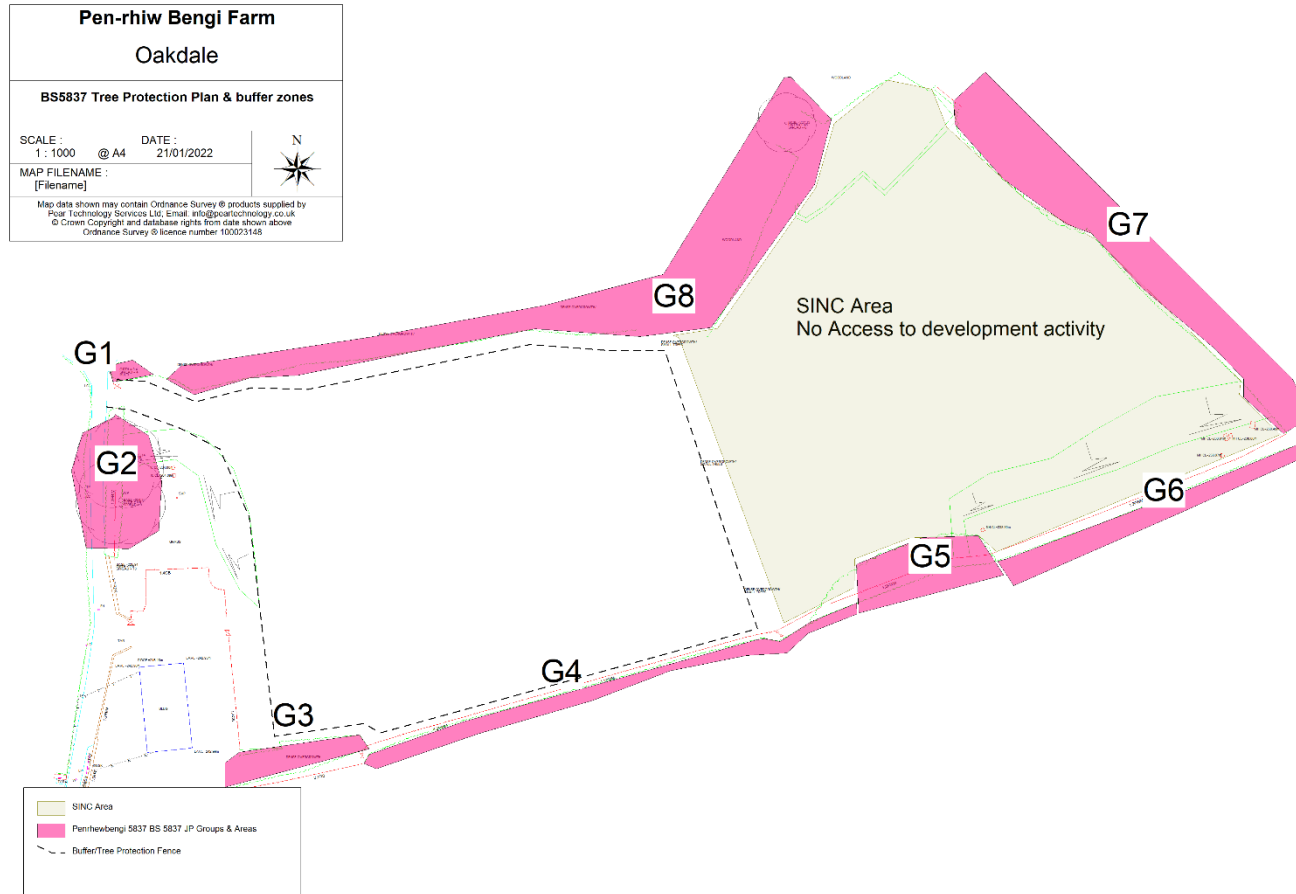
Site Plan screen grab – please see scale pdf plan also

Scale plans can be sent as PDF files if required. The plans are to indicate locations of trees, locations of main objects on site and the location of tree protection fencing. Stem diameters found in tree and tree group data tables should be used to mark out the location of root protection fencing on site.
