## Revised Heritage Statement for Oakwood Hall, Wylam, Northumberland. July 2020

Historic Environment Research and Interpretation, on behalf of Peter McGirr.

This document has been prepared in response to guidance given by Karen Derham, Assistant County Archaeologist, Northumberland County Council, 27 May 2020, following receipt of the original Heritage Statement prepared by Milbank Architects April 2020.

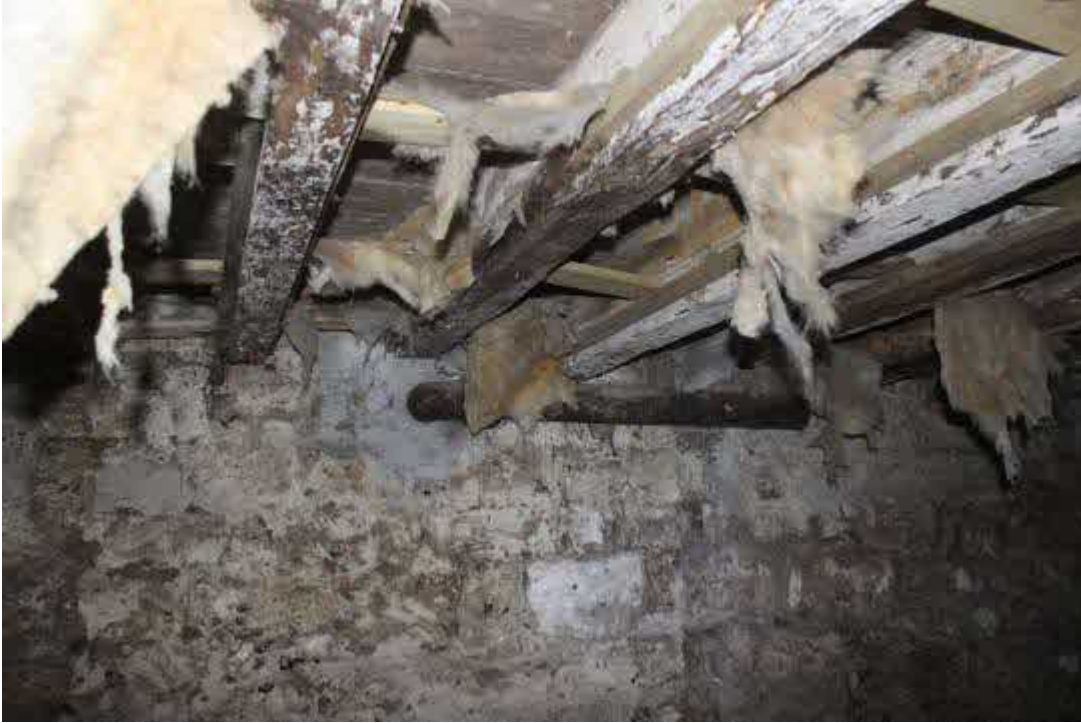
Roughly trimmed floor joists running to S wall of 1840's build. Iron pipe (?support for dropped joists) set into S wall

The structural engineer's advice will be required here. The condition of the joists will also need to be assessed. Joists will be treated and underdrawn with fire resistant boarding.

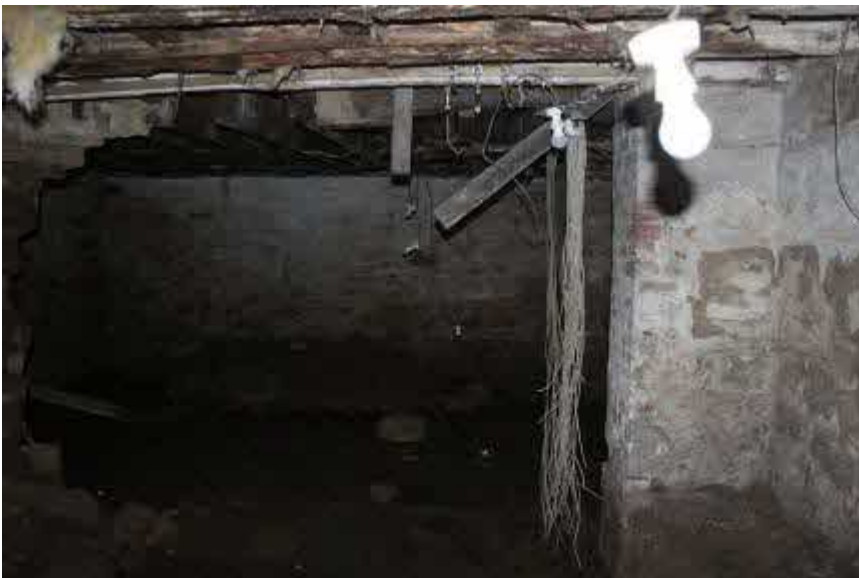
N side of doorway between 1840's cellar and 1880's cellar beyond. All of dividing wall to L removed leaving joists hanging

[refer to Structural Engineer's proposal [MD1448 Basement Structural] for detail of new supporting pillars and beam to span the opening]

A strip foundation and two new stone built support pillars are proposed to either side of the existing opening with a steel beam across to support the wall above and the existing floor joists [refer to Structural Engineer's proposal [see MD1448 Basement Structural submitted with this updated HS] for new supporting pillars and beam to span the opening]

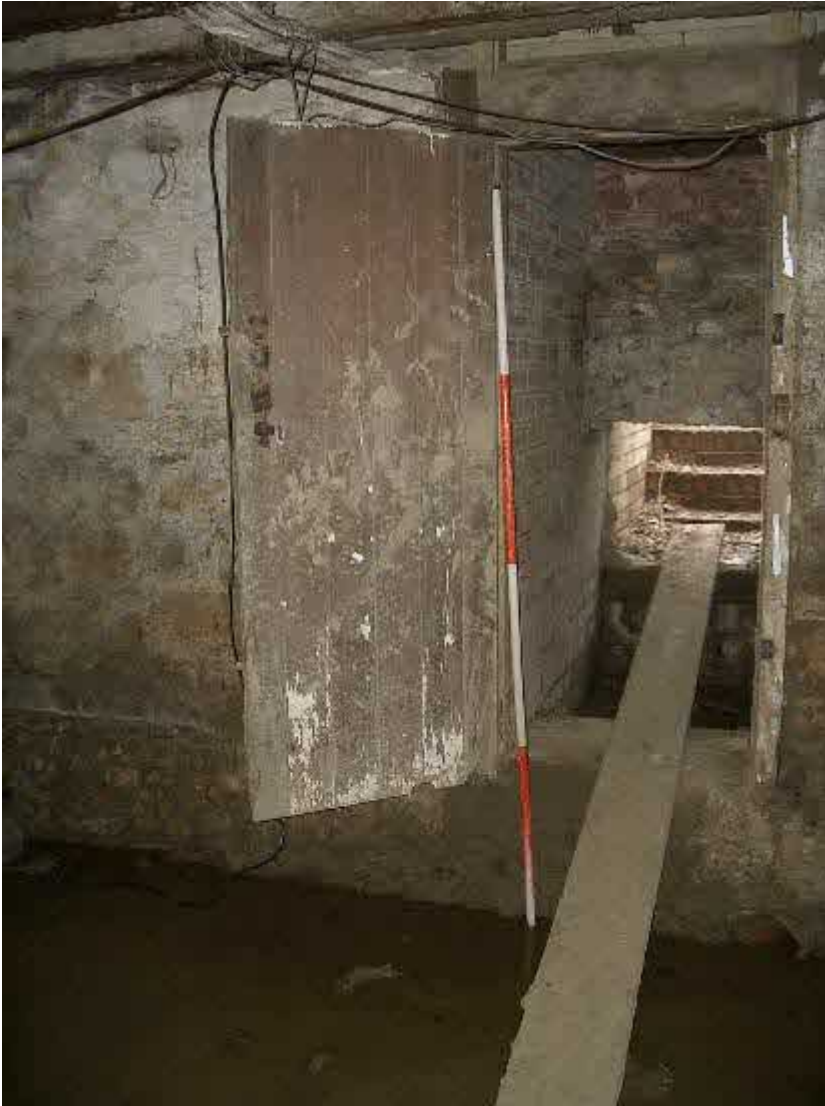
D53 leading S from 1880's cellar. Note height of threshold and excavation tidemark on walls, broken drain to R and "sump" beyond door. Steps up to garden terrace in passage beyond

New strip foundation supporting blockwork wall. Door (proposed D54) to match existing plank door D53.

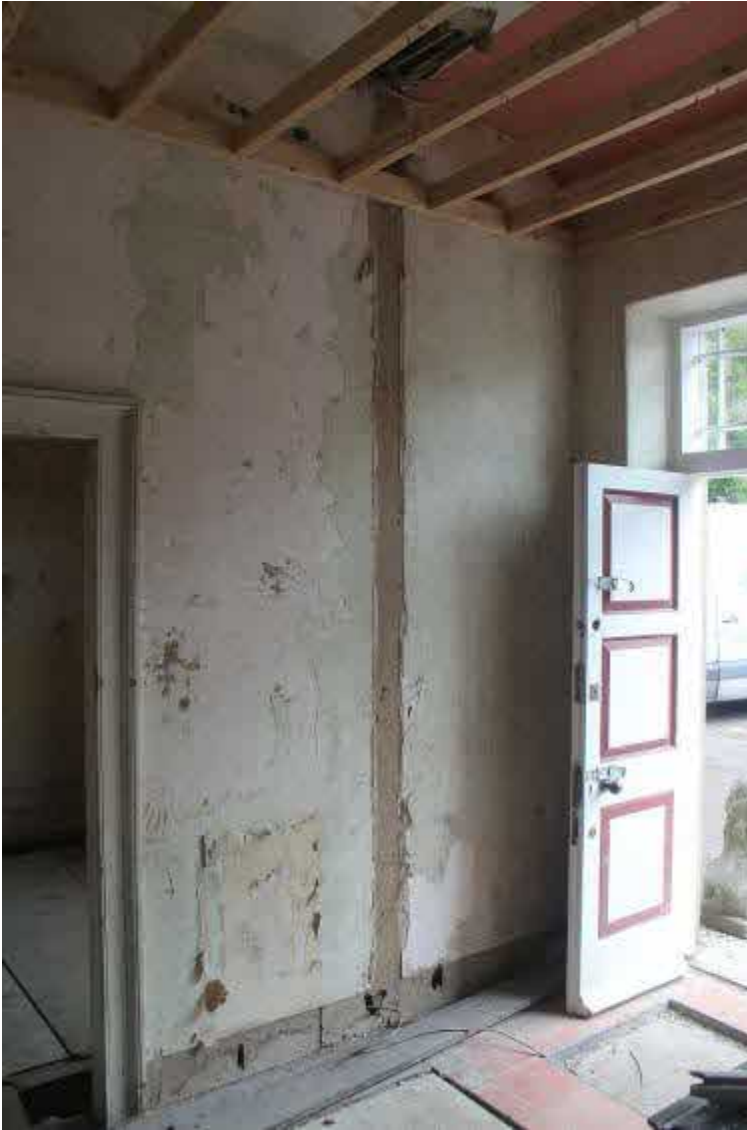
“Cloaks” partition inside D1 with scar of internal Draught Screen. Tiled porch area with mat well inside D1. Frame of D8 to L (no door). Timbers for intended modern lowered ceiling (top).

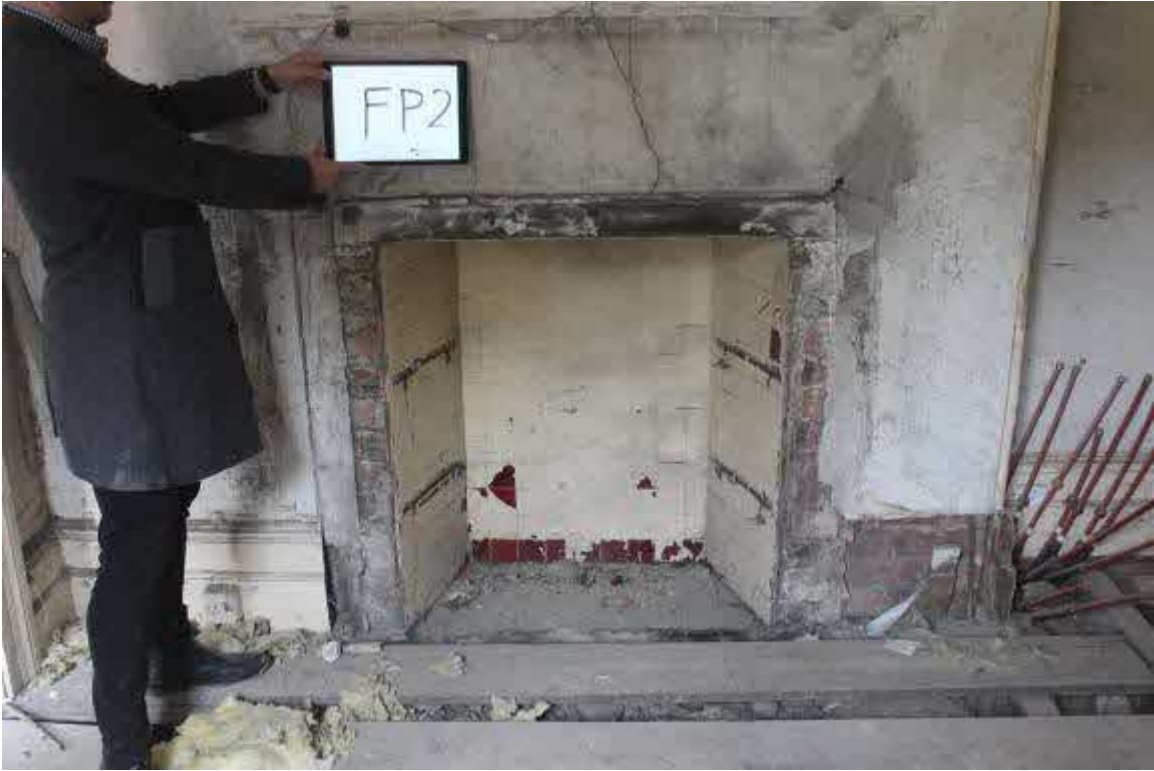
FP2 1930's tiled insert to original construction hearth? The pipework to R is from an attempted modern underfloor heating installation. Some skirting surviving

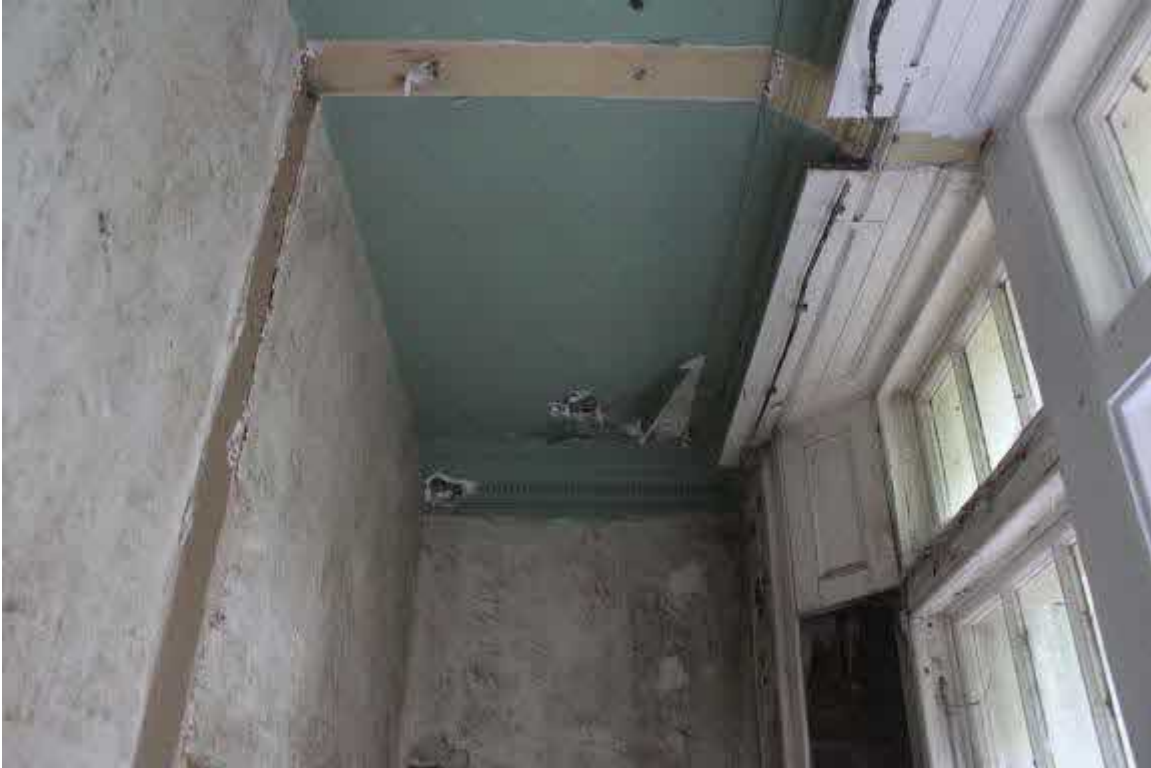
Surviving cornice cut by partition forming WC. Internal WC partition removed. Joinery around W21 substantially intact (but ? shutters gone)

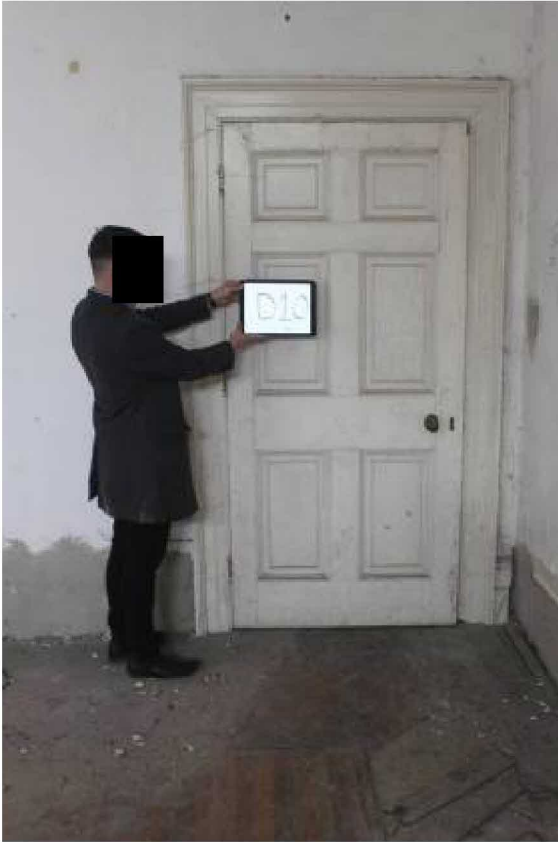
**D10 inside Drawing Room. Some limited damage to parquet flooring (R)**

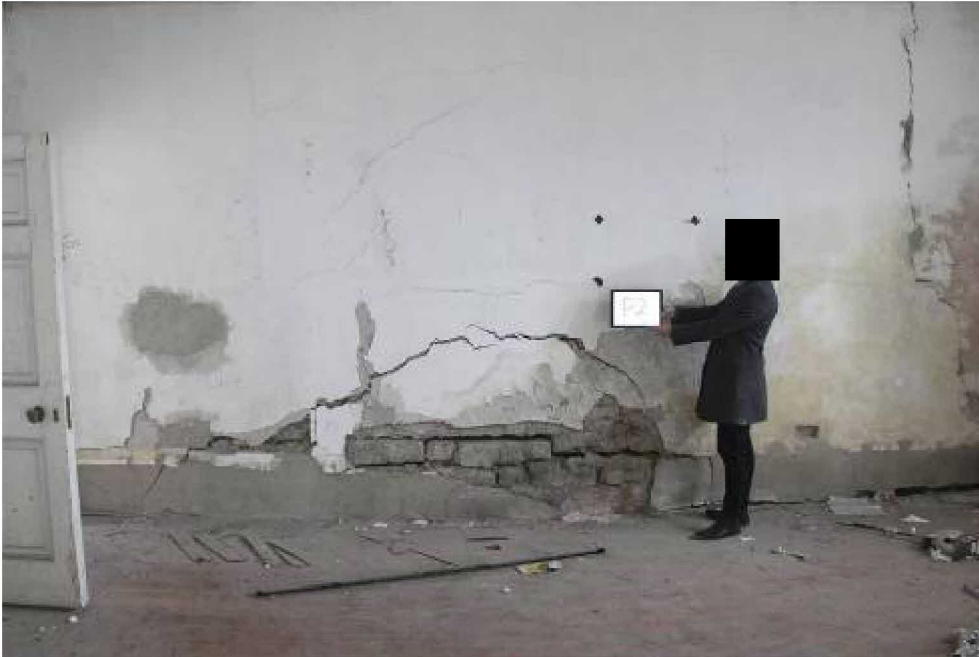
the period of the room. Bad settlement cracking in base of E wall due to removal of load bearing wall in cellar below.

**Settlement cracking in E wall due to breach made in cellar below Proposal GF2**

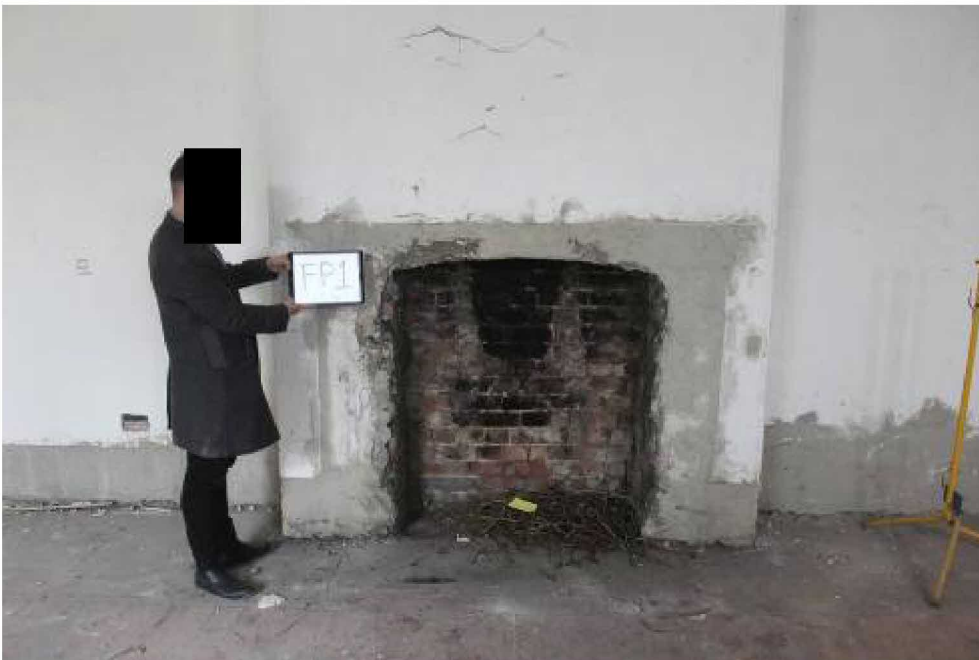
**FP1 removed. Scar gives an idea of dimensions**

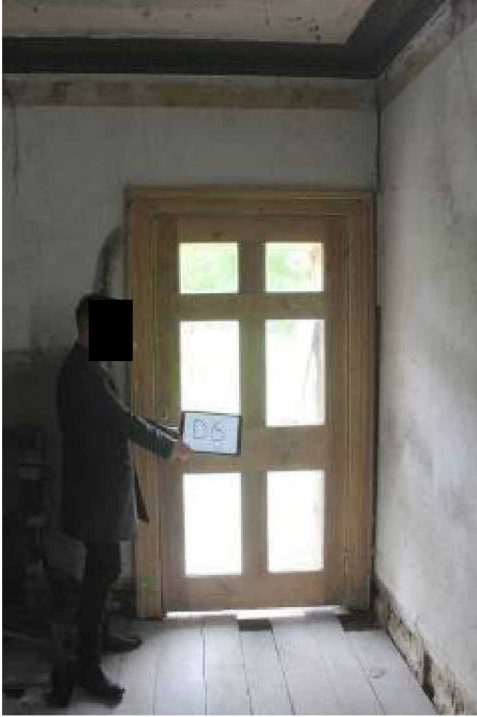
**D6 Panels removed and glazed for modern access to late 1980's conservatory. Proposal GF4**

*And door D6 retained (with solid panels replaced - to read with D13 each side of FP in this formal setting)*

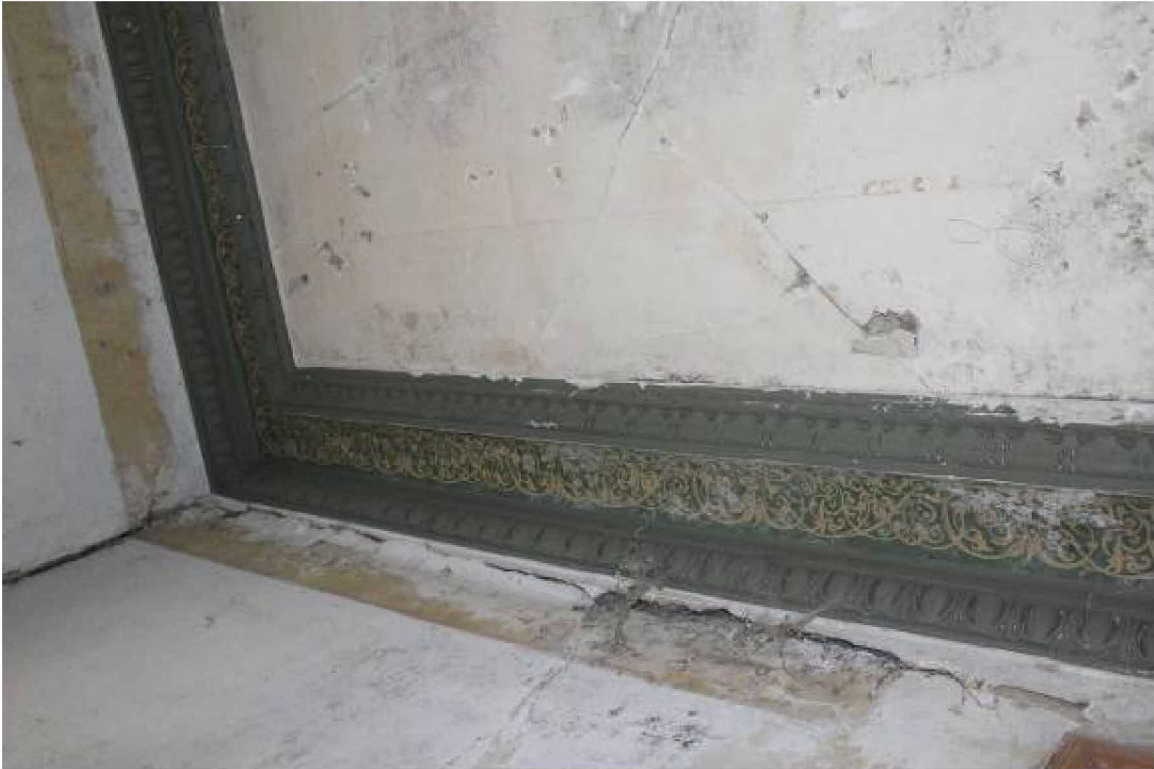
**Cornice detail (badly damaged ceiling)**

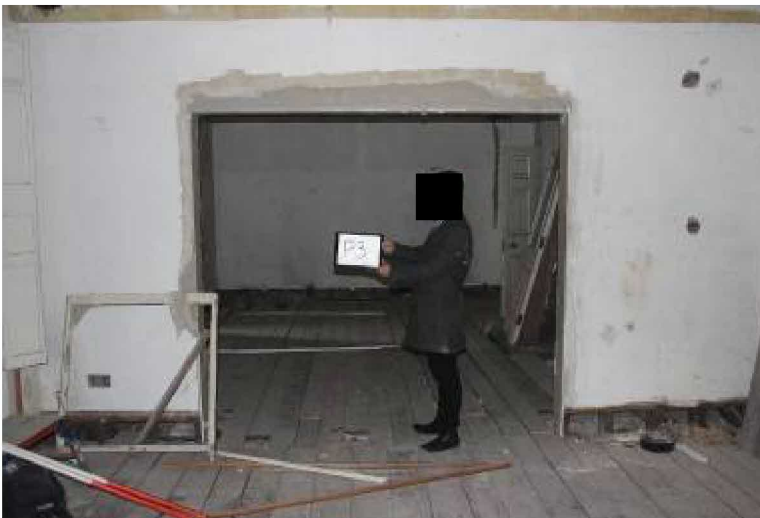
**Modern opening looking west  
(to be reduced again Proposal GF 3)**

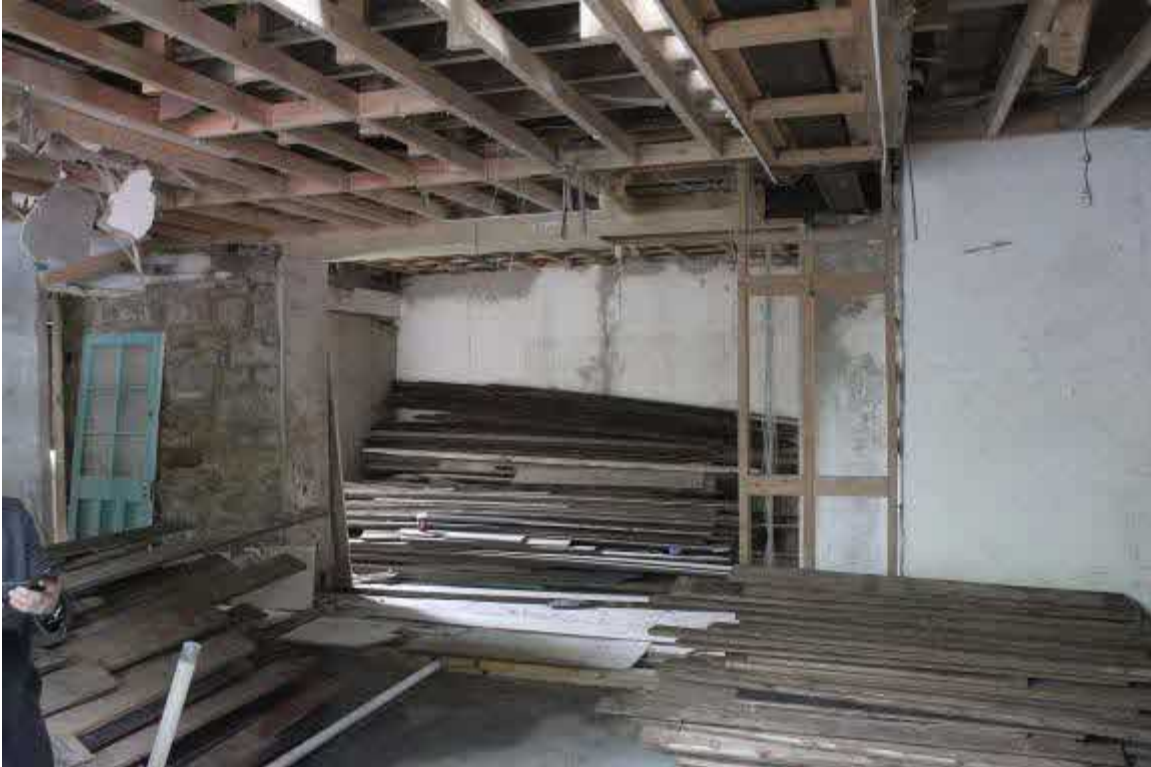
Modern opening in S wall. RSJs spanning (and also from RHS of opening to above viewpoint) when recent (2000's) kitchen made. Beyond the remaining wall (right) was a pantry, lit by W4

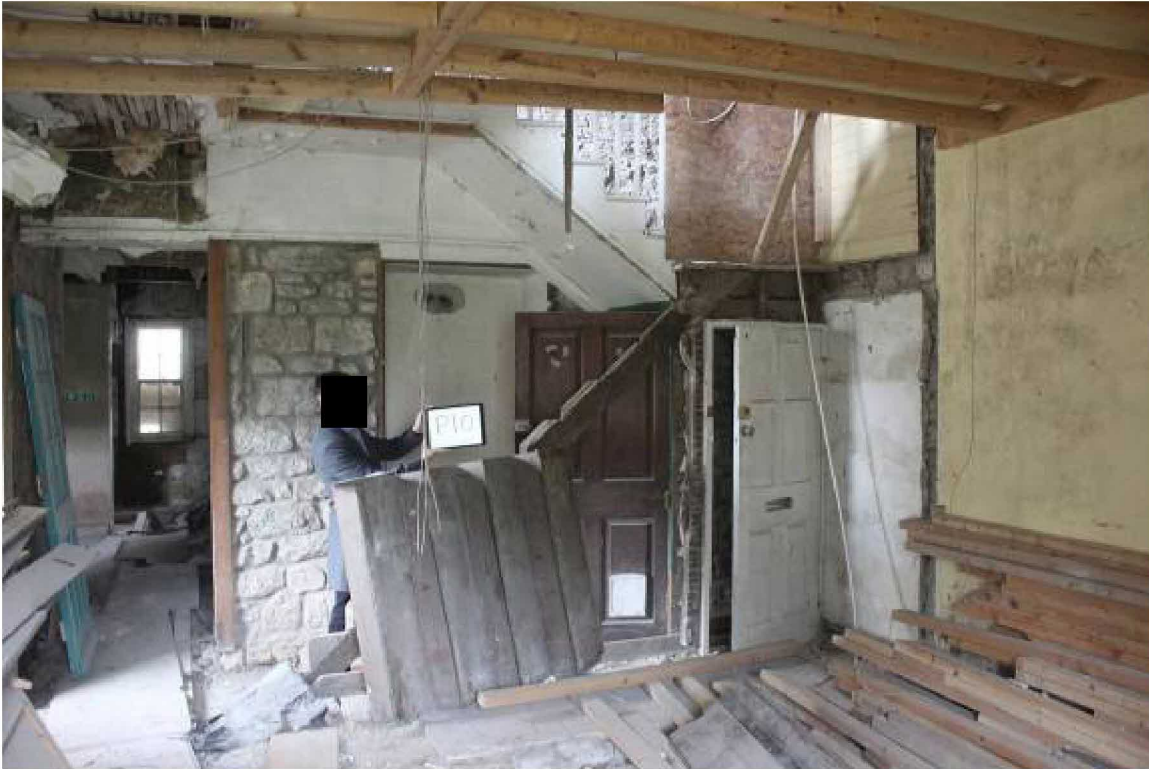
**From former parlour looking NW towards remnants of lower flight of back stair and scar of landing, removed with partitions from stair and passage beyond in previous works. Note D17 (with letter box slot!) to right. Proposal 10 to reinstate stair and landing.**

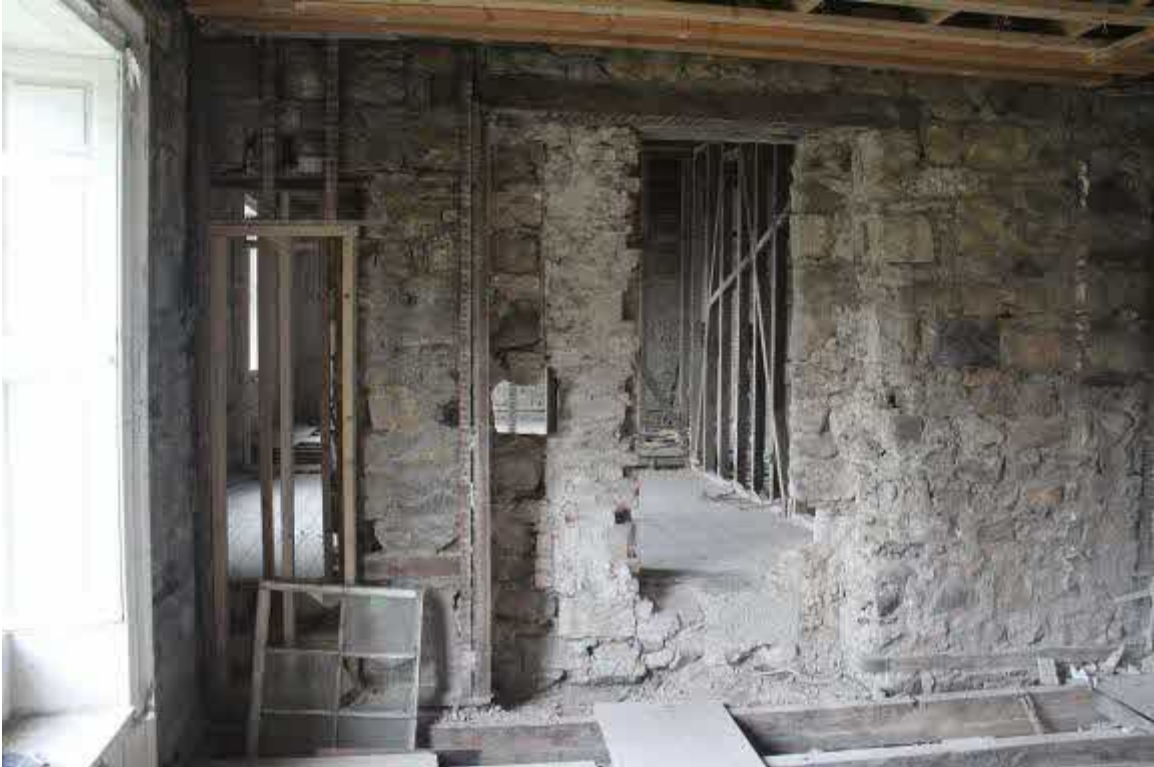
W wall. Timber lintel and brick infill of poss. window in rubble stone W elevation of Late C18/early C19 house. Modern breaches (to be infilled)

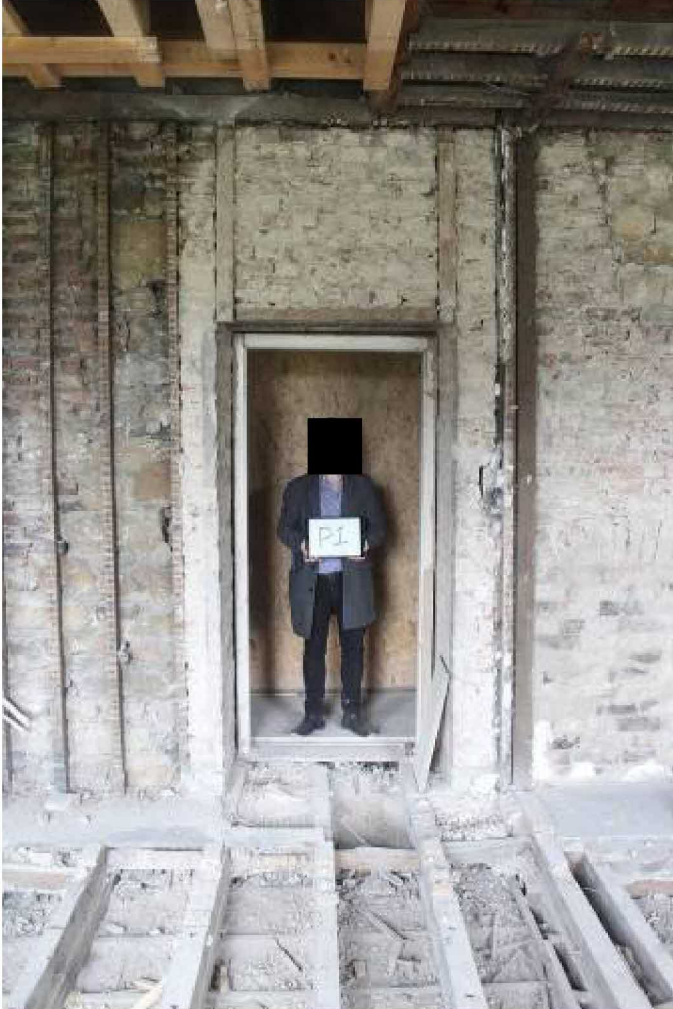
**Bedroom side of D28, to be blocked (P1).  
Note blocked FP to R.  
C20 western bathroom partition in front of it**

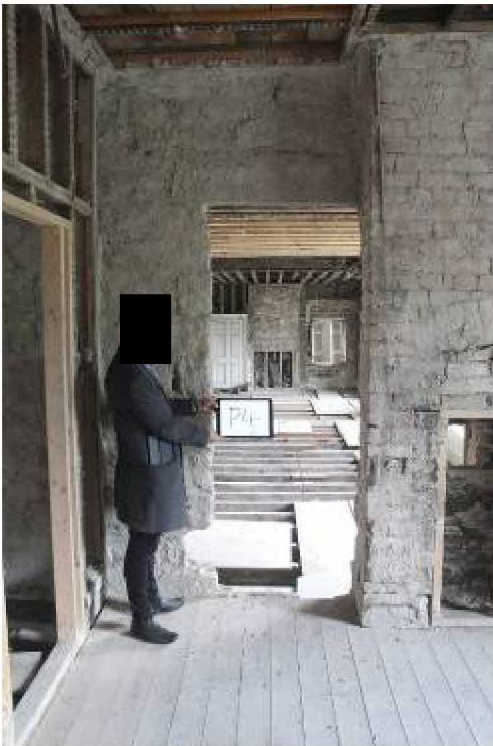
**Breach cut through to S range**

– to be reinstated  
D27 to L. original door missing?

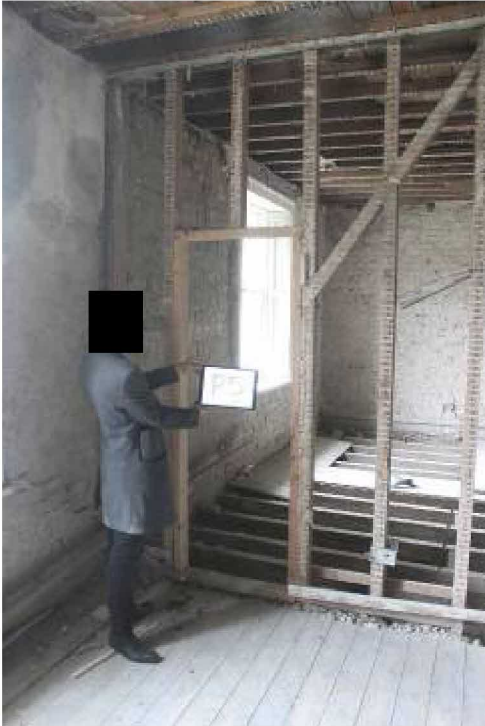
Doorway D26 to be closed up  
Proposal 5

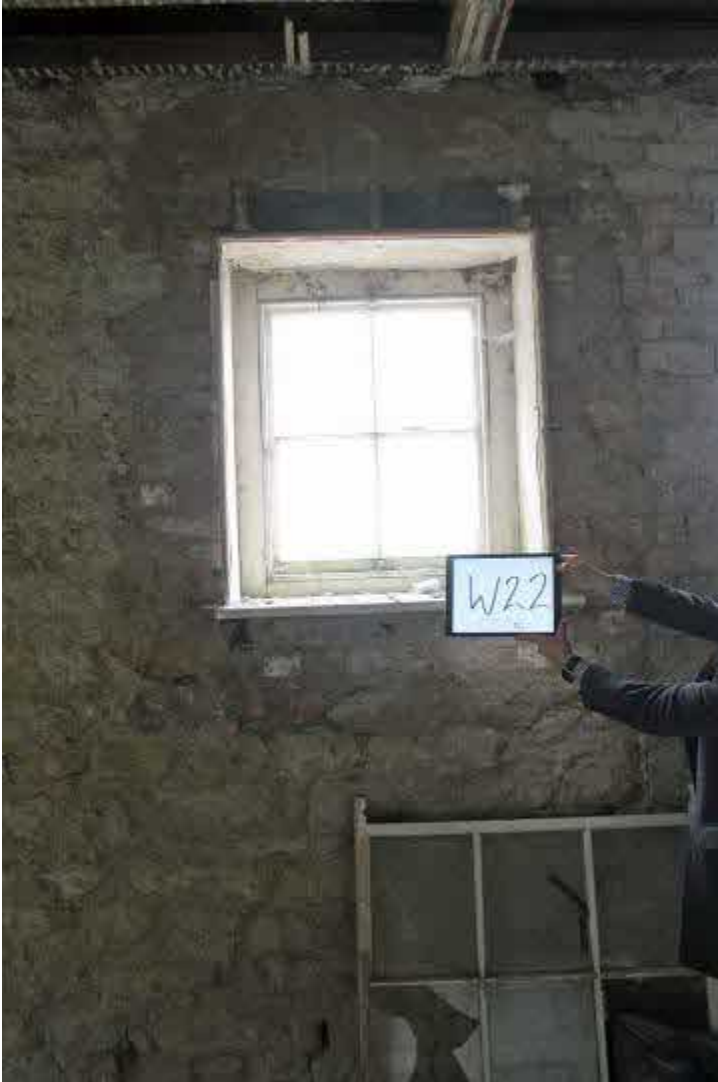
W22 inserted, with a large area of disturbance,  
into earlier window opening?  
Stonework to L and below. 1930's work to  
balance W 24 on re-worked N façade.  
Note change to brick walling to R

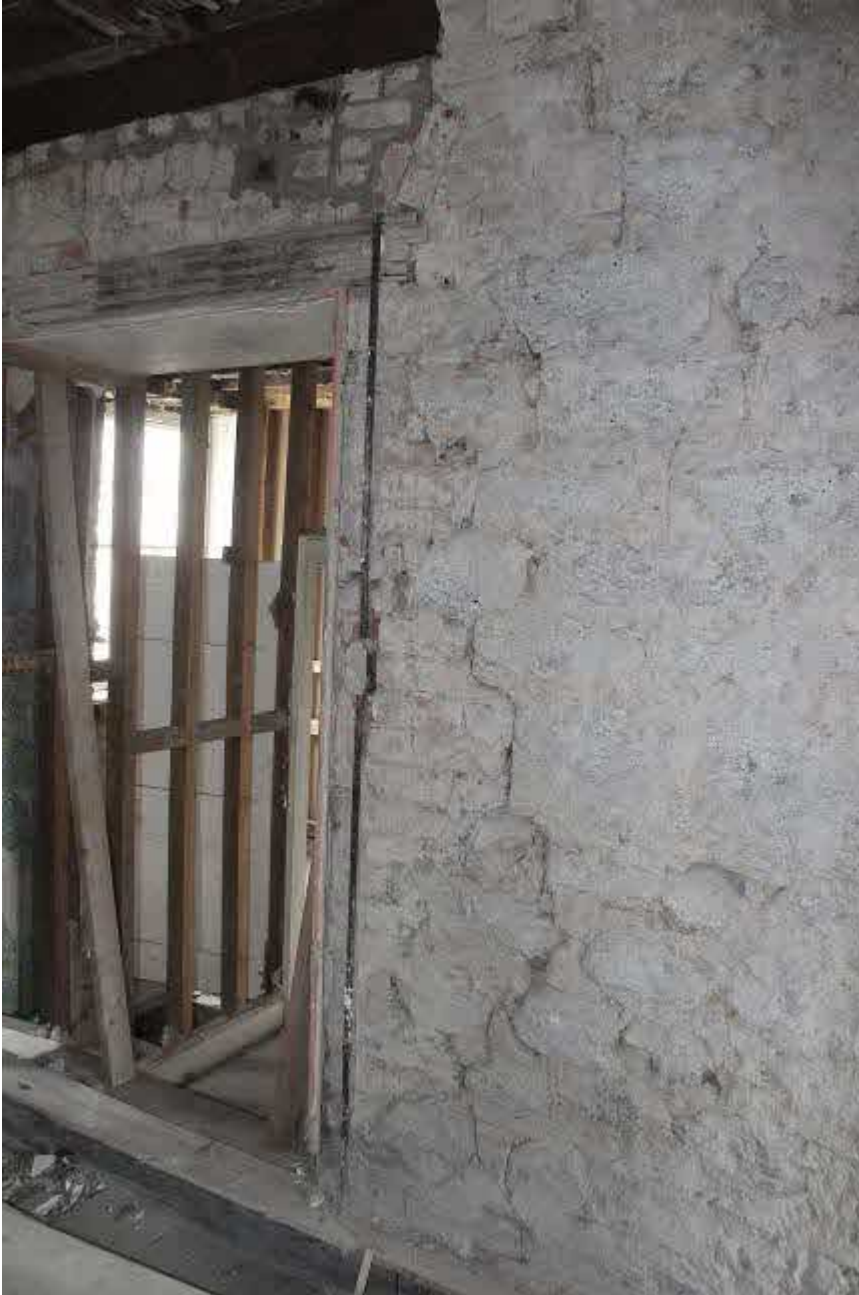
Ragged break in rubble stonework of late C18/early C19 build to R, Brick infill and relieving arch over change in level of corridor and beam above 1880's work

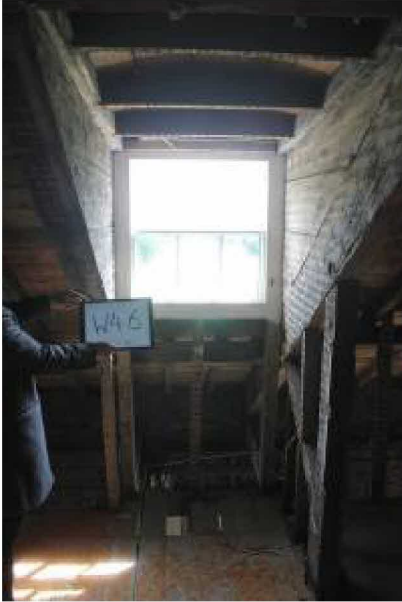
**W46 one of three S facing dormer windows. Secondary glazing proposed for the attic windows to improve insulation values**

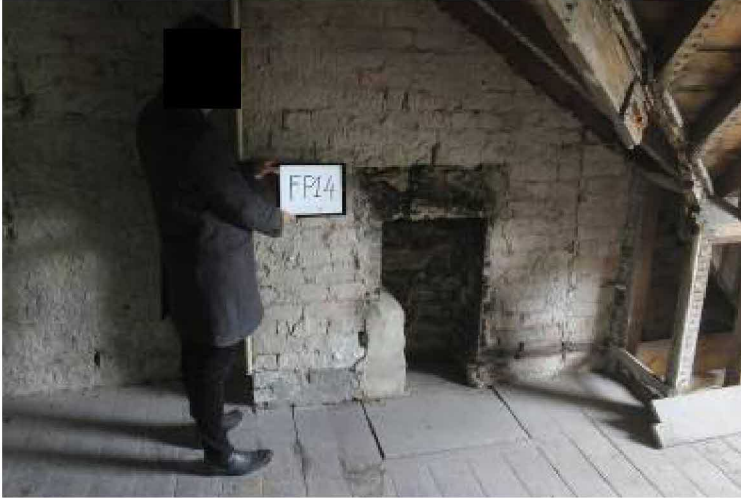
**FP14 Modest 1880's attic bedroom FP.  
Note rot damage to roof timber to R.**

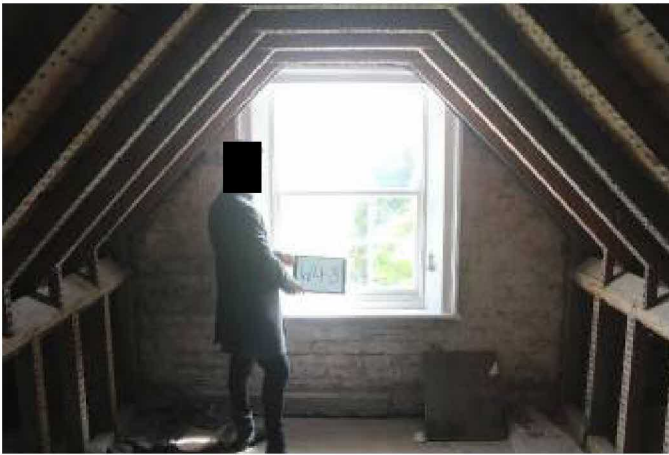
**W48 in S facing 1880's gable. Note fixture R.  
Secondary glazing is proposed for the attic  
windows to improve insulation values**

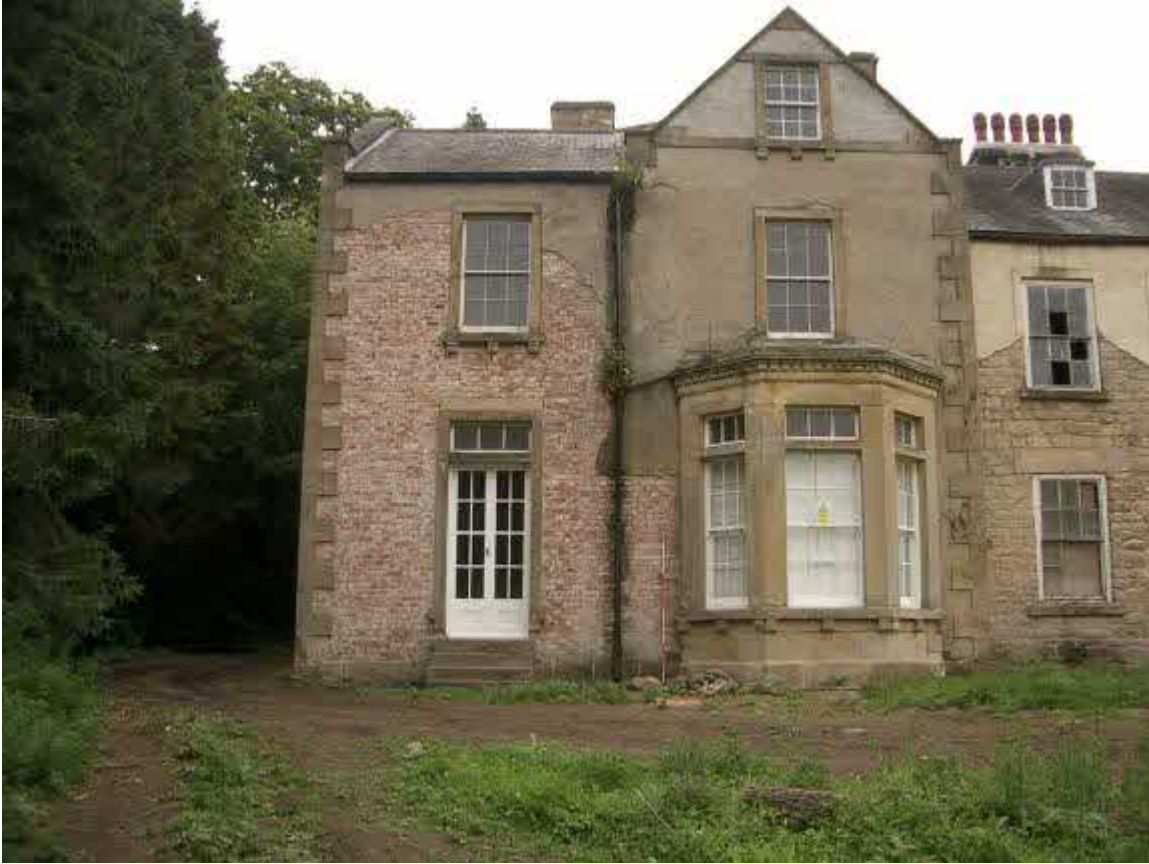
The western part of the south elevation, looking North. This 1880's addition is in brick with a Portland cement-based render, lined in imitation of ashlar

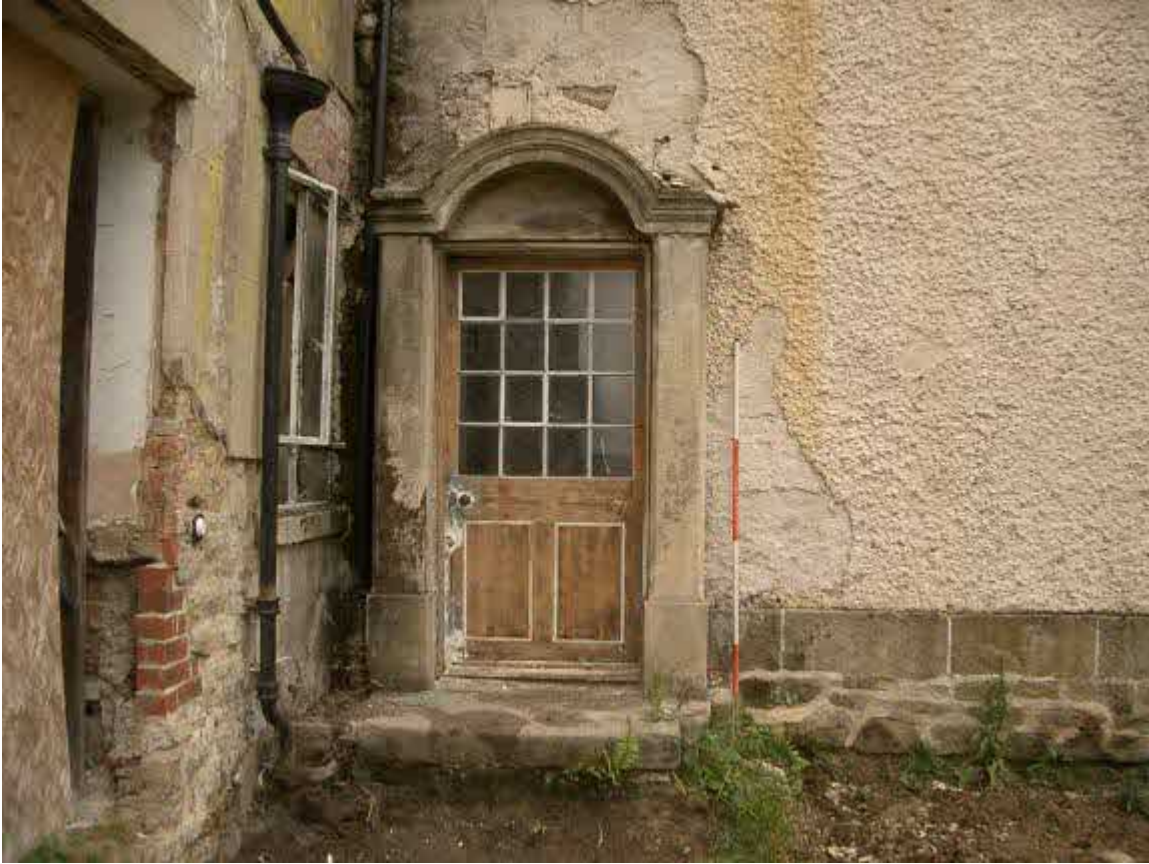
Detail of early C18 doorway in shallow stone porch. The glazing in the door is a late modification. The previous excavation has left thresholds and base plinth "perched".

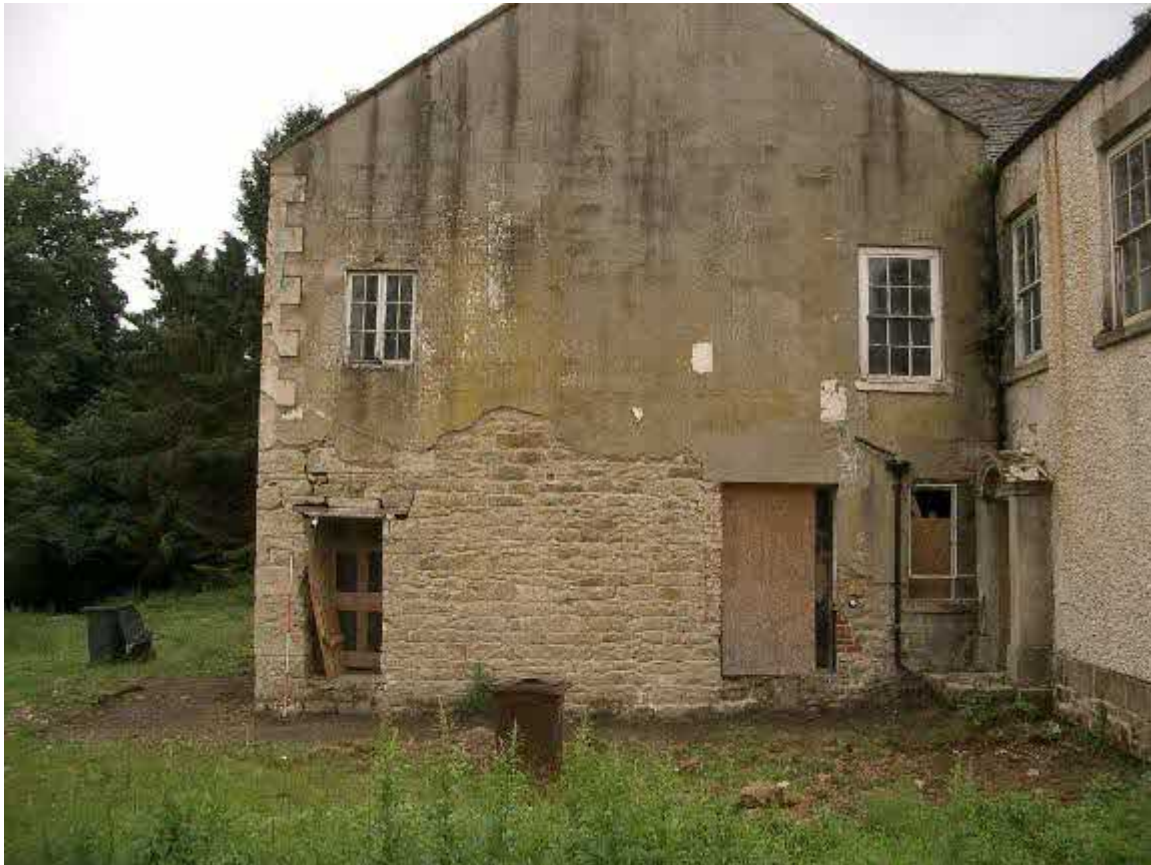
Return of S range. Coursed rubble stonework. Hard cement render with (recent?) stucco quoins. GF - Modern late C20 doorway D6 and 1960's metal replacements W11/W12. FF - One original window W35. W36 C20 replacement?

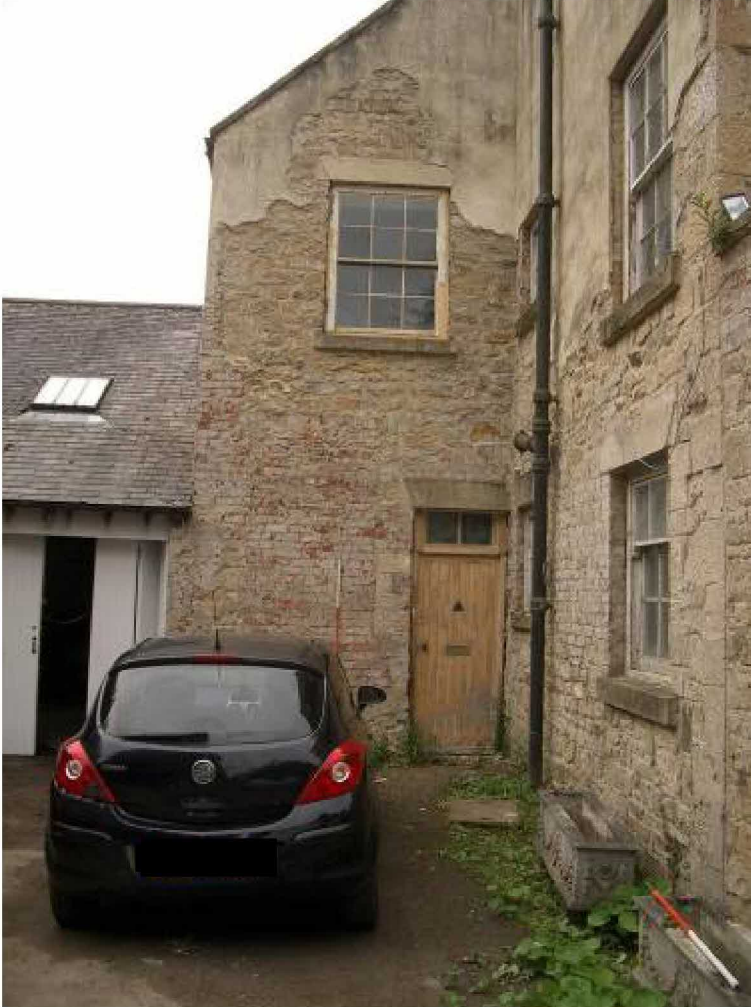
**W end of C18 double span block in rubble stone.  
Note no quoins and ragged brickwork up LH return  
and poss. brick blocked opening behind car.  
W31 No horns on sash**

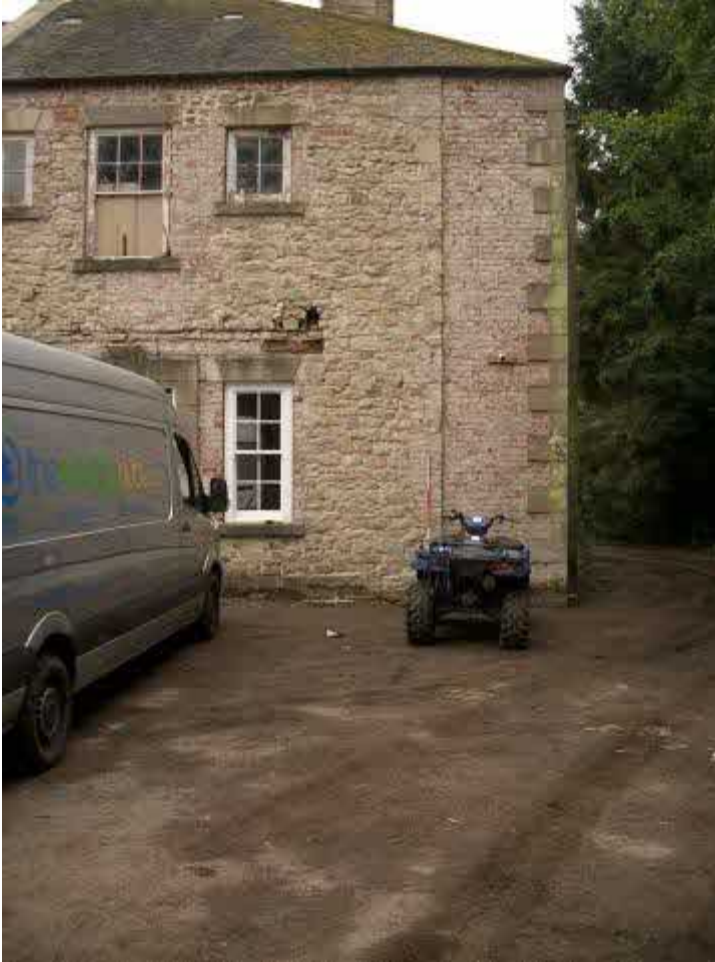
Cut back return of lost NW range. Sockets for previous FF joists above embedded timber. 1880s brick addition to R.

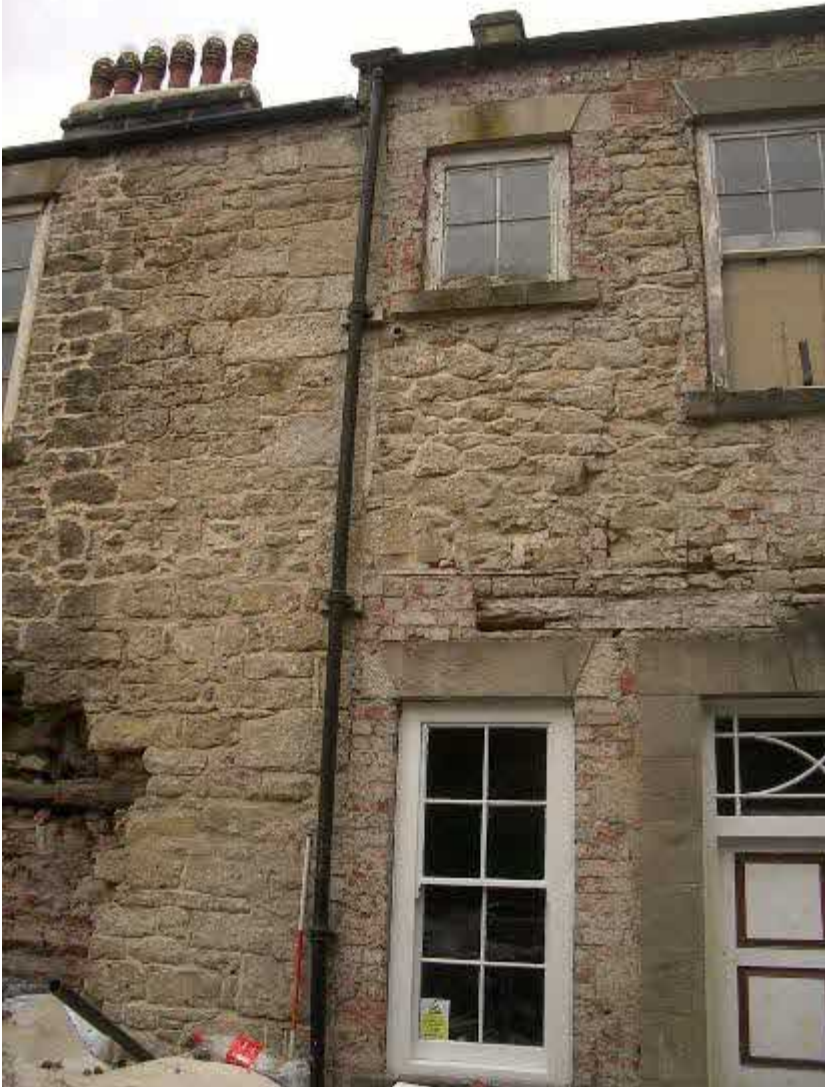
Build break to East of main door. Very irregular quoins. W2 & W24 above, inserted 1930's with doorway. Note blocked joist holes above embedded timber above door
