Bat Survey of Grove Barn Lakehouse Farm Hempstead

**John Dobson B.Sc
Essex Mammal Surveys**

May 2022

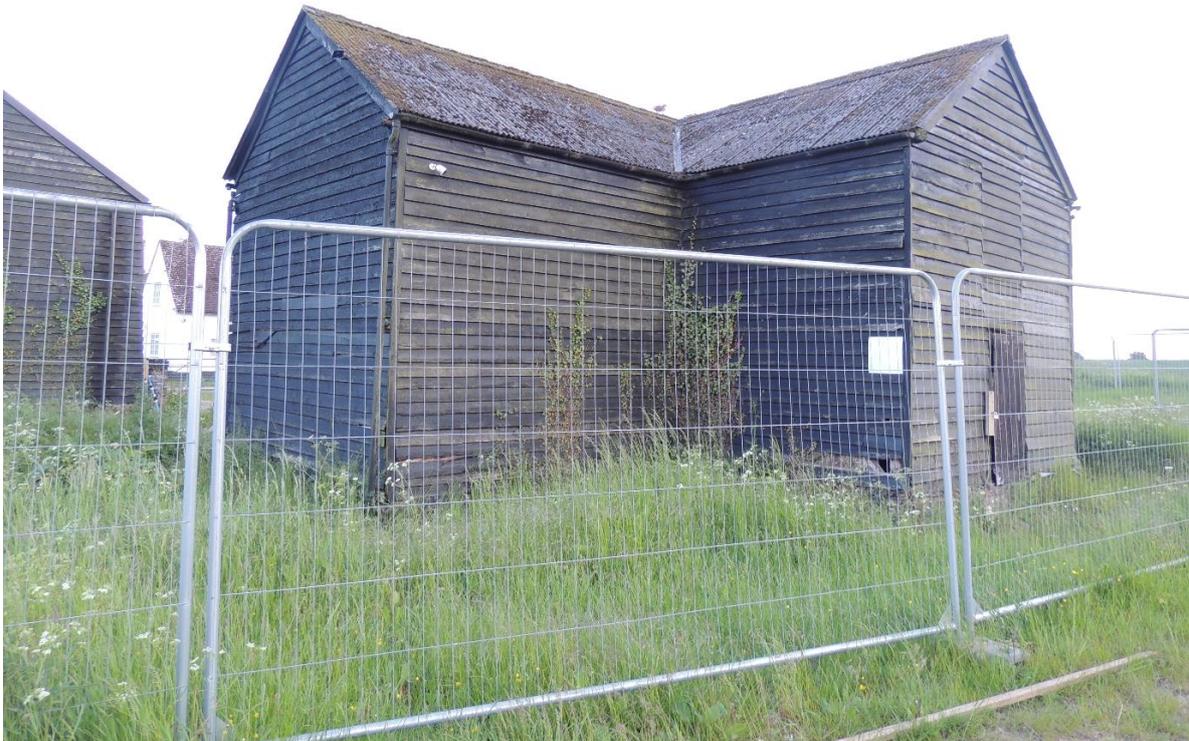
Photo 1: Northern (with midstrey) and eastern elevations

The survey building is a traditional, 3-bay, timber-framed barn with a corrugated asbestos roof and weather-boarded walls above a brick plinth. The barn is aligned E-W with a midstrey to the north. The barn is currently unused. There were very few gaps around mortise joints along the wall plates, and the wall braces were bolted to the beams rather than jointed, thereby reducing further the potential for roosting by bats. The floor of the barn was difficult to search as it was of sticky mud, perhaps indicating recent flooding. Externally, there was a tight seal to the eaves and gables, and no evidence of bats on the external surfaces.

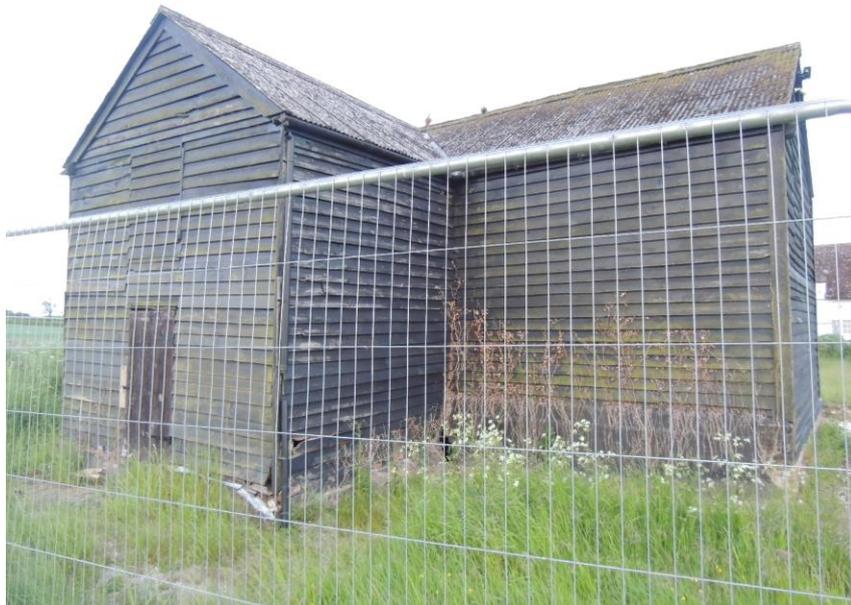
The survey building is a traditional, 3-bay, timber-framed barn with a corrugated asbestos roof and weather-boarded walls above a brick plinth. The barn is aligned E-W with a midstrey to the north. The barn is currently unused. There were very few gaps around mortise joints along the wall plates, and the wall braces were bolted to the beams rather than jointed, thereby reducing further the potential for roosting by bats. The floor of the barn was difficult to search as it was of sticky mud, perhaps indicating recent flooding. Externally, there was a tight seal to the eaves and gables, and no evidence of bats on the external surfaces.

Photo 2: Northern elevation

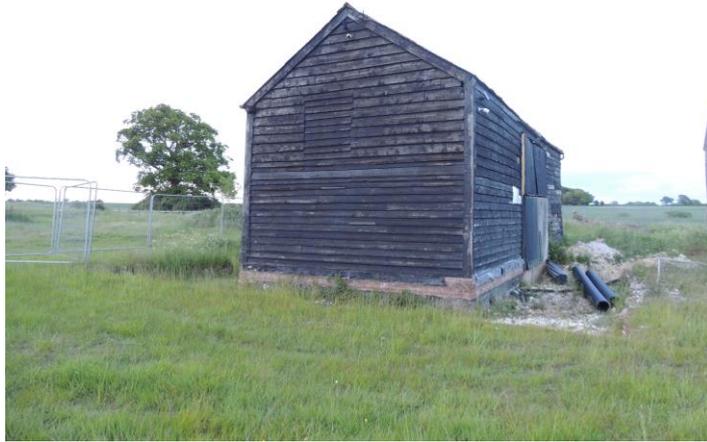
Photo 3: Western elevation

- at 21.20 (twenty-two after sunset), a common pipistrelle emerged from the north-western corner of the barn
- at 21.30, a common pipistrelle emerged from the north-western corner of the barn
- at 21.33, a common pipistrelle was heard briefly to the north
- at 21.34 – 21.35, a common pipistrelle foraged in the barn
- at 21.38, a common pipistrelle flew W-E along north side of barn

Since bats were found to be using the barn as a place of shelter, a European Protected Species Licence (EPSL) will be required to work on the building. It is therefore recommended that a total of three dusk/dawn bat activity and emergence surveys should be conducted between mid-May and the end of September 2022 prior to any works taking place. These surveys should be conducted at least two weeks apart and should take place in appropriate weather conditions. The bat activity and emergence surveys would be required to confirm how the bats are using the building and the population of bats that may be affected by any changes. Ultimately, Natural England, in conjunction with the licence applicant, would confirm the level of mitigation required to retain or enhance the population of bats at the site. Planning consent would be required before a EPSL could be granted.

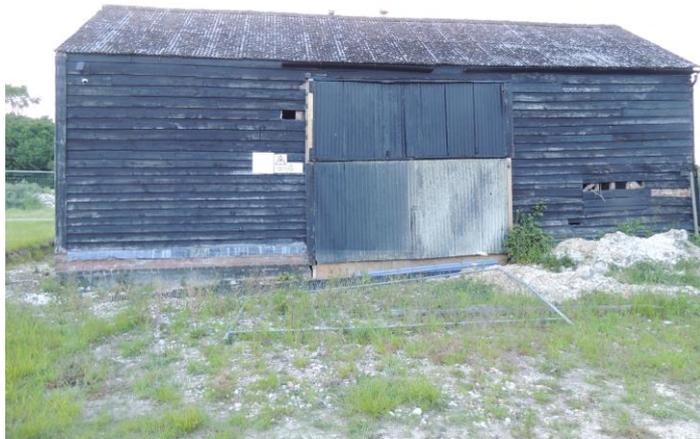
Photo 4: Southern elevation

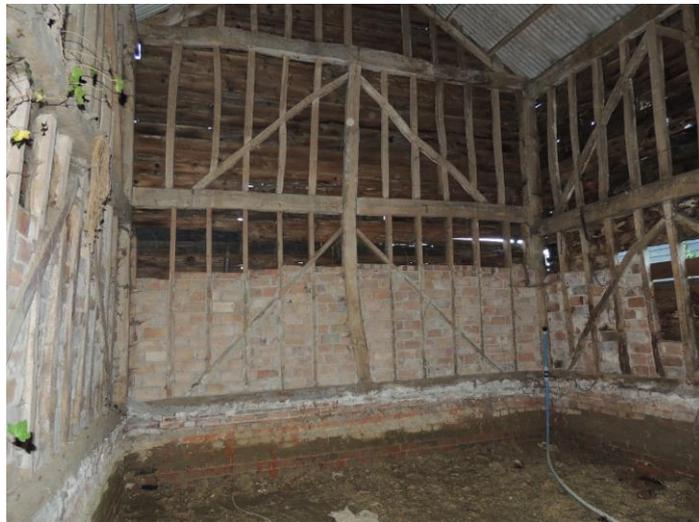
Photo 5: Looking eastwards in the barn

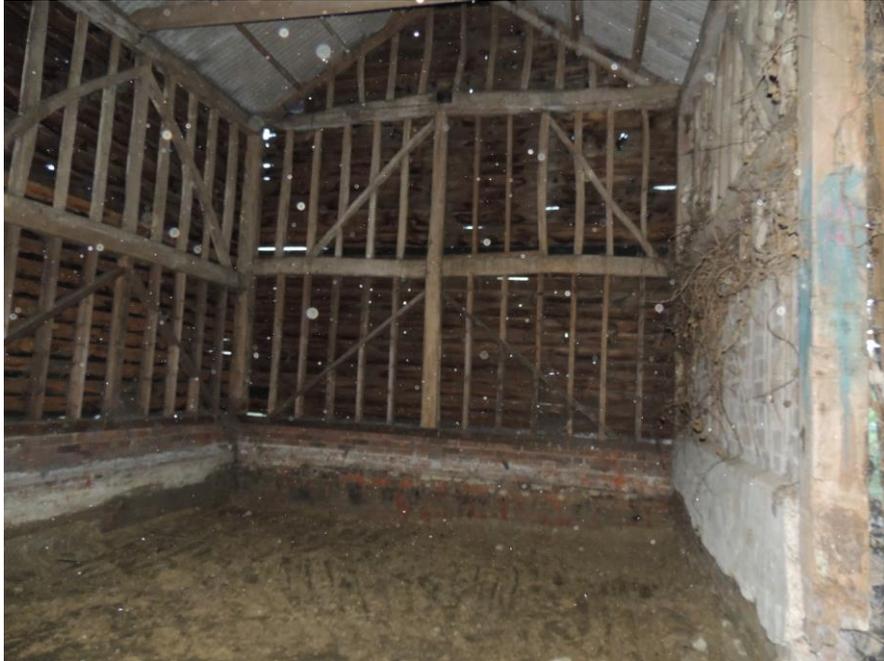
Photo 6: Looking westwards

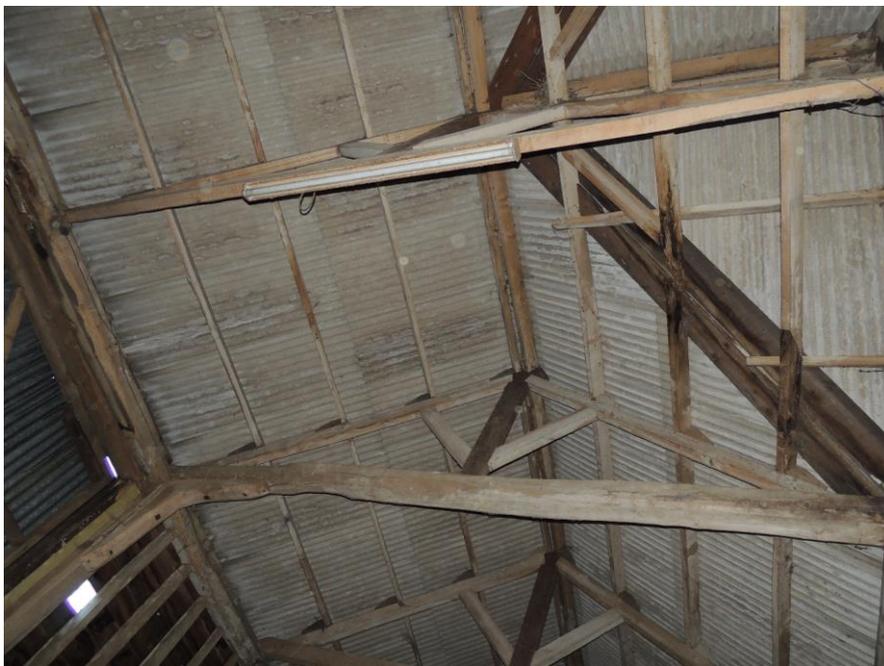
Photo 7: Showing roof area

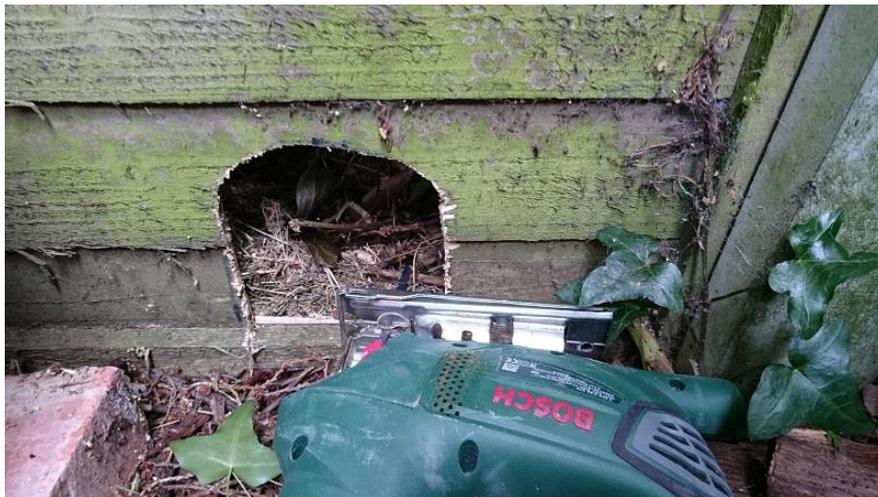
Photo 8: Hedgehog pathway at base of fence

A gap 13cm by 13cm is sufficient for any hedgehog to pass through. This will be too small for nearly all pets.

1: It is recommended that the existing gaps along the site boundaries are retained to allow hedgehogs and common toads to forage across the site as, potentially, at present. However if any boundary fences are to be introduced, see below:

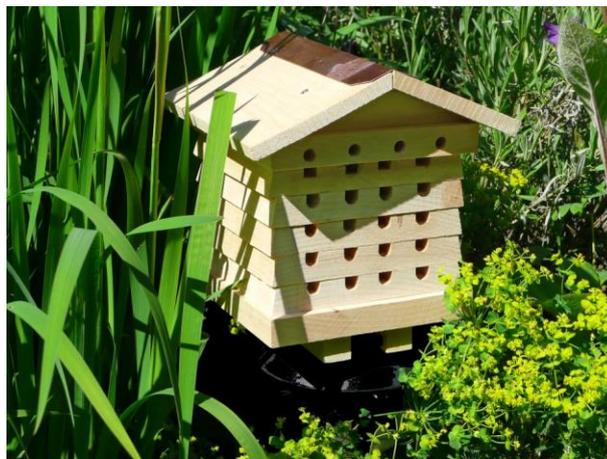
Photo 9: Solitary bee hive

A range of designs are commercially available, but they may be manufactured from durable FSC timber and provide valuable habitat for bees in modern gardens. They are designed specifically to attract non-swarming bees like the Red Mason Bee, Leafcutter Bee and other solitary bees which are naturally attracted to holes in wood.

4: Two solitary bee hives to be erected at the site.

Siting: Site in a visible warm place ideally oriented to face between southeast and south and to catch some sun. It is helpful to have soil nearby, and food sources such as flowers, orchards and fruit.
