Bat Survey Report

**Lakehouse Farm Barns (B2 and B3),
Finchingfield Road, Hempstead, Essex CB10 2PR.**

Survey Commissioned by:	Humphreys Homes Ltd.
Project Number:	REP18041.2021
Report issued:	23 rd October 2021 (13 th October 2021 - Draft)
Date of surveys:	B3: 02/08/21, 19/08/21, 06/09/21 B2: 03/08/21, 18/08/21, 07/09/21. Remote monitoring: 5 nights (B2 and B3) - August 2021 (2018 Surveys in B2: 28/06/18, 11/07/18, 26/07/18)
Surveyors:	Odette Robson BSc (Hons) PhD MCIEEM; Mary Power BSc (Hons) MSc MCIEEM; Juliette Banwell; Ben Robson.

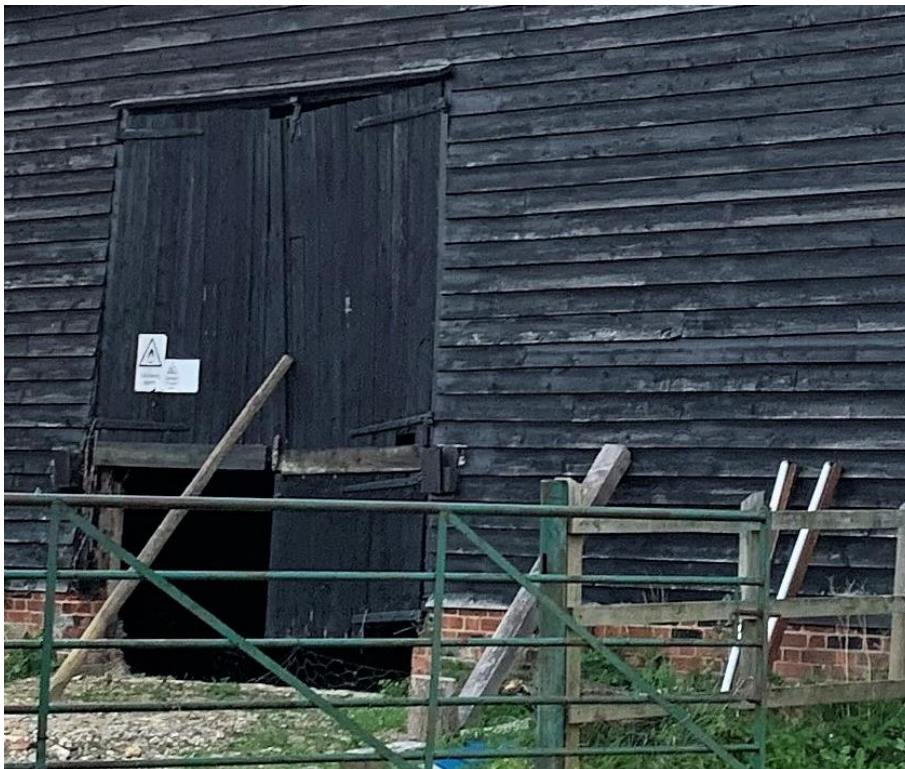
Plate 3.1: Western elevation of B2 – (Photo: 07/09/21 – O. Robson)

Timber framed barn with newer replacement stud walls and weatherboarding added over the original frame. Single-sheet profiled-tin roof with no internal lining or voids. Scattered pipistrelle and medium-sized bat droppings throughout, which were of a variety of ages: Some fresh (from the current active season), some several years old. Small accumulations of approximately 20 droppings in three areas: On a ledge at the base of the stud walls – eastern wall, southern gable and Midstrey (eastern wall). Weatherboarding was generally well-sealed on the eastern and western walls, with minimal warping or gaps below the boards which bats could access. The three gable ends all had numerous gaps at slipped or damaged boards which provided potential access/egress points for bats. The door on the western elevation was in poor repair, with the lower section missing and the upper part damaged and with a large number of gaps between boards (Plate 3.1).

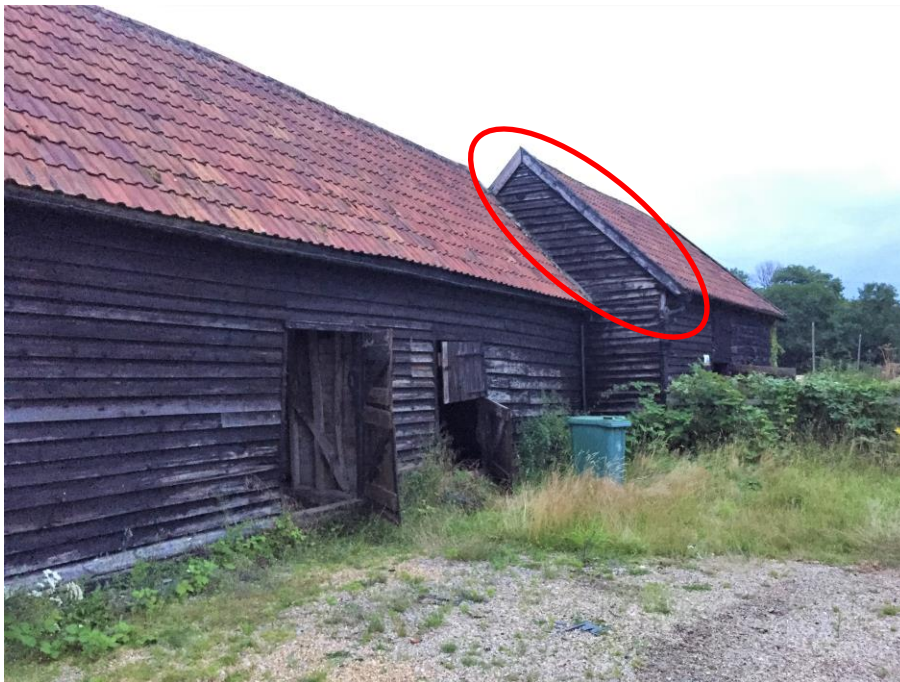
Plate 3.4: Eastern elevation of B3 (two parts, internally joined) - (Photo: 02/08/21 – O. Robson)

Barn 3 was two adjoined buildings with an opening internally between the two parts. The southern part was further subdivided into three, with internal walls to eaves height only (flight access between all sections below the ridge). B3 had a short brick plinth with stud walls above (frequent gaps and crevices at mortise joints), and externally clad in timber weather-boards, many of which had gaps/damage, and/or warped/lifting. Gables were weather-boarded to the apex. The two sections were slightly off-set and different heights exposing a partial gable at the join (circled in Plate 3.4). Many of the roof tiles were slipped and missing/damaged. No internal roof void or lining: Tiles were laid directly onto roof timbers.

Scattered bat droppings were present throughout: Beneath the ridge – approximately 40 medium-sized (brown long-eared and barbastelle), and approximately 10 pipistrelle-sized dropping. Feeding remains (moth wings) and brown long-eared bat droppings (approximately 10) in the northern section of B3.

Two barbastelle bats entered B3 at the gable-join between the two parts of B3 (Plate 3.4 and Appendix B, Plate 4), at 48 minutes before sunrise. The bats foraged internally (mainly in the northern part of B3) for 5 minutes before roosting in internal crevices/ridge after investigating several potential crevices, mainly in the northern part of B3.

Entry/exit to the B3 was through damaged weather-boarding on the south-facing gable apex which is exposed where the two parts of B3 join (Plate 3.4 and Plate 4, Appendix B). Roosting bats leaving B3, all headed north or north-east, towards the woodland as shown in Appendix D.

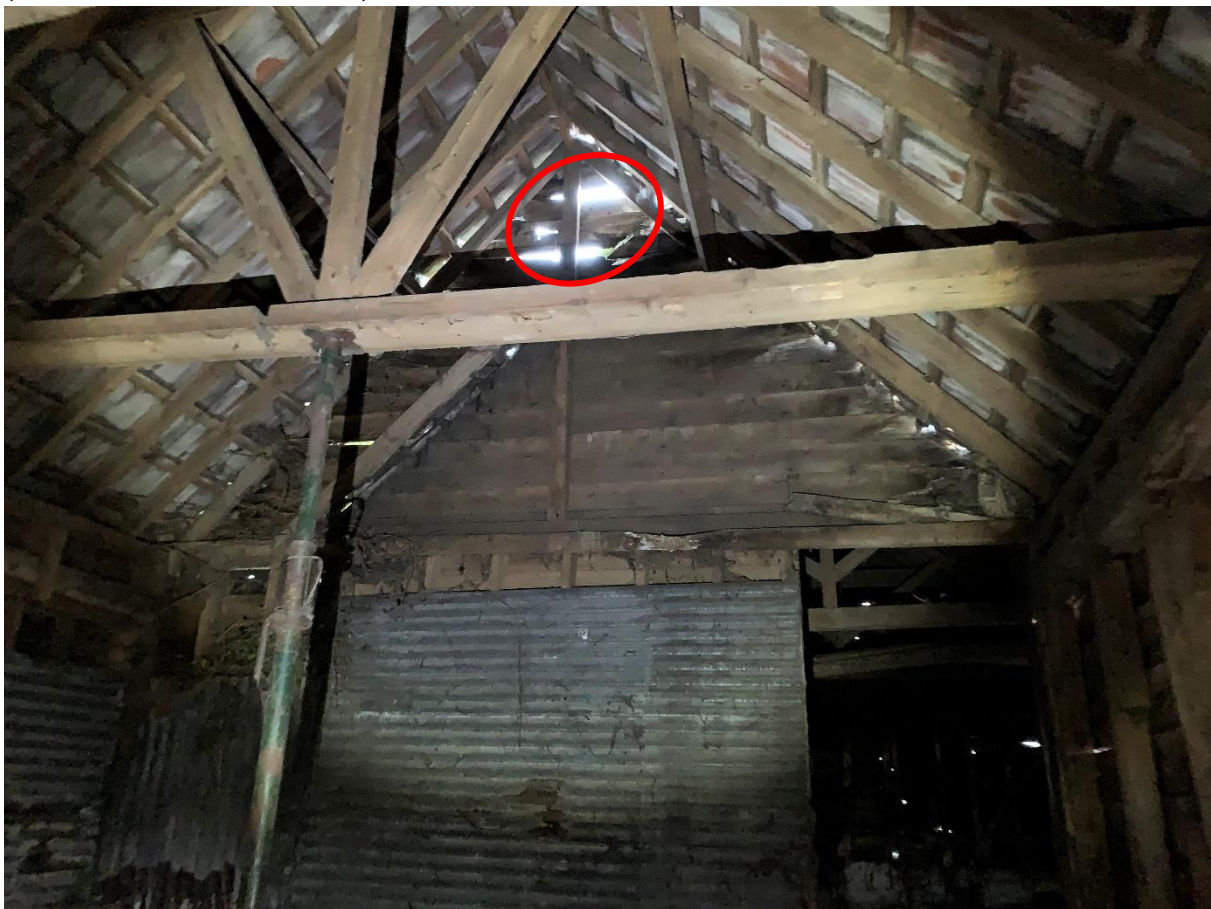
Plate 4: 2021: Access point into B3 – used by brown long-eared and barbastelle bats (Photo: O Robson 07/09/21).

Two brown long-eared bats entered the barn at the gable-joins in the middle of B3 (Appendix B, Plate 4) and roosted at the ridge in the northern part of B3 (44 minutes and 39 minutes before sunrise). Twenty minutes prior to entry, brief brown long-eared foraging was recorded in the Farmhouse garden to the south of the barn.

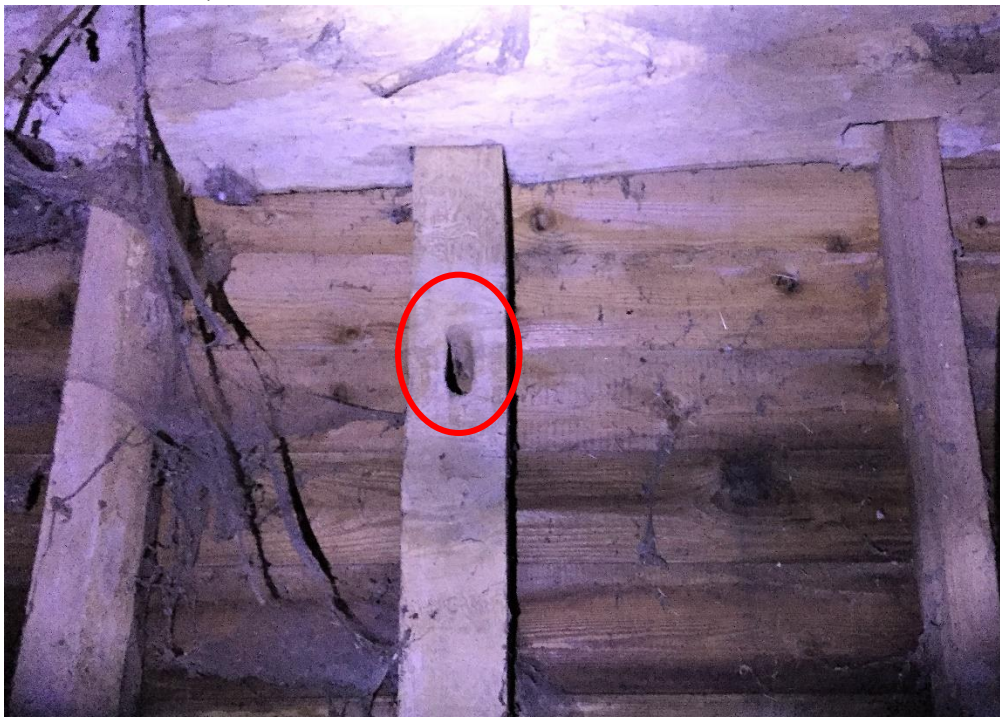
Plate 6: 2021: Crevice on stud-wall used by roosting barbastelle on 02.08.21 - (Photo: O Robson 02/08/21).

Pre-survey internal inspection: 1 x barbastelle roosting in a crevice/mortise hole on the western internal wall (Appendix B, Plate 6) – moved to ridge beam during the survey; 1 x barbastelle roosting at the ridge-beam in the north section of B3 (Appendix B, Plate 7), with a collection of approximately 20 droppings beneath, suggesting occasional roosting at this location; 1 x brown long-eared bat roosting at the ridge beam to the north of the northern section of B3 – internal flight during the survey, and a collection of yellow underwing moth wings and droppings (10) suggest an occasionally used feeding perch and day-roost.

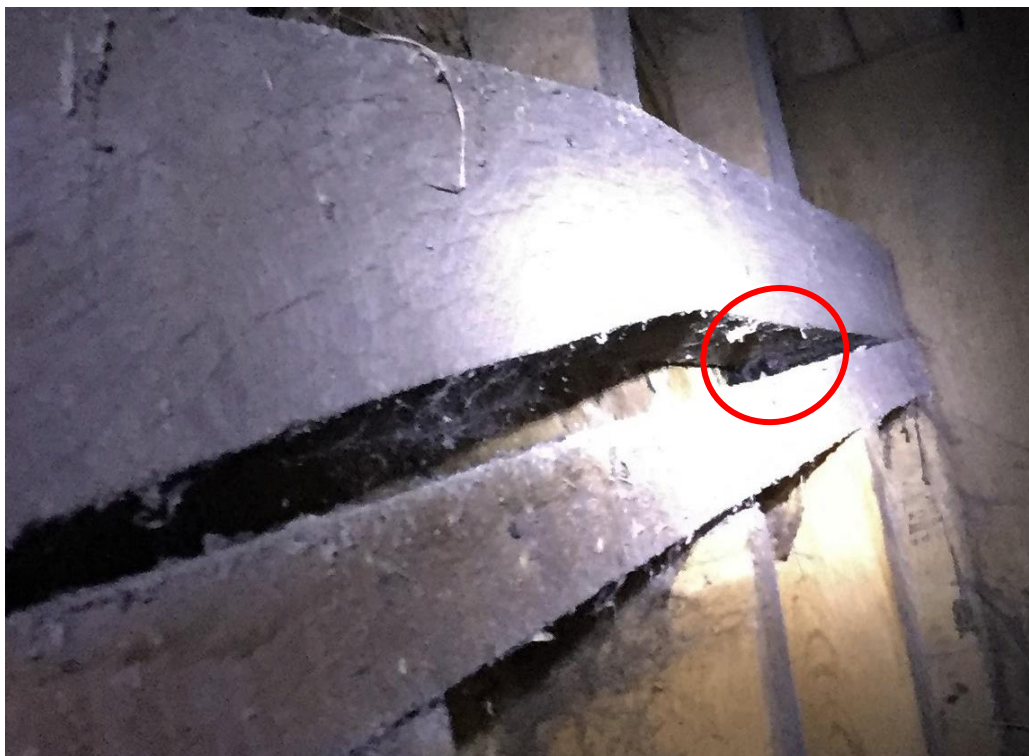
Plate 8: 2021: Roosting barbastelle in wall crevice in B2 (eastern wall) on 03.08.21 - (Photo: O Robson 03/08/21).

A single barbastelle returned to roost on the eastern wall between two wall support beams at 58 minutes before sunrise (Appendix 3, Plate 8).
