Planning, Heritage & Design Statement

The Old Farmhouse, West High House Farm, Morpeth, NE61 2YT

April 2023

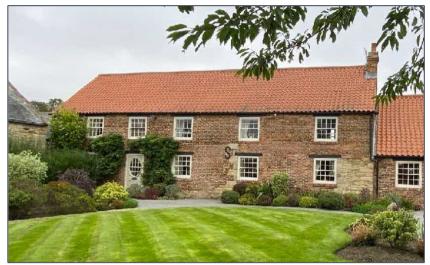
Photo 3 Front south elevation today

- 3.6 The character of both elevations has changed considerably during the early 1990s conversion. The south front elevation has lost its external steps and blocked window/hayloft door (which were non-original) as well as the addition of windows and removal of a ground floor door to the right hand side. The rear elevation has changed from being one of few openings, to one of domestic character with nine new sash windows and a pair of French doors.
- 3.7 Given the extent of works in the early 1990s it is likely that there was a considerable amount of rebuilding. The existing plan (Figure 6) does not identify a door in this location (Photo 7), but does identify a bulge in the stonework. The door as well as the window are both recent insertions.

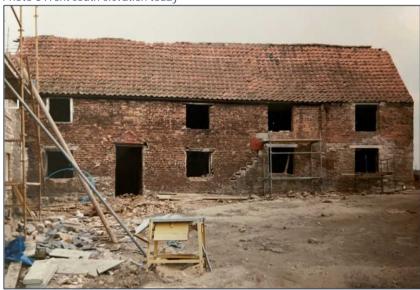
Photo 4 Front south elevation prior to conversion from pigsty to dwelling

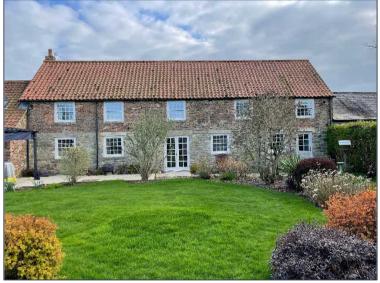
Photo 7 Rear north elevation – all modern apertures – compare with Figure 8
