**Ecological survey:
Protected species survey (Bats).**

**'Mizpah'
Bell Lane,
Hinderclay,
Suffolk.**

Final report: 2nd May 2023.

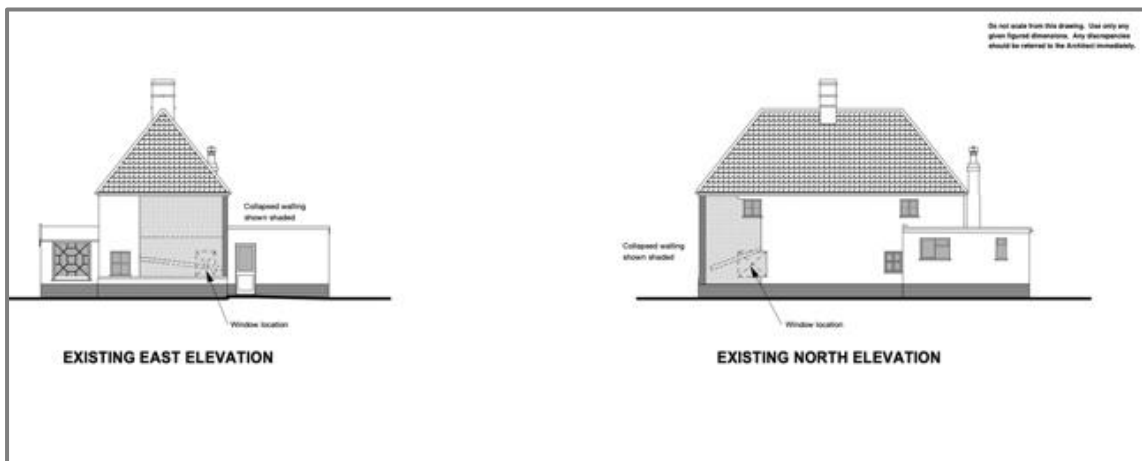
Plan 3. Showing extent of wall collapse. (Illustrative do not scale)

The collapsed section of wall have been cleared however it would appear that the building has solid walls without cavities.

The collapse occurred during the winter of 2022, the architects suggest around November December, and the property was an occupied dwelling prior to that, and consequently the exposed interior of the building would have been enclosed living space and would not have been occupied by bats prior to that.

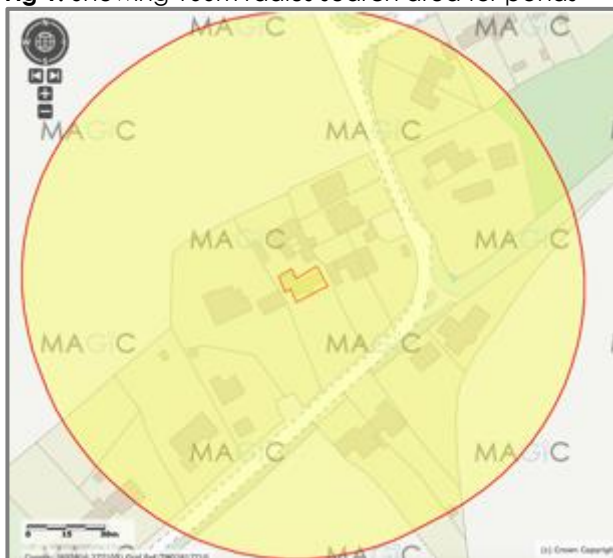
Fig 1. Showing 100m radius search area for ponds

Ponds and watercourses within 200m (see fig 3 above):

- Ponds 1 there is one pond shown on OS maps at OS Grid ref: TM02747708. This pond is known to have become infilled with debris and does not function as an aquatic water feature.
- There are no permanent or named watercourses shown on OS maps within 200m of the site.

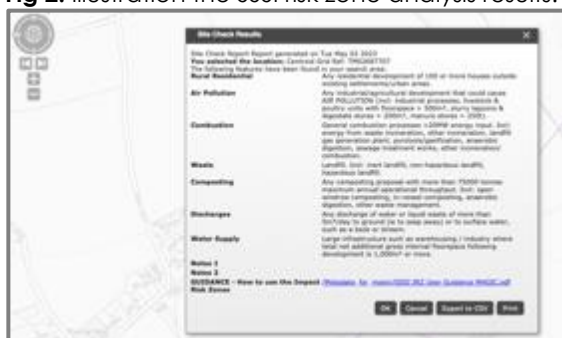
Fig 2. Illustration the SSSI risk zone analysis results.

An SSSI risk zone assessment was conducted using Defra Magic maps, This did not return any requirement to notify or request consultation from Natural England.

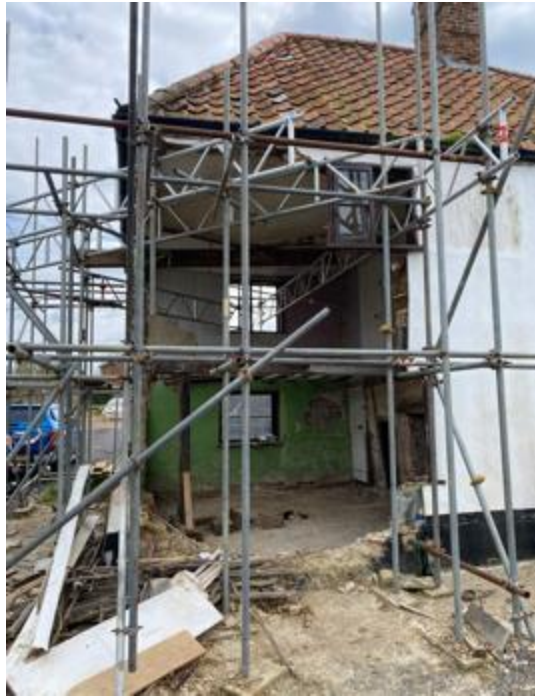
Table 1: Illustrating survey results.		
Photo No	Image	Notes
Photo 1§

Image to show the extent of the collapsed wall.
Photo 2

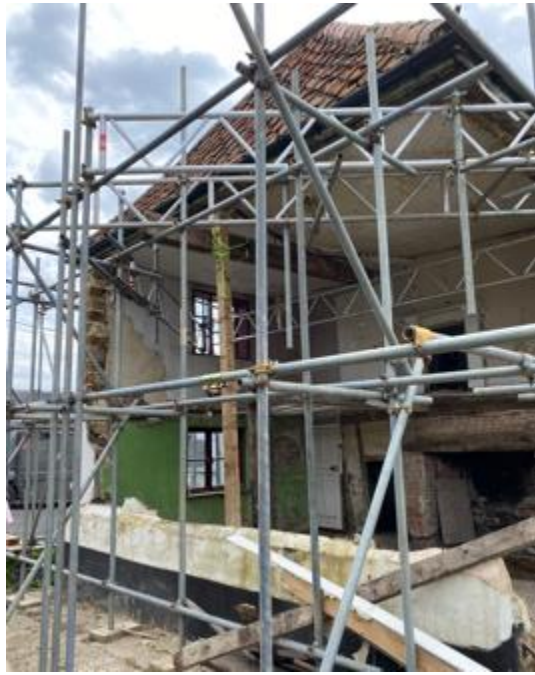
Image to show the extent of the collapsed wall. Not the roof is enclosed and currently supported.
Photo 3

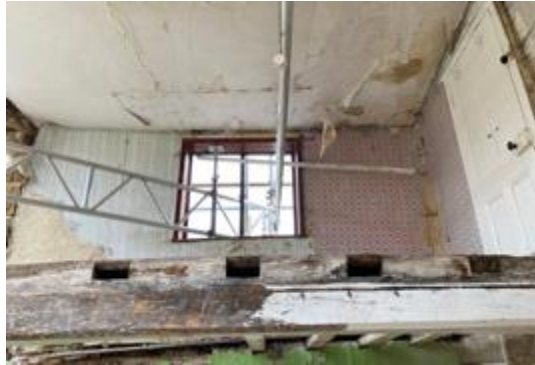
A thorough search of the area of the property where the walls had collapsed and the exposed former internal spaces found no bats or evidence of bats in the form of bat droppings, urine splashes, scratch marks, polishing or staining.

Image to show the exposed interior of the building

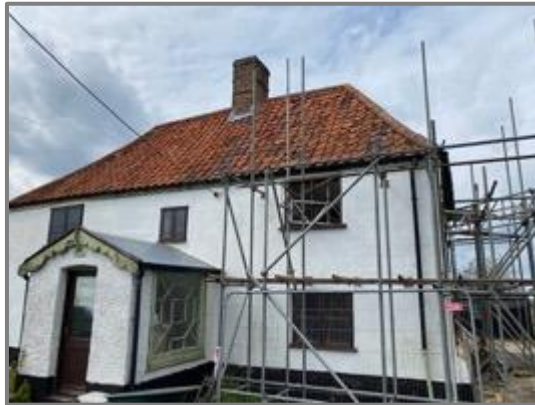
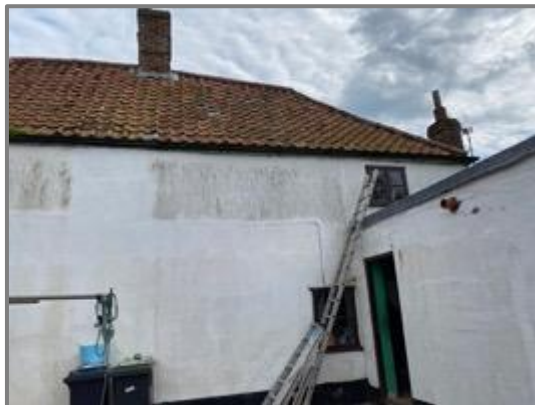
Photo 4 & 5

The intact sections of the building are rendered externally without any cracks, crevices or potential for bats to roost within the walls.

Images to show the condition of the exterior of the building. Showing rendered walls without cracks, crevices or bat roosting opportunities within the walls. Note the roof is intact and enclosed.
