**Courtyard Buildings, Ellingham Farm, Somerley
Estate, Ellingham, Hampshire, BH24 3PJ**

Ecological Assessment

Report Number: 0525

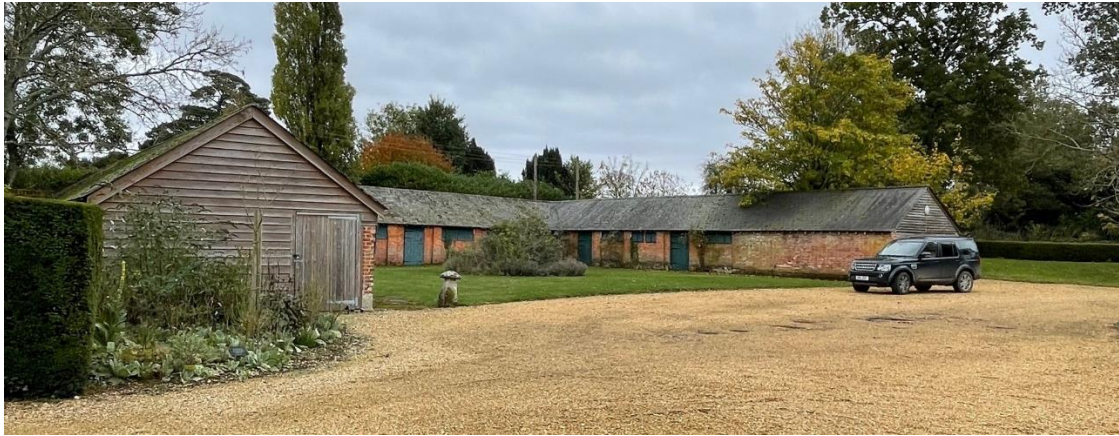
- 4.3 The brick built, wooden framed building (Photo 1) is C shaped and is located around a courtyard with short well maintained lawn with a rose bush in the centre (Photo 2). The building was previously used for livestock but for many years has been used for storage and most of it is unused. It is all single storey, open to the rafters (Photo 3), with no attic area – the building is divided up into separate sections internally but these are all connected for species like bats and birds at roof level (Photo 4). The building has a slate roof (Photo 5) with wooden weather boarding (single skin) at the gables (Photo 6), there is a plastic roof membrane below the slates in places.

Photo 1: The building from the north-west

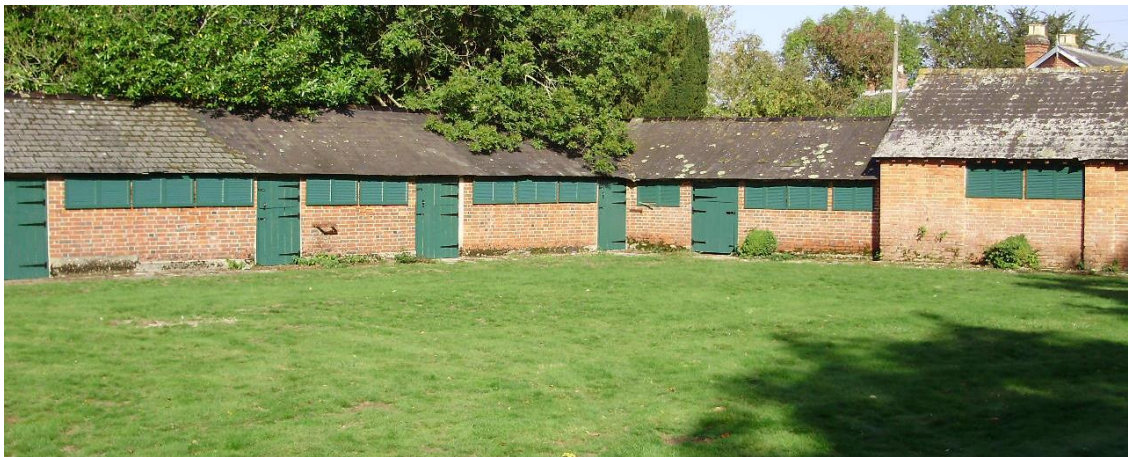
Photo 2: The central courtyard

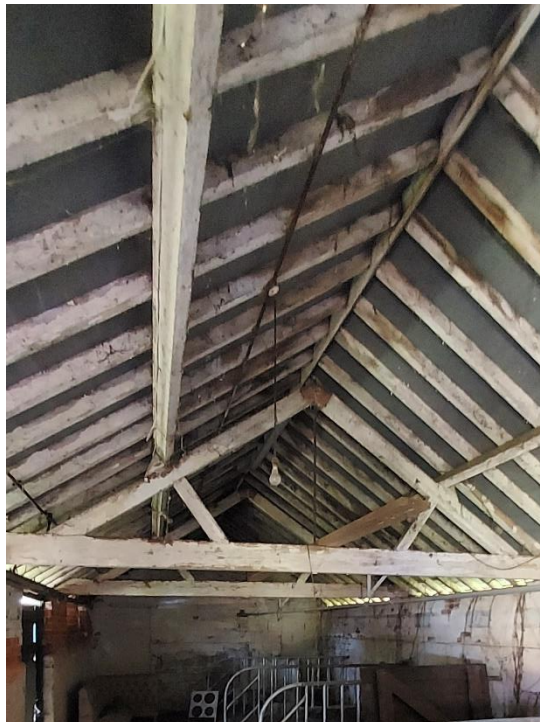
Photo 3: Internally

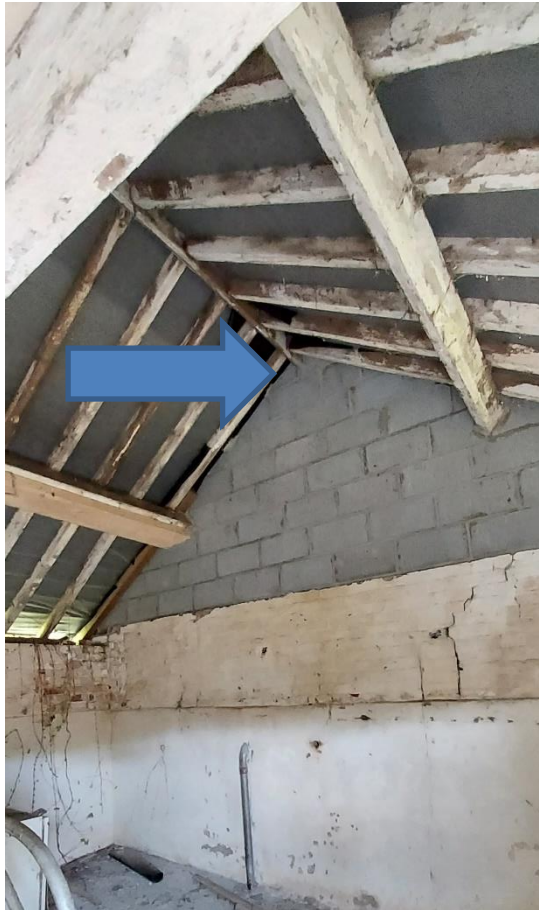
Photo 4: Gaps for bats between different internal rooms

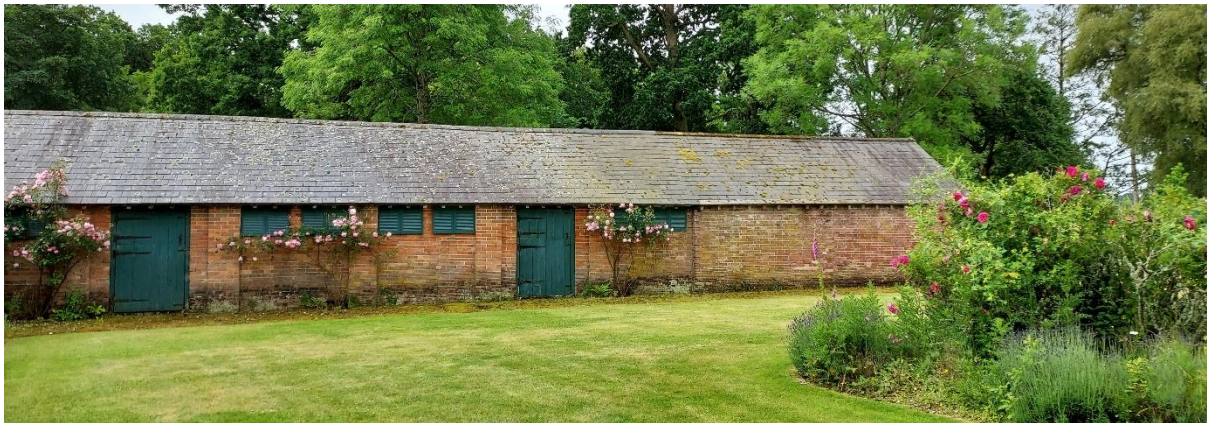
Photo 5: Slate roof

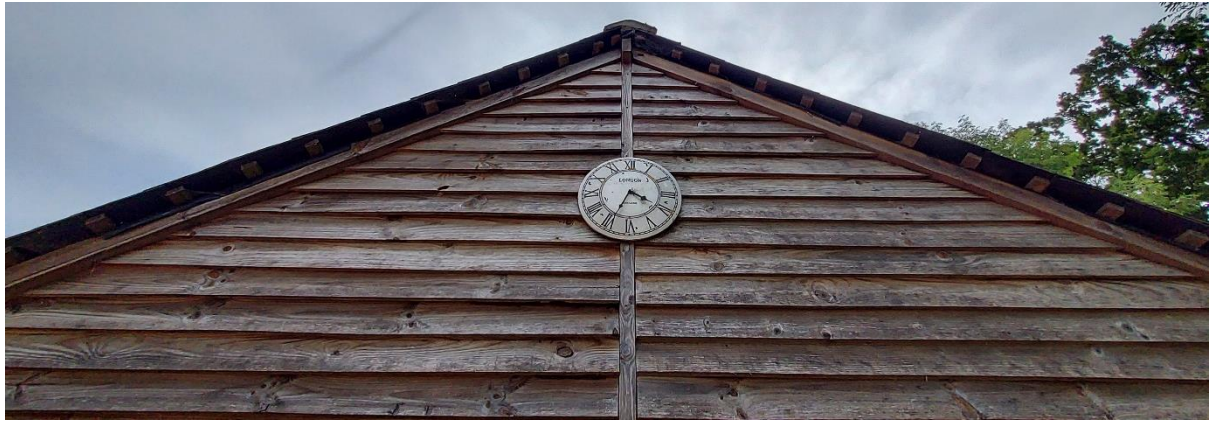
Photo 6: Gable to south

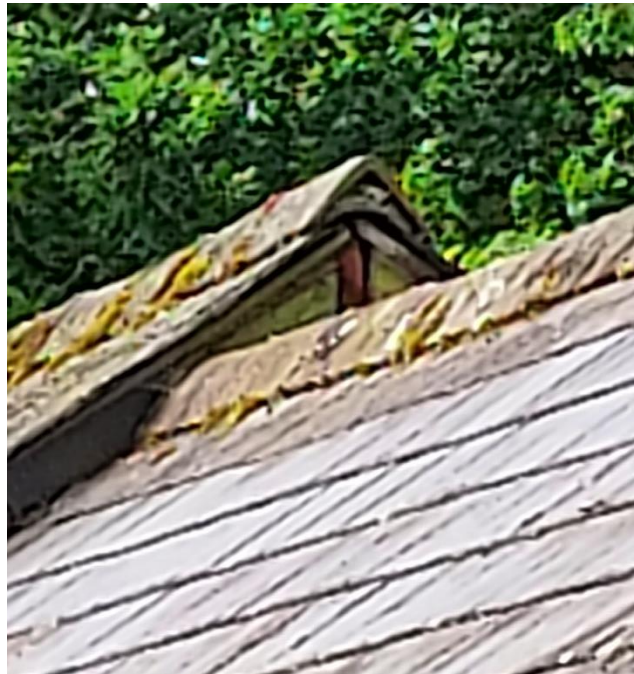
- 4.4 Access is possible for bats and birds:
- at the gable by the weather boarding and at the apex (Photo 7)
 - possibly at occasional ridge tiles where mortar is missing (Photo 8)

Photo 7: Access at the ridge tile where two sections of roof meet

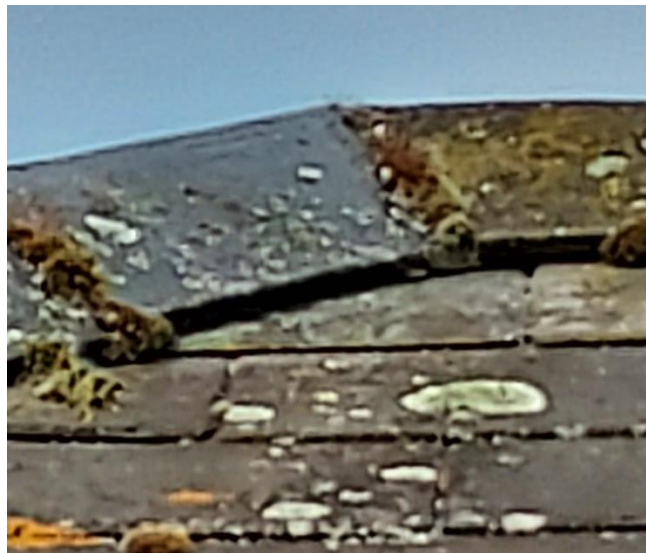
Photo 8: Ridge tile access

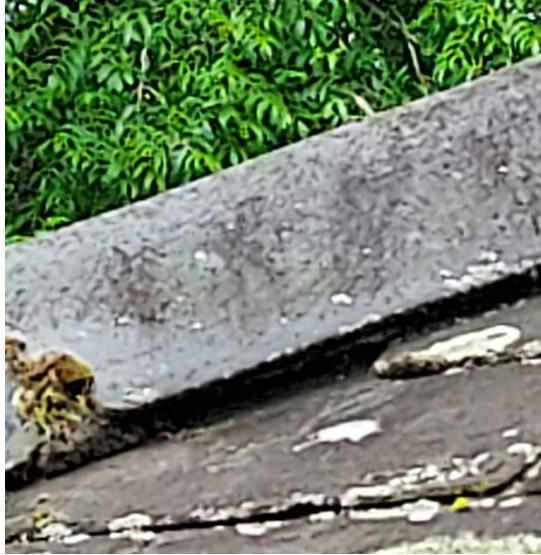
- at ridge edge tiles (Photo 9)
 - at the soffits in places (Photo 10)
 - at an open stable door (Photo 11)
 - and at the top of a stable door (Phot 12)

Photo 9: Access at a hip ridge tile

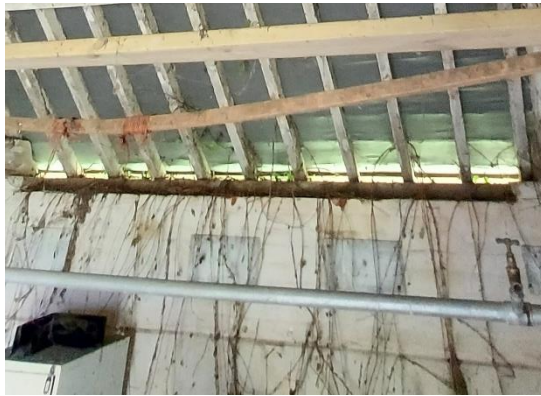
Photo 10: Access under soffits

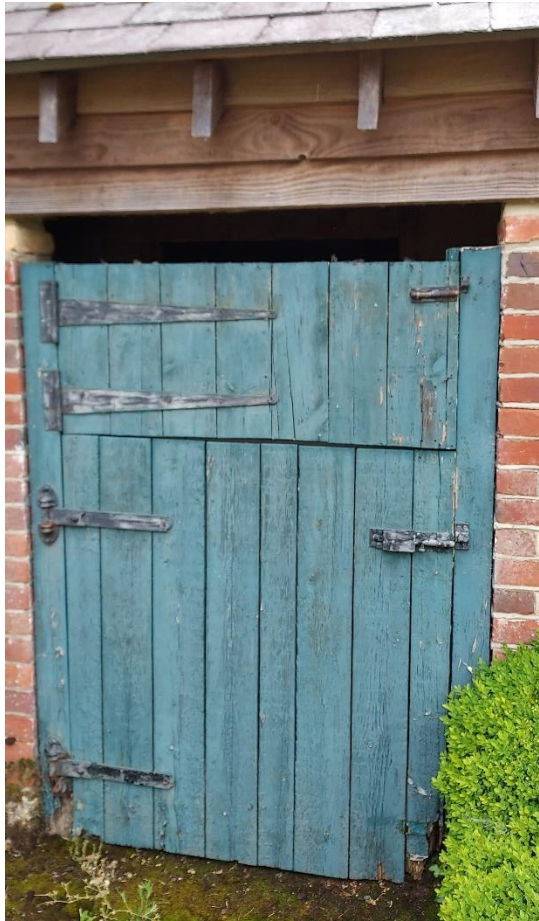
Photo 11: Open stable door access

- 4.12 During the first emergence survey the Greater Horseshoe bat was recorded emerging from above the stable door (See Photo 11) facing west at 2147-2148, the bat then flew over the building east before heading north towards St Mary's Church. 2 soprano pipistrelle were recorded emerging from under a ridge tile where two different roof sections meet, one being slightly higher than the other (See Photo 7). The bats were recorded emerging at approximately 2130, Other bats recorded in the vicinity included:

- 5.4 A night time dusk survey will be undertaken to ensure the Greater Horseshoe has left the stables before work is undertaken there. The stable door and any other direct flight access points will be sealed up to ensure the bat can not get back in.

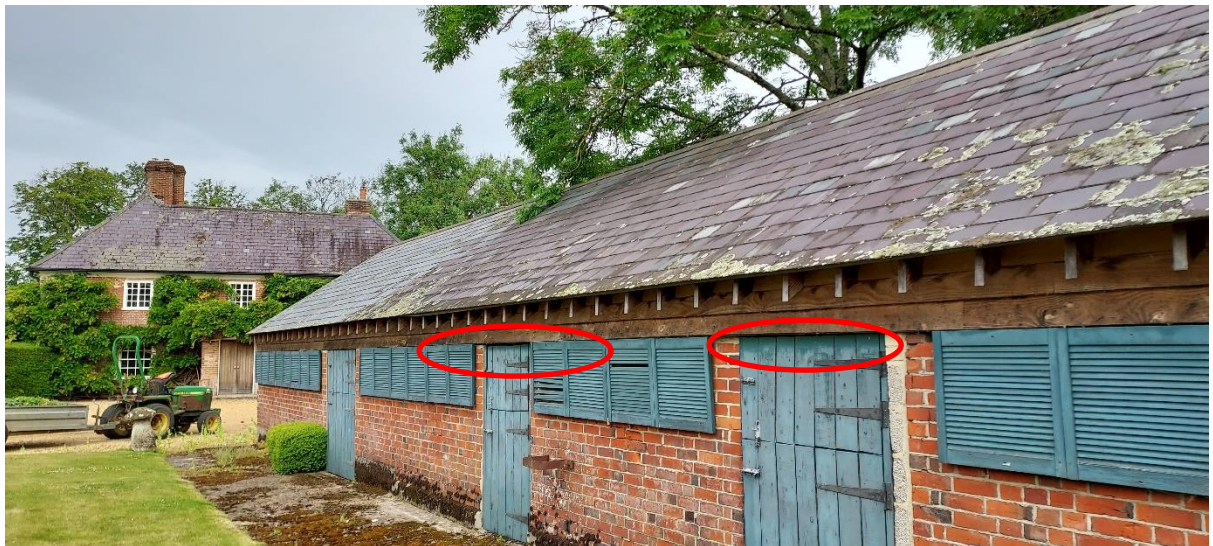
Photo 12: Gaps at the stable doors

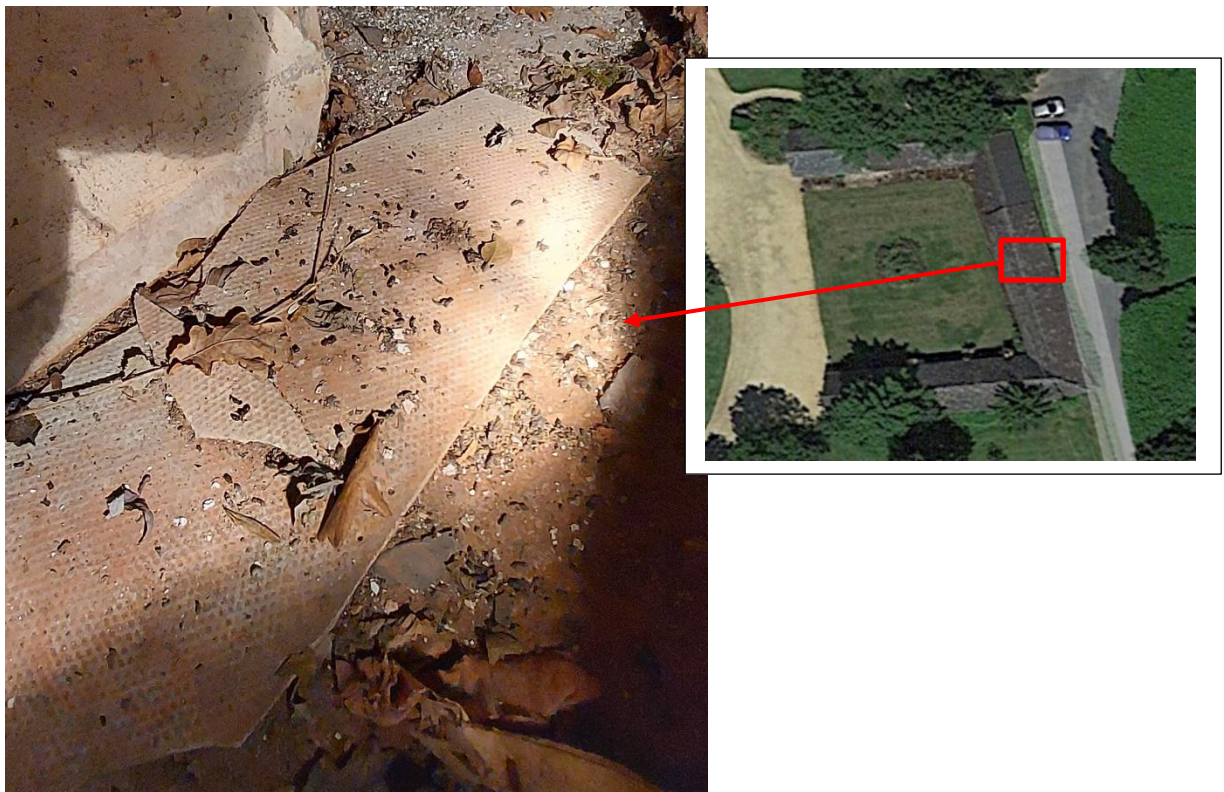
- 4.9 100 – 150 Greater Horseshoe (GHS) droppings (Photo 13) were recorded in one location in the building along with a single peacock butterfly wing which may be attributable to a feeding bat. The bat was recorded internally on two occasions, before the dusk emergence surveys. The GHS entered the building during the dawn survey but it was not seen roosting.

Photo 13: Some of the GHS droppings and where they were located

- 4.18 Mitigation for the loss of the roosting area will require a new stand alone space for the Horseshoe bat to roost and direct flight access to this area via a 'dormer' opening or similar.

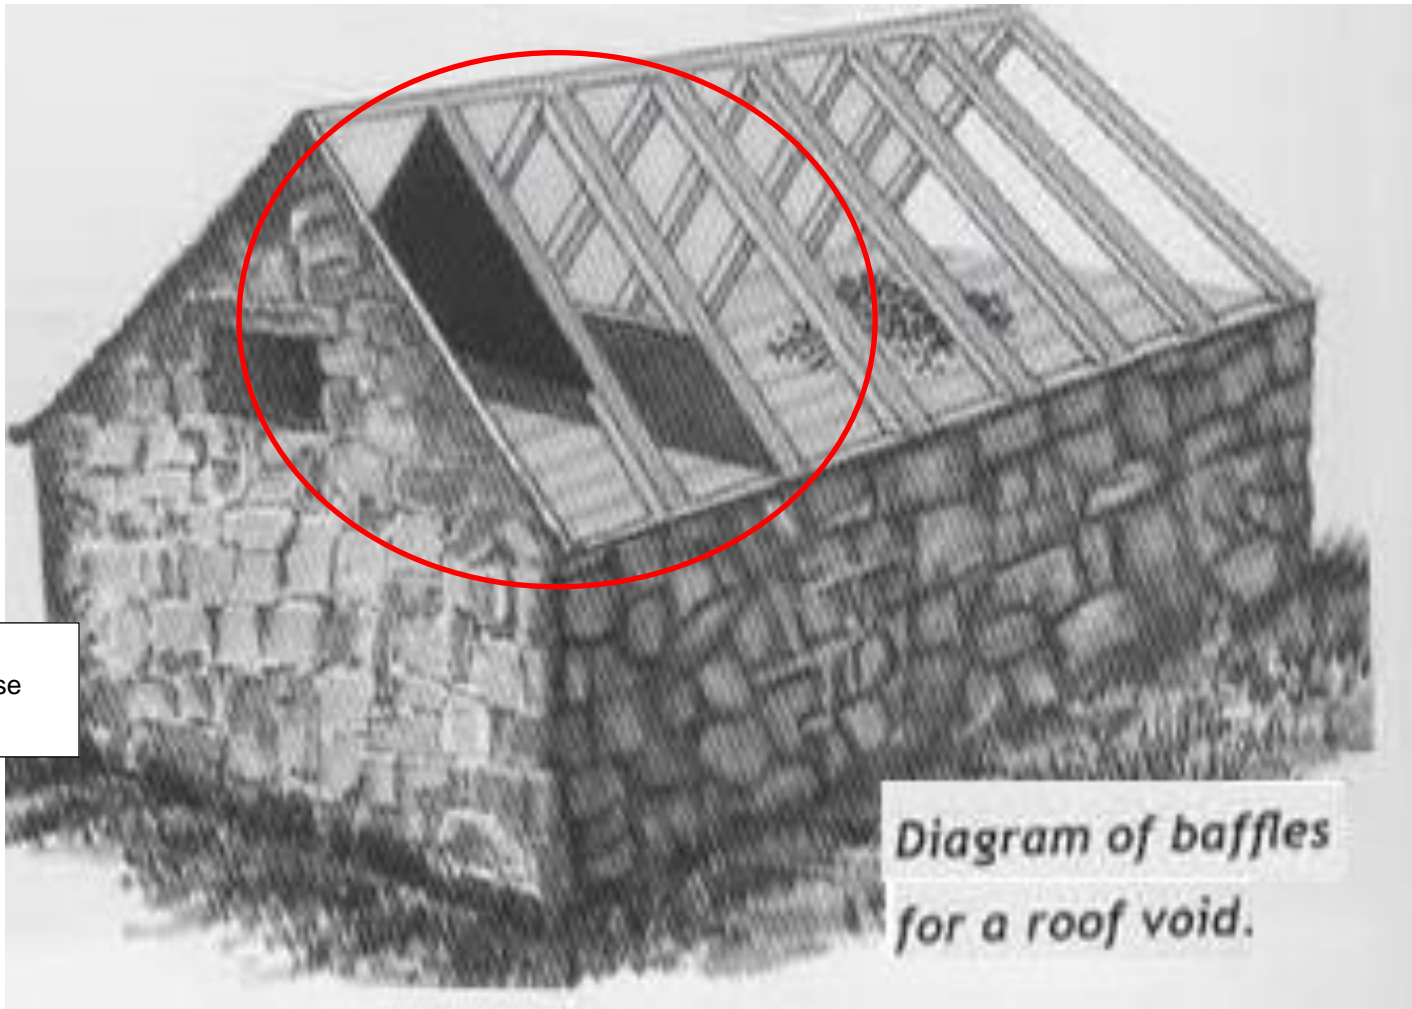
Installation of Baffles

Baffles will be used to create micro-environments to minimise draughts.

- Baffles will be used to create micro-environments to minimise draughts.
 - A 'hot box' is a sectioned off area within a bat roost that provides protection from any draughts, allowing the temperature to remain higher than the surrounding area. They are typically constructed from plywood panels. The access in the base must be 500mm x 500mm and the external parts will be painted black to increase heat absorption.

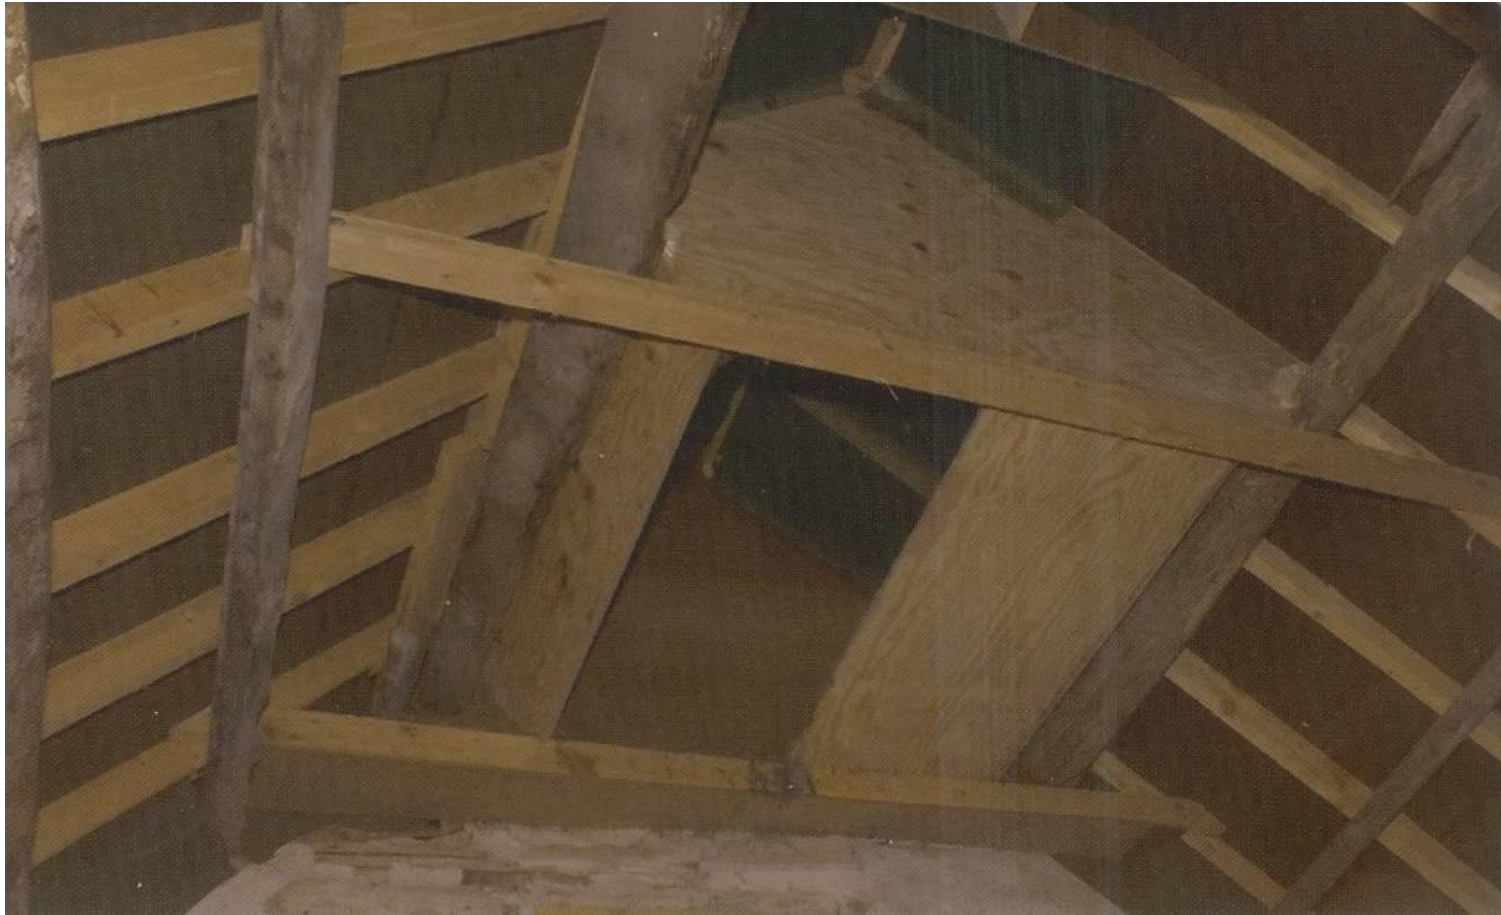
Hot Box

A 'hot box' is a sectioned off area within a bat roost that provides protection from any draughts, allowing the temperature to remain higher than the surrounding area. They are typically constructed from plywood panels. The access in the base must be 500mm x 500mm and the external parts will be painted black to increase heat absorption.
