**Buildings at Spooners
The Heath, Woolpit
Suffolk**

Preliminary Roost Assessment Report

VERSION 2
Final

22 February 2023

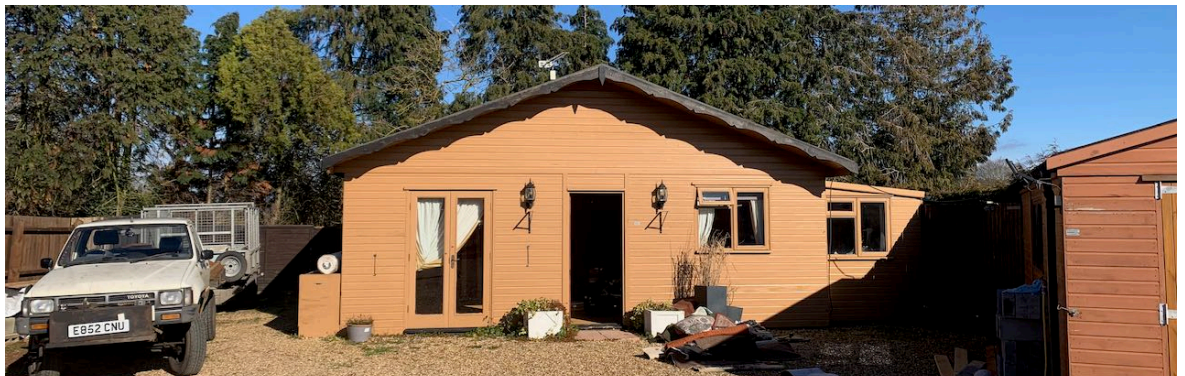
Photograph 1. Bungalow – south aspect

The bungalow was constructed of wood with a chipboard roof covered with 1F bitumen felt (**Photograph 1**).

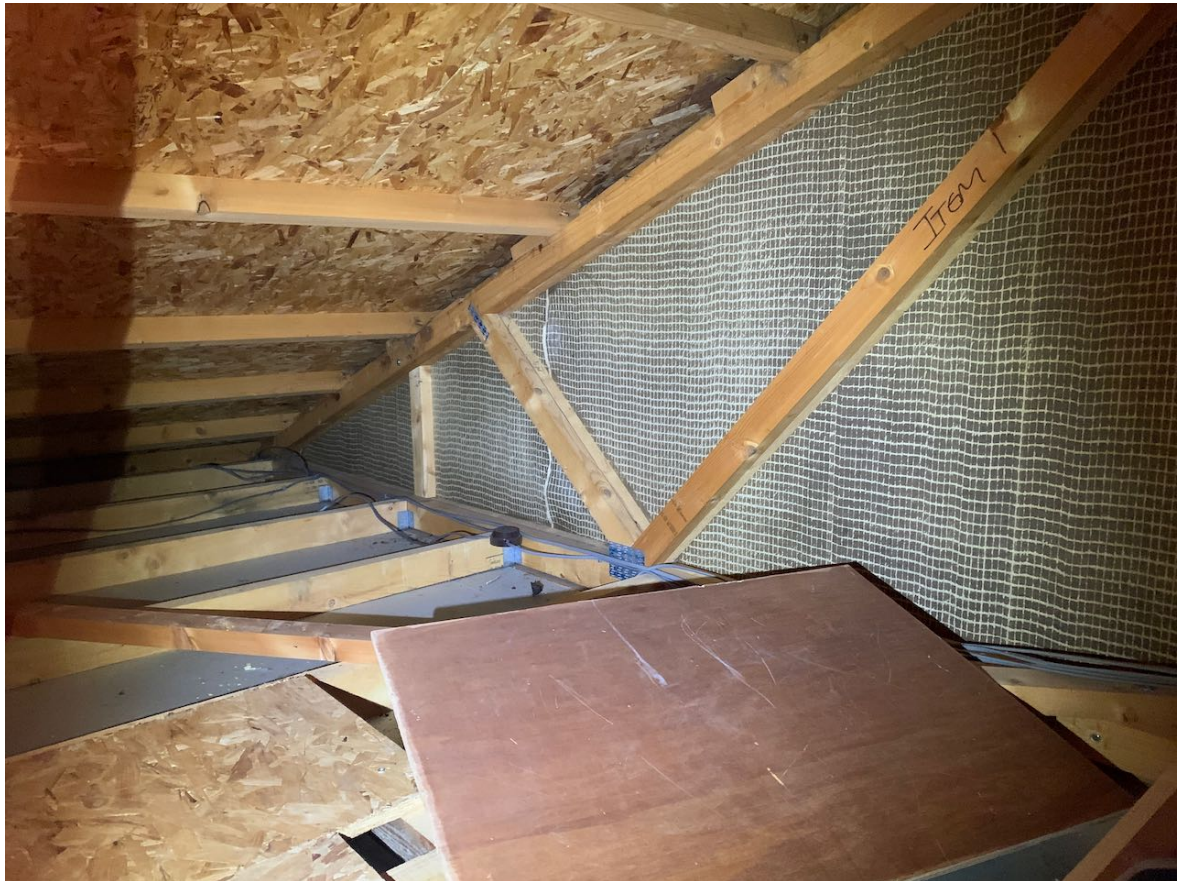
Photograph 2. Roof void

A single roof void was present (**Photograph 2**) measuring ca. 8m x 6m x 1.5m that was unlined below the chipboard and with breathable membrane at each gable end. No evidence of bats was recorded in the void.

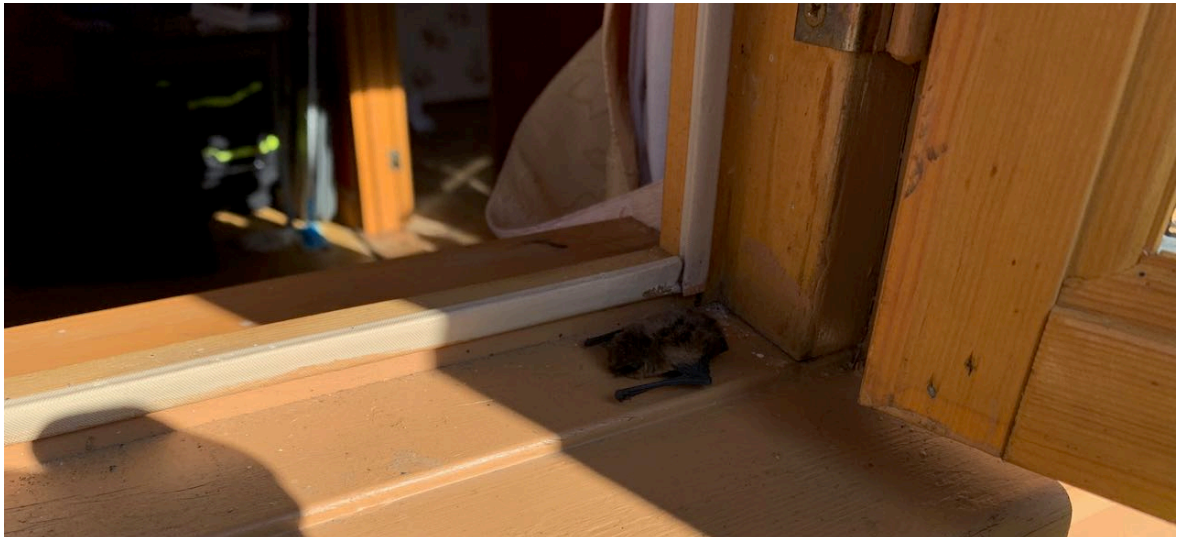
Photograph 3. Deceased Common Pipistrelle

A deceased Common Pipistrelle *Pipistrellus pipistrellus* bat was present in the window-frame just east of the entrance door (**Photograph 3**) with ca. 30 droppings around the frame, on the sills (both external and internal) and also around/in a broken vent above the window (**Photograph 4**).

This is considered likely to be an occasionally used day roost of a single individual bat (probably only the individual found deceased). However, the potential for more than one bat using this roost cannot be discounted at this stage.

The bungalow is a confirmed roost (**Table 1**).

Given the results of the PRA, further survey work to inform a Natural England European Protected Species (EPS) mitigation licence application will be required prior to any works commencing (to enable the works to be completed legally). This further survey work should take the form of two nocturnal surveys (emergence/re-entry surveys) completed May-August inclusive by a single surveyor (and infra-red cameras).

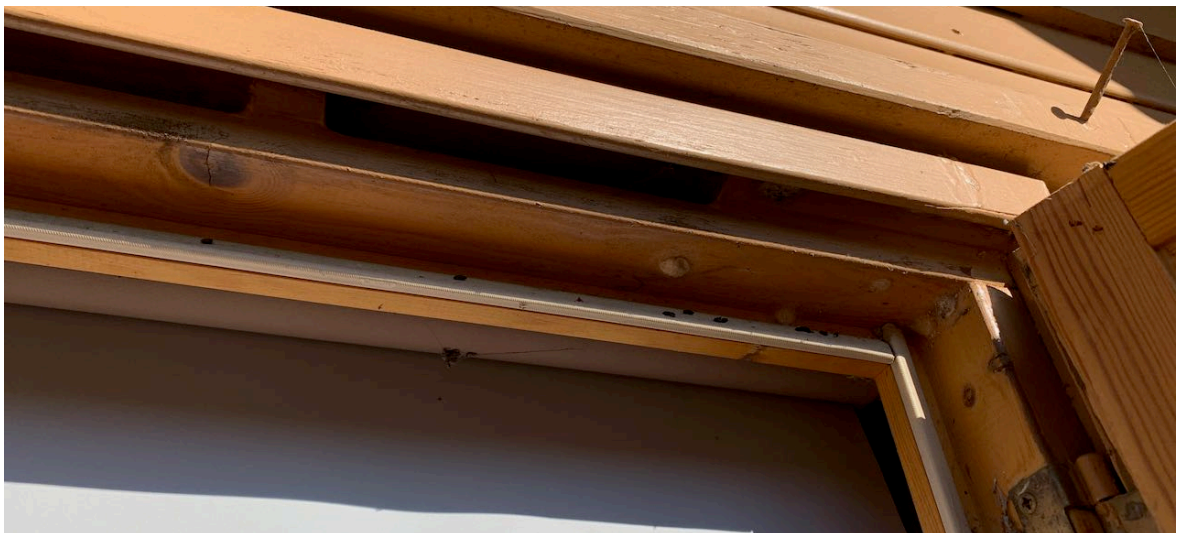
Photograph 4. Common Pipistrelle droppings around window frame (with broken vent visible above)

A single roost site of a Common Pipistrelle was recorded around a window frame/broken vent above, with a deceased individual present.

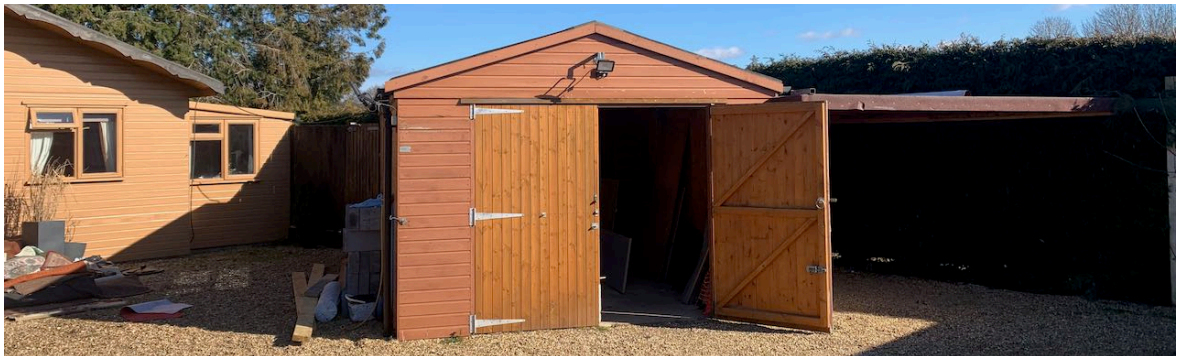
Photograph 5. Garage

The garage (**Photograph 5**) was constructed of wood and was without any bat evidence or PRFs. Consequently, the garage was assessed to be of negligible potential to support roosting bats (**Table 1**).

No evidence/potential for roosting bats was recorded and no further survey work in relation to this building is considered necessary.
