# **DESIGN AND ACCESS STATEMENT/ HERITAGE STATEMENT**

2 HOLLIN TERRACE  
RIDING MILL  
NORTHUMBERLAND  
NE44 6HR

Application for listed building consent for reroofing the house.

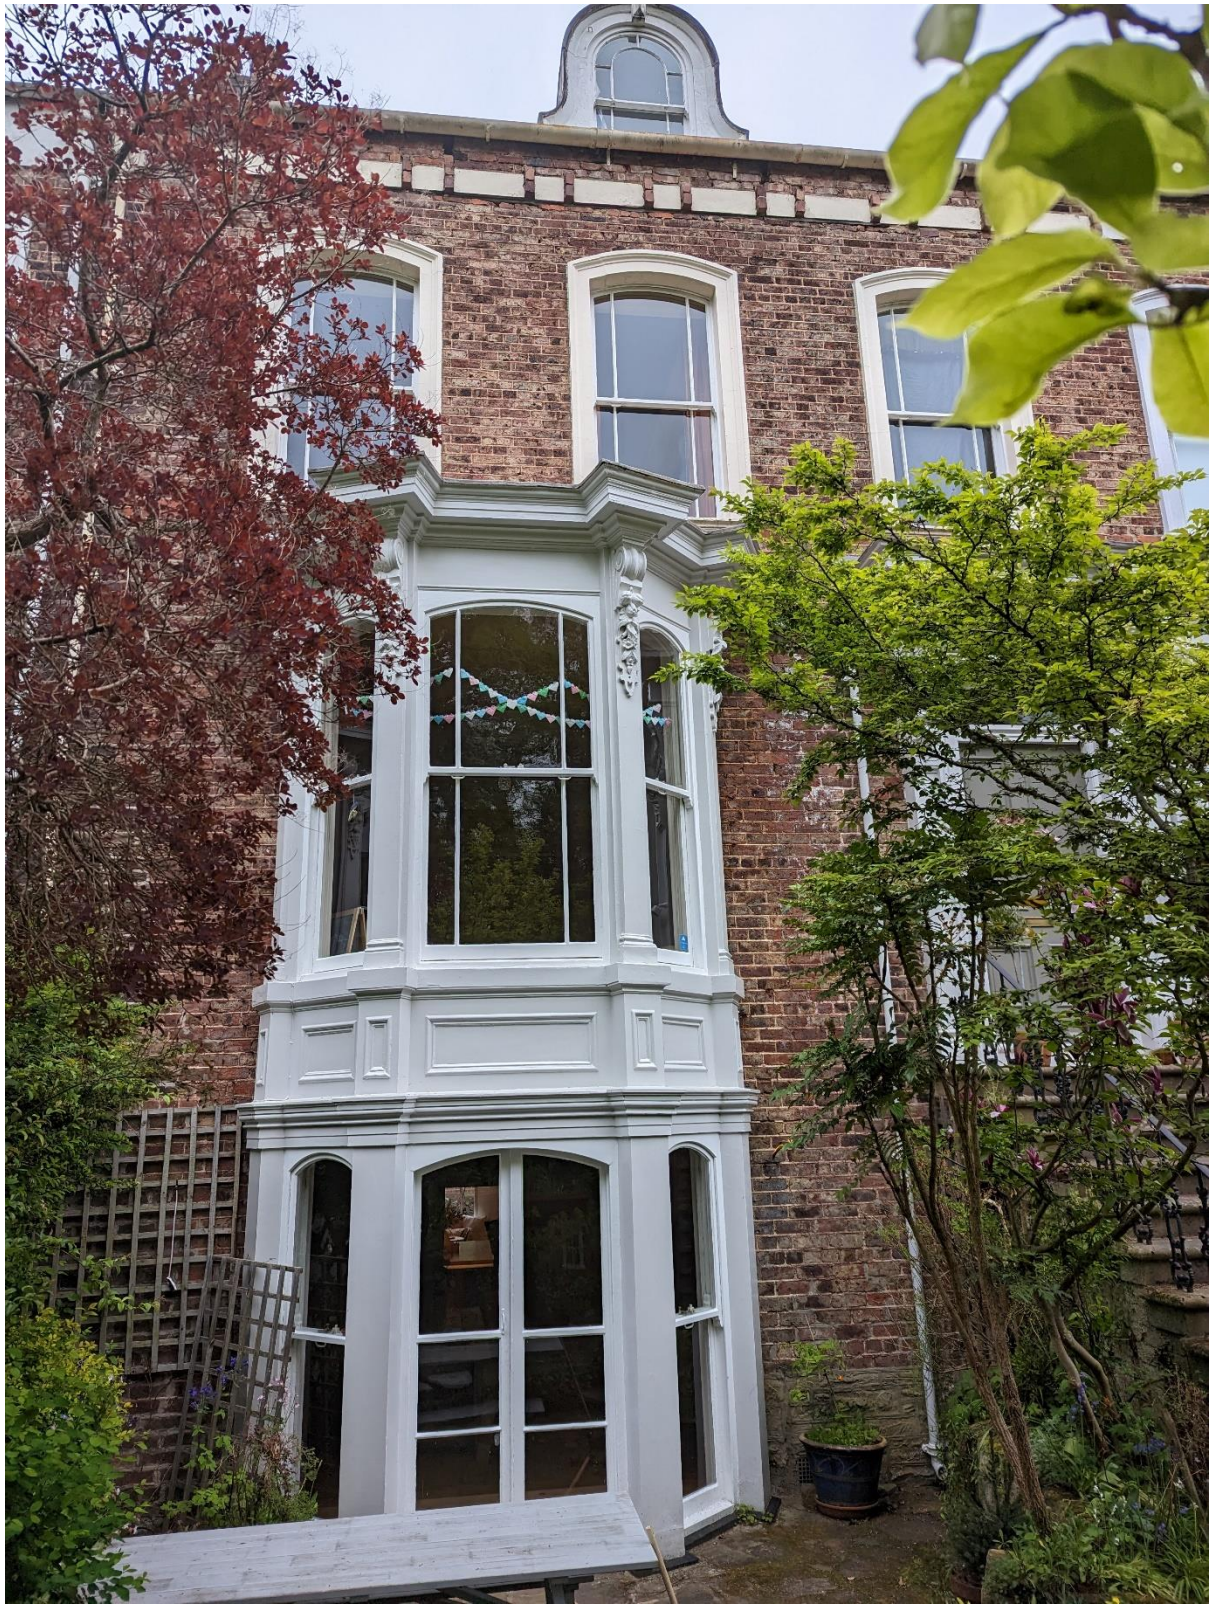
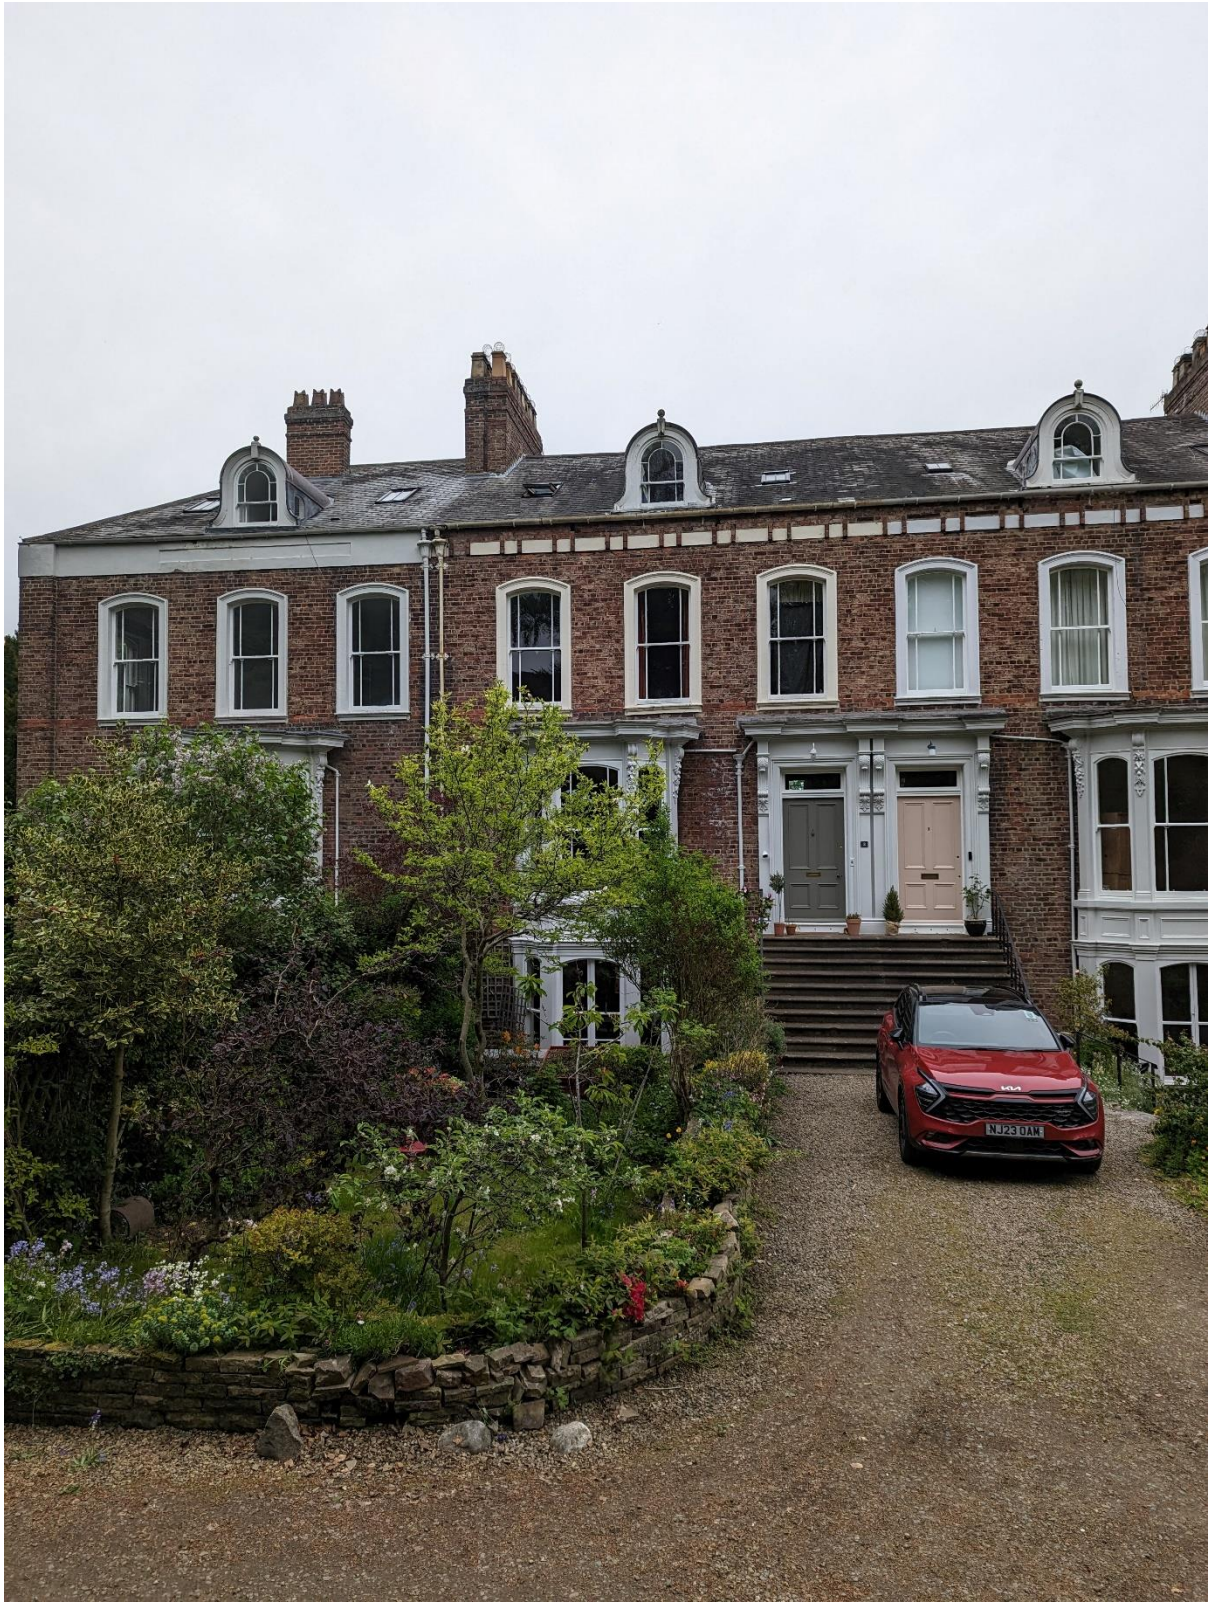
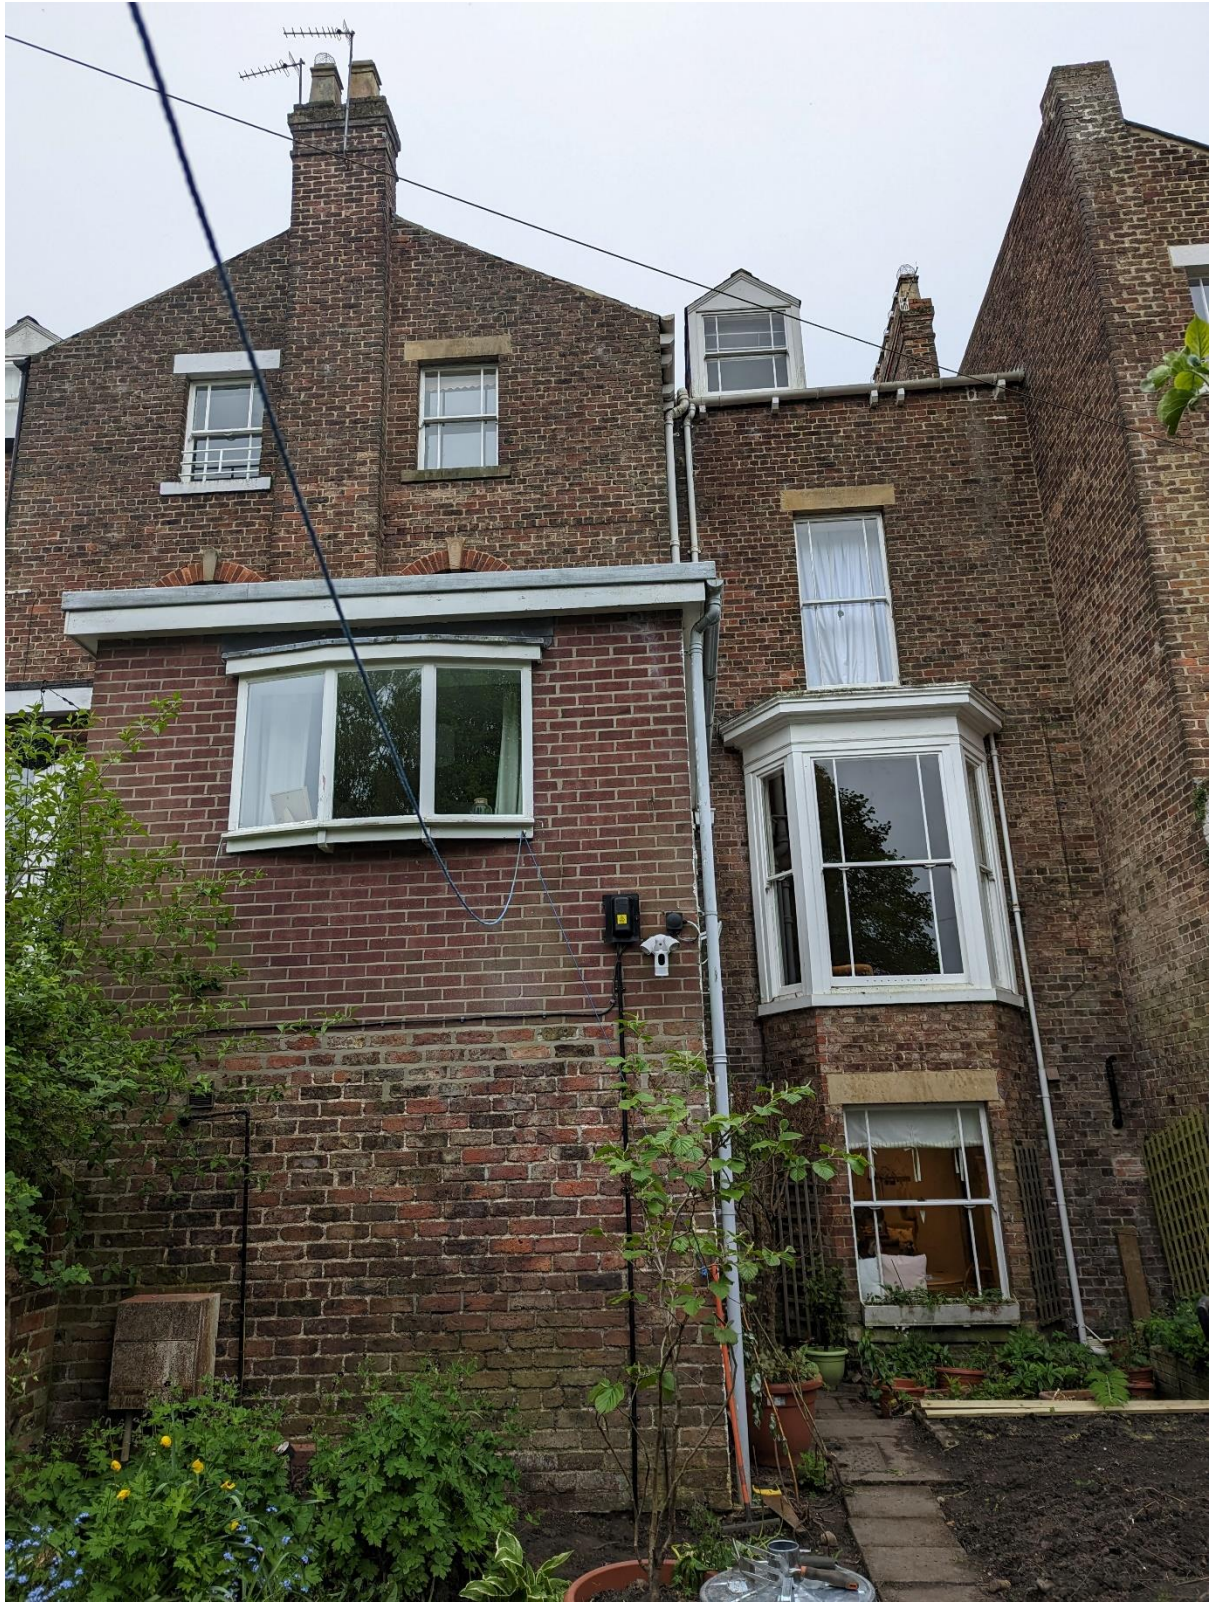
Photos below show 2 Hollin Hill Terrace from the front (image 1 and 2) and rear (image 3)

This application is for listed building consent to re-roof the house. The existing roof covering is currently Welsh slate, the condition of which is poor, it suffers from nail rot and slate rot where the fixing nails have corroded and the holes in the slates are enlarging. Repairs have taken place in the past where slates have been wired in place.
