**ARCHAEOLOGICAL MONITORING  
OF WORKS ASSOCIATED WITH  
THE ALTERATION AND  
LANDSCAPING AT MOOR HALL  
THORLEY, BISHOPS STORTFORD,  
HERTFORDSHIRE, CM23 4BJ**

**PCA REPORT NO: R15407 V1**

**SITE CODE: MHT21**

**APRIL 2022**

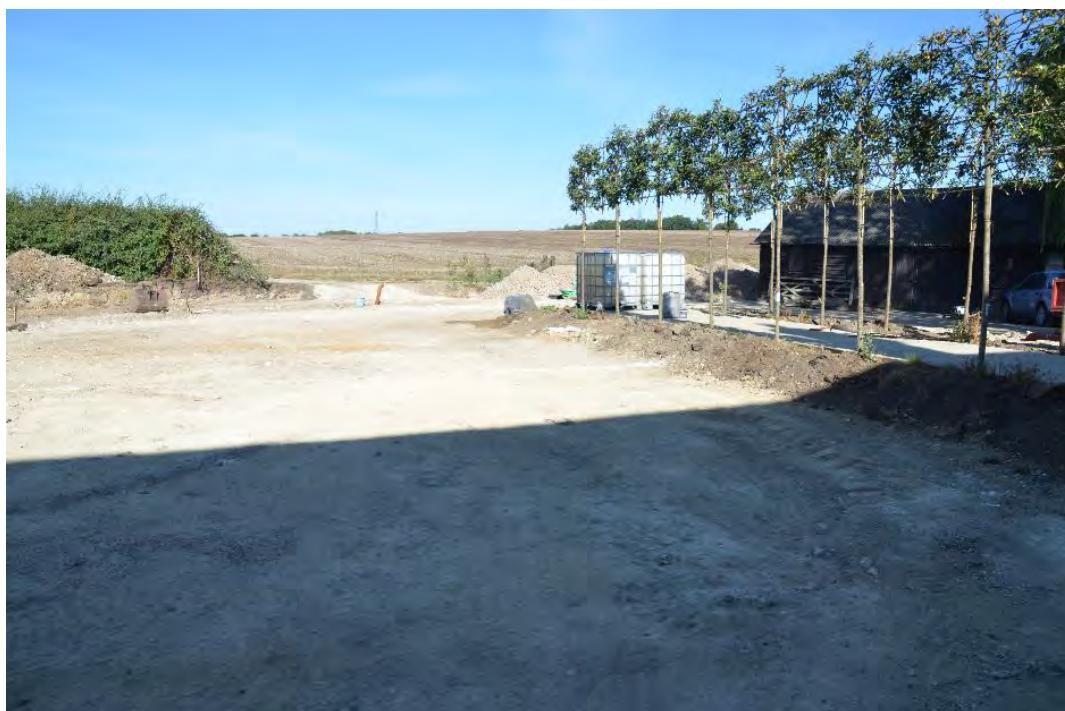
- 6.5.1 The western area covers approximately the width of the western elevation of the house and a few metres either side (totalling approximately 37m) and extending from the house to the boundary in the west (c.42m). Any top and sub soil in this monitoring area was removed prior to the site visit, and the pathway extending from the door of the western elevation had been constructed prior to archaeological monitoring so it is not known if features existed in this area, however it is likely past landscaping would have disturbed any that may have been present.

Plate 1: Western driveway area. View west.

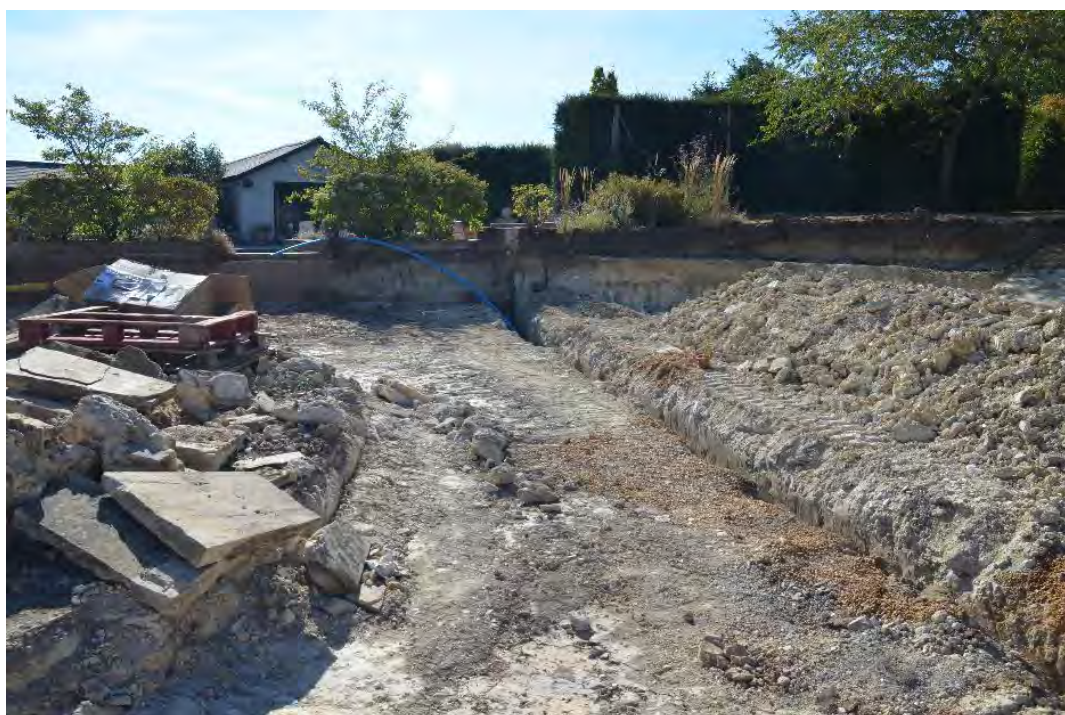
6.7.1 Immediately south of the house was the patio area where features [4], [5], [15], and (6) were situated.

Plate 2: Southern patio area. View southeast.

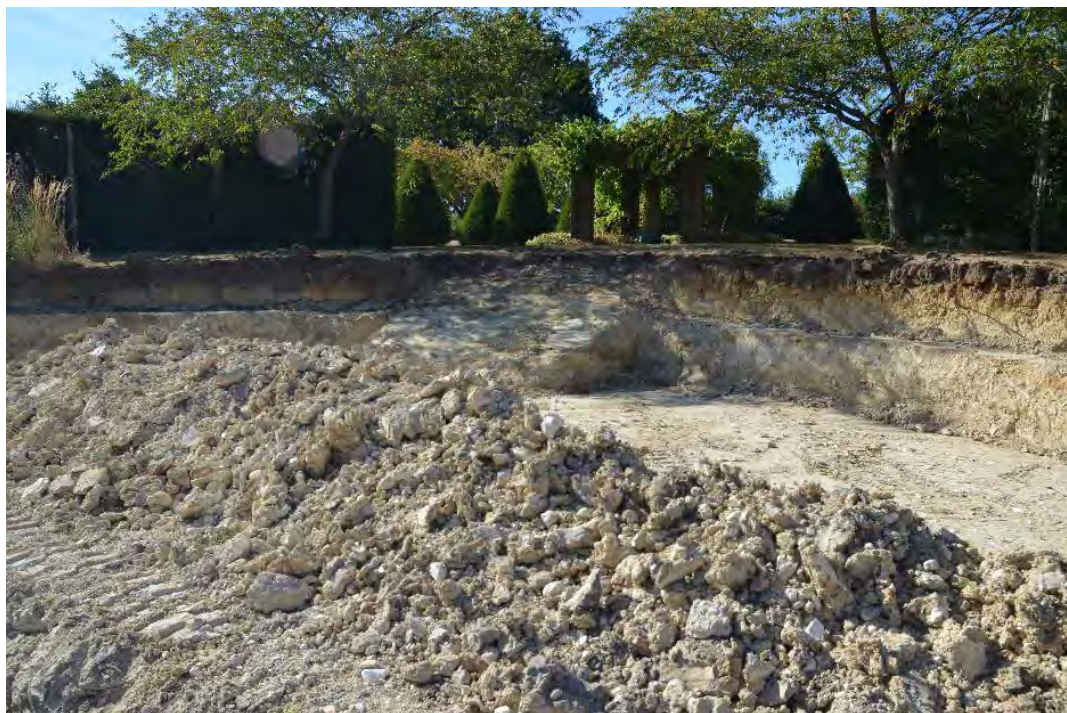
6.6.2 The semi-circular area to the south of the house (Plate 3) also yielded no archaeological evidence, with no CBM sherds in top or sub soil. This area had been excavated without archaeological monitoring, so it is not known if any archaeology was in the central areas away from the remaining bulk section. The applicant of the proposed development stated that this area was field, when they moved into the property in the 1990s, that has since been landscaped (D Tinney pers. Comm.), so it is possible any potential archaeology here may have been disturbed by this.

Plate 3: Southern landscaping area. View southeast.

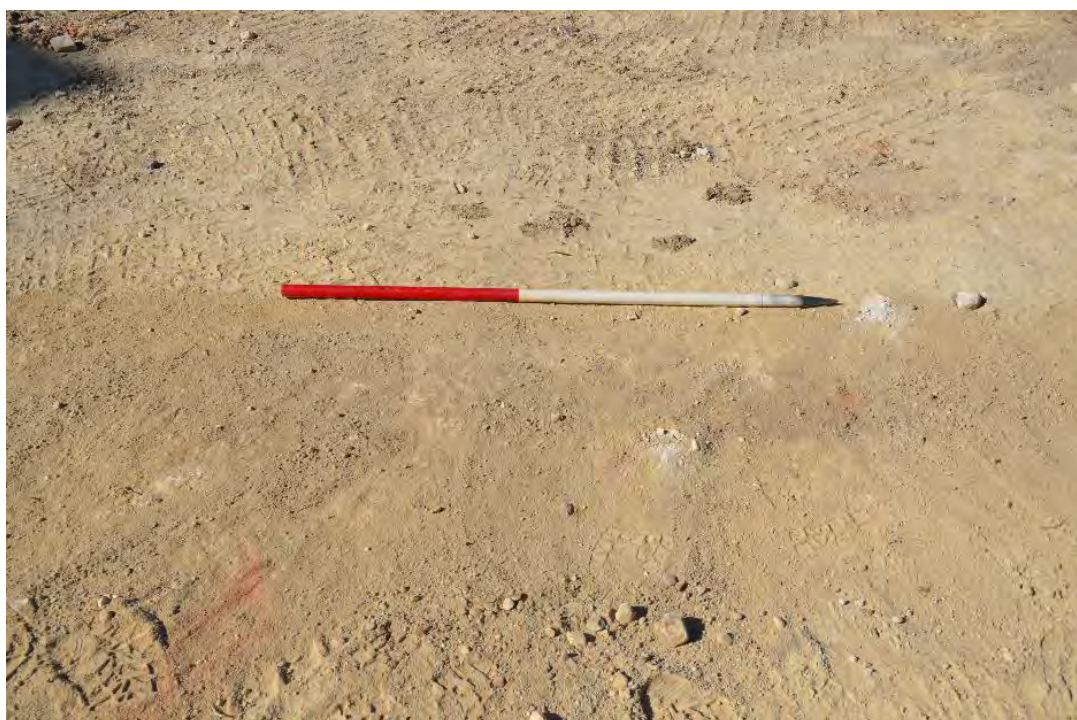
- 6.5.2 In this area, two unstratified find spots (1 and 2) were noted closer to the field, with three other features (Treethrow [3], linear feature [7], and brick drain (9)) with one further find spot (8) situated closer to the house. Feature [3] (Plate 4) was a curvilinear treethrow that measured approximately 1.5m long and 0.3m wide.

Plate 4: Treethrow/hedgeline [3]. View southwest.

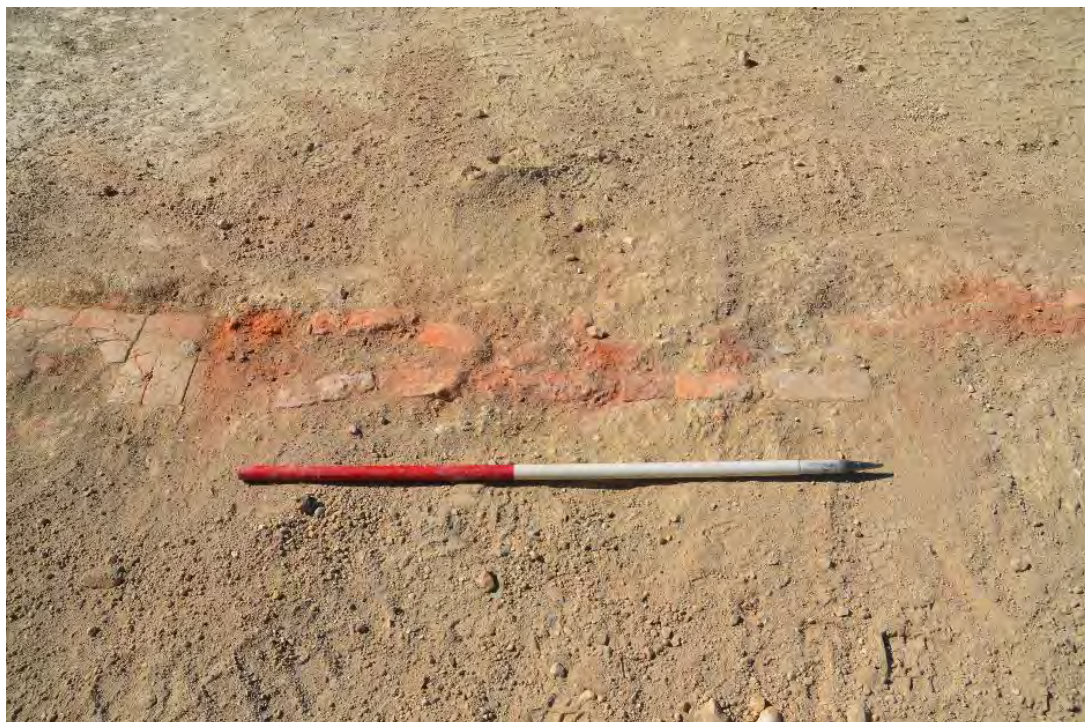
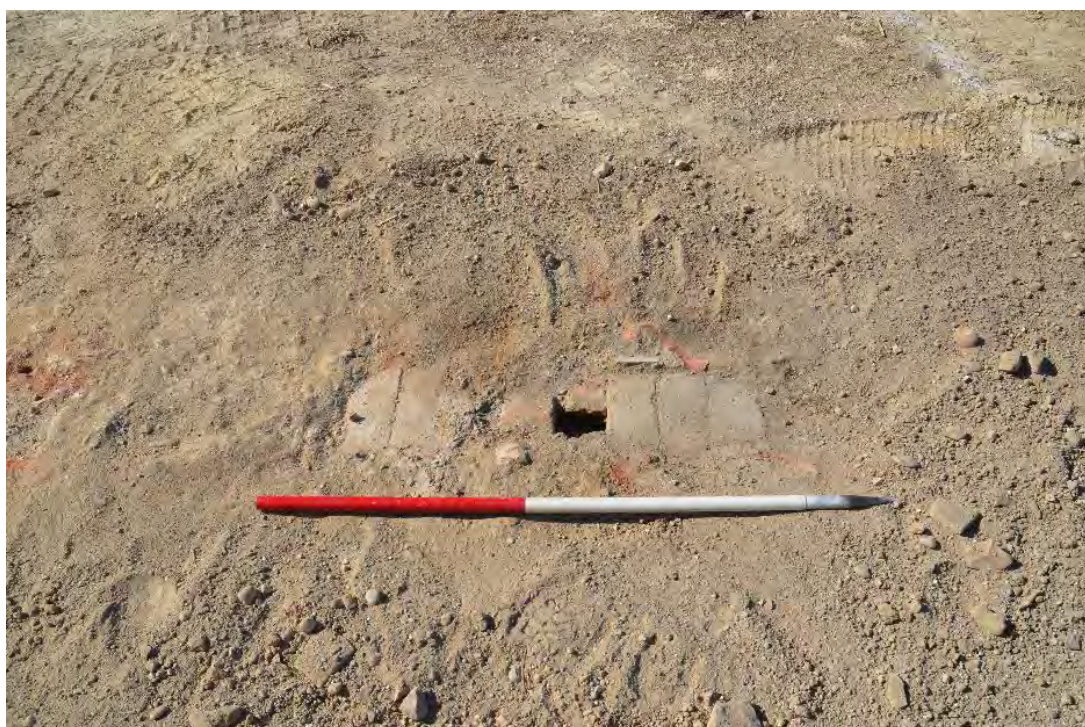
- 6.5.4 Feature (9) (Plate 5; Plate 6) was a brick drainage structure leading from the house and extending approximately 8.4m before its onward trajectory was no longer visible. The drain consisted of unfrosted red bricks measuring 0.2mx0.1mx0.05m. The drain was constructed with the bricks lining a small ditch, then further bricks placed side by side along their stretcher length atop this ditch to form a hollow through which presumably waste could run. A single sherd of a plate dating from 1789–1900 was retrieved from this feature.

Plate 5: Drain (9). View south.

Plate 6: Drain (9) view of cavity and brick covering. View south.

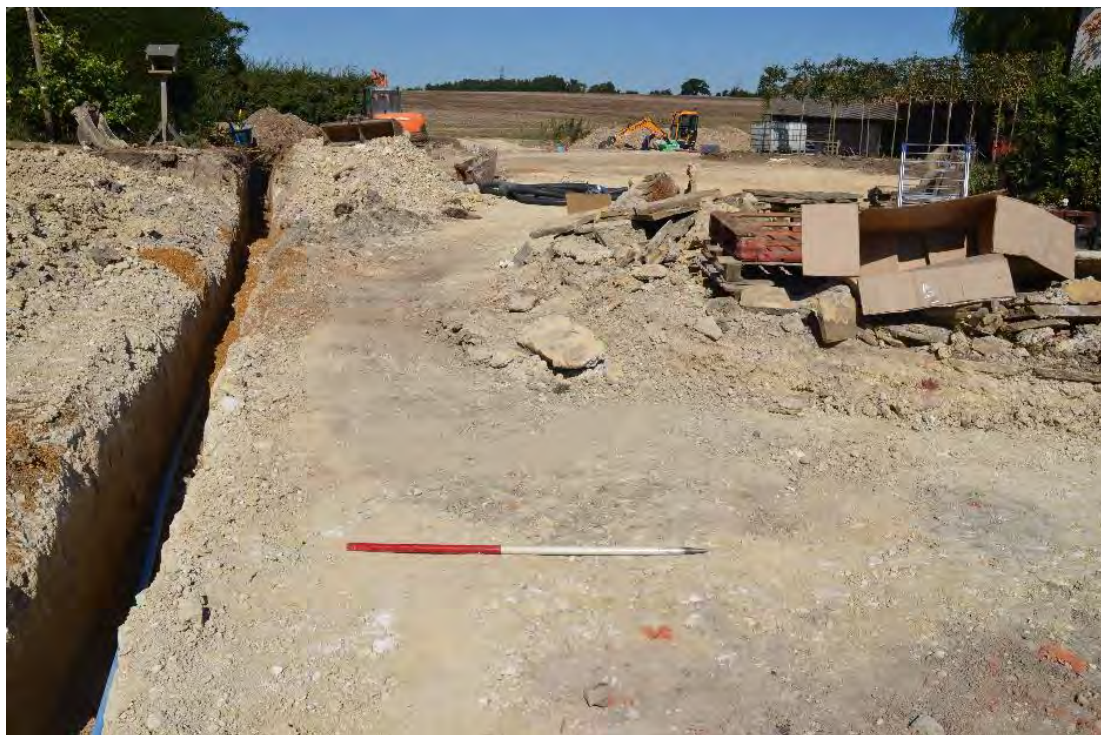
6.7.2 Feature [4] was large, uneven, and curvilinear in plan when it was first encountered during the initial ground reduction works (Plate 7). It was approximately 8.2m in length and 2.5m at its widest point. The feature yielded 200g of pottery dating to between 1630 and 1700 AD at the surface that were likely introduced through a combination of manuring of the neighbouring fields and bioturbation. This feature yielded a 19<sup>th</sup> century glass bottle.

Plate 7: Feature [4] pre-excitation. Service trench visible on the left of photo. View west.

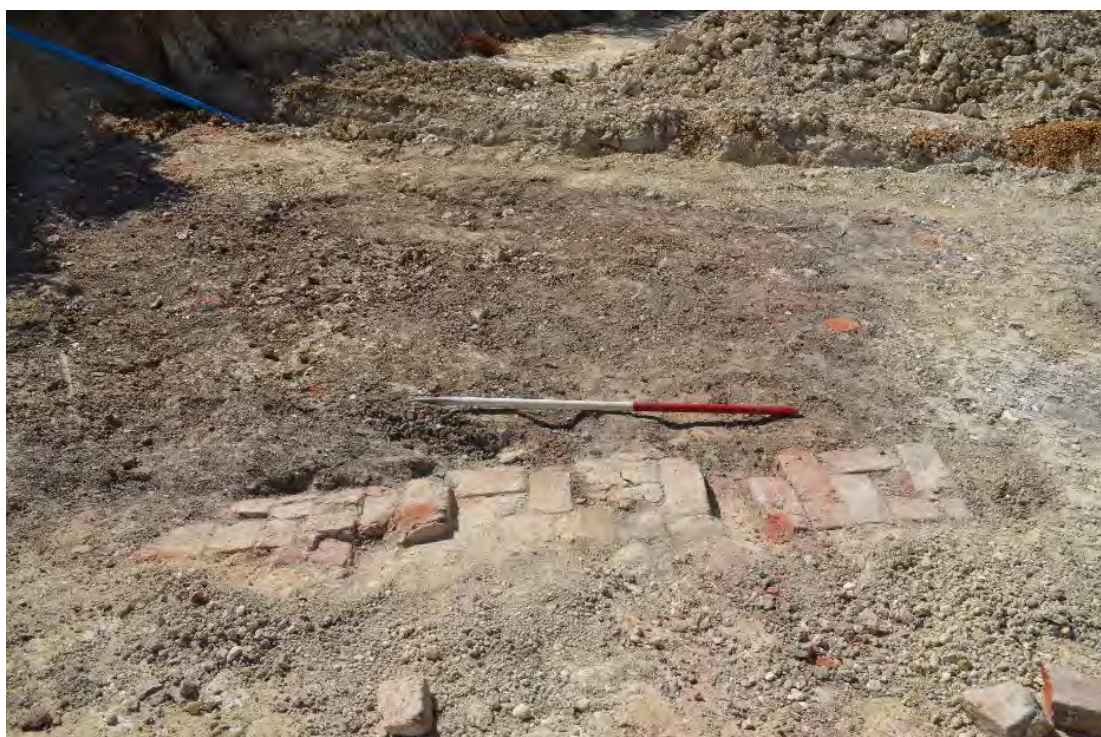
Plate 8: Wall (6) in foreground, pit [15] in background. View south.

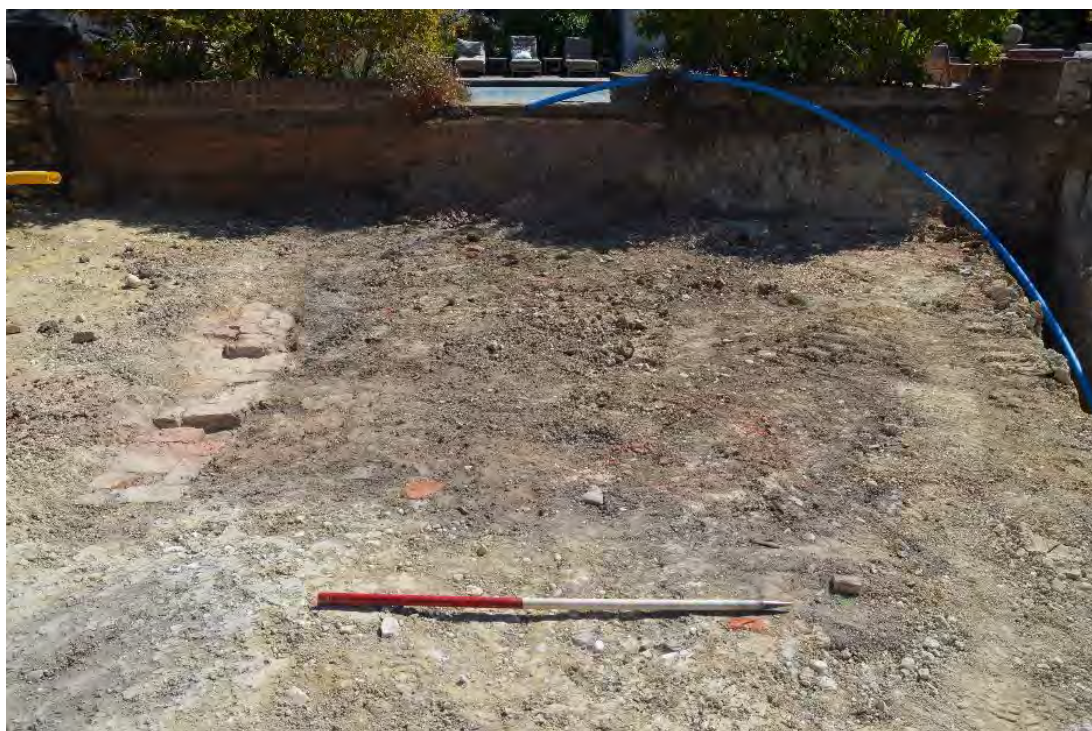
- 6.7.6 Feature [15] (Plate 9, Plate 14) was dark on plan with regular rectangular shape, steep sides, and an uneven base, measuring c.3.7m x 2.8m and up to 0.6m deep. It ran parallel and immediately adjacent to wall (6), which was approximately 3.3m long. The section of Feature [15] was revealed during the excavation of the foundation trenches. It comprised a very dark greyish brown silty clay fill with flecks of chalk and a deposit of CBM, possibly tiles. It is possible that the interface between it and the natural beneath represents blending of this demolition fill and the natural. The uneven base also suggests that the natural here could be redeposited. A total of 88g of pottery was retrieved from fill (14), all of which dated to between 1760 and 1800 AD, clay pipe was also retrieved from this fill and was tentatively dated to between 1730 and 1910. Fill (14) also yielded a small quantity of glass and undatable metalwork.

Plate 9: Pits [5] and [15] pre-excitation, wall (6). View east.

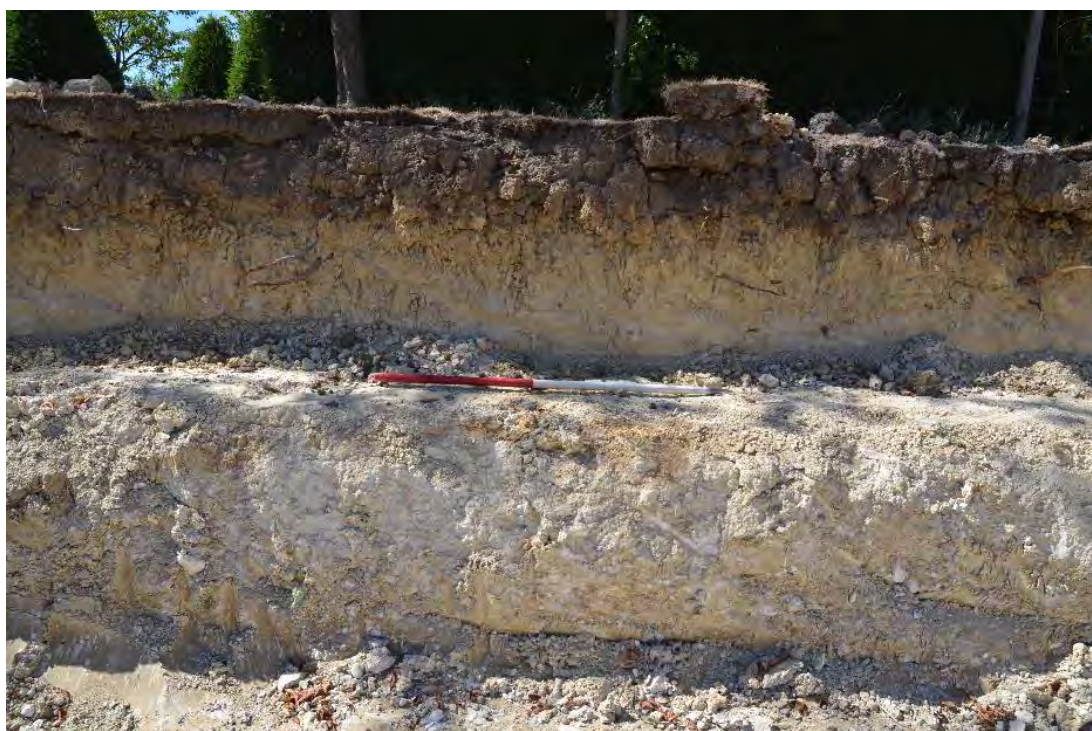
Plate 10: Section 1 located in southern landscaping area. View south.

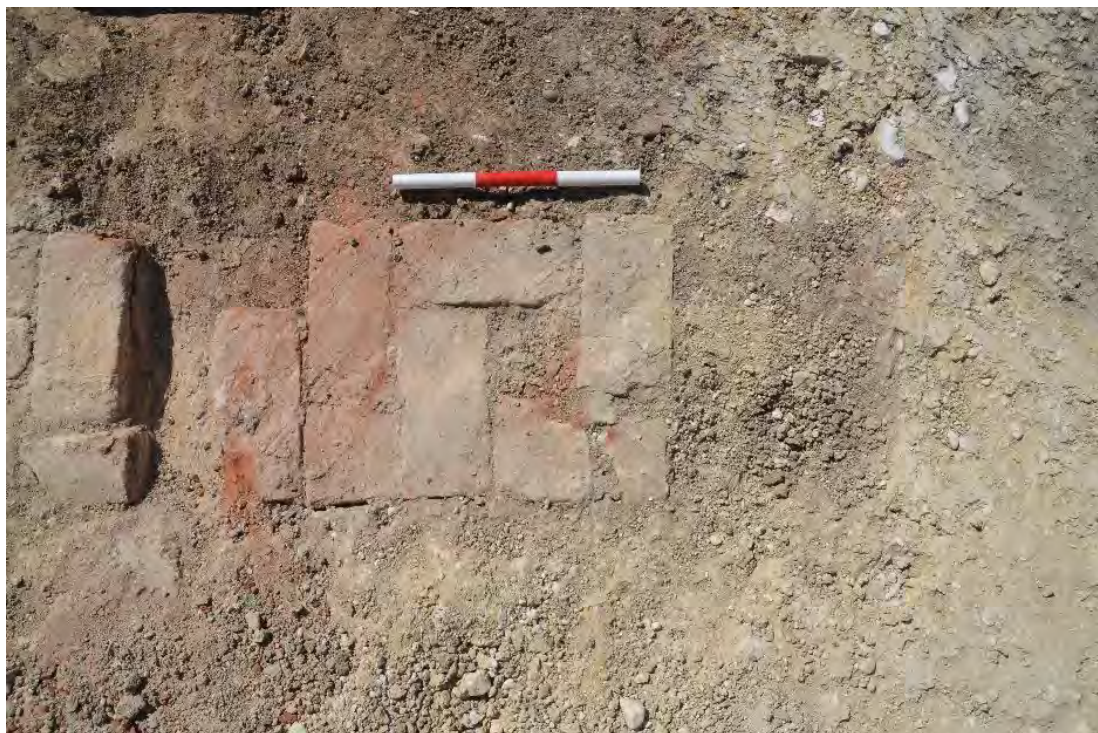
- 8.1.4 The applicant of the proposed development stated that, when they initially moved into the property in the 1990s, the southern patio area had a low wall of only a few brick courses high that ran around the patio area adjacent to a large hedge (D Tinney, pers. Comm.). This aligns with the area in which brick foundation (6) was identified. Excavation of foundation trenches offered a section view of this wall which indicated that only a single course of degraded unfrosted red bricks the same as those used for drain (9) remained.

Plate 11: Detailed shot of wall (6). View in plan.

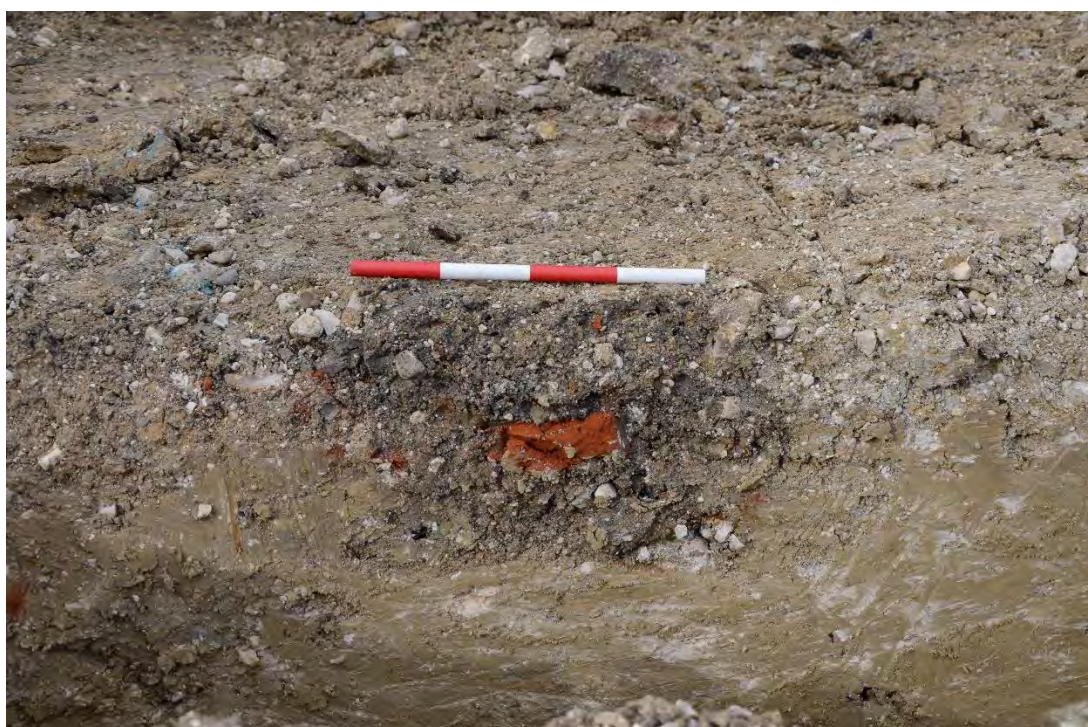
- 6.7.5 Feature [5] (Plate 12) was a small circular pit with vertical sides and a concave base situated between [4] and (6)/[15]. A gate used to be located here (D Tinney, pers. comm.) however [5] does not fit the appearance for a post hole for a gate post and as such its purpose remains uncertain. Its fill (12) was very blended, comprising a mixture of dark brownish silty clay and chalk. A large piece of CBM, probably a brick, was in its centre, possibly representing backfill. The pit was approximately 0.42m deep and 0.55m in diameter.

Plate 12: Pit [5]. View west.

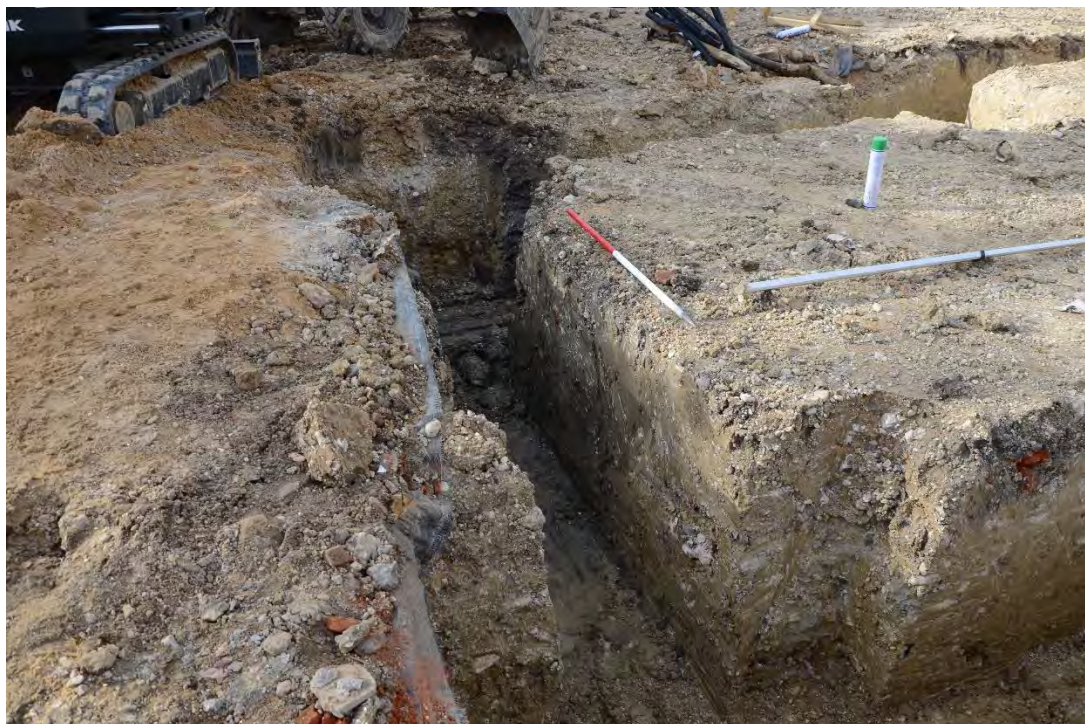
6.7.3 The feature was excavated further during the foundation trench and slab excavation works (Plate 13). These offered an insight into part of the extent and profile of the feature. The foundation trench reached a maximum depth of 1.3m yet did not reach the bottom of this feature. The sides appeared to be steep in profile, and it is possible that this represents a possible southern moat.

6.7.4 The main fill (11) of feature [4] was very dark, moist, and silty, some rare flecks of charcoal and small pieces of chalk were observed throughout, though these were scarcer the deeper the excavation. This feature had been disturbed and the fill was blended with redeposited natural and construction debris. Two upper fills were observed and were likely a result of redeposition or disturbance of the

Plate 13: Oblique view of possible moat [4] being excavated. View north-west.

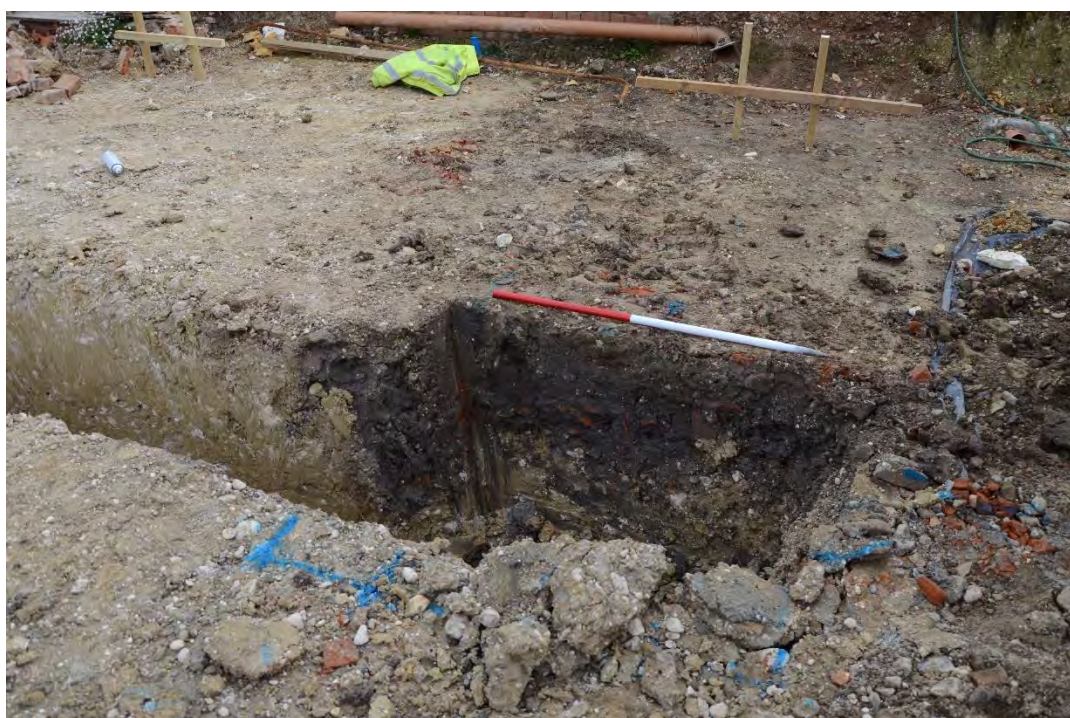
- 8.1.6 Historic cartographic sources suggest that feature [15] could be the line of the southernmost barn, the length of which was reduced sometime between the 1951 and 1960 OS maps of the area. However it does not line up very well with the barn on the maps (Figure 5), so could represent another, smaller structure that never existed long enough to be on any map. Its very rectangular shape in plan certainly does not align with the typical appearance of a pit, a hedge or field boundary (as was observed continuing from this area during works associated with the installation of the swimming pool to the east) and has more the appearance of the footprint of an outbuilding/barn, bounded by a wall (6) to the north. However, no post holes or beam slots or foundations were identified either, which are typical indicators of buildings.

Plate 14: Structure (6) and feature [15]. View east.

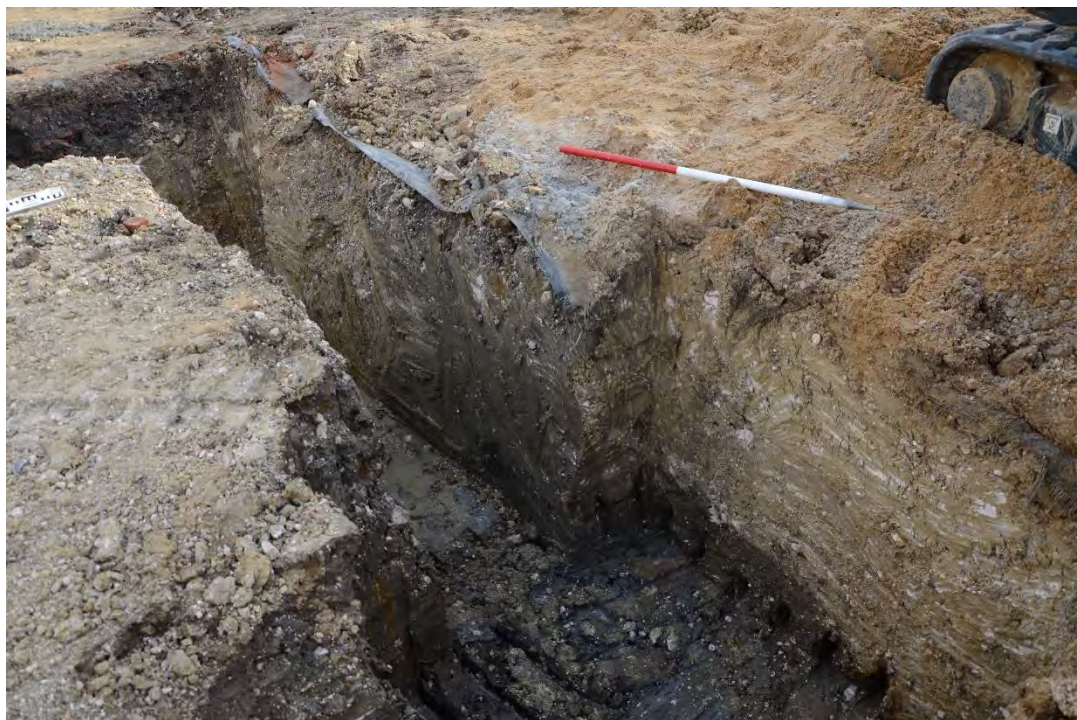
Plate 15: Oblique view of possible moat [4]. View south-east.

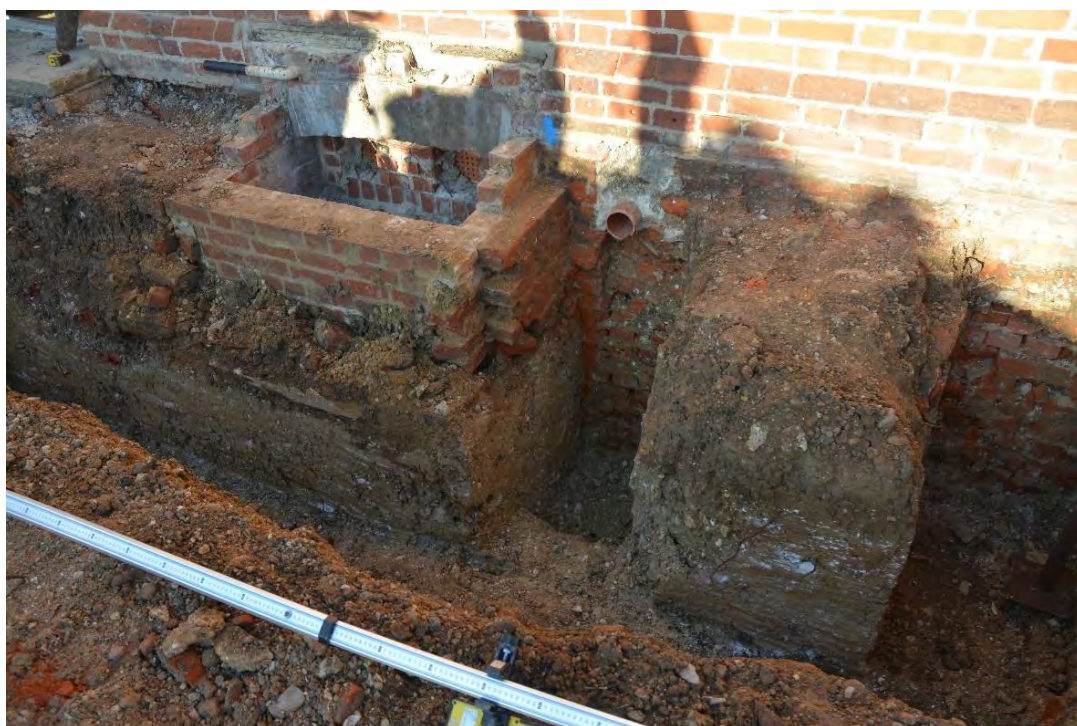
6.3 The works on the 28<sup>th</sup> September 2022 also yielded no archaeology, with the exception of one piece of unstratified, modern pottery. The ground in this area was heavily disturbed, presumably from centuries of work in the area (the construction of the Victorian extension, laying of the patio, laying of the drive area, pipes and cables from various periods running from the house) and so the ground seemed to be a blend of natural, redeposited natural, and building materials such as pea gravel. The works did uncover brickwork relating to the cellar, presumably a coal chute (Plate 16).

Plate 16: Eastern foundation trenches, including view of possible coal chute. View west.
