**BUILT HERITAGE RECORDING  
AT  
MOOR HALL, WEST THORLEY,  
BISHOPS STORTFORD, HERTS  
CM23 4BJ**

**REPORT NO. R14922 (DRAFT REV2)**

**Built Heritage Recording at Moor Hall, West Thorley, Bishops Stortford,  
Hertfordshire, CM23 4BJ**

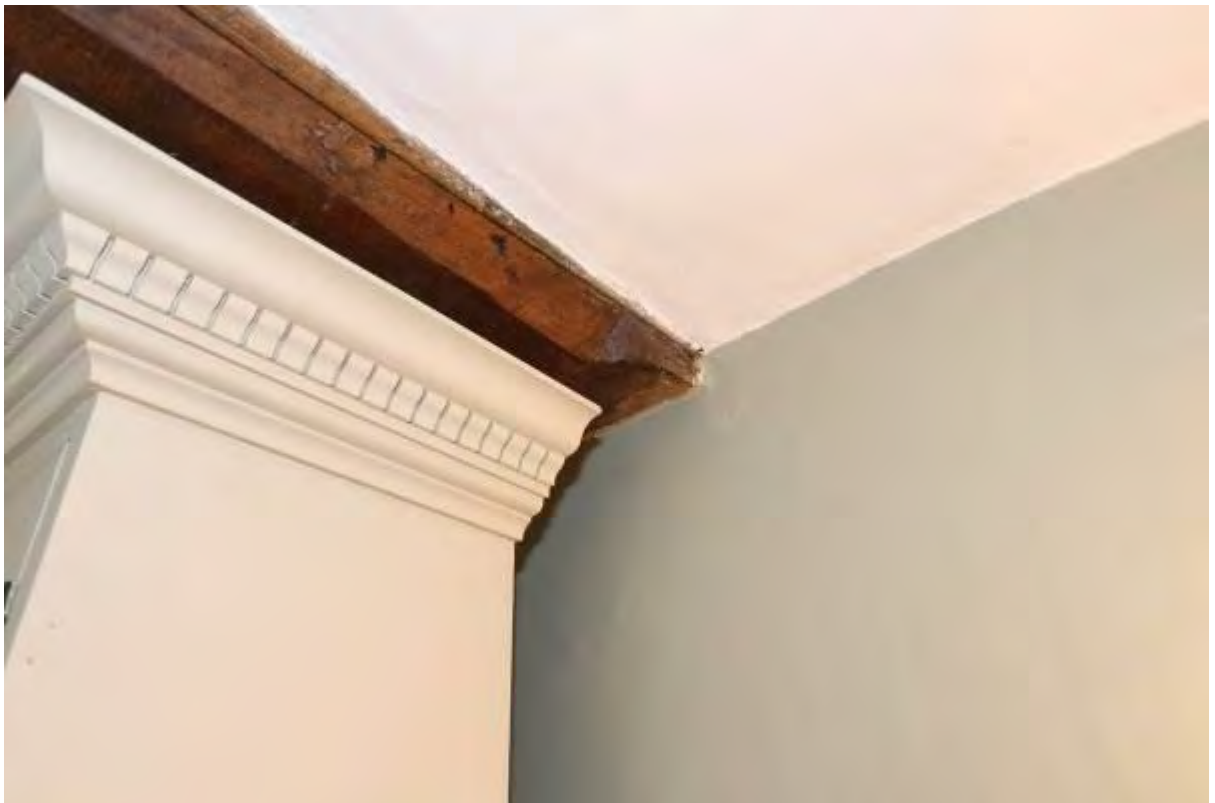
Plate 12 Axial beam with stopped chamfer (G1)

5.14 The breakfast room (G1: Plates 11-12) lies at the southern end of the timber-framed range and is crossed off-centre by an axial beam with a soffit chamfer and a step and run-out stop at its north end (later C16 onwards). The present brick-built fireplace in the south wall is a relatively recent rebuild which now accommodates a cast-iron wood burner. The two casement windows to the kitchen are both C19 replacements/additions while the door to the garden room (G11) is modern. The garden room (G11: Plate 18) is a recent addition, built with a mainly glazed south gable and west walls.

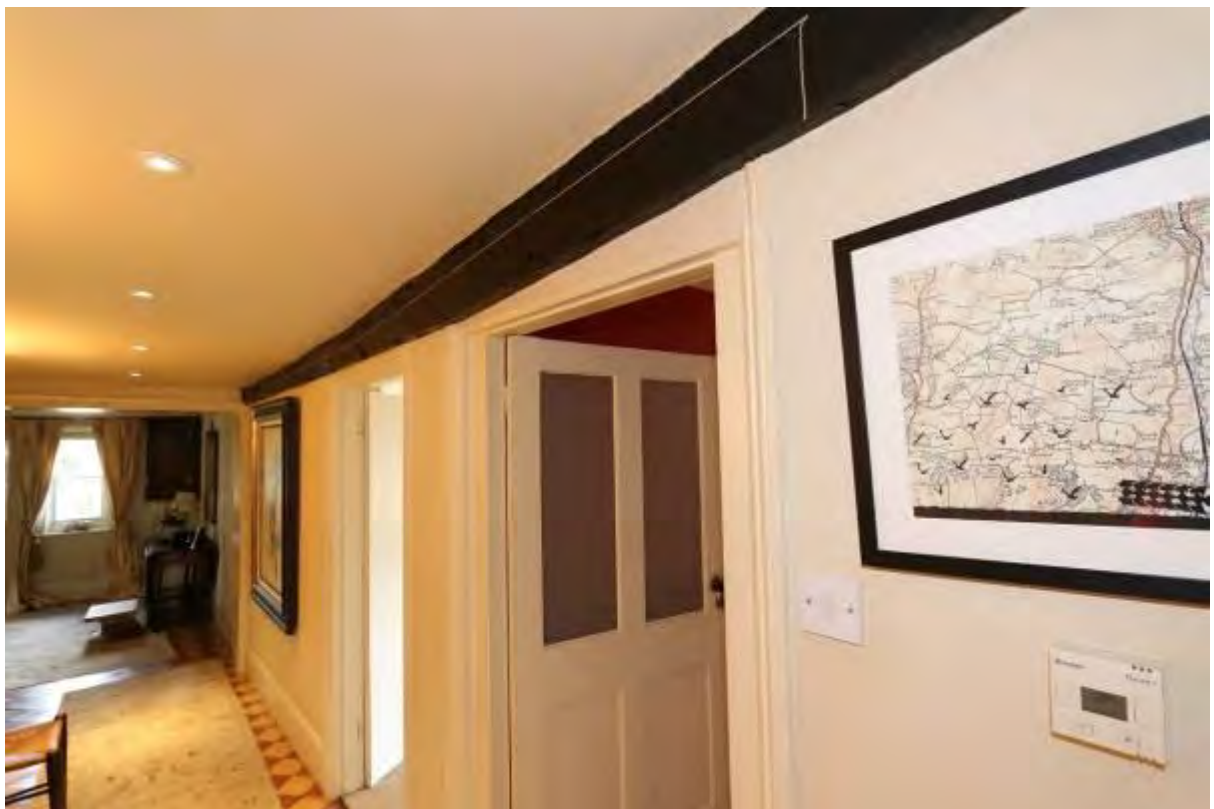
Plate 20 Passage (G4), showing mid-rail, looking north-east

- 5.17 The inner hall or passage (G4: Plate 20) extends along the eastern side of the timber framed house, in so doing, connecting the northernmost (G9) and southernmost (G1) rooms. It is not an original feature of the open hall house and was likely created after the insertion of the central chimney during the 17<sup>th</sup>-18<sup>th</sup> century. The mid rail of the eastern wall of the original building is visible along its eastern side and above the door openings into the adjoining rooms (G5-7). The floor of the hall is covered using a chequer work of alternating red and yellow terracotta tiles laid in a diamond pattern. As they are also present within the Front Hall, they presumably date to the C19.

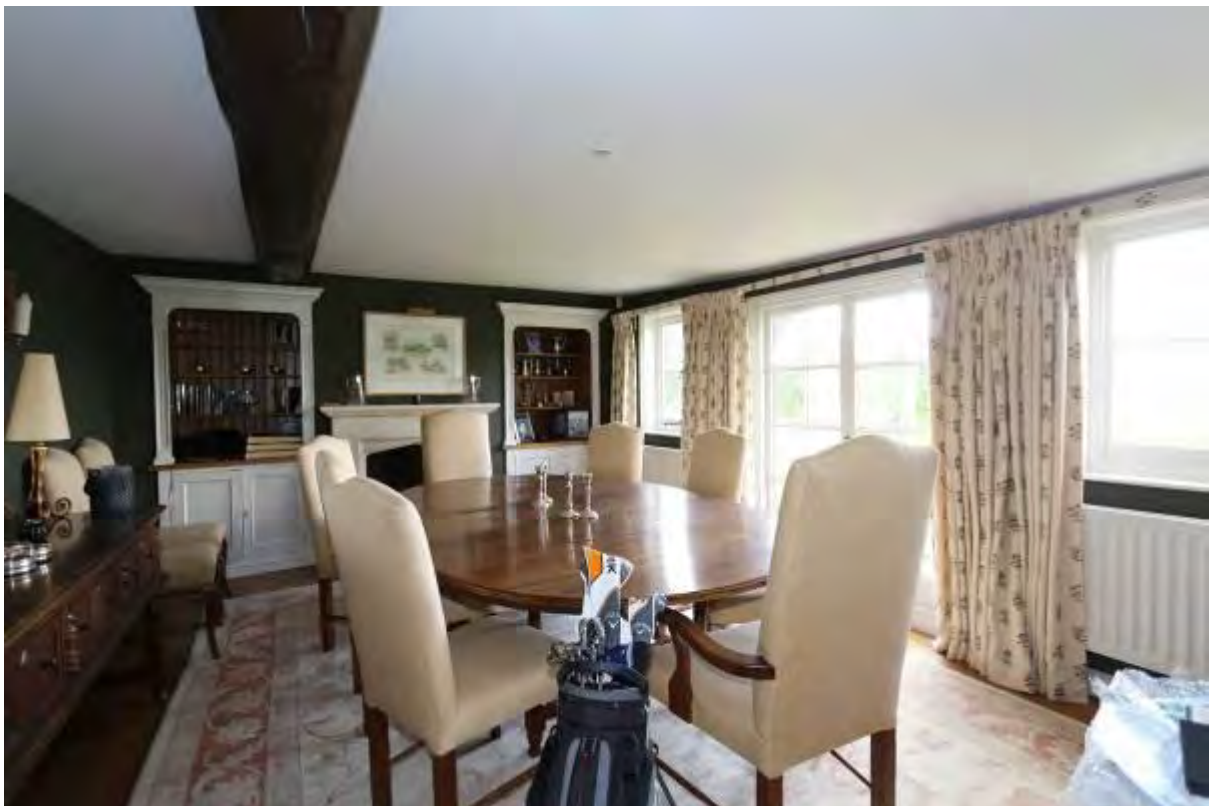
Plate 27 Dining Room (G8), showing axial beam, looking south-west

- 5.22 The dining room (G8: Plates 27-28) is crossed by an off-centre axial beam with a deep soffit chamfer and a crude run-out stop at its north end. The axial beam lies central to the full width of the timber framed range but distinctly off centre to the later remodelling which forms the present rooms. Its northern end is supported by the timber-framed former end wall of the C16 house and the southern end reset into the inserted stack. The central chimney stack now includes fitted cupboard/shelves built into alcoves to either side of the fireplace. The latter adopts the same Tudor style stone surround also seen in the drawing room. The room is lit a pair of later C19-early C20 French doors, which is flanked by a pair of later casement windows.
