Project
**LEISURE WATER EXTENSION,
 HAVEN ALLHALLOWS HOLIDAY PARK**

Title
TREE PROTECTION PLAN

Drawing Number
2055-KC-XX-YTREE-TPP01RevA

Trees at Allhallows, Leisure Water Extension, Rochester, ME3 9QD

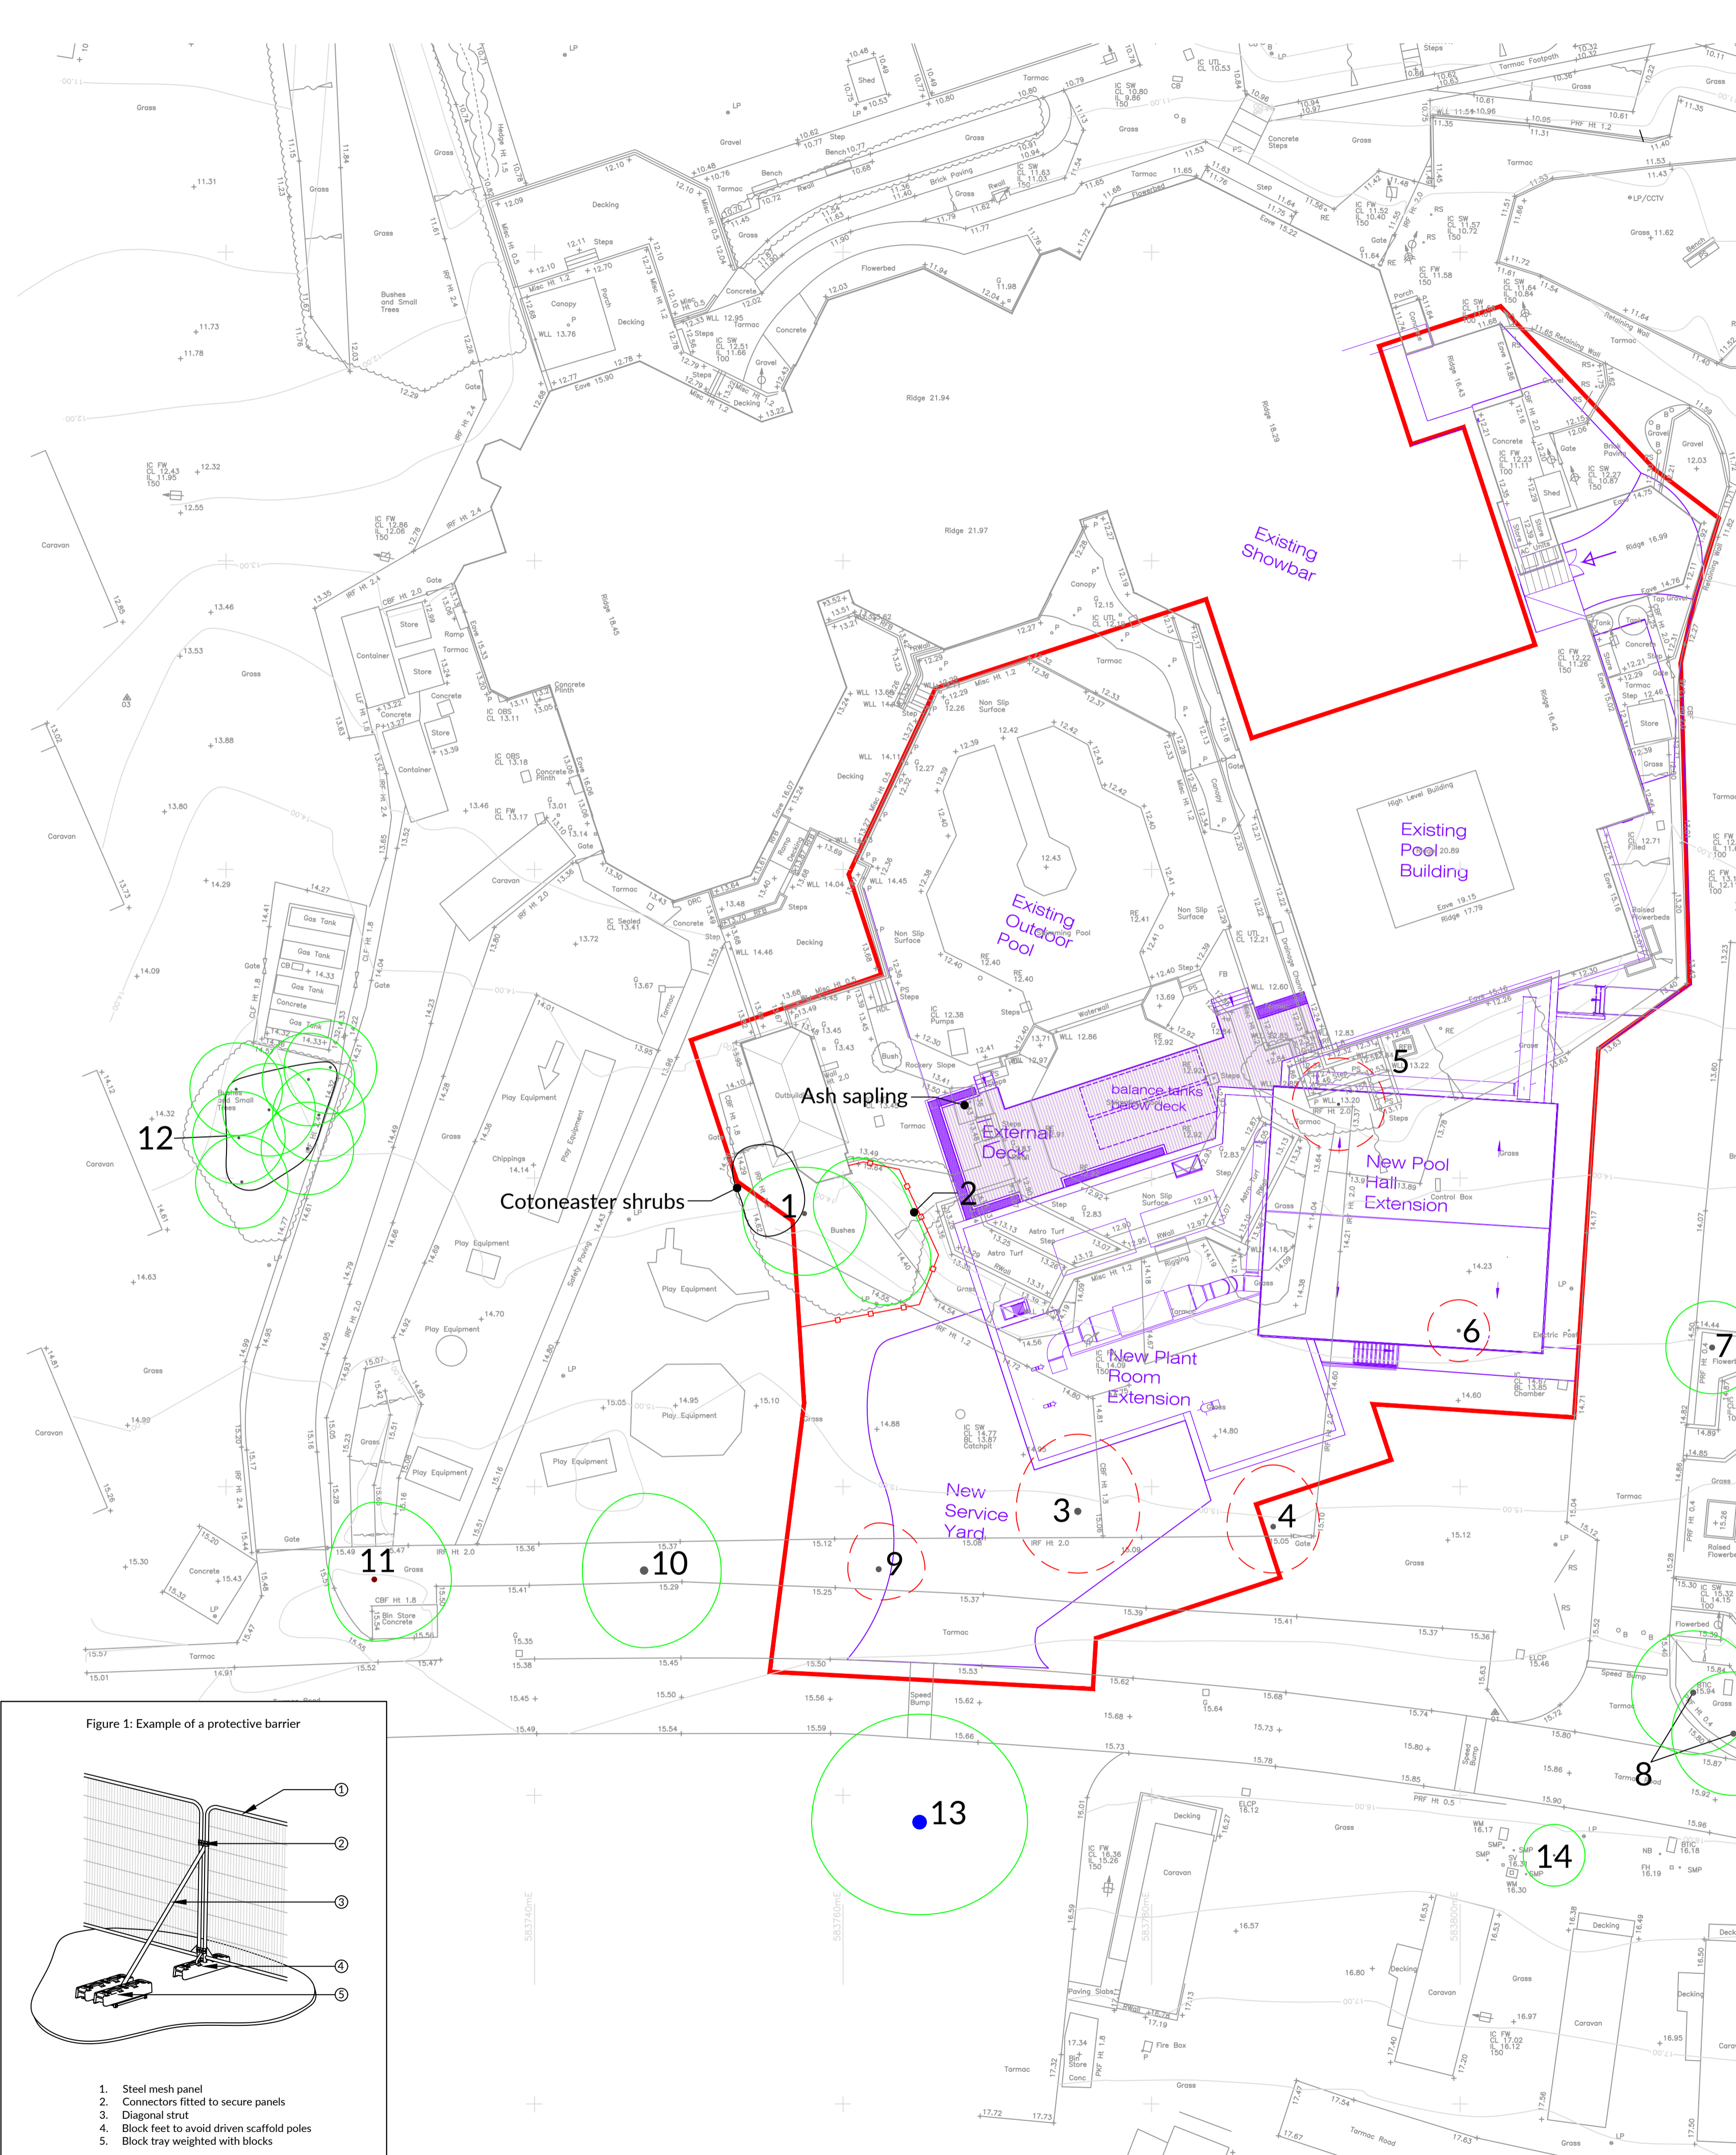
- KEY**
- Existing site features
 - Proposed structures
 - Trees retained (Green-coloured line indicates extent of canopy)
 - Trees for removal (Red-coloured dash line indicates extent of canopy)
 - 2.0m high barrier as detail in Figure 1
