# Cawdles, Keer's Green, Aythorpe Roding, Essex

*A Level-2 Historic-Assessment Report*

Report dated March 2023.

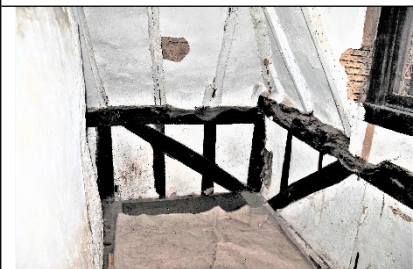
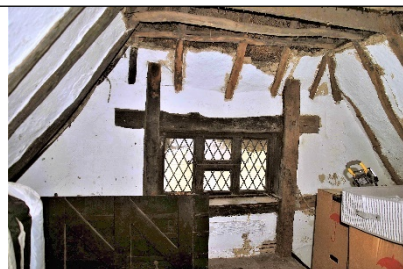
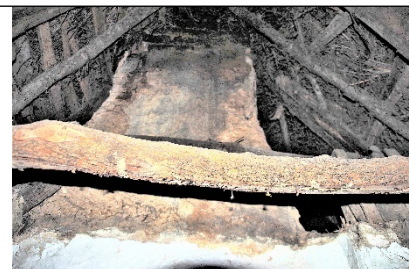
<i>E bay first-floor wall bracing</i>	<i>W bay attic, C20 alterations</i>	<i>Clay and daub chimney with brick stack through the roof.</i>

The wall bracing seen in the northeast corner of the frame is of horizontal, straight arch-bracing, rising from the corner post to the wall plate and is of secondary construction so that the brace does not interrupt the aesthetics of the exposed vertical studs as seen on the front elevation for display to the lane. As such the building had some modest pretence of a style on modest means. The period for this style of construction would be from the late-C16 to the mid C17. The face-bladded scarf joint in the wall plates would suggest any time between the early-C16 to the mid C19 as it became an almost universal joint-type, but in context with other features suggests the late-C16 to mid-C17 for the wall framing.

The present stack stops short within the roof space and is surmounted by C18/C19 brickwork beneath and through the roof, with modern brickwork above. The stack could have passed through the roof in rendered clay-block, but some early examples are known where the stack stopped short in the original construction so that heat (and smoke) could have been distributed throughout the roof spaces with the smoke percolating out through the roof finish and possible gablets, either end of the roof, although the chimney stack is more likely in a building of this later date.
