### FORMER ROSE AND CROWN PUBLIC HOUSE

### **1 HIGH STREET ISLIP NN14 3JS**

# Mr. P Newman and Mr J Gorell Barnes SCHEDULE OF PROPOSED WORKS TO LISTED BUILDING

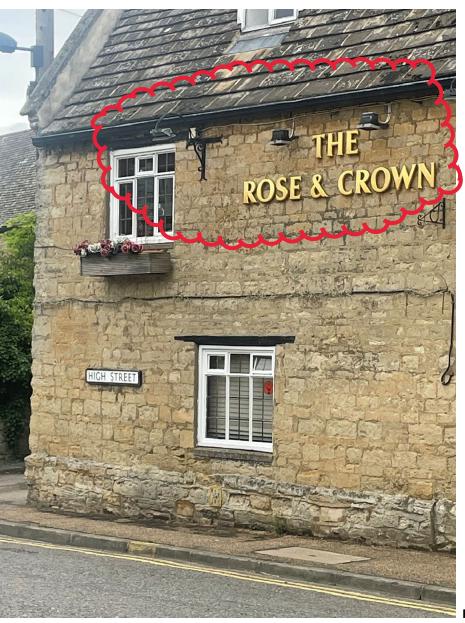
RC 1

Rose and Crown Signage and Flood Lighting

- 5. Remove 'The Rose & Crown" signage from front elevation complete with overhead flood lighting and bracketry. Made good surfaces disturbed. (**Photograph RC1**)

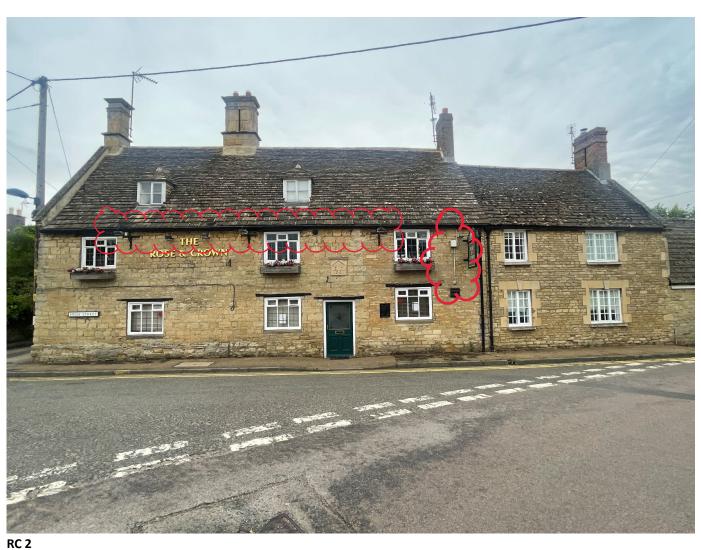
External Flood Lighting, and Lighting Controls highlighted

- 6. Remove general flood lighting and bracketry along frontage of building along with all cabling and lighting controls. Make good surfaces disturbed. (**Photograph RC2**)

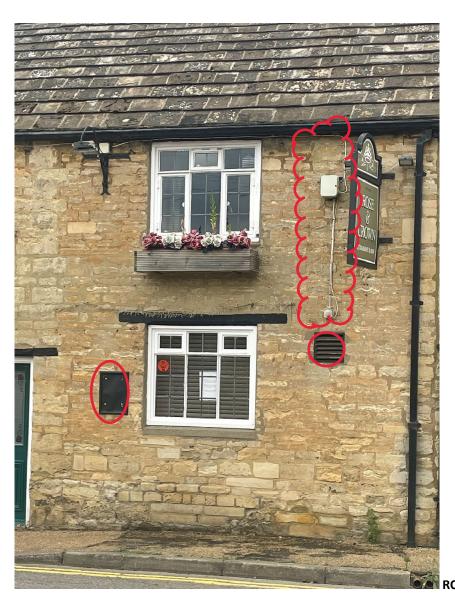
**External Lighting Control, Extractor Farm and Menu Board**

- 7. Remove menu board between entrance door and window. Make good surfaces disturbed (Photograph RC3)
- 8. Remove extract fan and cowl from ground floor south west corner. Infill opening with limestone coursed and bonded to match existing coursing arrangement in matching lime mortar. (Photograph RC3)

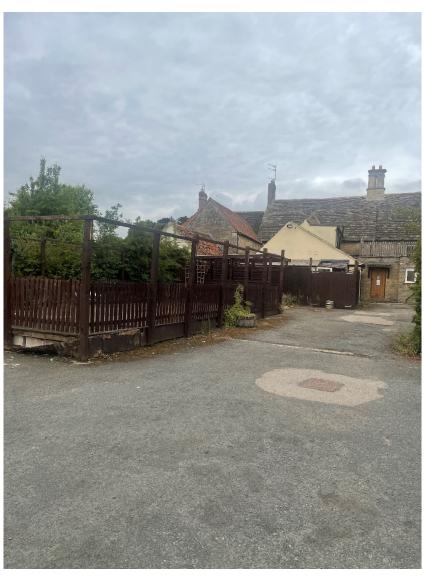
RC 4

**External Decked Area and Fencing**

- 9. Remove fenced enclosure and fenced seating area from rear of site. Remove decked area. (Photograph RC4)
- 10. Demolish timber smoking shelter structure abutting Kitchen. (Photograph RC5)

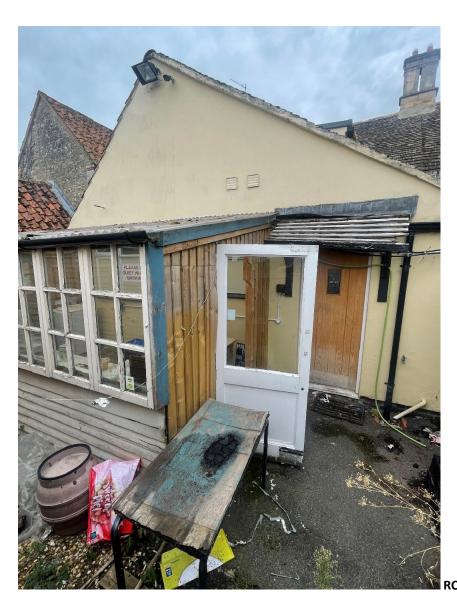
**Smoking Shelter**

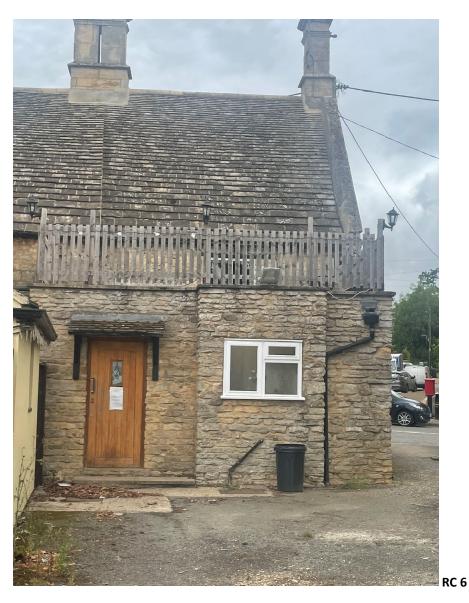
**Flat Roof Toilet Rear Addition**

- 11. Demolish 20th Century rear additions:-
  - Single storey toilet flat roof addition with balcony fencing above (Photographs RC6, RC7 and RC 8)
  - Single storey kitchen addition and 2 Storey adjoining extension with flat roof dormer construction. (Photographs RC 9 and RC 10)

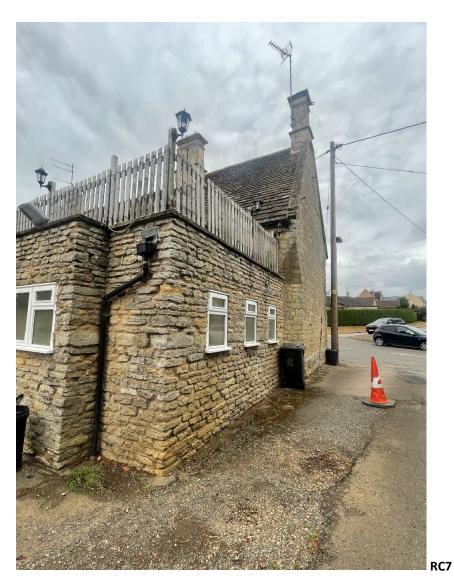
**Flat Roof Toilet Rear Addition**

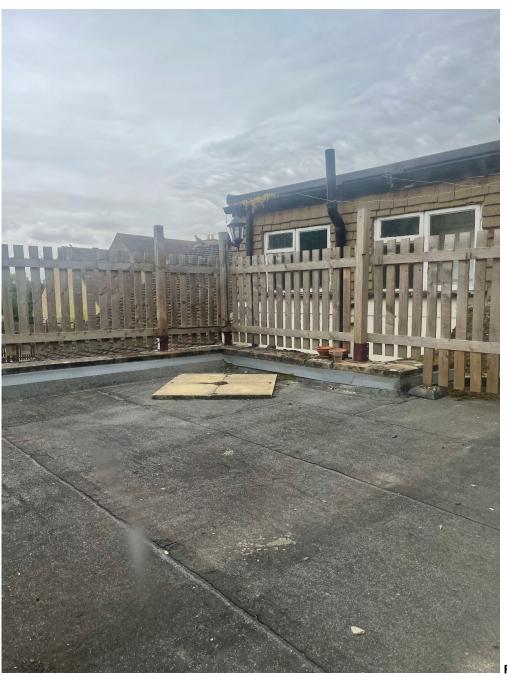
Flat Roof 'Terrace' Area

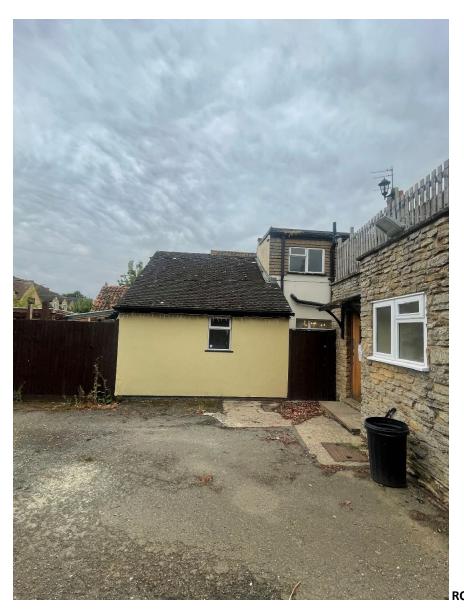
Single Storey and 2 Storey Dormer Rear Addition

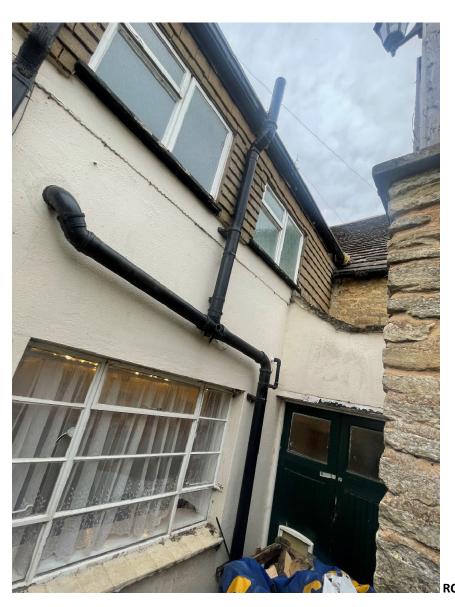
2 Storey Dormer Rear Addition

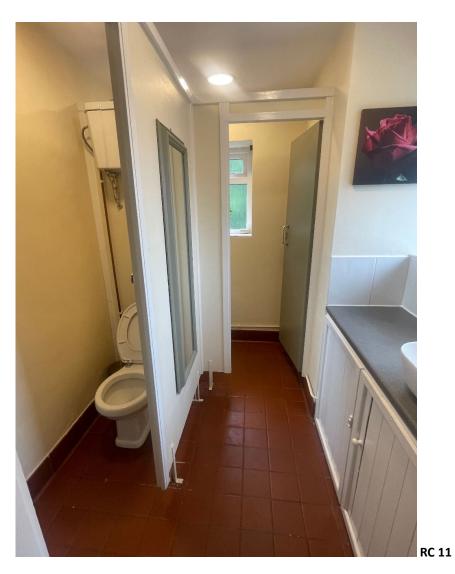
**Gents WC area**

- 12. Internal record photographs of structures proposed to be demolished are scheduled below.
  - RC 11 Gents ground floor toilet.
  - RC 12 Ladies / Disabled ground floor toilet.
  - RC 13 and RC 14 Rear Lobby Area
  - RC 15 Rear Lobby entrance to bar.
  - RC 16, RC 17 and RC 18- Rear village store.
  - RC 19 Commercial Kitchen
  - RC 20 Beer cellar
  - RC 21 First floor bathroom
- Remove extract fan from ground floor north gable elevation and infill opening with limestone coursed and bonded to match existing coursing arrangement in matching lime mortar. (Photograph RC 22)
- 14. Demolish single storey rendered outbuilding structure in car park area (Photograph RC 23)

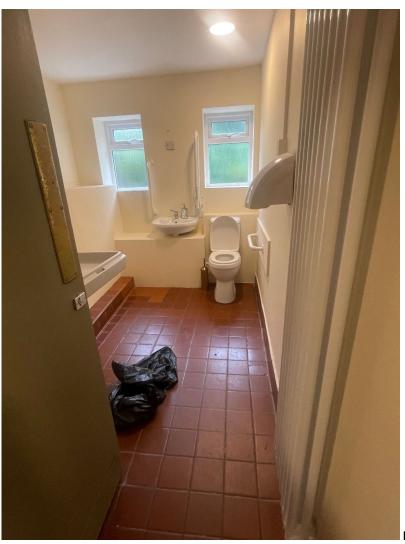
Ladies / Disabled WC area

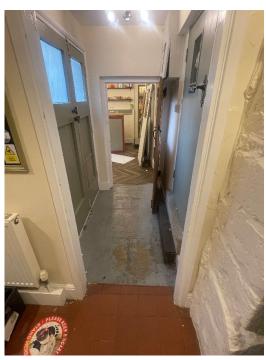
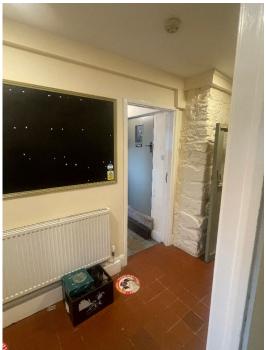
**Rear Lobby Area**

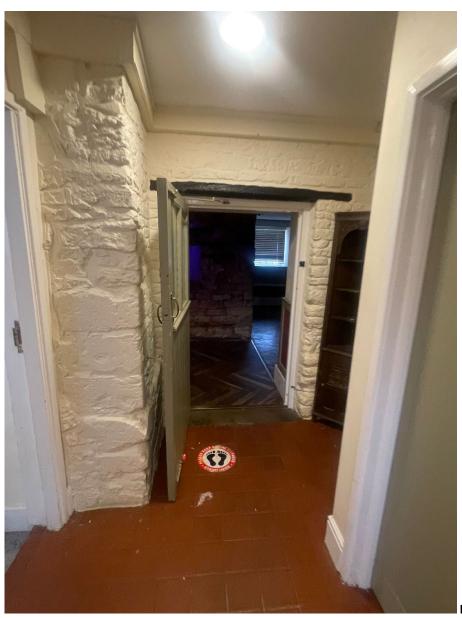
**Rear Lobby / Bar Entrance**

- 18. Remove existing glazed internal fire door, overhead closer and frame leading from bar area into rear lobby (Photograph RC 15); adapt opening for new purpose made flush casement window to replicate existing units; provide new low level cavity walling (as per specification in paragraph 16) complete with new stone cill.

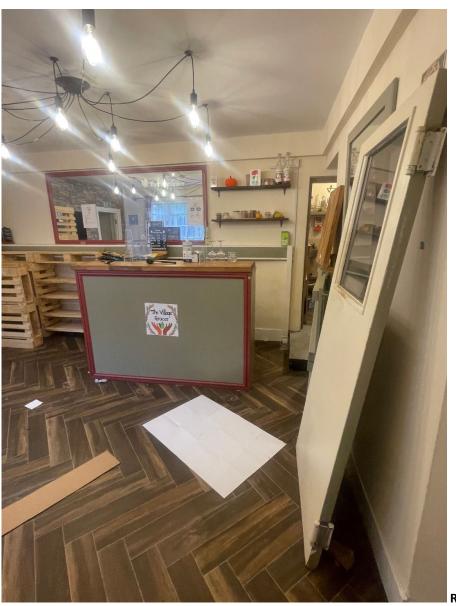
RC 16

**Rear Village Store Retail Area**

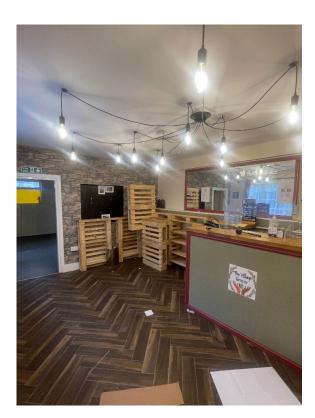
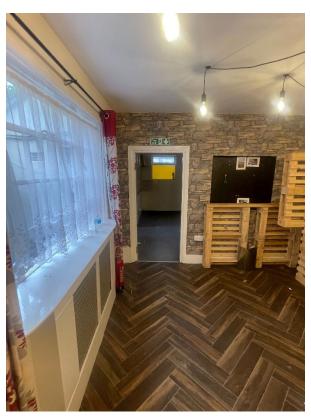
RC 17 RC 18

**Village Store**

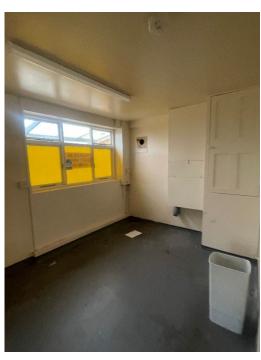
**RC 19**

#### **Commercial Kitchen Area**

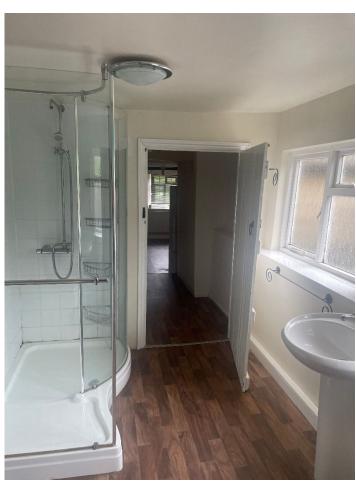
First Floor Bathroom

Clean limestone facings from toilet extension and set aside for reuse. Retain ledged and braced door to first floor bathroom for re-use.

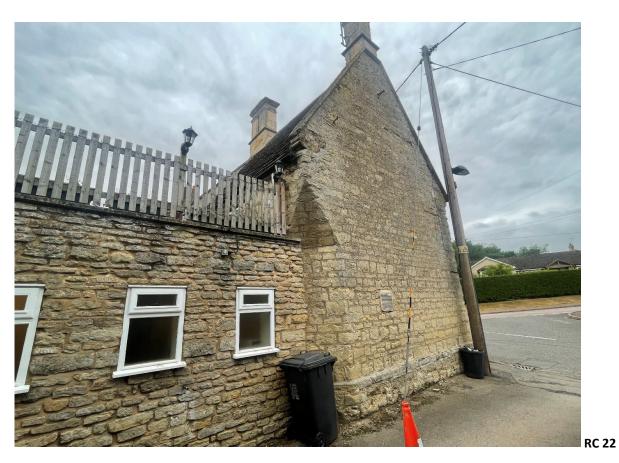
**Junction with Toilet Rear Addition and Main Building**

- 20. Remove paintwork from exposed areas of external walling forming part of toilet area extension. Remove paintwork using mixture of high temperature pressure washer and brick cleaning acid. Make good pointing.

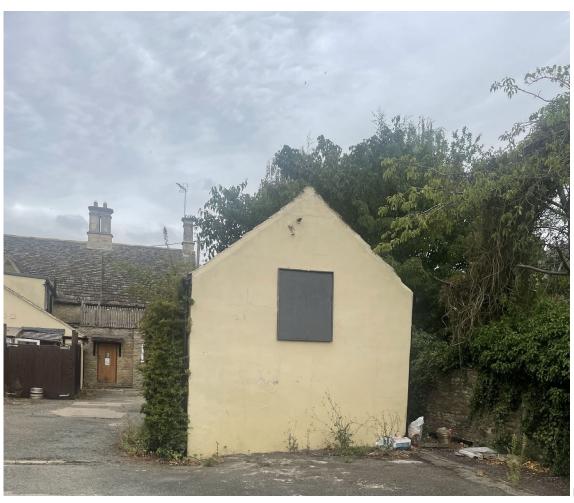
**Single Storey Outbuilding**

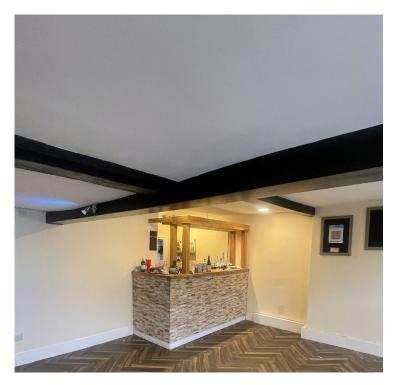
**RC 25**

**Bar Service Counter**

- 15. Remove beer lines, and timber framed bar (Photographs RC 24 and RC 25)
- 16. Infill original rear wall following demolition of cellar area with new cavity walling constructed off new 600mm concrete trench fill foundation. External face of walling to be faced in limestone salvaged from demolition of toilet block bedded and pointed in approved lime mortar, 150mm cavity fully insulated with Knauf Dritherm 32 Cavity Wall Slabs and 100mm wide 3.5N blockwork. Walling pinned to underside of retained walling at first floor level.

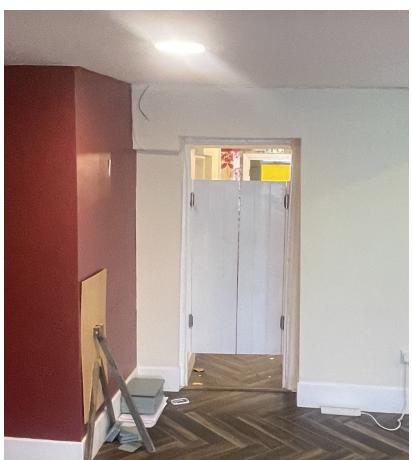
**RC 26**

**Bar Swing Doors**

- 17. Remove softwood swing doors between bar area and toilet lobby. Install new purpose made ledged and braced softwood door to match first and second floor internal doors.

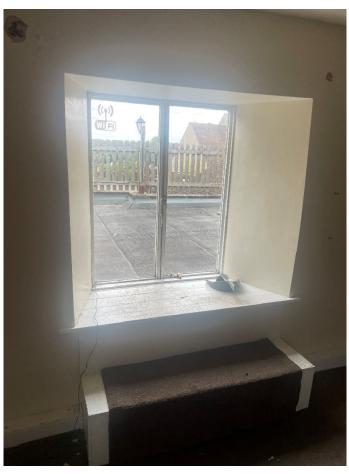
Step Arrangement to Window / Access to Flat Roof 'Terrace'

- 21. Remove timber boxing / step (previously used to facilitate access to flat roof "terrace" through window. Remove casement window and install new purpose made flush casement to replicate existing windows on front elevation; provide new stone cill externally and make good finishes internally (Photograph RC 26)

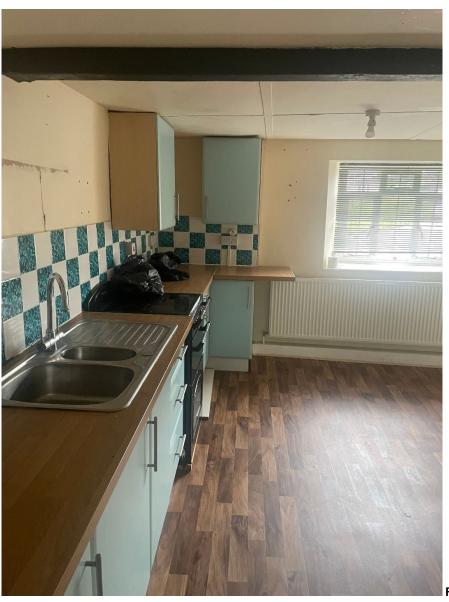
**First Floor Kitchen**

- 22. Remove laminate flooring from existing first floor kitchen. Remove kitchen base and wall units, worktops, sink and all associated services. Remove wall tiling and make good all wall finishes. (**Photograph RC 27**). Install new stud partition to form bathroom area. Install new plumbing, drainage and sanitaryware to create new family bathroom. Overlay existing floor boarding with 12mm plywood and lay new ceramic floor tiling.

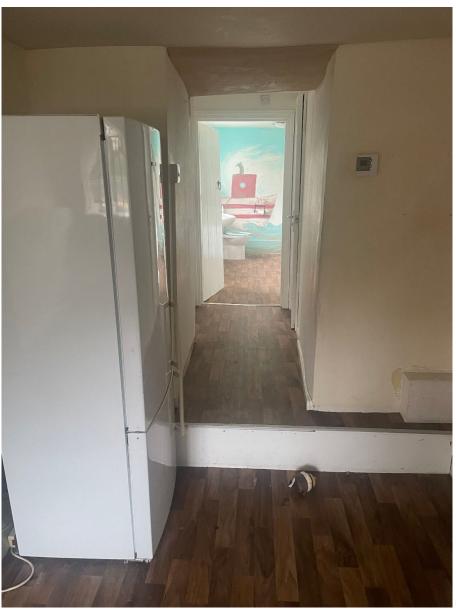
First Floor Kitchen / Step through to Bathroom Rear Addition

- 23. Remove stepped floor arrangement created as a result of 1970's bathroom extension. Provide new section of floor joists and flooring to provide area of level flooring leading through into new extension; make good all plastered finishes and provide new skirtings to match existing profile. (Photograph RC 28)

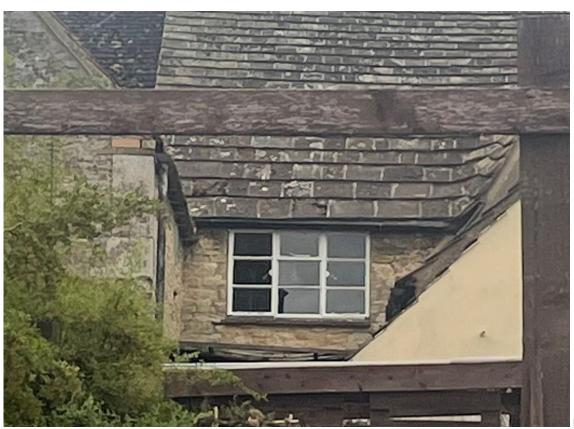
**First Floor Crittall Window**

- 24. Remove Crittall window from rear elevation of bedroom 2. Adapt opening to facilitate new purpose made flush casement window matching size and profile of existing front elevation windows. Alterations externally faced in matching stonework and all finishes made good internally. (Photograph 29)

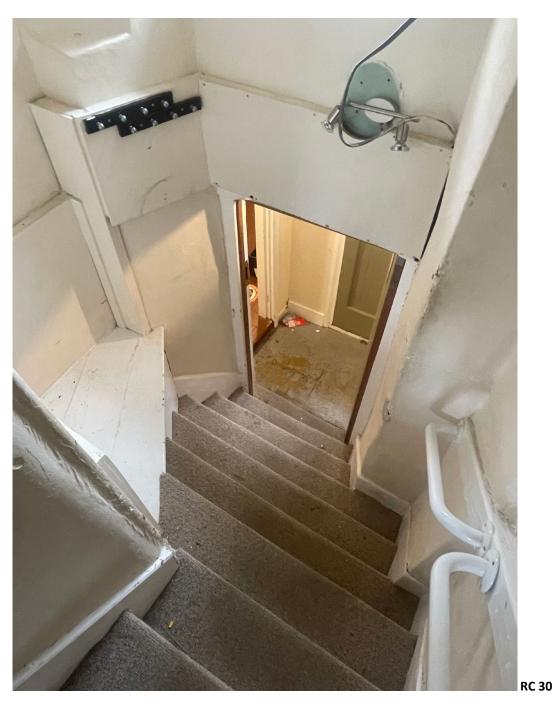
**Ground to First Floor Staircase**

- 25. Grab rails removed from existing ground to first floor staircase, plaster repairs carried out, plywood boxing replaced and lighting removed. (Photograph RC 30). Install new white oak mopstick handrail

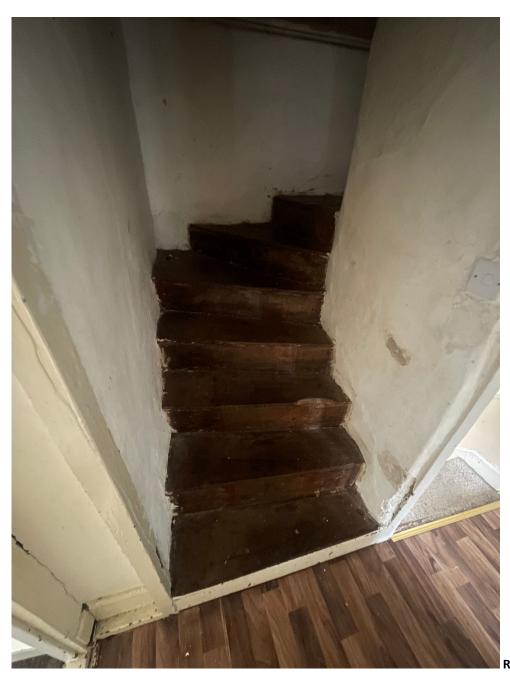
First to Second Floor Staircase

- 26. Sand down plasterwork to of 1st to 2nd floor stairwell and provide plaster repairs as required. Install new white oak mopstick handrail.
