Woodlands, 217 Harwich Rd, Little Clacton

Ecological Impact Assessment

Ref: 1780

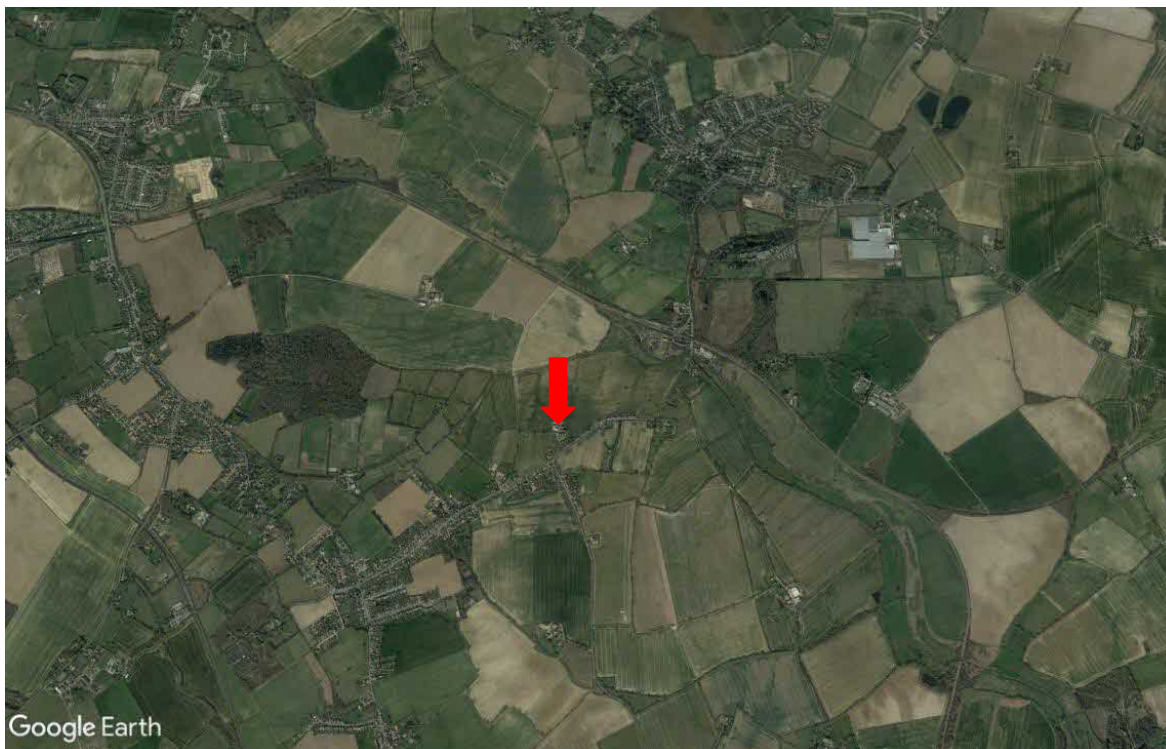
Fig 1A: Site location, with site location indicated beneath red arrow. Aerial photograph sourced from Google Earth Pro

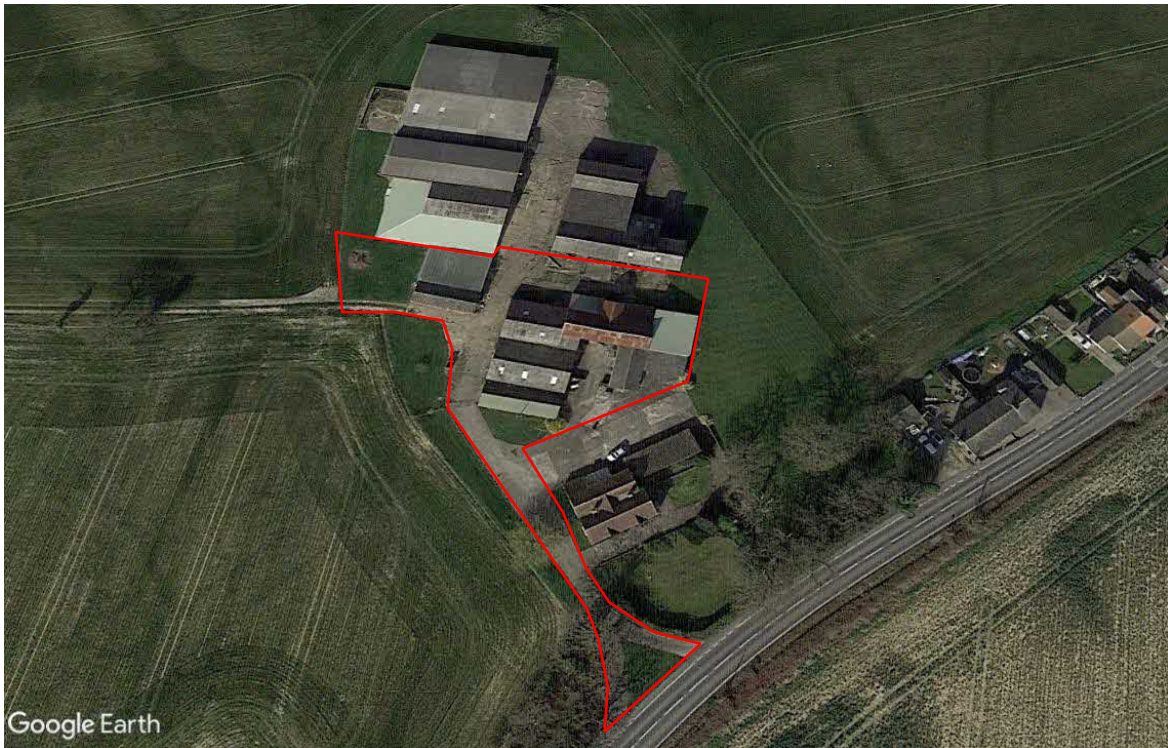
Fig 1B: Aerial plan, with approximate site boundary outlined in red. Aerial photograph sourced from Google Earth Pro

- 3.8 The survey area was limited to the buildings and immediately surrounding land as highlighted in Figure 1B and Appendix 1, plus land within the potential Zone of Influence.
- 3.9 Using criteria provided in best practice guidelines, habitats have been assessed for their potential to support protected species; notably bats, barn owls *Tyto alba*, badgers *Meles meles*, great crested newts *Triturus cristatus*, reptiles, water voles *Arvicola amphibius*, dormice *Muscardinus a vellanarius* and otters *Lutra lutra*.
- 3.10 Where methodologies, classification or recommendations deviate from best practice guidelines, this report provides ecological justification for such changes.

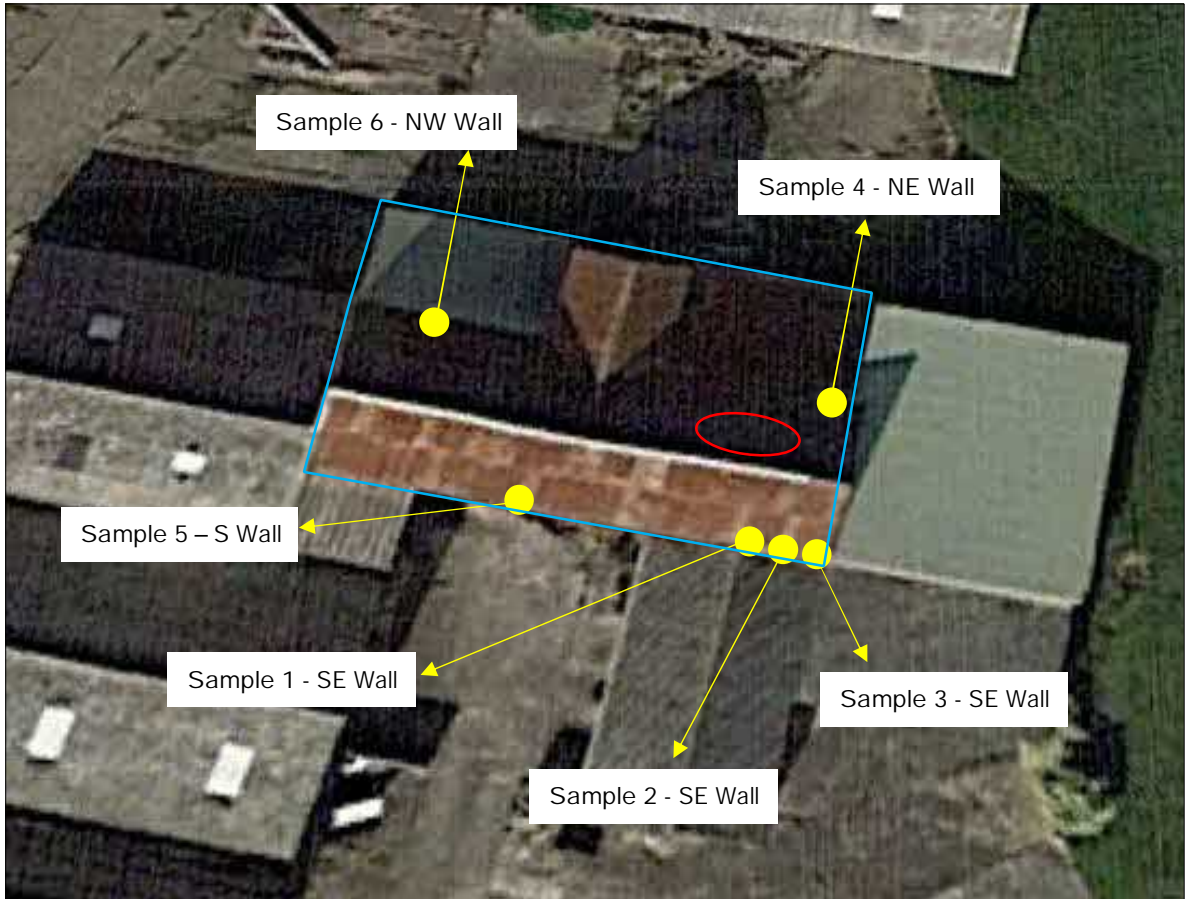
Fig 2: Building 6, outlined in blue, showing locations of six bat dropping samples. Refer to Appendix 2 for the full results of the DNA dropping analysis. Red circle shows location of brown long-eared bat droppings and feeding remains

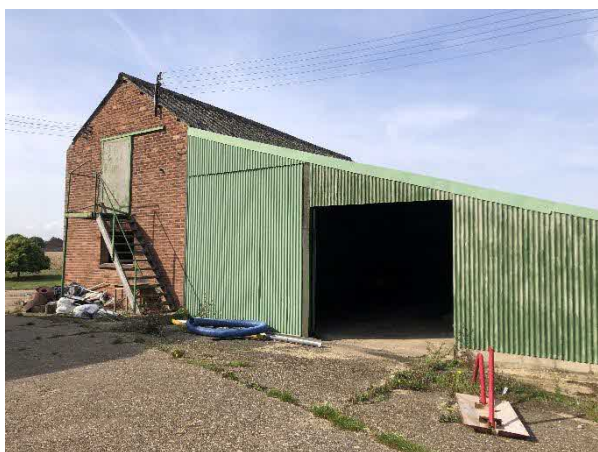
- 4.13 A modern lean-to building with a wood and metal frame covered with corrugated tin. The brick wall it adjoins to the south is in good condition, as is a small section of rendered brickwork in the western wall.

Photo 1: Eastern facade of B1, adjoining B2

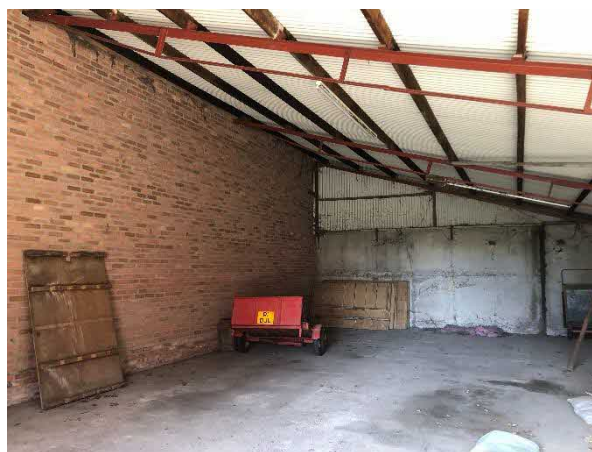
Photo 2: Internal view of B1

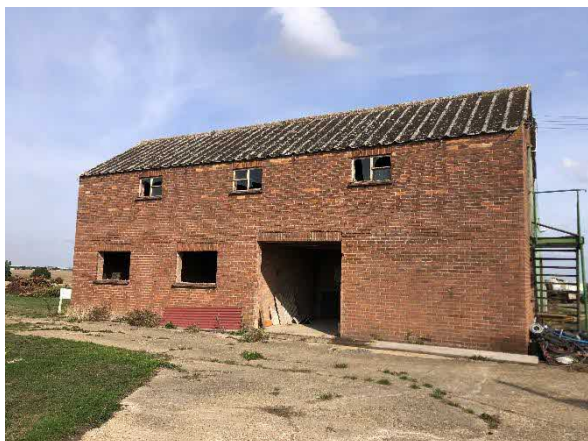
- 4.14 A brick, two storey barn in good overall condition. Most of the metal window frames are missing glass and a doorway in the southern façade is permanently open. A metal roof frame supports unlined corrugated fibreboards. No ridge beam is present. Gaps at the ends of the corrugated sheeting are filled with cement. At ground level there are c.10mm gaps between wooden floor supports and the rear brick wall, but were full of dirt and debris at the time of inspection, not indicative of recent use by bats.

Photo 3: Building 2, southern facade

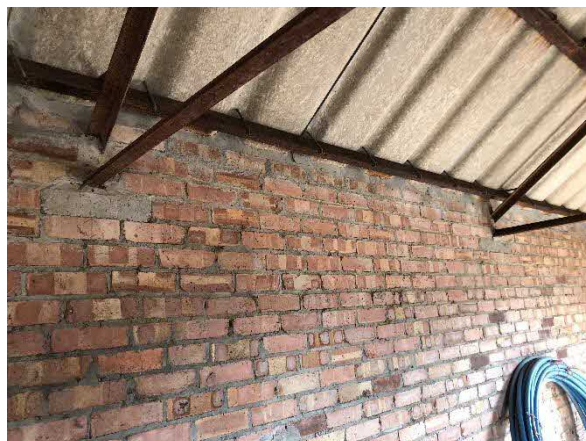
Photo 4: Internal view of B2, upper floor, showing cemented eaves

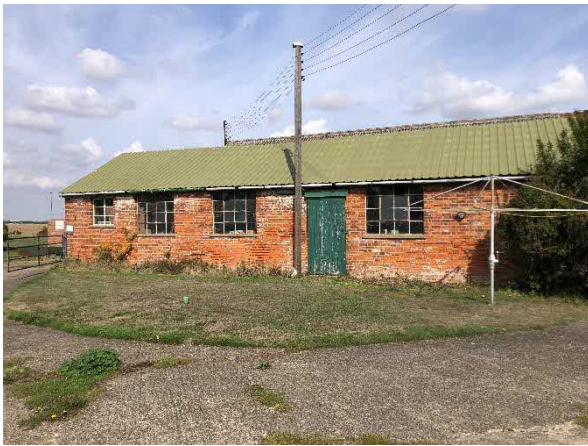
- 4.15 The former dairy and workshop, now dis-used. A single storey brick building with five large metal framed windows along the southern facade creating light internal conditions. A metal roller door sits in the western gable end. Modern wooden rafters and purlins indicate the past presence of roof tiles, however the roof is covered with a mix of corrugated onduline (or similar) and corrugated tin. Part of the ridge covering is missing in places, and the western half of the roof shows extensive rot and frequent holes. Patchy, rotting felt sits beneath small parts of the north eastern roof where a small area of slate tiles appear to remain. The remains of a partially vaulted Styrofoam ceiling are also present here.

Photo 5: Southern facade of B3

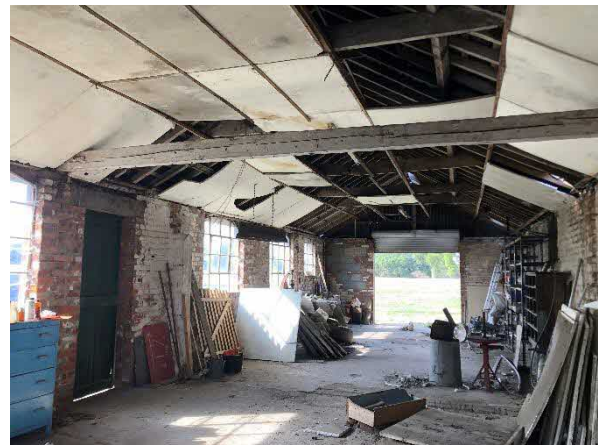
Photo 6: Internal view of B3

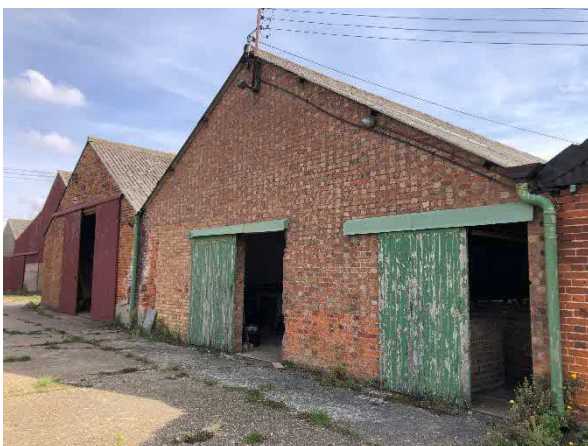
- 4.16 A single storey brick building, formerly used to house cattle, pigs and chickens. Brick walls are in good condition, and a metal frame supports unlined corrugated fibreboard roof sheets. Three large skylights create a light internal environment. No ridge beam is present. At eave height is a central wooden walkway running the length of the building. Significant areas of damp are present on the northern wall where it adjoins Building 5. Pigeon egg shells were recorded in the building, as well as an old swallow nest with no signs of recent use, and a single old bat dropping (dull and crumbly).

Photo 7: Western view of B4, with B5 to north

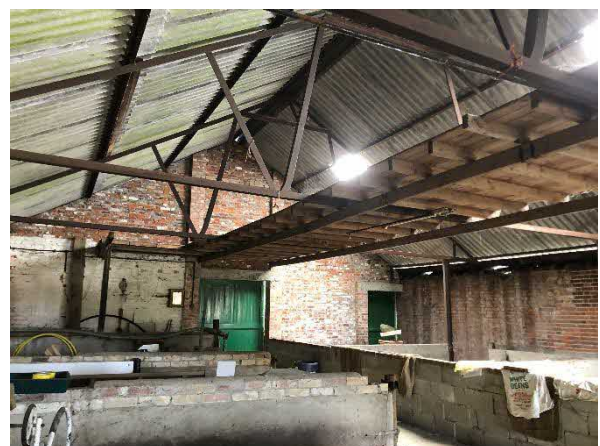
Photo 8: Internal view of B4

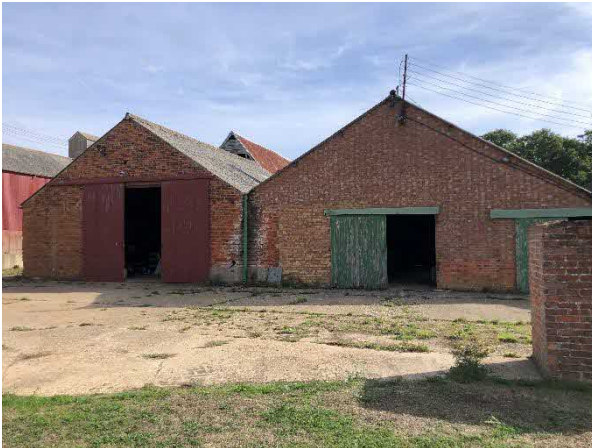
- 4.17 Another single storey brick building, with metal sliding doors. In current use as a workshop. Parts of the internal brick walls are rendered, parts are lined internally with breezeblocks, with no resultant cavity; all are in good condition. Four skylights create a light internal environment, and the corrugated fibreboard roof is supported by metal frame. Gaps at eave height beneath the corrugated sheets are filled with cement.

Photo 9: Western façade of B5

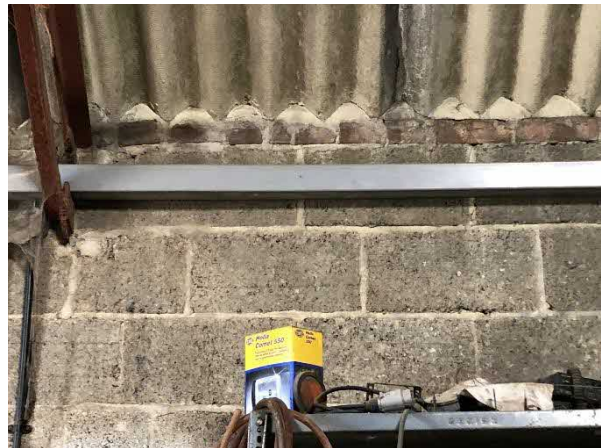
Photo 10: Internal view of B5 showing filled gaps around eaves

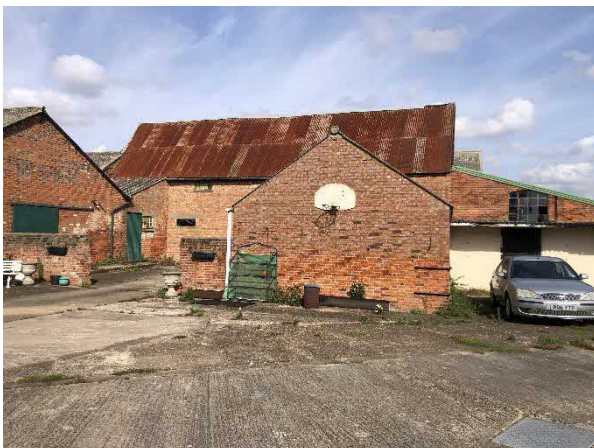
Photo 11: Southern gable end of B7, with tin roof of B6 immediately behind

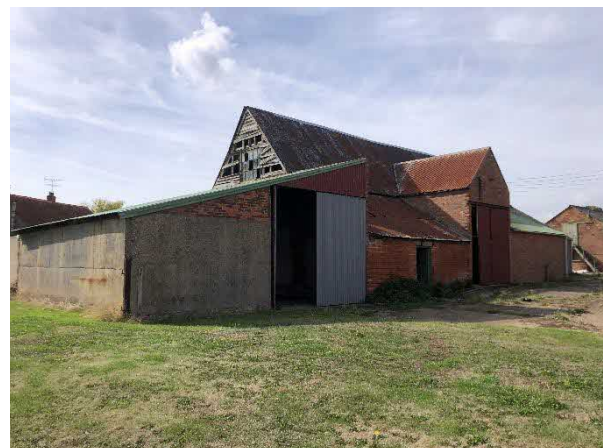
- 4.18 A two storey barn with a northern midstrey and single storey lean-to sections on either side of the northern midstrey. The pitched roof is covered in unlined corrugated tin, and there is no ridge beam present. The wall plate and roof beams appear to be the only remaining part of the original timber frame, with the remainder of the vertical wooden wall beams appearing to have been replaced by brick supporting columns, with the gaps between infilled with brick. Metal window frames are present, with no associated gaps which are not filled with very dense cobwebs and large spiders.

Photo 12: North eastern facades of B6, with adjoining to the east

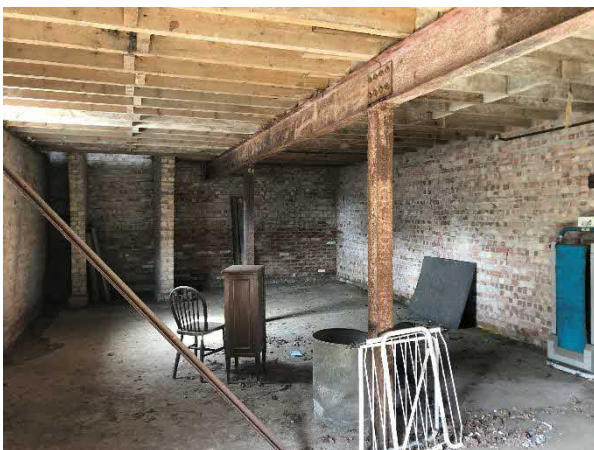
Photo 13: Internal view of B6, ground floor

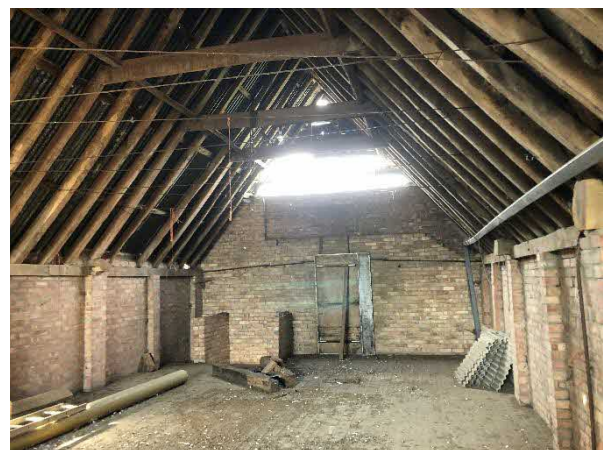
- 4.21 At first floor level, <10 bat droppings were recorded beneath a gap between the wall plate beam and brick column on which the beam rests, and beneath a warped join in the wall plate beam (see Figures 2 and 4). A further two potential roosting crevices – gaps in adjoining wooden wall plate beams – were noted close to the centre of the northern wall, but with no associated bat droppings. Both crevices could be fully inspected.

Photo 14: Internal view of B6, upper floor. Brickwork to eave height, and above eave height at the gable ends. Wooden wall plate rest: brick walls

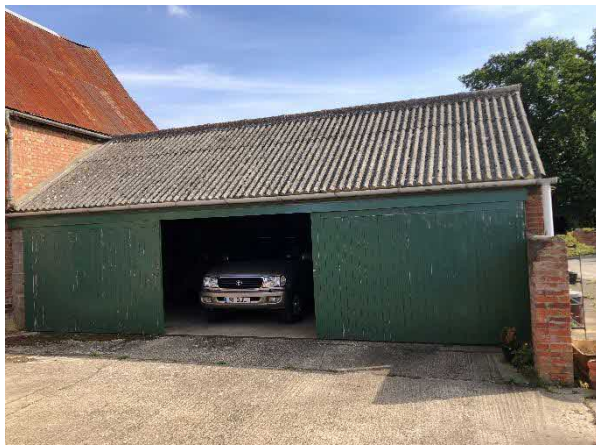
- 4.24 A single storey brick building with metal sliding doors and a corrugated fibreboard roof supported by a metal frame. Brick walls are in good condition. The roof has been internally insulated with a sprayed foam.

Photo 15: Western façade of B7, with B6 to north

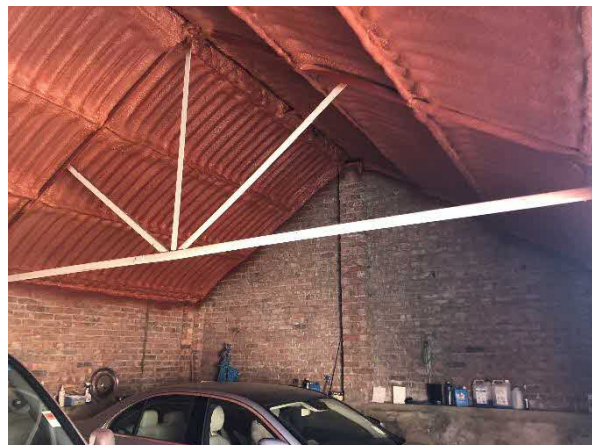
Photo 16: Internal view of B7, showing foam line roof

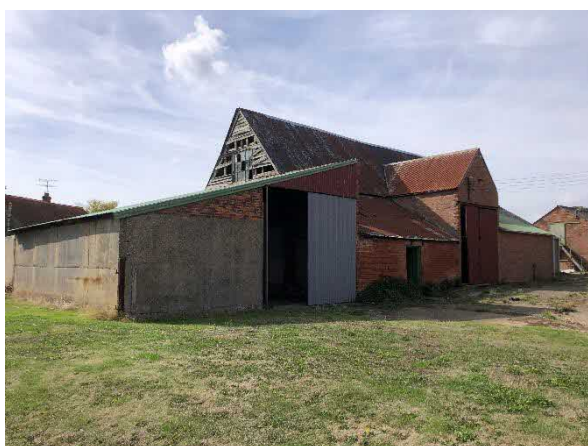
- 4.25 A single storey modern lean to, built of partially rendered brickwork with an unlit corrugated metal sheet roof supported by modern, closely fitting wooden beams. A sliding metal door is present on the northern wall.

Photo 17: North western facades of B8, with B6 background

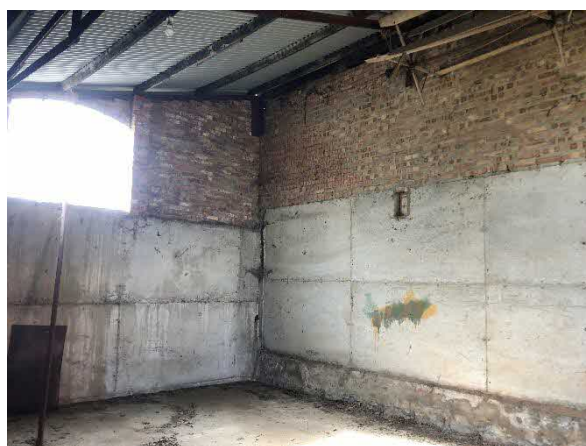
Photo 18: Internal view of B8

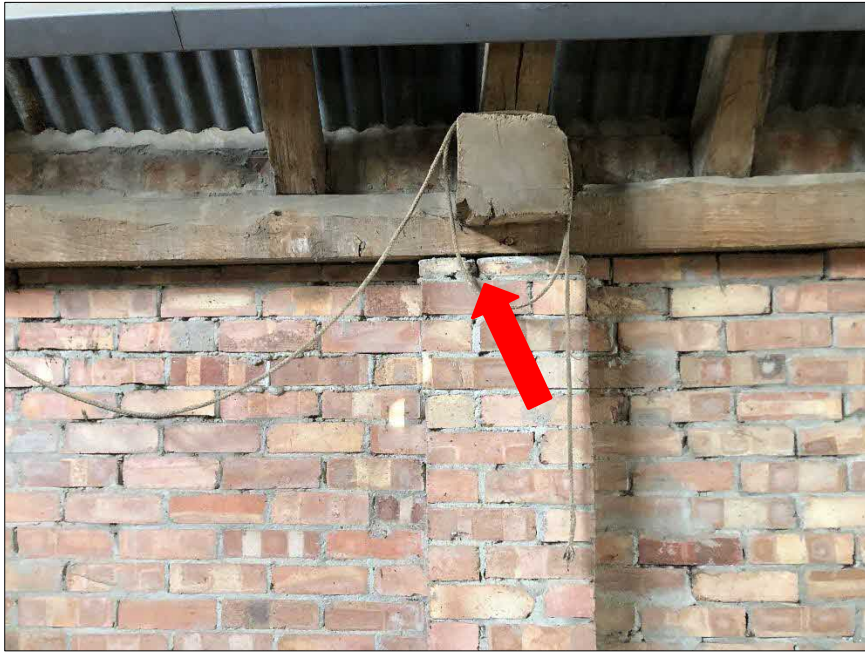
Left: location of confirmed features in north west corner of the barn (Sample 6 – NW Wall), where 8 common pipistrelle droppings were recorded beneath a clean crevice between the brick column and wooden wall plate

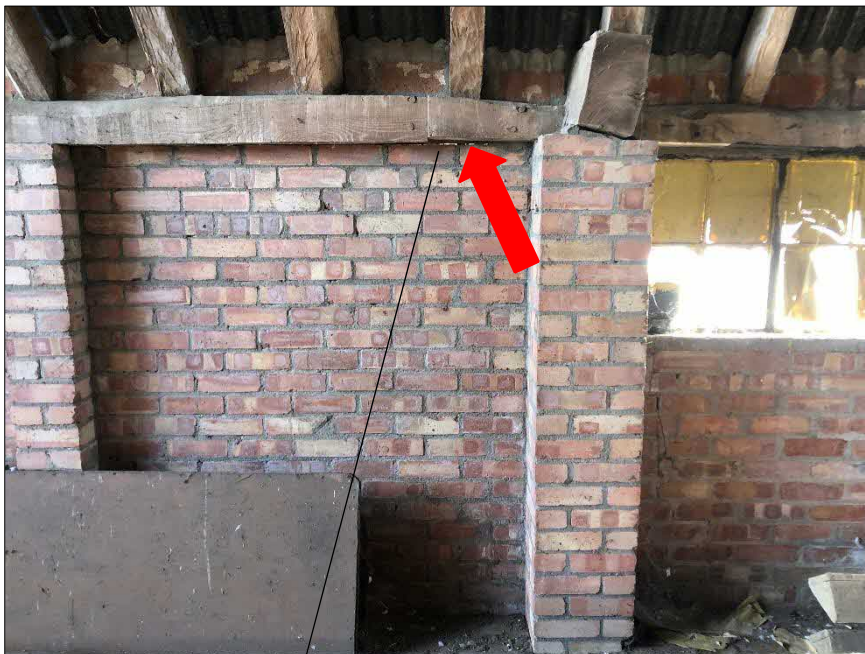
Above: location of confirmed common pipistrelle roosting crevice on the southern wall, in a gap between two adjoining wall plate beam sections (Sample 7 – S Wall), as indicated by red arrow

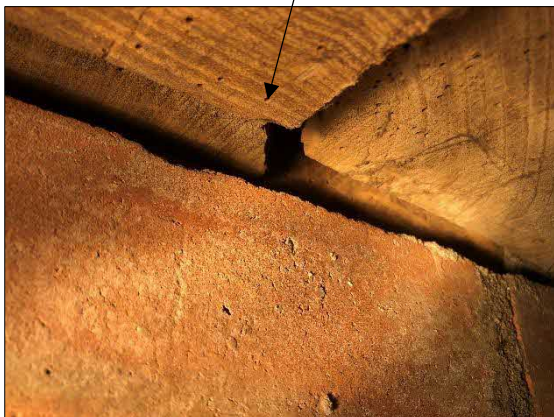
Left: close up of gap between wall plate section and between wall plate and brick wall. Common pipistrelle droppings were recorded in this crevice and on the floor beneath

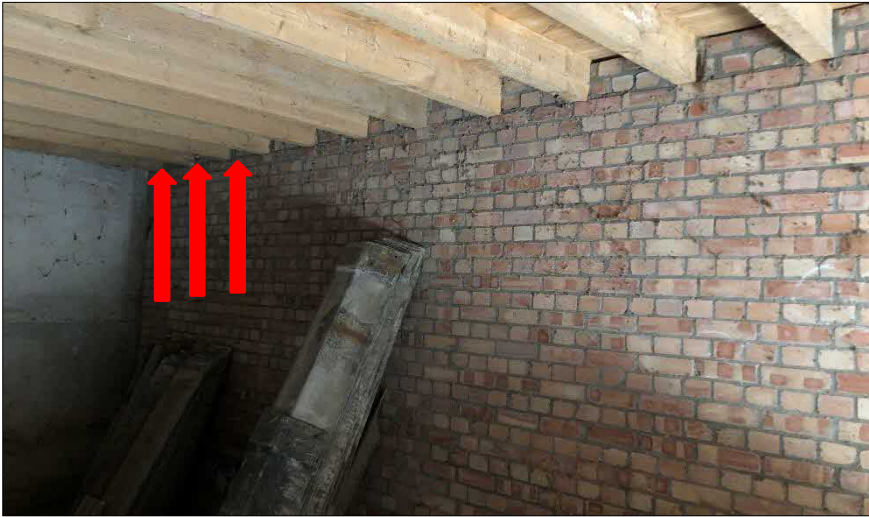
Above: location of three confirmed common pipistrelle roosting crevices in gaps between floor boards and the supporting wall beams (Samples 1, 2 & 3 – SE Wall), as indicated by red arrows

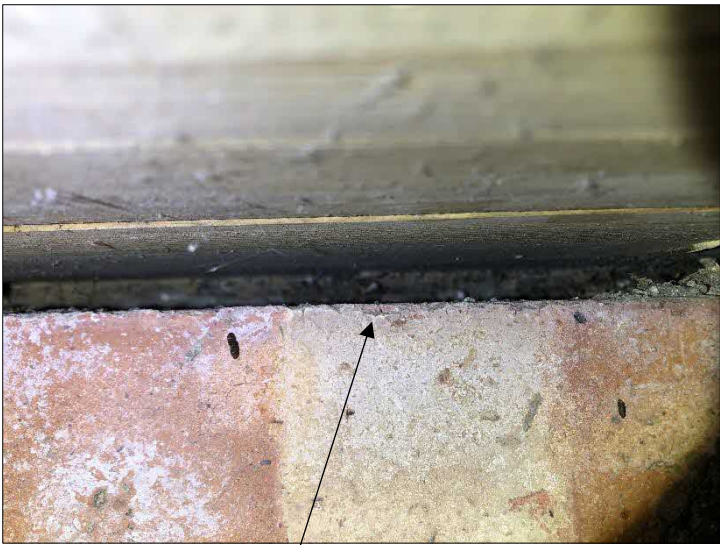
Left: close up of gap between brick wall and floor boards, with droppings on wall beneath

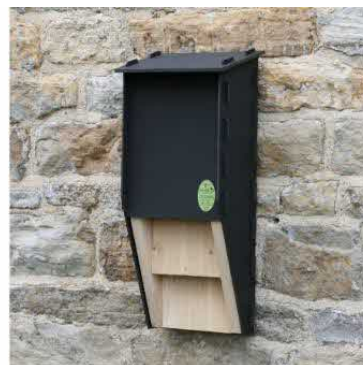
Vivara Pro Beaumaris woodstone box midi– for installation on walls or trees

- 6.3 **2 no. bat boxes** will be fixed externally to existing offsite buildings within the blue line boundary to provide alternative roosting opportunities for the duration of demolition and construction, and will be retained permanently as an enhancement for local bat populations. The boxes will face two different aspects, at heights of 3-6m. There will be a 1-2m clear drop beneath the box entrance i.e. clear of all wires etc. The recommended box types are shown below; others must be agreed with an ecologist.
