**Bat Survey Report for
Upper Chimney and surrounding roof,
Turkdean Manor, Turkdean,
Cheltenham, GL54 3NU**

NKM Associates

19th April 2023

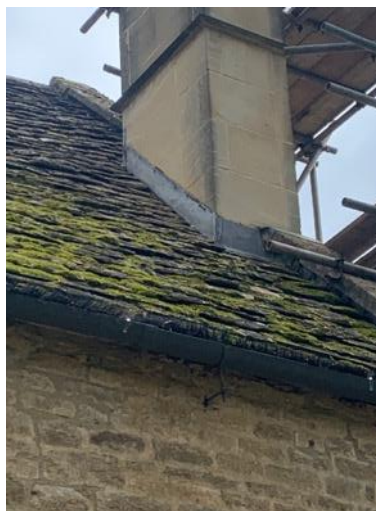
Fig. 1 Aspect to the west

The survey site comprised the upper chimney and surrounding roof of Turkdean Manor (Fig. 1).

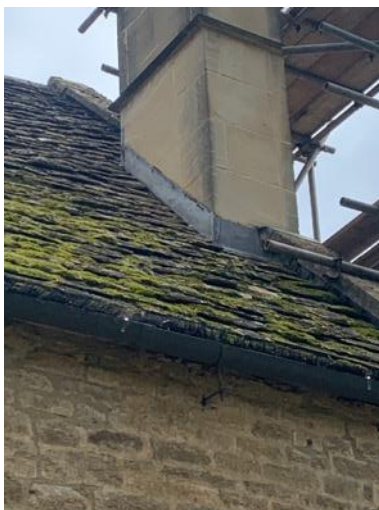
Figs. 2 & 3 Upper Chimney and surrounding roof (L); vaulted room (R)

The stonework of the upper chimney was in good condition with no crevices or gaps, the adjoining roof tiles were all present with two slightly raised tiles which when closely inspected were considered too small for bat occupation and had cobwebs over their front edges, the lead flashing was tightly moulded all round (Fig. 2). Internally the room directly below the chimney was vaulted (Fig. 3).

No evidence of bat activity was found around the outside of the upper chimney and adjoining roof or inside the room directly below the chimney.

At the time of the survey, the upper chimney and surrounding roof were not identified as bat roosts or hibernation sites, and as such no further surveys or mitigation measures are required.
