HERITAGE, DESIGN & ACCESS STATEMENT

PROPOSED DE & RE-CONSTRUCTION OF ASHLAR CHIMNEY STACK

THE STABLES TURKDEAN MANOR, TURKDEAN, CHELTENHAM, GLOUCESTERSHIRE, GL54 3NU

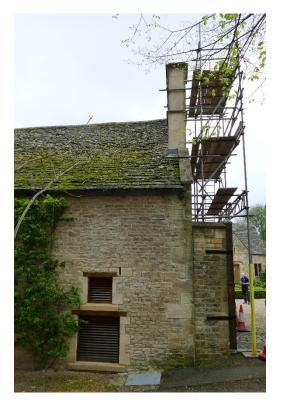
Photograph 1.2 The Stables – Northern Elevation

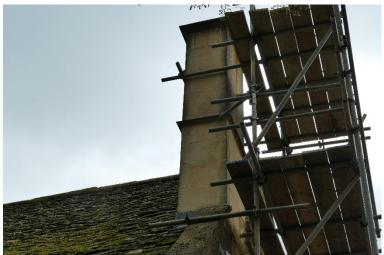
Photograph 1.4 Ashlar stack – Northern aspect

- 1.4 The existing ashlar stack was constructed around the turn of the millennium for aesthetic reasons to obscure two integrated stainless-steel flues installed in conjunction with two oil-fired boilers located in the plant room at ground floor level within The Stables, with the original consent for construction of the stack (*Ref: CD.1225/C* & *CD.1225/D*, *dated* 21st April 1998) being subsequently altered via an informal minor amendment request to subtly reposition the stack, agreed in writing by Cotswold District Council on 26th November 1998.

- 1.7 Following closer examination of the existing system, removal of the existing flues without de-construction of the existing ashlar stack has been found to be impossible, due to an existing kink present to the flues and that the existing system may have been clipped in place internally in locations within the chimney breast and stack.

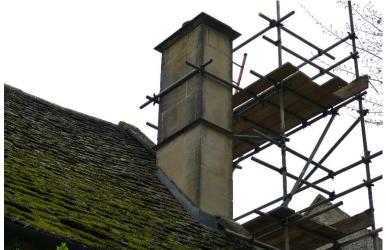
Photograph 1.5 Ashlar stack – Northern and Eastern aspects

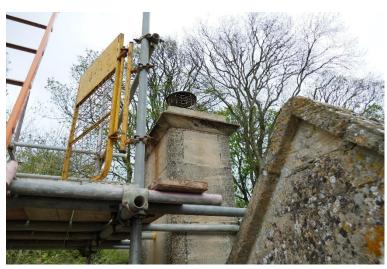
Photograph 1.6 Ashlar stack – Southern aspect
