Preliminary Roost Assessment:
The Old School House, Ashbocking, Suffolk

On behalf of:
Mr and Mrs R Webber

Report version:
Version 1:
June 2023

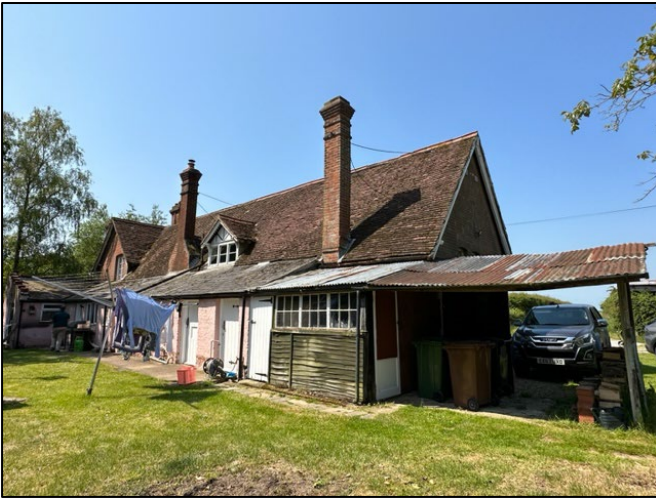
- 4.4 The modern rear extension projects to the east and is proposed for demolition/replacement. It is single-storey and split into several rooms, storage, bathroom, kitchen and a small log store/lean to on the northern end. The log store is an open building with tin roof, otherwise the remainder of the building is a mix of boarded or brick walls and an asymmetric slate tiled roof. All rooms were inspected internally, there is no loft void above. Roof tiles are generally in good condition throughout, none were noted as slipped or missing and they are tightly sealed. The large brick chimney breast on the southern aspect is well-sealed with intact lead flashing (note no chimney stacks will be affected). Several tiles above the kitchen, facing north are covered with moss. No bat droppings were identified externally on roof tiles, nor on walls, around window frames or the floor.

a) Extension, to be demolished and replaced.

- 5.3 As a precautionary measure, it is recommended that slate roof tiles are removed carefully from the top down and carefully checked before being discarded/stored for re-use. Ideally, works will take place in September/October when the risk of encountering wildlife, including nesting birds is greatly reduced.

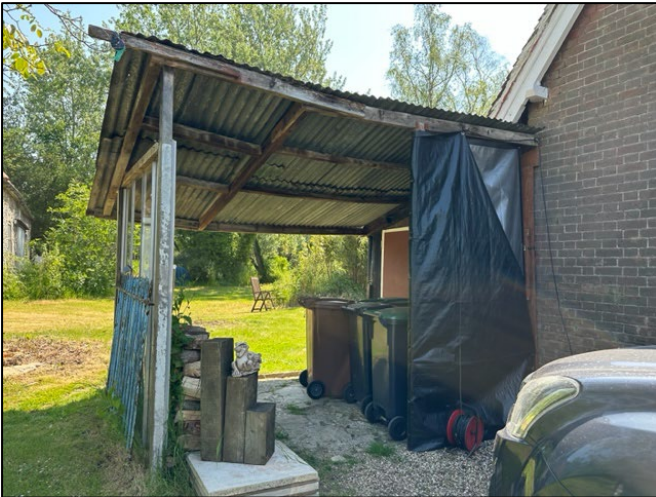
b) Northern end of extension – log store.

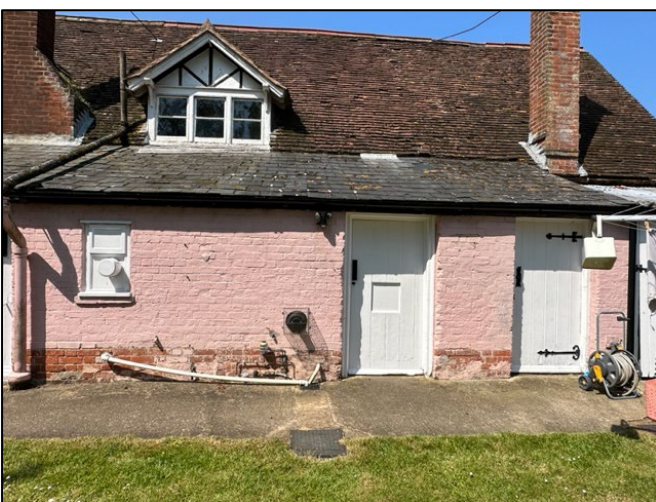
c) Store and utility room.

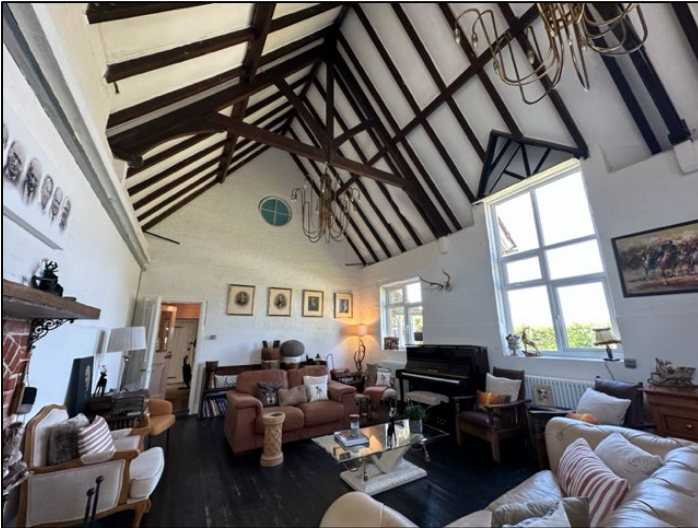
- 4.3 The main house has brick walls and is two-storeys with a pitched, tiled roof aligned north/south. There are 4 large brick chimneys. There are minor crevices under roof tiles on the eastern and western aspects of the roof, although the main roof will be completely untouched. Internally, the ceiling is vaulted and the rooms are open to the ridge, there is no enclosed loft void.

d) Vaulted ceiling inside the main house.

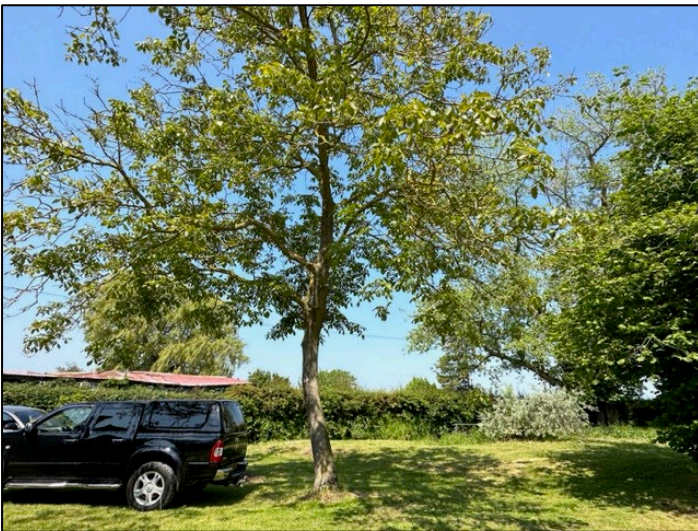
- 4.6 The house is surrounded by a well-maintained garden, there is a semi-mature walnut tree to the north, and several oak and silver birch trees to the east/south-east. There is a native hedgerow extending to the east from the kitchen. We understand all surrounding vegetation will be retained and protected throughout works. Heras fencing is recommended around at least the “drip line” of tree canopies to ensure direct damage is avoided. Parking/storage of materials within Root Protection Areas should be avoided.

e) Walnut tree to the north, to be retained and protected.

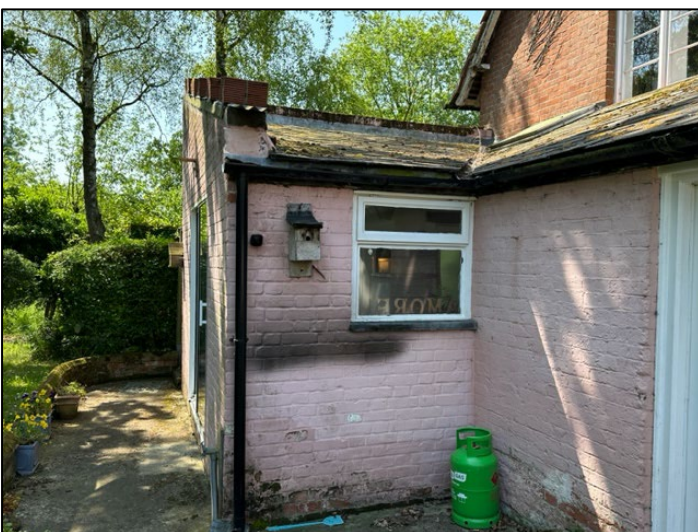
f) Bird boxes on the kitchen, to be removed outside nesting season.

4.7 There are bird boxes installed around the kitchen, facing north and east. Active nests are legally protected. It is recommended that bird boxes are removed between September – February inclusive or when it is clear to the occupants that any young have fledged.

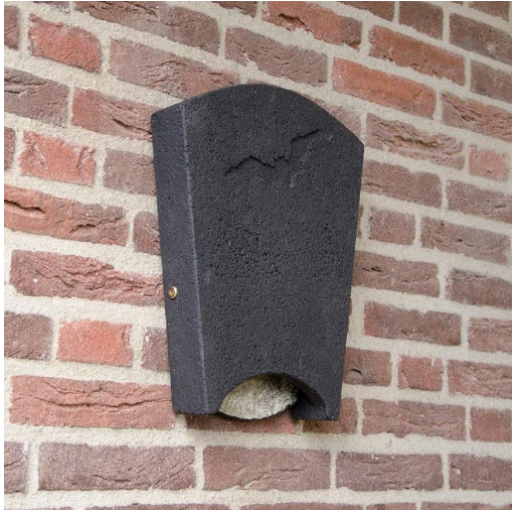
Beaumaris bat box for gable ends [Beaumaris WoodStone Bat Box Midi | Vivara](#)

- 5.5 It is recommended that at least one bat roost feature/box is installed on site, ideally on a retained mature tree. Bat boxes should be installed above 3 metres and face south, south-east or south-west for maximum chance of occupation. Bat boxes could also be integrated into the walls of the new extension, or externally mounted. See Appendix 1 for recommendations.

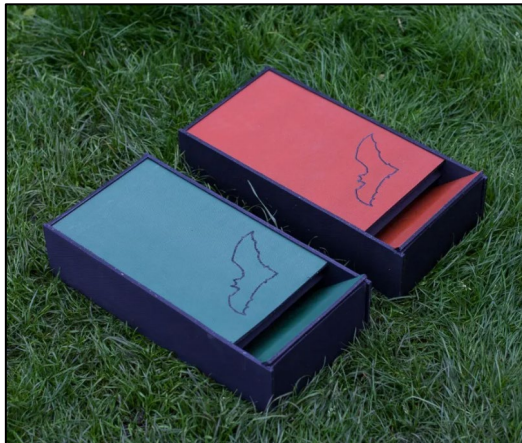
Integrated Eco Bat Box – [Integrated Eco Bat Box | NHBS Practical Conservation Equipment](#)
