Preliminary Bat Roost Assessment.
of
10 Edies Lane, Leavenheath, Suffolk, CO6 4PA.

Survey Commissioned by:	Mrs Yasmine Clarke
Project Number:	REP23004
Report issued:	17 th February 2023
Date of survey:	25 th January 2023
Surveyor:	Odette Robson BSc (Hons) PhD MCIEEM

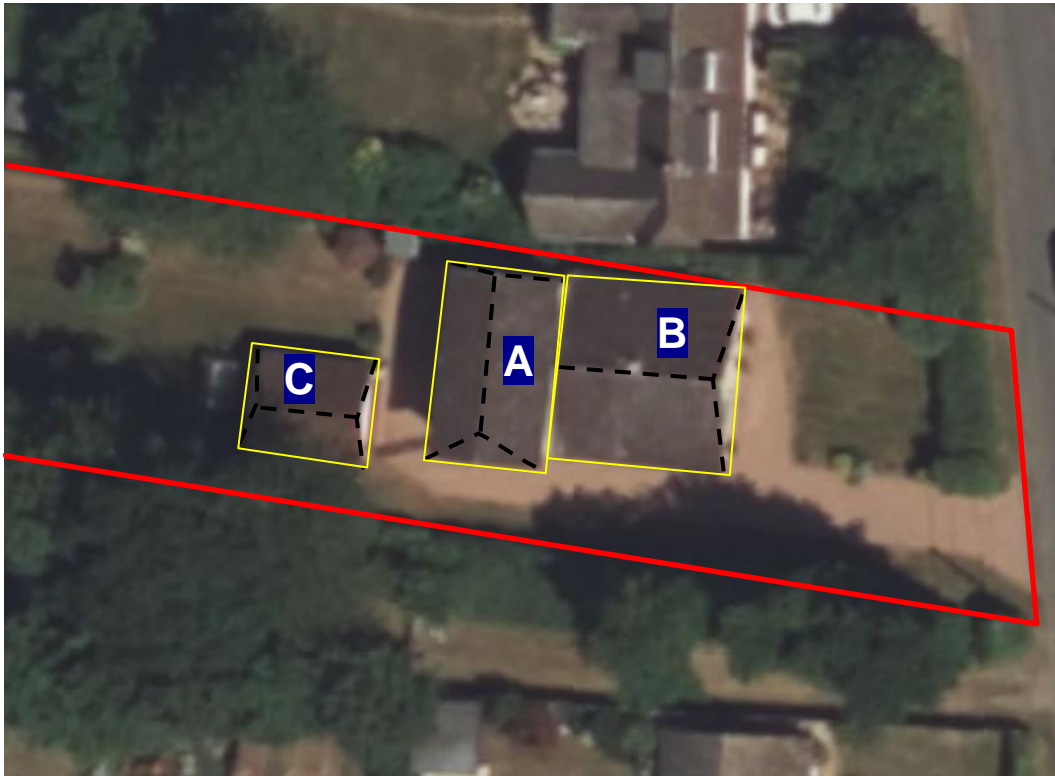
Figure 3.1 – Target Note locations. **A** = two-storey dwelling; **B** = attached single-storey dwelling; **C** = detached, single-storey garage.

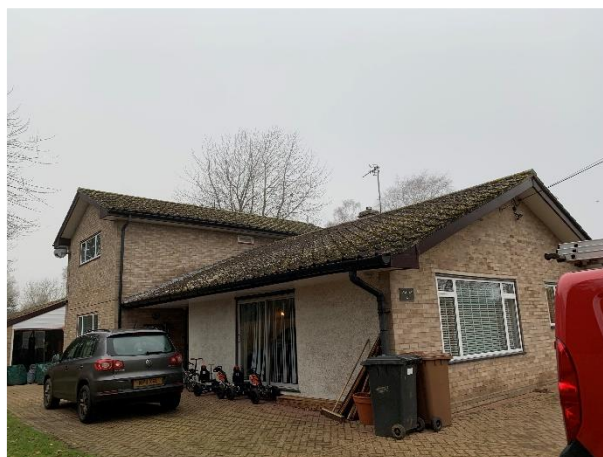
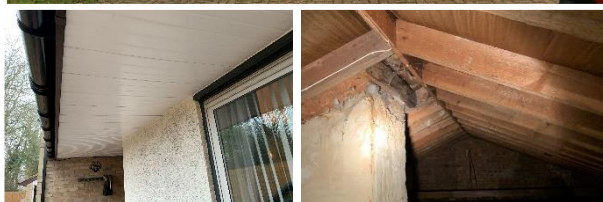
Section B - Single storey house.

External: The single-storey section (B) adjoins A below the eaves on the eastern elevation. Similar in build-materials and condition as A, with intact bricks/mortar and roof-tiles on the shallow double-pitched roof. Large uPVC soffits were well-sealed to the brickwork with no gaps or crevices beneath at the wall-join. All windows were well-sealed into brick surrounds and there were no gaps at the east-facing gable end. No access points for bats or birds into the roof/cavity.

Internal: The roof void was insulated with lagging. The roof tiles were internally lined with a paper-backed lagging insulation. Modern roof timbers and no crevices. Rendered chimney was cobwebbed. No droppings or other evidence of bats was recorded. Overall risk of presence of roosting bats or nesting birds was negligible.

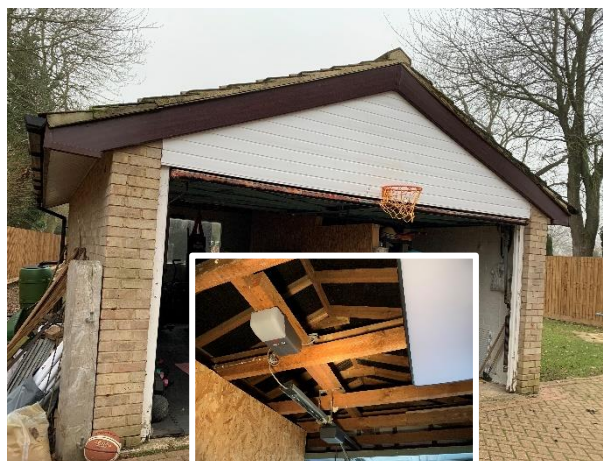
Section C - Garage

The detached garage was of similar build-materials to the house and in similarly intact condition to Sections A and B: uPVC soffits and boarding on the eastern gable were well-sealed to brickwork. Roof-tiles were intact and sealed with no gaps or lifting/damaged tiles.

Internally, there was no roof-void: Roof timbers were cluttered and the roof was internally lined with bitumen roofing felt. High internal light levels due to a window on the western elevation.

Negligible potential for roosting bats or nesting birds due to lack of access and nesting/roosting opportunities.

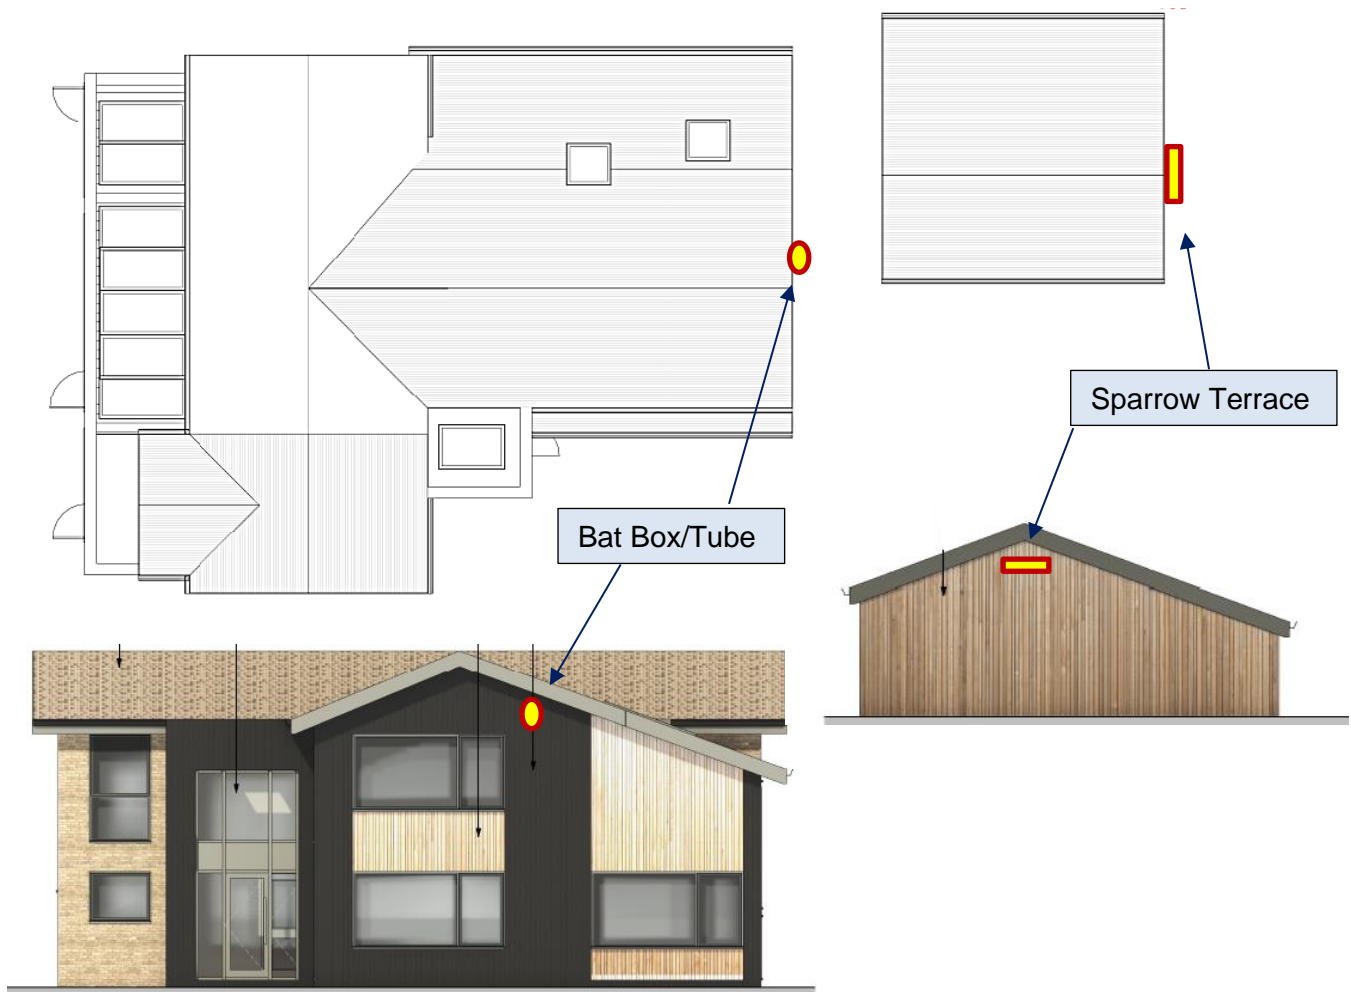
Figure 4.1: Location of enhancement habitat boxes

An integrated bat tube, or building-mounted box (see Table 4.1) could be mounted on the east-facing gable end of the house: e.g., low profile Chillon or Beaumaris externally

mounted boxes, or an integrated box under the vertical timber cladding (not above a window or door). Location is shown in Figure 4.1.

The BoCC red-listed house sparrow has been recorded locally and will readily use nesting boxes. With installation of artificial nesting opportunities, this species can be encouraged to breed on the site post-development. Sparrow terraces, such as the Schwegler 1SP, open fronted Vivara Pro WoodStone House Sparrow or WoodStone Build-in House Sparrow Nest Box, would be suitable for the new car-port. One of these house sparrow terraces (or three individual boxes, located close together for this colonial nesting species) could be installed just below the eaves on the eastern elevation of the new-build car-port/garage outbuilding.
