Phase I Geo-Environmental Desk Study

13-15 West Street
Over
Cambridgeshire
CB24 5PL

EPS Project Reference: UK23.6479

Date Issued: 14th June 2023

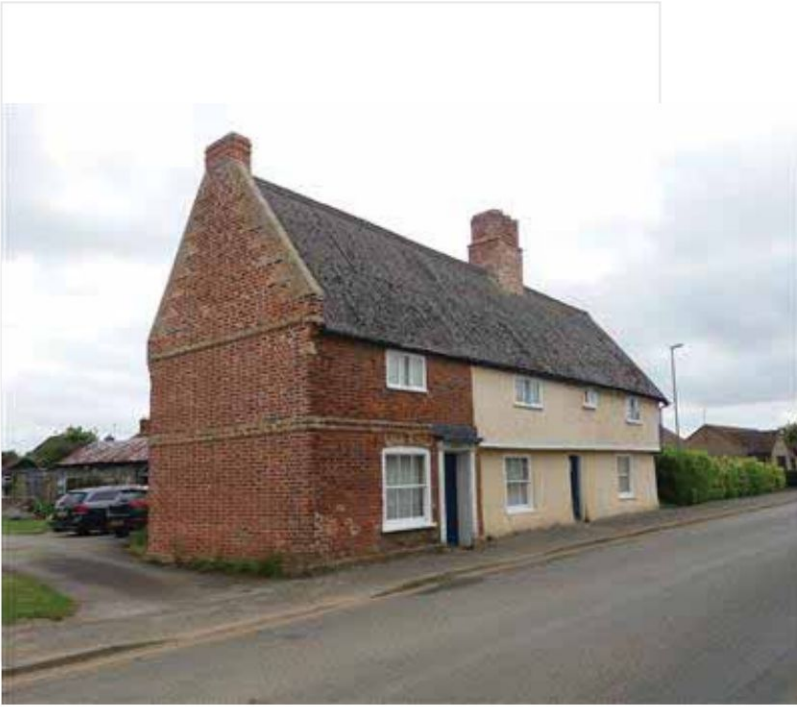
General Site Photo 1

2-storey brick-built semi-detached house at the front, with driveway to the west of the house leading to rear parking space and garden. A number of garages/outbuildings span both the east and west site boundaries in various states of dilapidation.

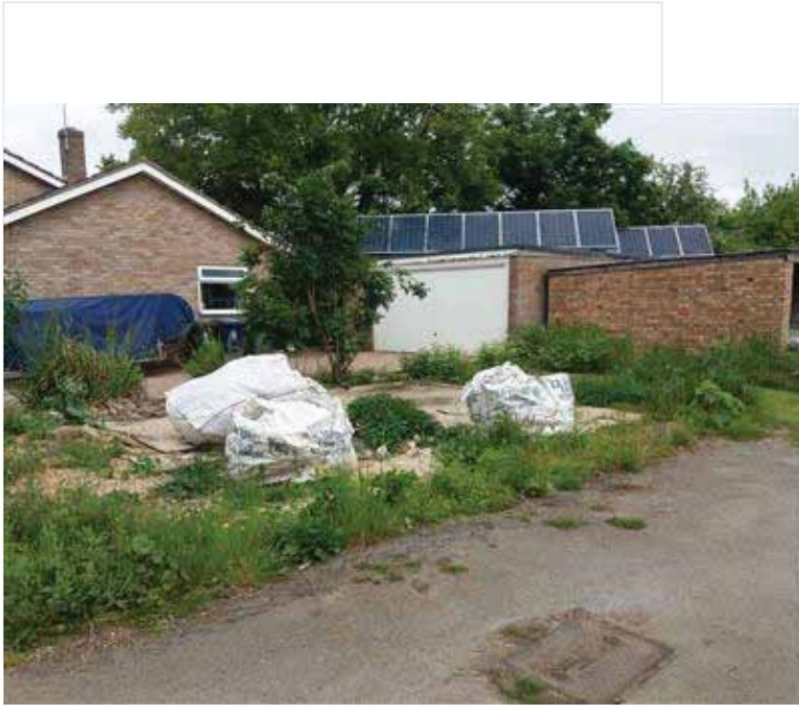
Photo of historic site use.

Concrete floor slab still present where a former barn used to stand in SW corner of site.

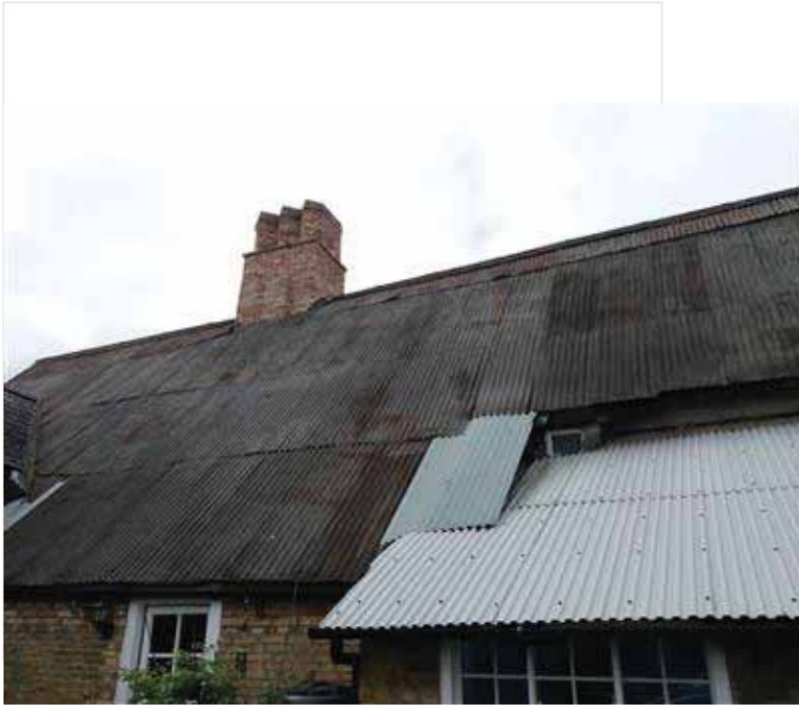
Photo of suspected asbestos

Suspected asbestos-containing cement sheeting present in roof of main house and western garage.

- In terms of the suspected asbestos-containing materials within the roof construction of both the main house and one of the garages along the west side of the rear garden, if any of these are to be disturbed during the development works then they must be fully assessed, and if necessary removed and appropriately disposed of, by a specialist contractor.

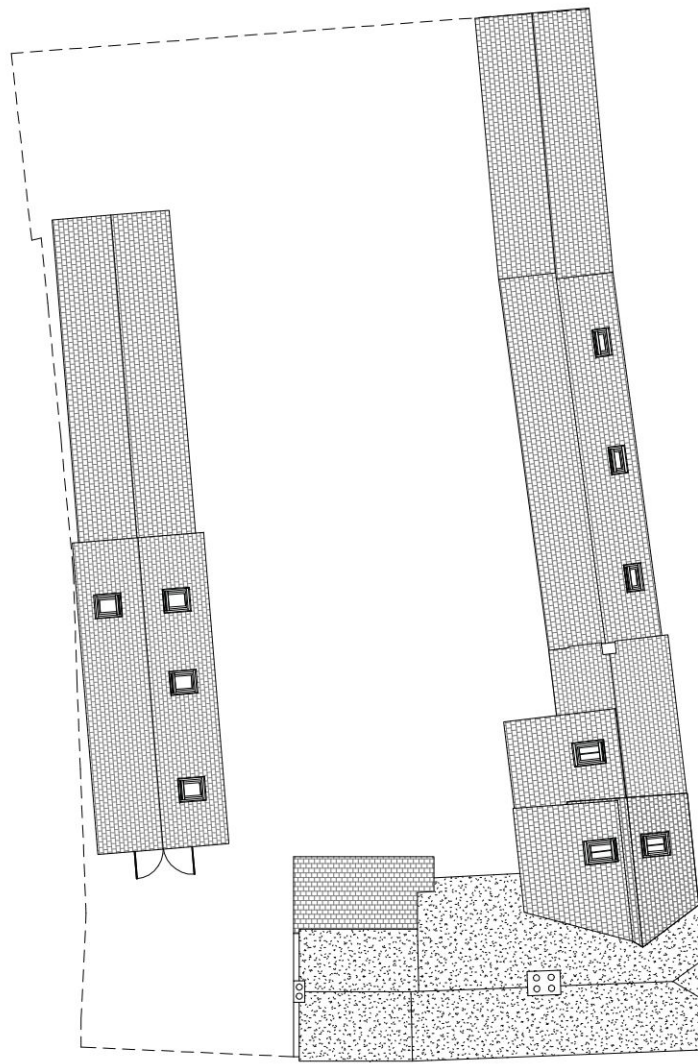
1 Existing Site Plan
1 : 200

Flat roof garage and store. Poor state of repair. Not Listed.

Flat Roof out-building. Poor state of repair. Not listed.

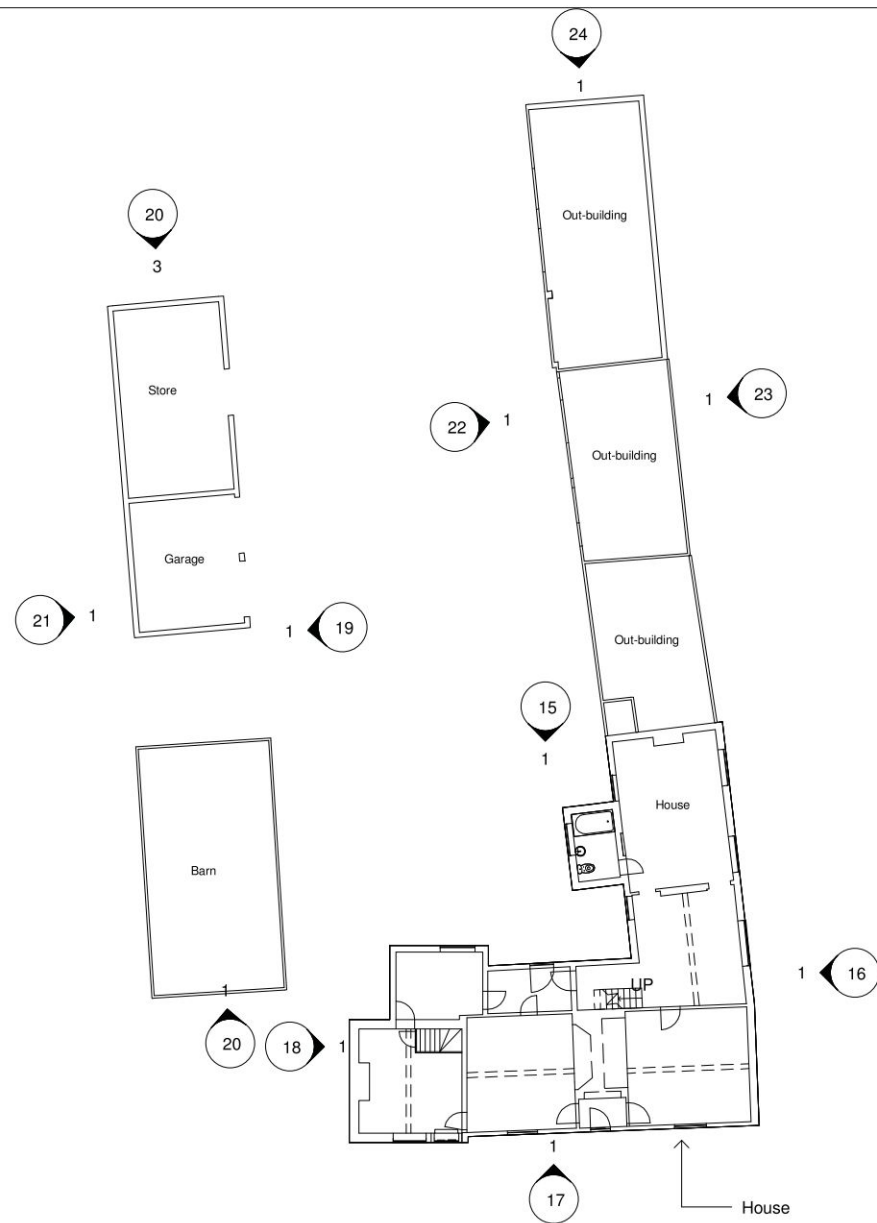
1 Proposed Site Plan
1 : 200

↑ For Information. Extend existing drop kerb in front of proposed garage. This would be applied for as a separate application to the highways authority.
