Preliminary Bat Roost Assessment

**Church Lane Cottage, Church Lane,
Aldham, IP7 6NP.**

Survey Commissioned by:	Paul Pentney on behalf of Mr Peter King
Project Number:	REP23007
Report issued:	12 th March 2023
Date of survey:	13 th February 2023
Surveyor:	Odette Robson BSc (Hons) PhD MCIEEM

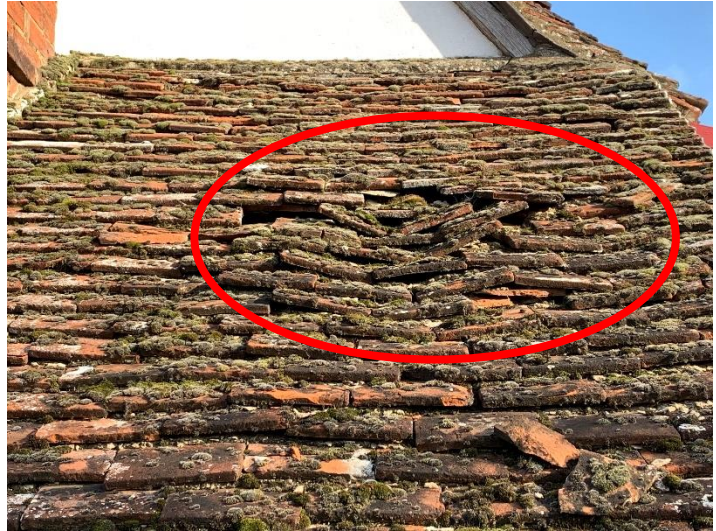
Lean-to - SW Elevation

Single-storey extension with well-sealed painted brickwork. Peg-tiled mono-pitched roof was mostly sealed and sparsely moss-covered. Damaged area of slipped and missing tiles which could provide access to bats to the cavity between roofing felt and tiles.

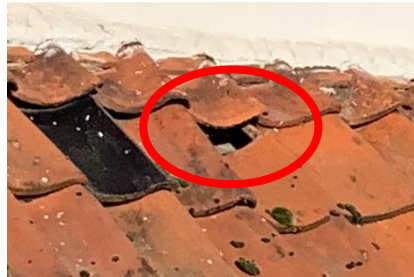
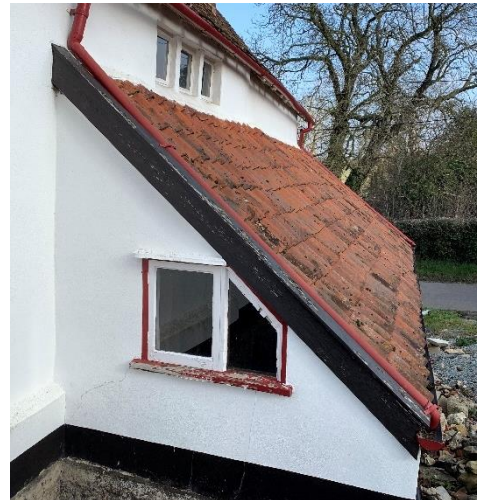
Lean-to - SE Elevation

Peg-tiled roof with occasional lifted and damaged tiles, though mostly intact. A cracked tile close to the wall-join (circled below) provided potential bat-access to the crevice between tiles and roofing felt beneath.

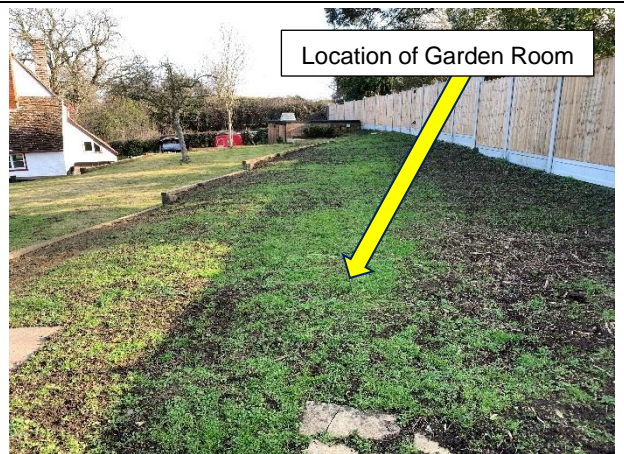
Garden:

The location of the proposed Garden Room was paving slabs and sparse ruderal vegetation.

No protected species issues in relation to construction of the proposed structure.
